PRELIMINARY REPORT

ACCIDENT 2021/3056

AIRCRAFT – Diamond DA-42 airplane, SP-TRL

DATE AND PLACE OF OCCURRENCE – 19 August 2021, EPMO

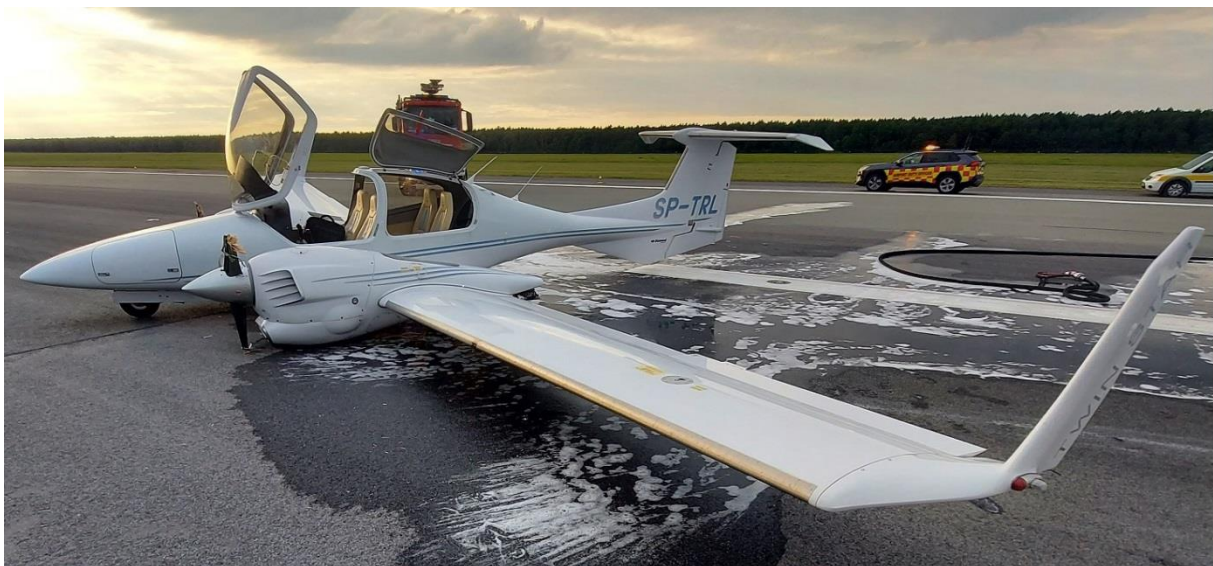
As a result of the accident, the airplane sustained substantial damage (Fig.1). The wheels of the main landing gear were broken off (Fig.2), the nose landing gear and both propellers were damaged (Fig.3).

Fig. 1. The airplane after the accident – general view (source: PKBWL)

As a result of the airplane movement without the landing gear, the lower part of the fuselage and the lower engine fairings were damaged. Probably the engines were also damaged, but it is not possible to determine the level of damage at the current stage of the investigation.

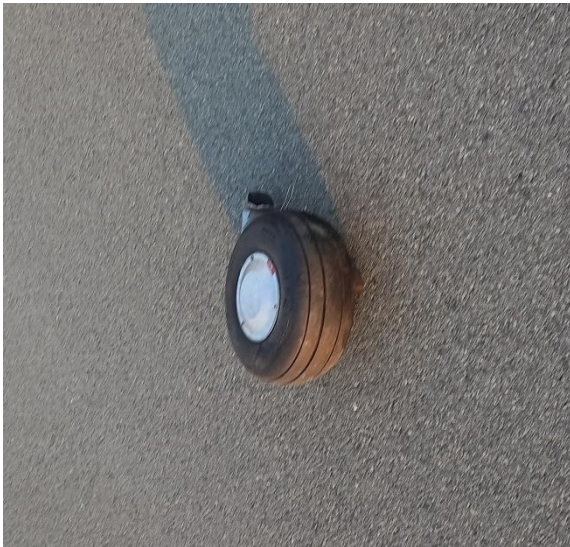
Fig. 2. Separated wheel of the main landing gear (source: PKBWL)

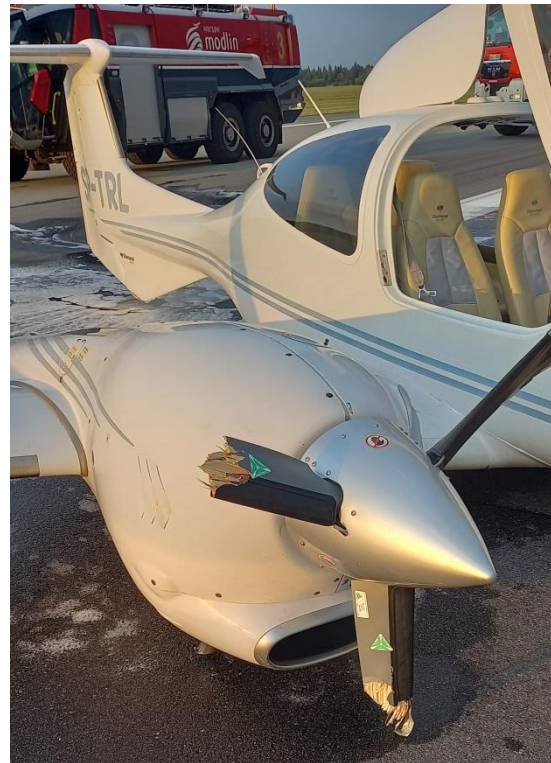
Fig. 3. Damaged propeller of the right engine (source: PKBWL)
