PRELIMINARY REPORT

SERIOUS INCIDENT

OCCURRENCE NO – 2022/2076

AIRCRAFT – Aeroplane, Tecnam P2008-JC, SP-SCS

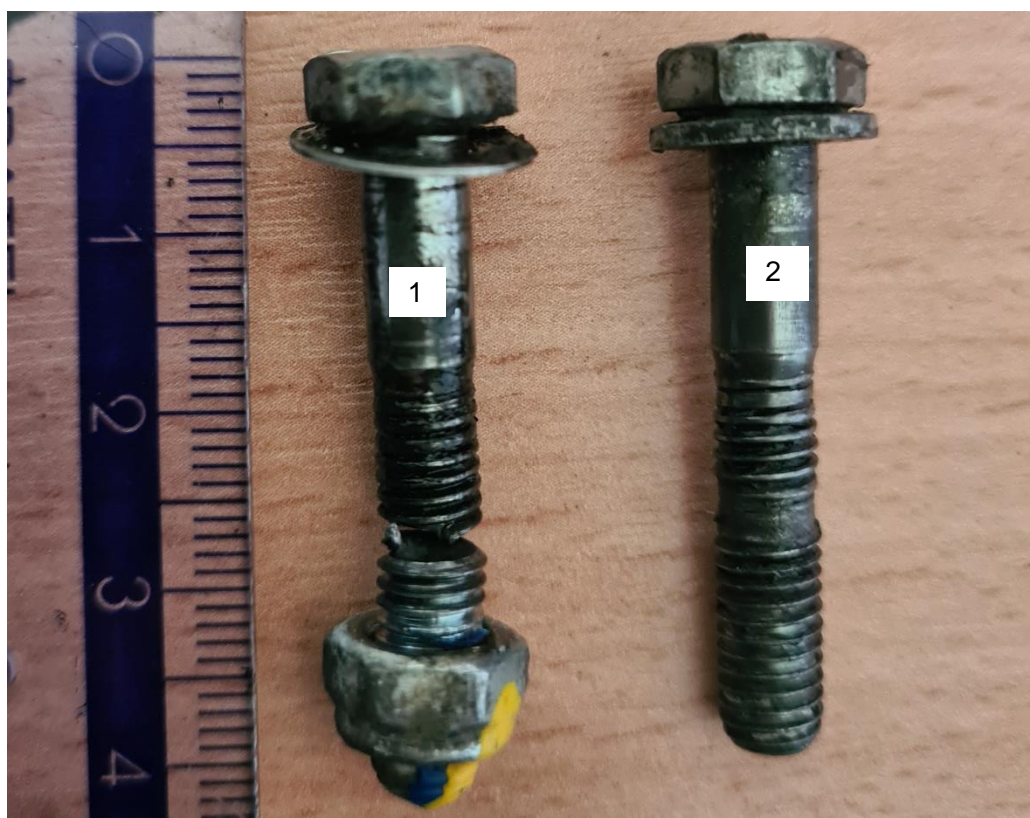
During the inspection of the plane after the flight, it was revealed that the left bolt of the stabilator hinge was broken and the right bolt was damaged (Fig. 1).

Fig. 1. Broken (1) and damaged (2) bolt of the stabilator hinge [source: PKBWL]

The thread was also damaged on the broken bolt. In addition, both bolts were bent. According to the information obtained, from some users in recent years, due to the occurrence of excessive play at the stabilator, the bolts were replaced on eight aircraft and all of them were detected during inspections or maintenance. The incident that occurred on May 6, 2022 occurred inflight and posed a serious hazard to flight safety due to blockade of the stabilator.

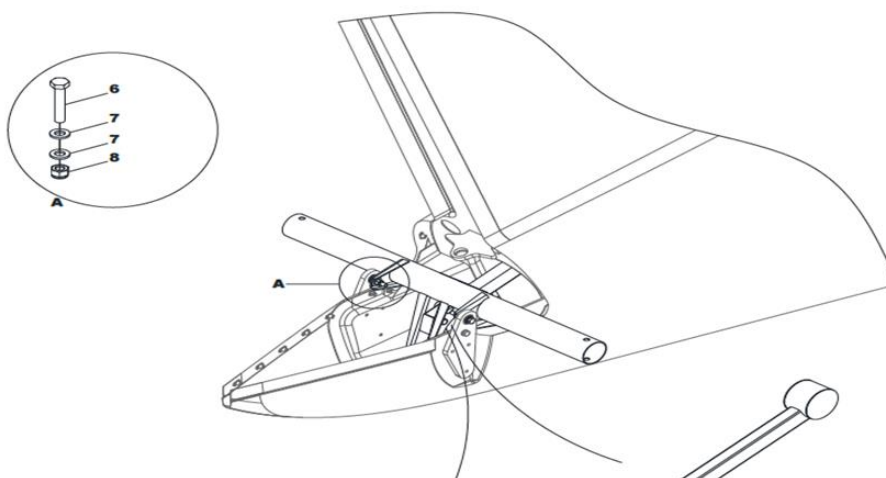
During visual inspection the left bolt of the stabilator hinge (PN UNI 5736-6-35) was found broken (Fig. 2, item 6).

Fig.2. Broken bolt P/N UNI5737-6-35 (item.6) [source: IPC]

In order to determine the factors causing damage to the thread, measurements of bolts and connected elements (hinges, washers, adjustment washers) were taken. It was found that PN UNI 5737-6-35 bolts with a diameter of 6 mm and a length of 35 mm have a non-threaded portion of 12 mm. The joined elements, after tightening the nut with a torque of 10 Nm, should be on the unthreaded part. The measurements showed that the thickness of the joined elements exceeded 12 mm.

The thickness of the joined elements increased with the increase of the thickness of the installed adjustment washers decreasing the play of the stabilator control system.

Moving the connected elements towards the threaded part of a bolt caused its damage visible on both bolts.

On 10 April 2018 the manufacturer issued Service Bulletin No. SB 298 - CS recommending the replacement of PN UNI 5737-6-35 bolts with a diameter of 6 mm and a length of 35 mm to PN AN4 - 11A with a diameter of 6,35 mm and a length of 30 mm and on 18 June 2021 issued Job Card No. 1466 describing the procedure for their replacement. The PN AN4 - 11A bolt with a diameter of 6,35 mm has the unthreaded part longer of about 8 mm, which eliminates the main factor causing damage to the bolts.

Consequently, SCAA I recommends that the aircraft manufacturer, changes the status of the Bulletin No SB 298 - CS to mandatory.

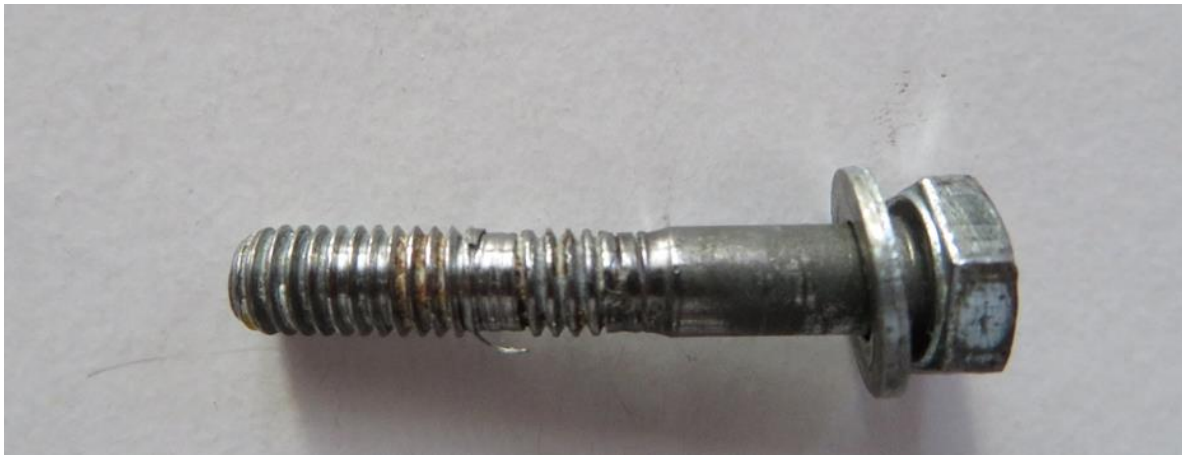
After dismantling the right bolt, damage in the form of dents and material losses was detected on its threaded part (Fig. 3).

Fig.3. The right bolt with damaged thread [source: PKBWL]
