PRELIMINARY REPORT

ACCIDENT 2021/0572

AIRCRAFT – 1 - Airplane VULCANAIR P68 OBSERVER 2, SP-FPM;
2 - Airplane SAAB-340 A, SP-KPU

OCCURRENCE DATE AND SITE – 23 March 2021, EPGD

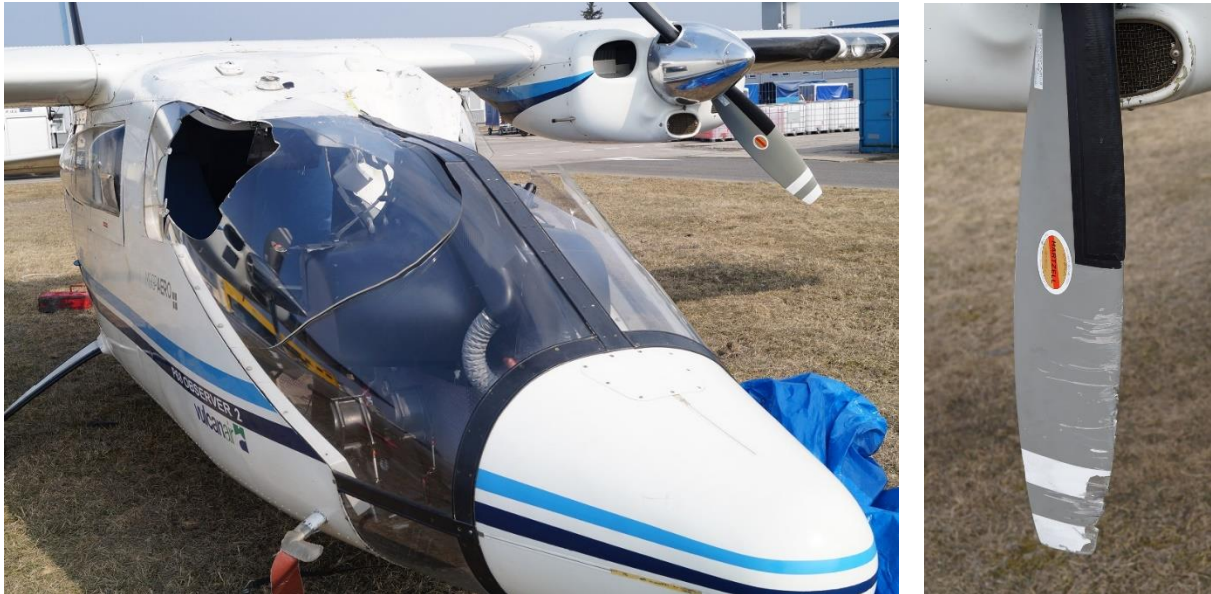
The aircraft sustained a substantial damage, mainly to its nose part, propellers and engines, i.e. the areas that collided with the other aircraft. The cockpit was severely damaged in its upper part from the nose of the aircraft to the center wing section. The glazing of the cabin on both sides cracked and its elements were pushed inside. On the right side, elements of the wing and the powerplant were damaged. On the left side, there was less damage to the powerplant and the wing was damaged.

Fig. 1. VULCANAIR P68 airplane: damaged cockpit glazing (left photo) and damaged RH propeller blade (right photo) [source: PKBWL]

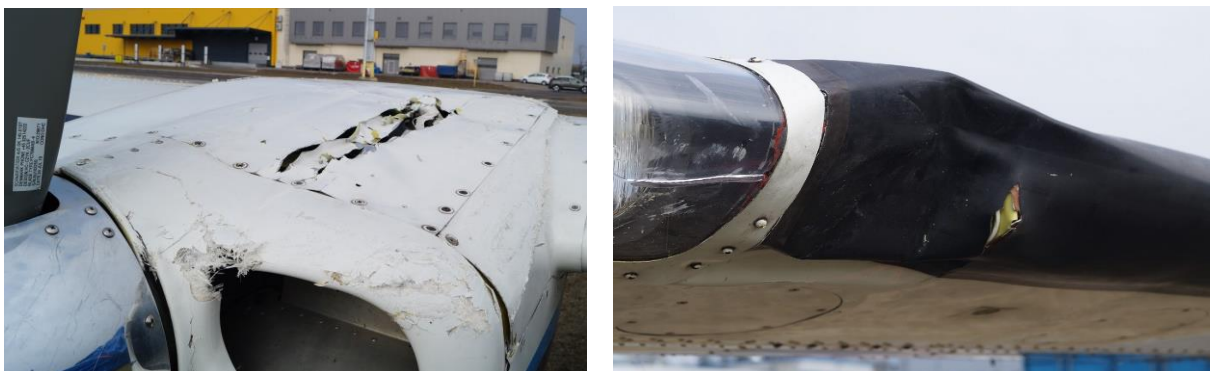
Fig. 2. VULCANAIR P68 airplane: damaged RH engine cowling (left photo) and damaged LH wing (right photo) [source: PKBWL]

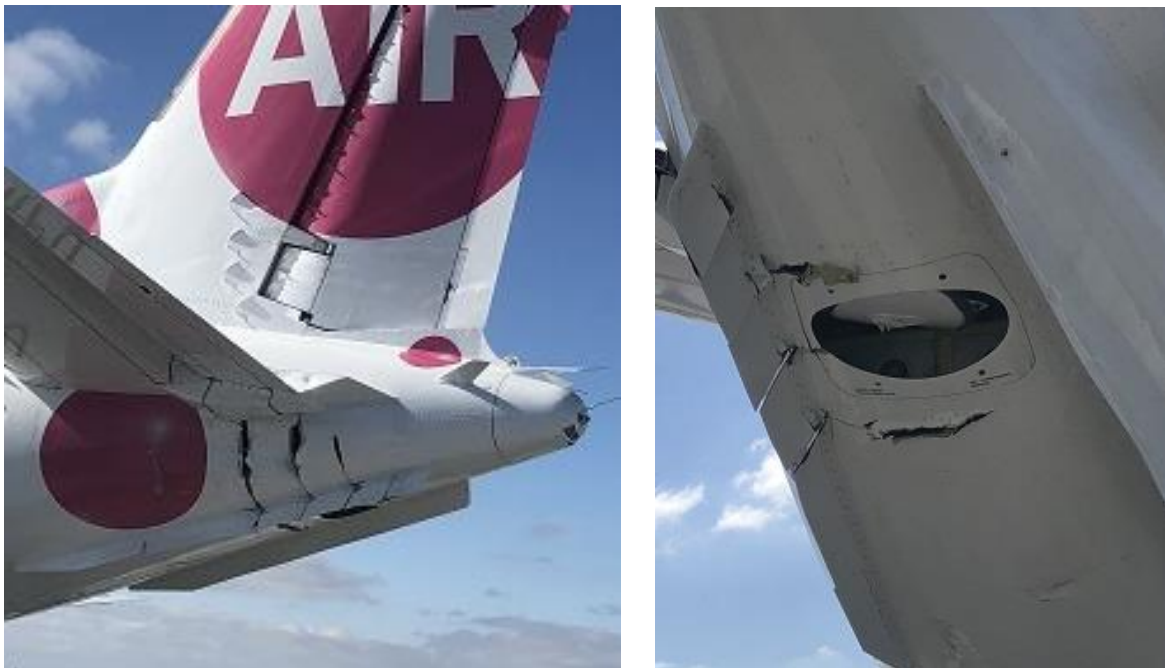
The aircraft was substantially damaged, mainly the left rear part of the fuselage, the left wing flap and the rear part of the left engine nacelle along with the exhaust pipe. The damage was deep and involved both the skin and the structure of the airframe.

Most of the damage was caused by the rotating propeller of the VULCANAIR P68 airplane. The following parts of the airplane were damaged:

Fig. 3. SAAB-340A airplane rear fuselage part damages [source: Gdańsk Airport]

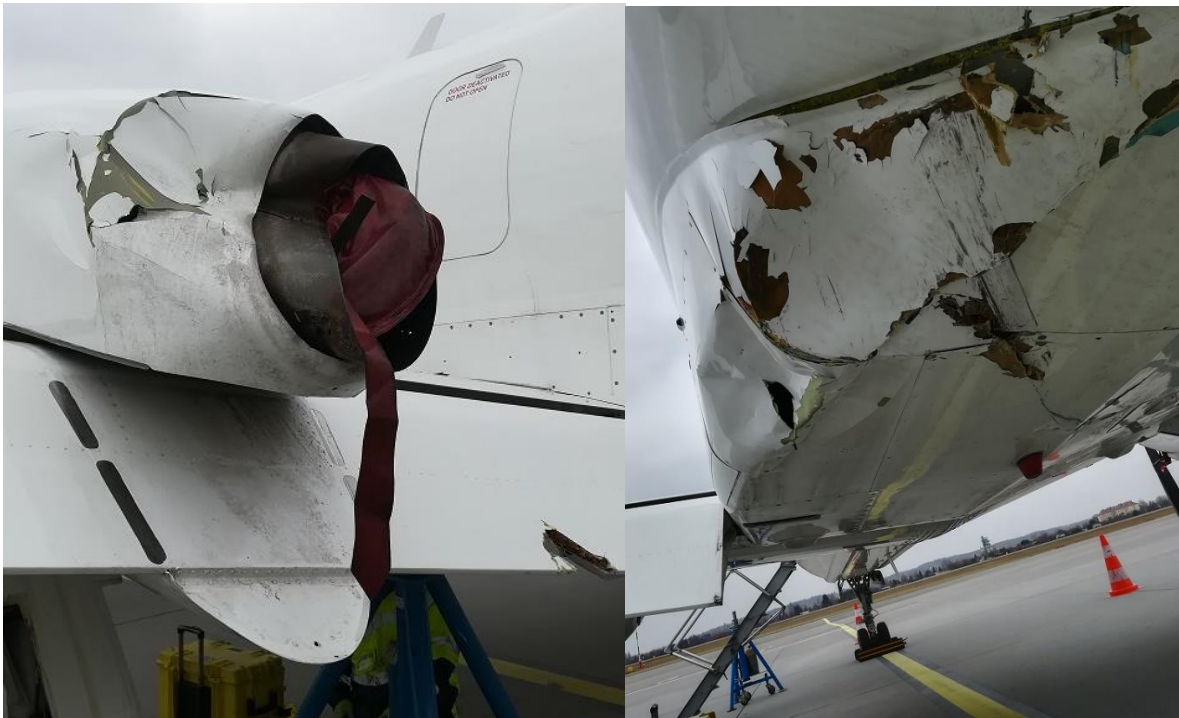
Fig. 4. SAAB-340A airplane: L/H engine and L/H wing flap damages (photo at left) and lower fuselage part (photo at right) [source: Gdańsk Airport]
