State Commission on Aircraft Accidents Investigation
ACCIDENT 2015/1735
RESOLUTION
of 8 August 2022

Type and model of aircraft:	Powered hang glider: ENDURO-XP Engine: ROTAX 582/54 PS
Registration marks:	D-MBCA
Date of occurrence:	19 August 2015
Place of occurrence:	EPWK (Kruszyn Aerodrome)

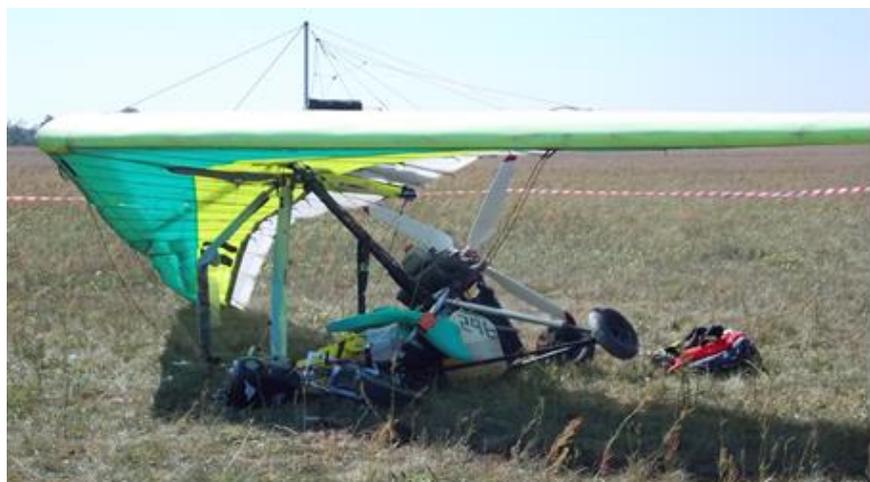
The hang glider was operated by a German pilot. During climb, at an altitude of about 40 m, the engine stopped. The pilot made a right turn, during which a stall occurred at a height of about 10 m. The aircraft started autorotation to the right and collided with the ground (Fig. 1, 2).

Fig. 1 The hang glider after the collision [source: PKBWL]

Hang glider wing stall in a turn during landing after engine failure.

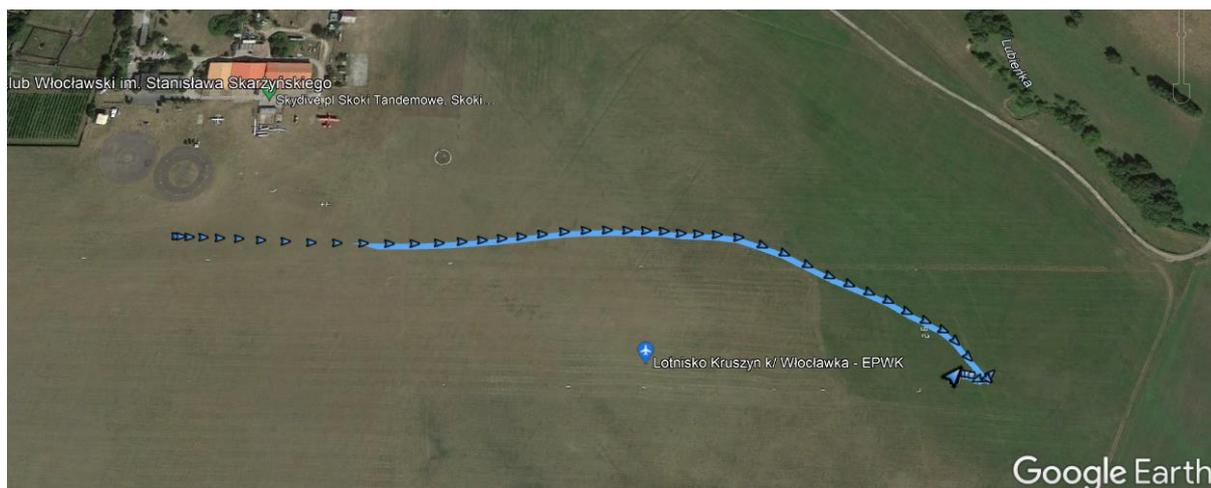
Fig. 2. Flight path GPS recording [source: pilot's GPS]

The course of the occurrence was reconstructed based on analysis of the GPS recording and recording from the camera installed on the right side of the wing of the powered hang glider.

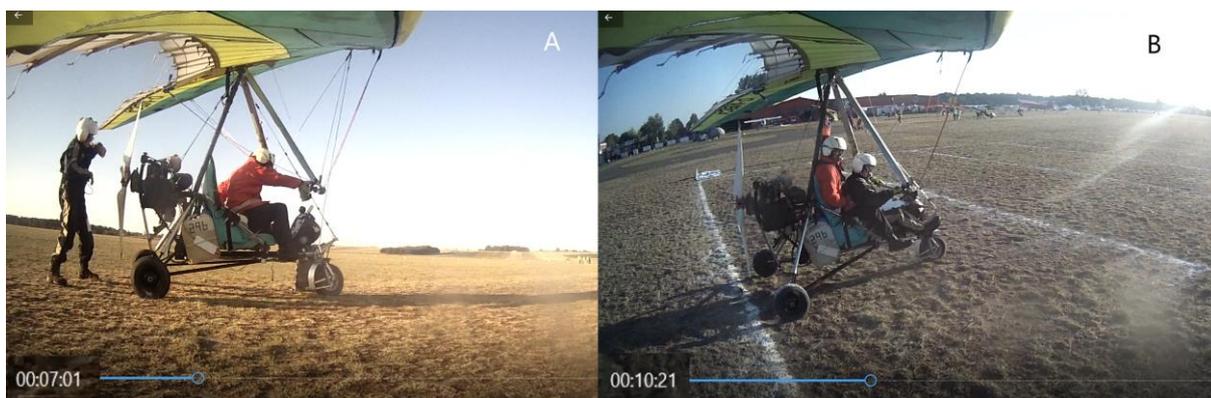
After starting the engine, the hang glider taxied to take-off area (fig. 3 - A, B). The pilot did not warm up the engine and did not perform test run prior to take-off.

Fig. 3. A – The pilot starts up the hang-glider engine B – Hang-glider take-off run [source: camera recording]

Take-off performed without warm-up of the engine, which could not be started until the fifth attempt.

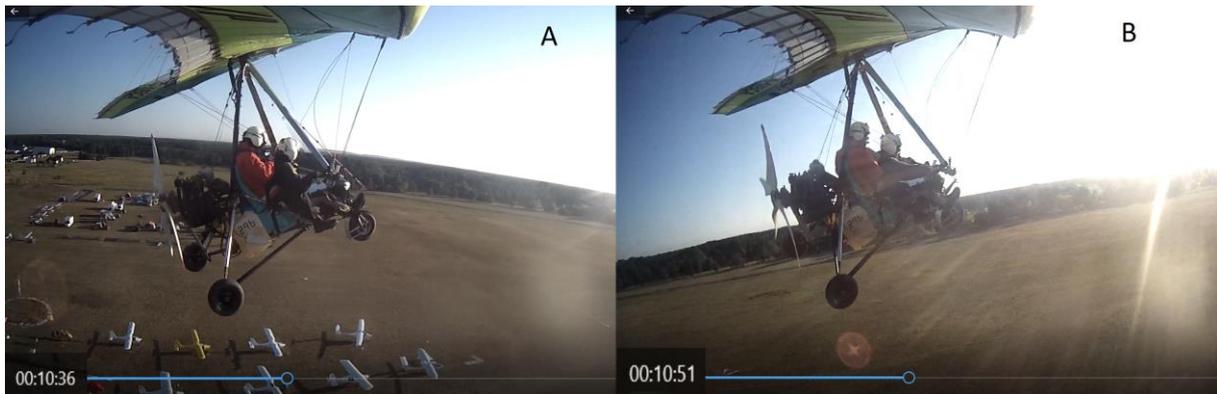
15 seconds after initiation of the take-off run, when the glider was at a height of about 40 m (during climb), the engine began to lose power and stopped. The pilot slightly pulled the control bar, increasing speed, and after 15 seconds he started the right turn (Fig. 4 - A, B).

Fig. 4. A Hang glider during climb. B Initiation of right turn
[source: camera recording]

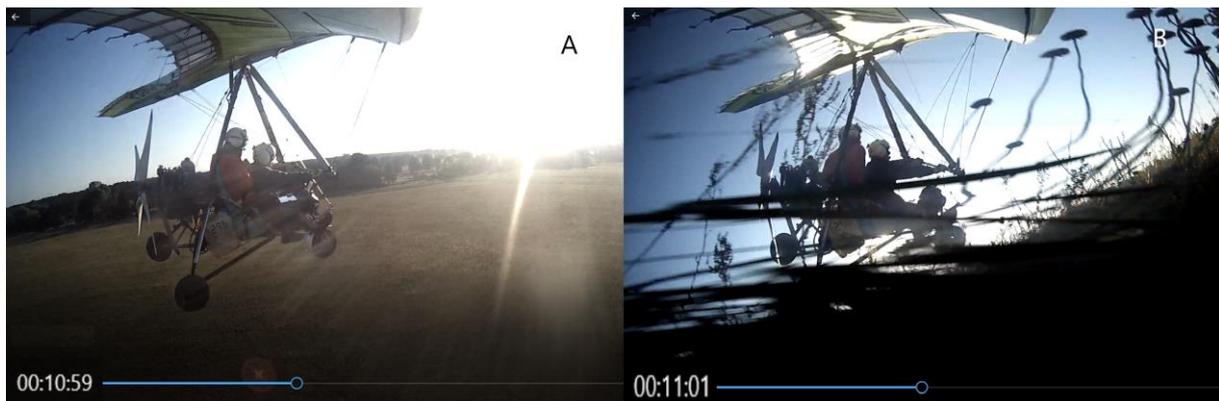
After making the turn (of about 25°), the hang glider flew straight for a while, and then the pilot started another turn to the right. In that turn he pushed the control bar, causing the wing to stall. At a height of about 10 m, the hang glider began autorotation to the right, and after a while it collided with the ground (Fig. 5 - A, B).

Fig. 5. A – Hang glider during the second right turn. B – A while before collision
[source: camera recording]
