FINAL REPORT

ACCIDENT 1676/17

OCCURRENCE NO – 1676/17

AIRCRAFT– aeroplane, Ultralight PelegrinTarragon

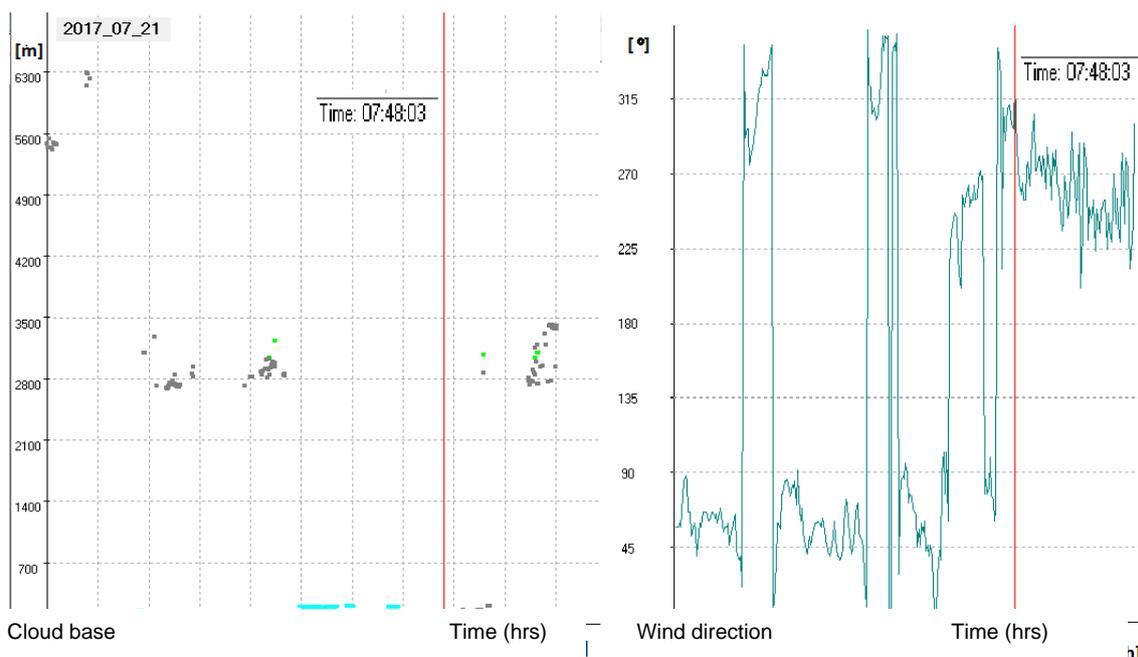
It was raining the day before the accident. The weather station of EPML aerodrome recorded the wind from the direction of 315° at a speed of 1.74 m/s, cloud cover about 5/8 Stratocumulus with base at about 200 m. The horizontal visibility was very good, as an AFIS officer stated, a church located 4.5 km from the aerodrome tower was clearly visible.

Weather conditions had an impact on the occurrence.

Fig. 1. Cloud base and wind direction [source: PKBWL]

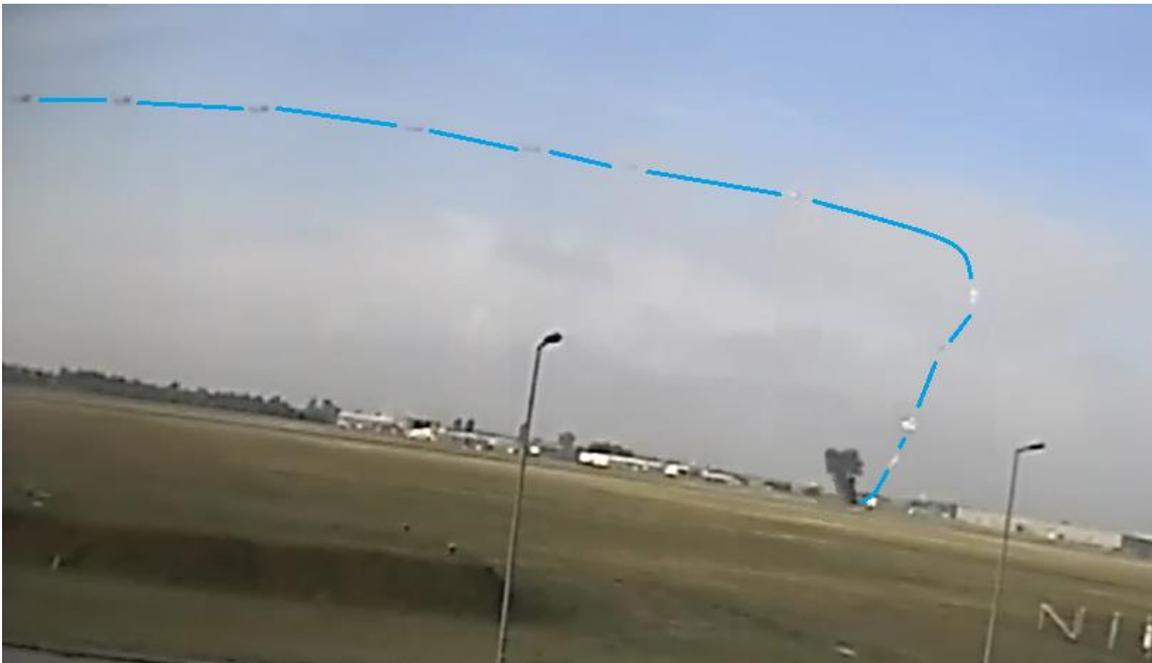
At about 200 m AGL the aircraft was brought to level flight and entered a cloud, in which, most likely, it was brought to stall during the left turn and started the left spin. At a height of about 30 m, the pilot activated a parachute rescue system (BRS), which was launched, but it turned out that it was not attached to the airframe. The plane crashed into the ground at an angle of about 70° and about 16 seconds later caught fire (Fig. 3).

Fig. 3. Time-lapse photos from aerodrome monitoring system [source: airport management]

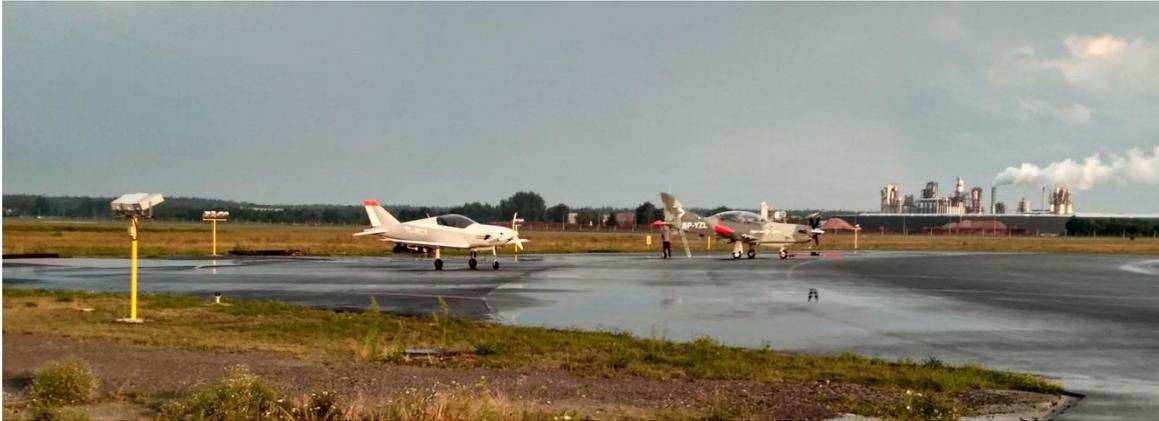
In the evening on the eve of the accident a crew testing Orlik aircraft on EPLM aerodrome noticed the accident Tarragon and looked more closely at it (it was interesting for them due to similarity of Tarragon shape to Orlik). When they moved the rudder and the ailerons, they found that water was flowing out of them (Fig. 4).

Fig. 4. Photo taken 20 July 2017 on EPRZ. Photo shows Tarragon and Orlik aircraft. Visible puddles of rainwater [source: test pilot]

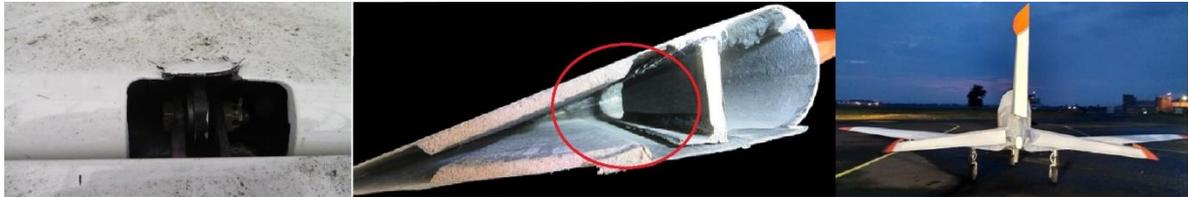
remained inside the elevator. It was found that it was possible via holes, where the hinges connecting the horizontal stabilizer to the elevator were attached. Because the horizontal stabilizer, to which the elevator is mounted, has a negative elevation angle, the water inside the tail could remain (Fig. 5). There were no drainage holes at the tips of the elevator.

Fig. 6. The horizontal tail hinge mounting hole, jack end and tail angle [source: PKBWL, test pilot]
During the test, when the elevator was in horizontal position, it was possible to pour inside about 3.2 l of water (1.6 l for each half of the elevator - Fig. 7)

Make drainage holes which can drain water that may accumulate inside the empennage.

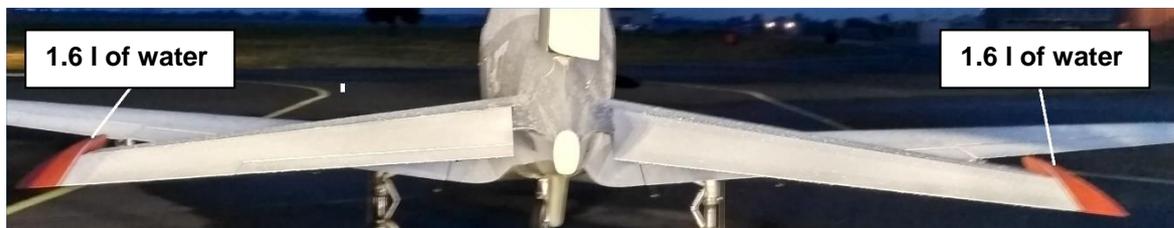
Fig. 7. Amount of water that was poured into the elevator [source: PKBWL, test pilot]
As a result of pouring water, the aircraft center of gravity moved back, but it was still within the prescribed limits (Table 1, item 9 and 10).

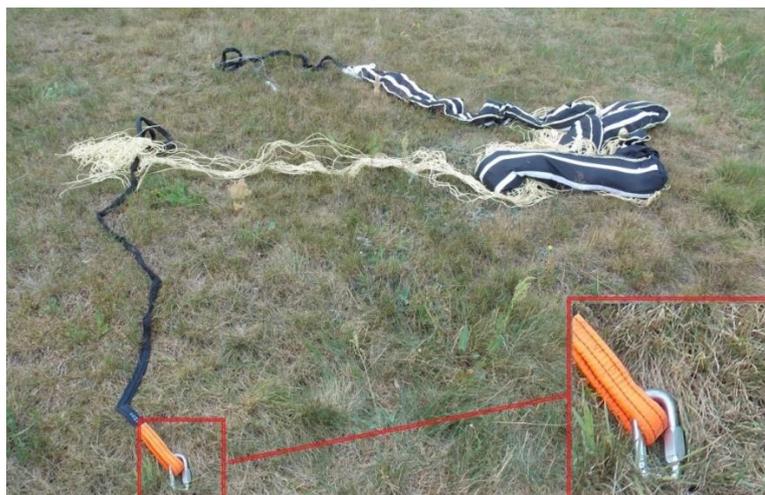
Fig. 8. Ballistic Recovery System [source: PKBWL]

- **Pre-flight check.** In the Commission opinion, the pilot probably did not check the control surfaces for free movement. When checking the tail of an airplane, the pilot should have noticed the presence of water in the elevator.
- **Rescue system.** Magnum 501 Ballistic Recovery System was installed on the plane. During the occurrence, when the plane was at a height of about 30 m, the pilot activated the system. The rocket engine pulled the parachute out of the container, but the parachute was not attached to the aircraft (Fig. 8).

The parachute with the rocket engine was found 43.5 m from the tail of the plane. The shackle connecting the system with the airframe was closed.

Using the system at such a low altitude did not give a chance for its effective operation. The Flight Manual of this aircraft states that:

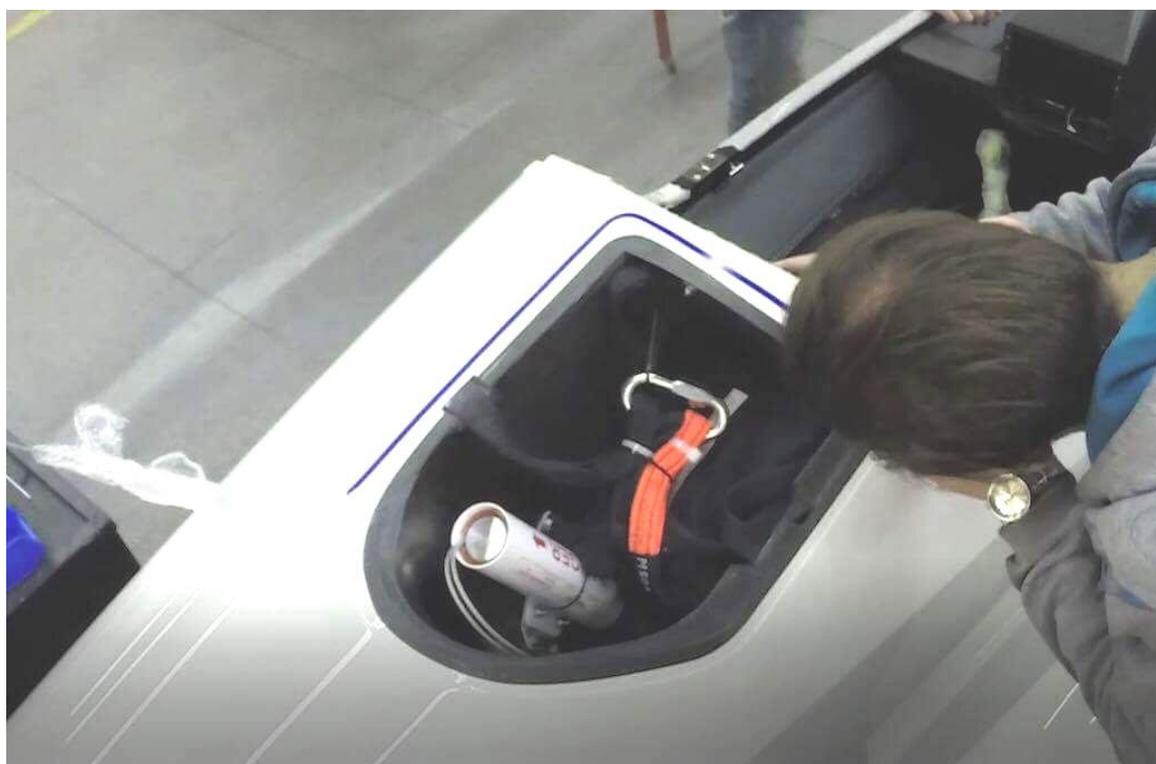
The aircraft manufacturer inquired about installation of the BRS system, replied that the system was installed on 7 April 2015 at Palegrin Sp. z o.o. premises. The manufacturer attached a photo showing the system installation (Fig. 9)

Fig. 9. Ballistic Recovery System installed on a Tarragon aircraft [source: SIA Pelegrin]

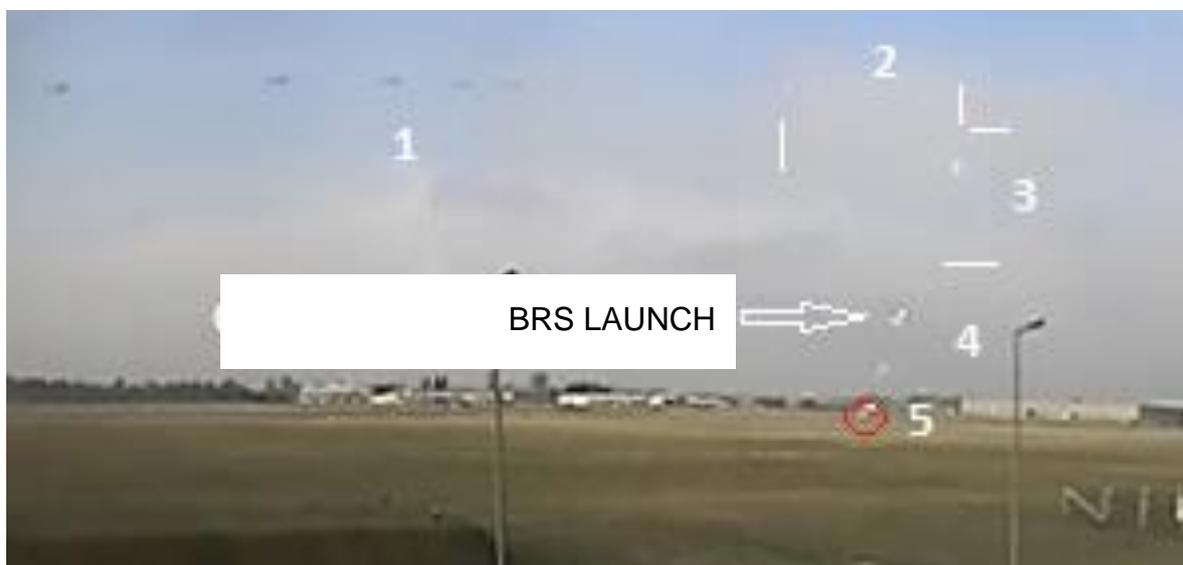
- Recording of the aerodrome camera (Fig. 10). The first section of the recording (“1” in Fig.10, from 7:48:27 to 7:48:39 hrs) is showing the plane during a gentle climb.

Fig. 10. Aerodrome camera recording [source: aerodrome management]

About 200 m AGL, the plane started a shallow left turn (as concluded from the change of the angle of sunlight on the fuselage) and entered a single cloud - section “2” (from 7:48:39 to 7:48:46 hrs). The entering into the cloud could have caused a temporary loss of spatial orientation by the pilot. Then the plane appeared in mushing condition and heavily rolled on left wing and started the left spin – section “3” (from 7:48:46 to 7:48:49 hrs).

In the next phase (section 4), the aircraft has transited from the left to the right spin. The change in the spin direction might have been caused by an incorrect recovery technique. If the pilot recovered from the spin by displacing the rudder in the direction opposite to the rotation direction and did not fully pushed the stick forward, then only the direction of the spin changed. It could have also happened that after stopping the spin to the left, due to the low height (deficit of height and time) the pilot did not stop applying the right pedal, brought the plane to the level flight too abruptly and entered a spin again, this time to the right.

About 30 m AGL the BRS was launched (from 7:48:49 to 7:48:51hrs). The recovery system was not attached to the airframe, so the process of opening the parachute was not initiated. At 7:48:51 hrs the plane collided with the ground – section “5”.

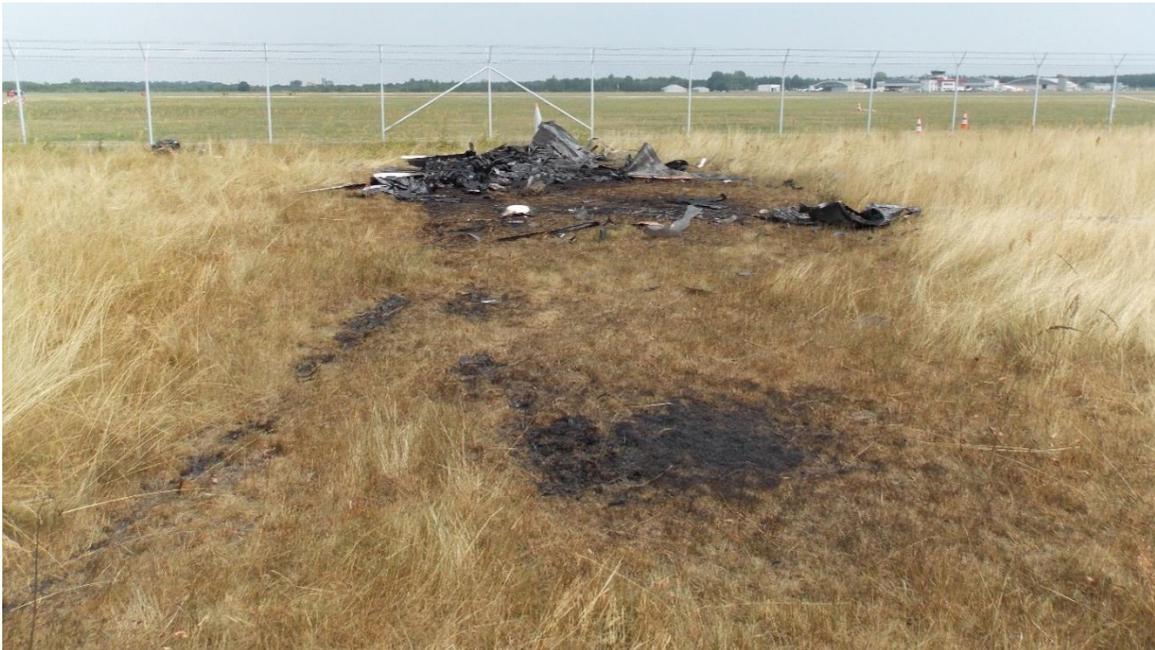
The collision occurred in the south direction. At the moment of collision the plane was descending at an angle of about 70° relative to the ground and was rolled a few degrees to the right wing. During an examination of the accident site no traces of the landing roll were found (Fig. 11).

Fig. 11. Accident site. Burnt wreck and burnt grass indicating the direction of the spilling fuel after the impact [source: PKBWL]
