FINAL REPORT

SERIOUS INCIDENT

Occurrence No.: 1709/17

Aircraft: Piper P-32R-301T, OH-IJO

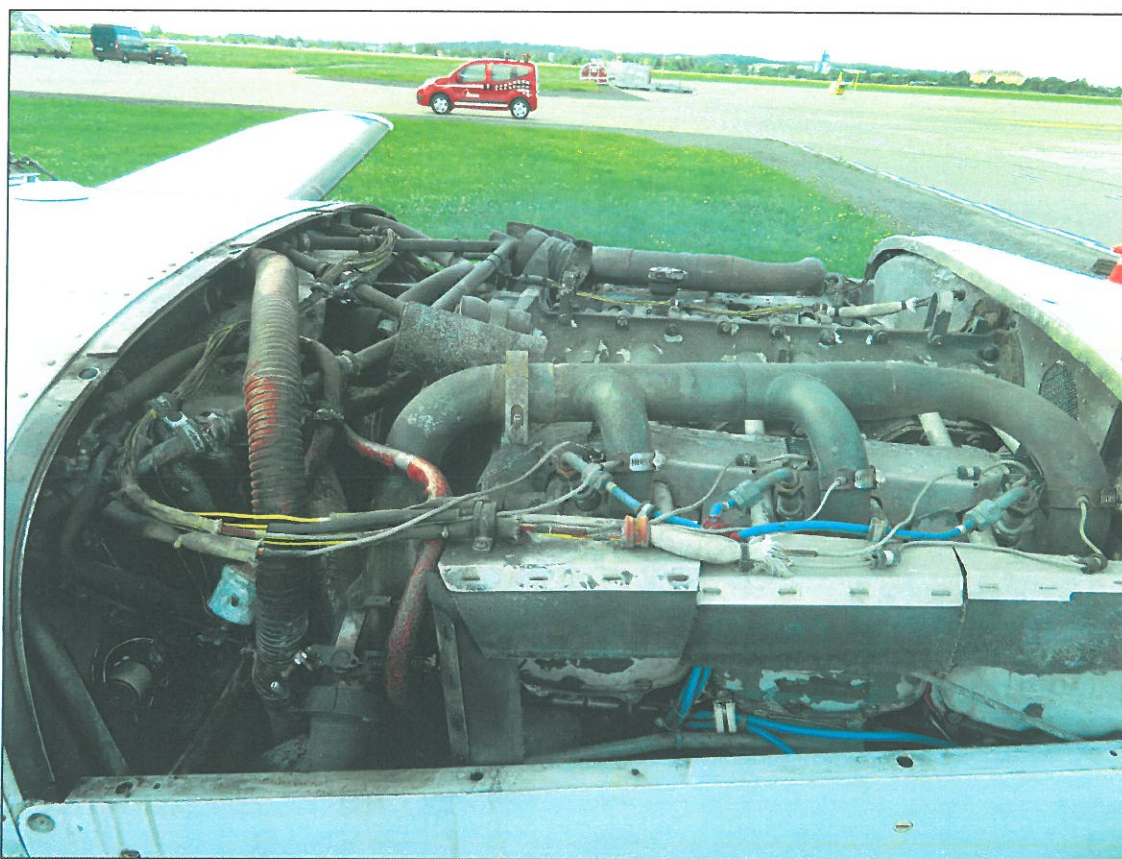
All damage to the aircraft was caused by the fire of the oil leaking from the melted hose in the engine compartment. The engine compartment, its fairings, hoses and components mounted on the engine were damaged.

Fig.1. Damage to the engine compartment – general view

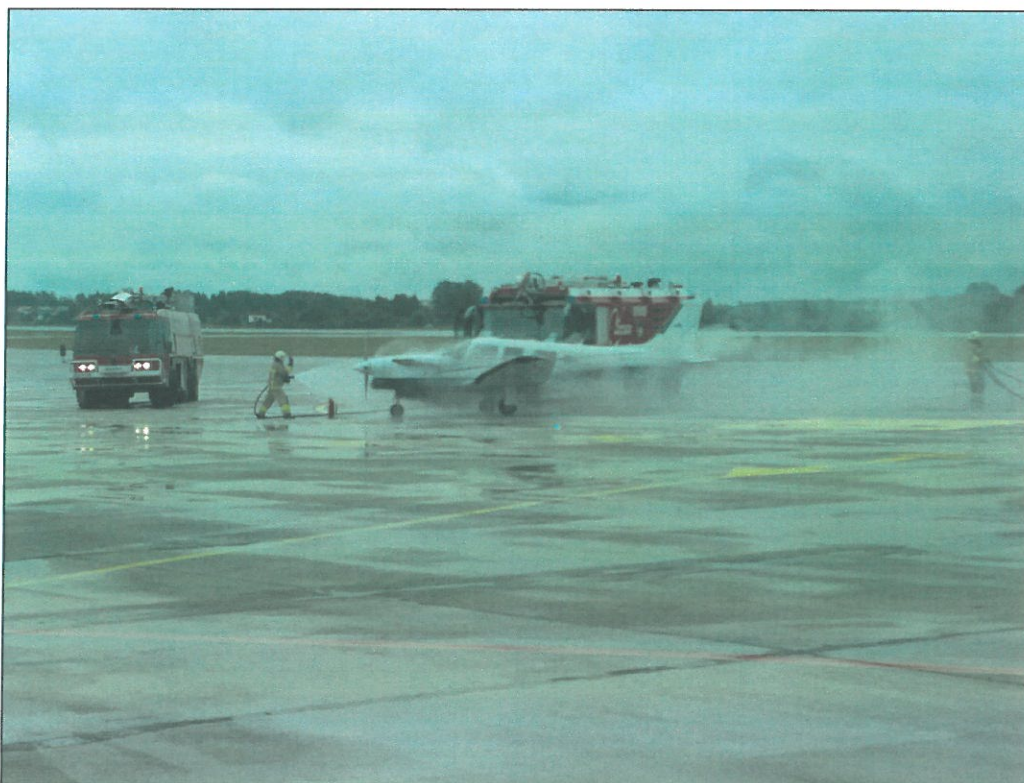
Fig. 4. Firefighting action on EPGD

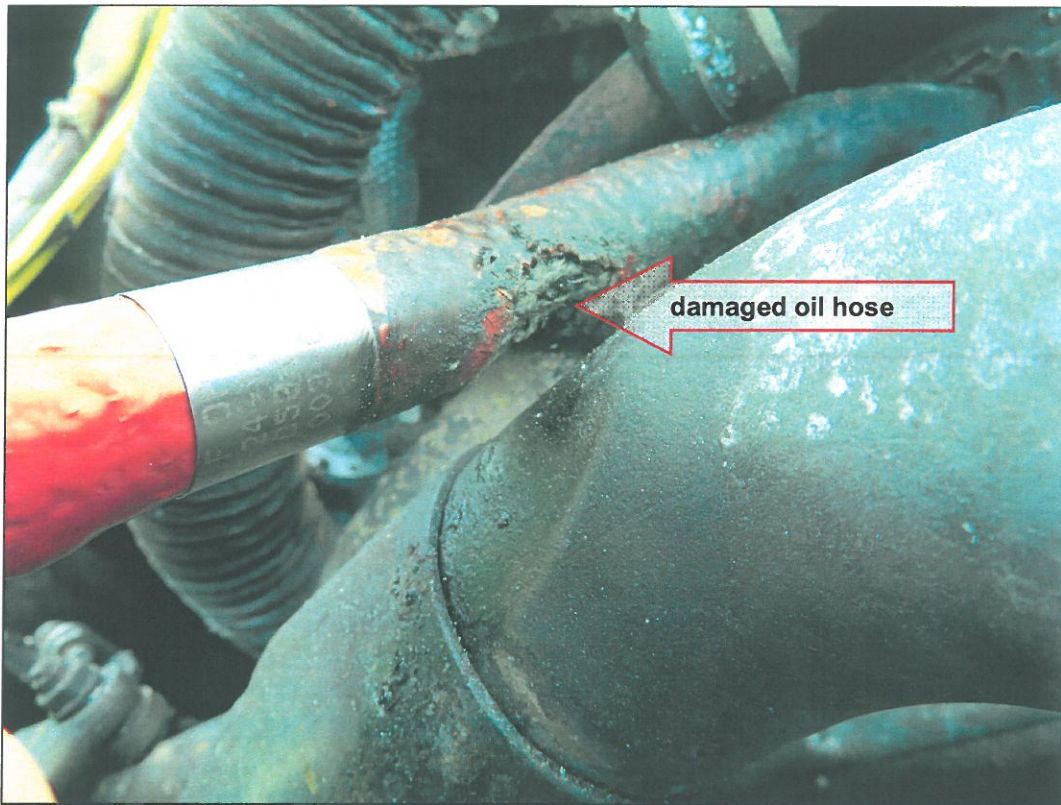
No person involved in the flight was injured. As a result of the fire the engine, its components and compartment sustained damage. The cause of the fire was burnout of the engine oil hose, which led to ignition of leaking oil. Burnout of the oil hose was caused by its direct contact with the engine exhaust manifold, caused by improper mounting of the hose and lack of its heat shield.

A visual inspection of the aircraft at the scene was carried out. As a result of the engine compartment examination it was unambiguously established that the source of the fire

was engine oil leaking from the damaged hose (the nature of the damage is shown in Fig. 5).

Fig. 5. Engine compartment with marked damage to the oil hose

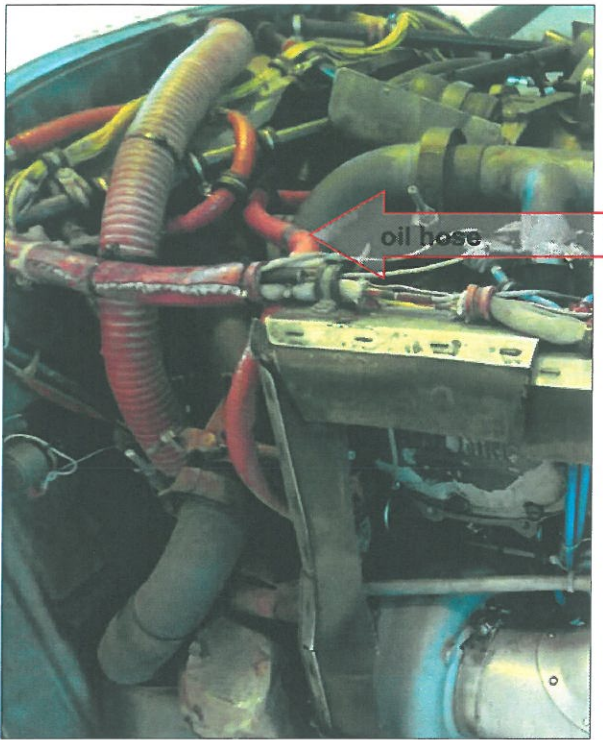
A "100h" inspection includes, among others, check of oil hoses and their connectors for leakage, protection, abrasions, dents and cracks. Fig. 6 shows the engine compartment during the inspection mentioned above. It clearly visible that the oil hose was located in immediate vicinity of the exhaust manifold and that the heat shield was not installed on the manifold.

The aircraft was released for flight with the oil hose improperly installed and without the heat shield on the manifold (correctly installed hose with the heat shield installed on the manifold is shown in Fig. 7).

Fig. 6. Engine with the oil hose installed over the exhaust manifold (incorrect installation)

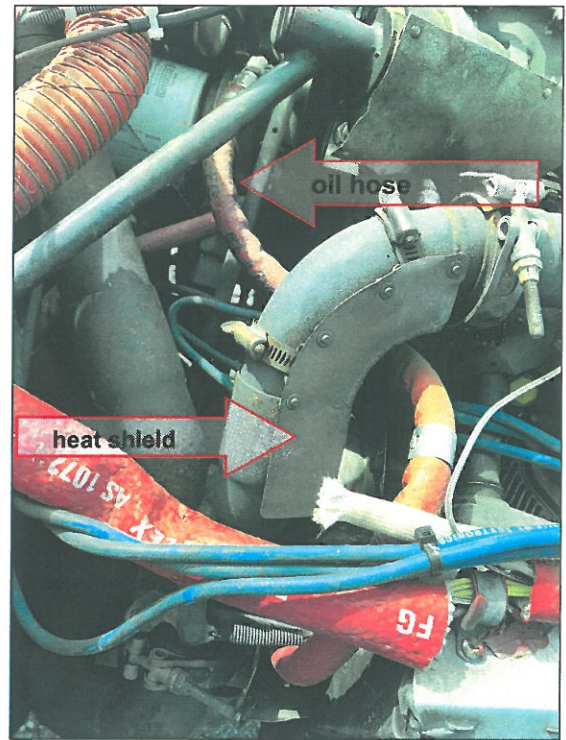
After the occurrence the aircraft owner received a confirmation from the aircraft manufacturer that prior to the incident the oil hose had been installed incorrectly and that the heat shield should have been installed.

Fig. 7. Engine with the oil hose installed under the exhaust manifold and the heat shield (correct installation)
