# FINAL REPORT

on safety investigation of an aviation accident  
of gliders type **LS8-18**  
registration marks **LY-GOT** and **SP-3893**

Reg. No: **SKA2018002**

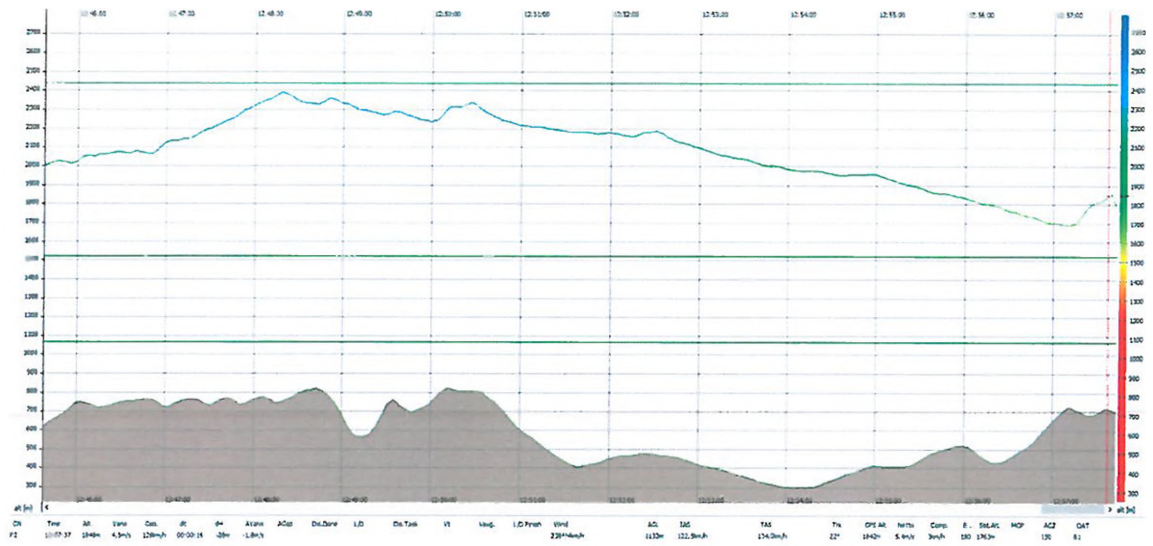
### "P2"

Being 4 m above the "P2" glider, the "A" glider's left wing hit the left wing of the "P2" glider at an altitude of 1,850 m; 710 m above the terrain.

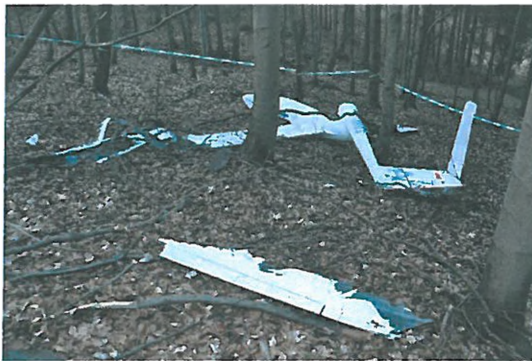
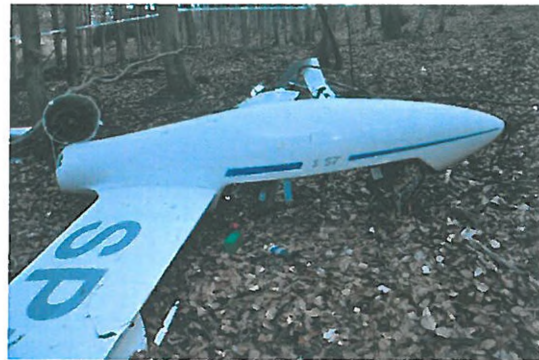
The "A" glider was destroyed in the aviation accident.

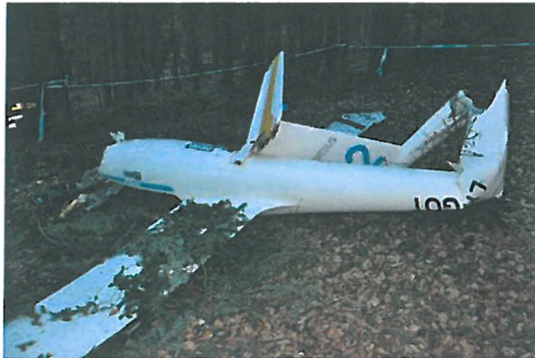
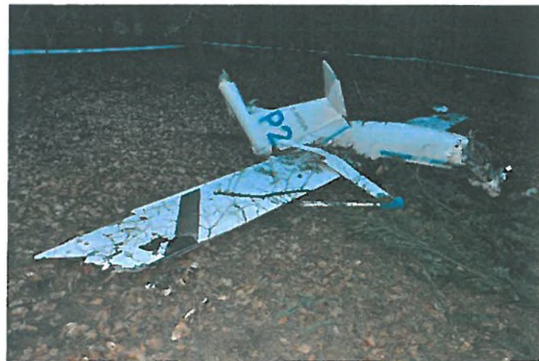
The "P2" glider was destroyed in the aviation accident.
