FINAL REPORT

OCCURRENCE NO – 1511/18

AIRCRAFT – aeroplane, VANS RV-10, UR-PMAV

DATE AND PLACE OF OCCURRENCE – 9 June 2018, Rzeszów (EPRZ)

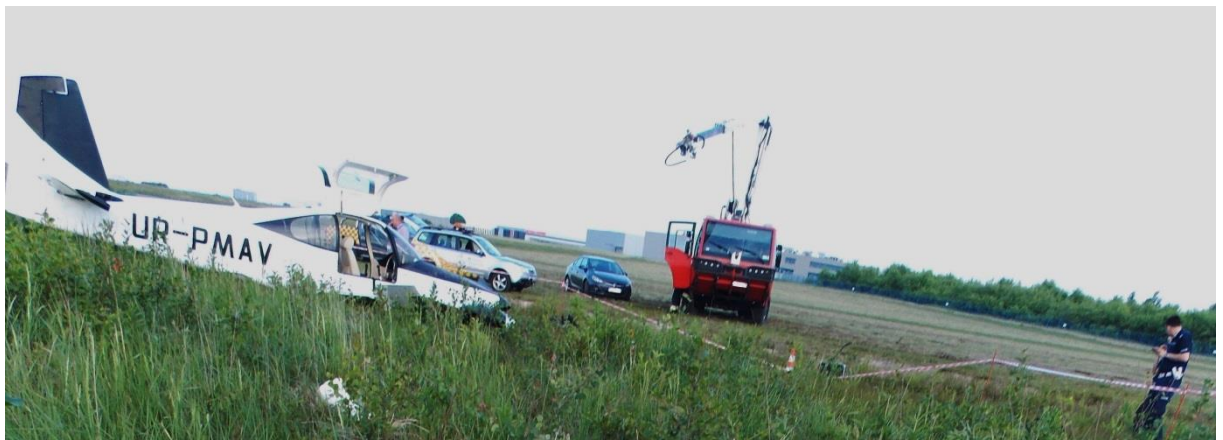
Fig.1. Damaged airplane and cars of the aerodrome rescue services. [source: PKBWL]

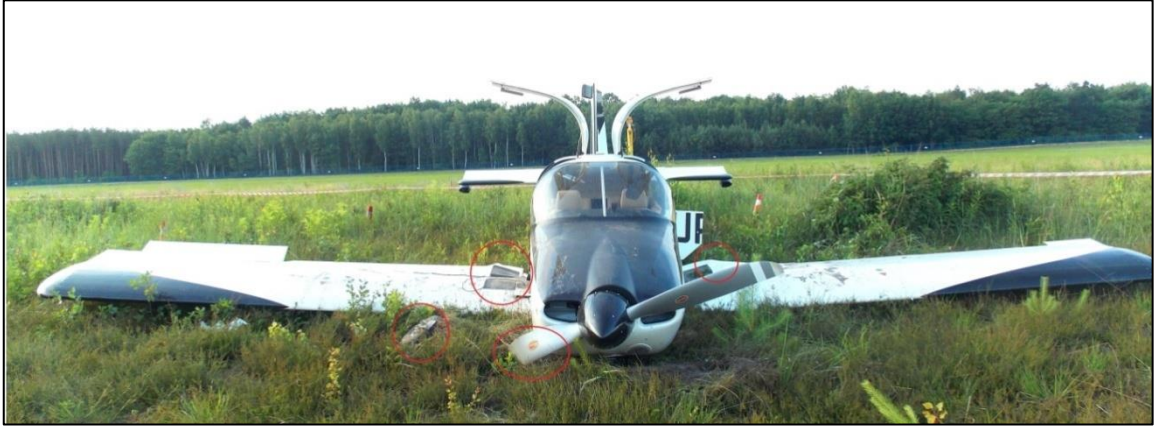
The airplane was substantially damaged. It sustained damage to the wings, front and center of the fuselage, propeller and landing gear, which was broken (Fig. 4,5,6).

Fig. 4. Damaged airplane - front view. Visible damaged propeller, wings and separated nose landing gear. [source: PKBWL]

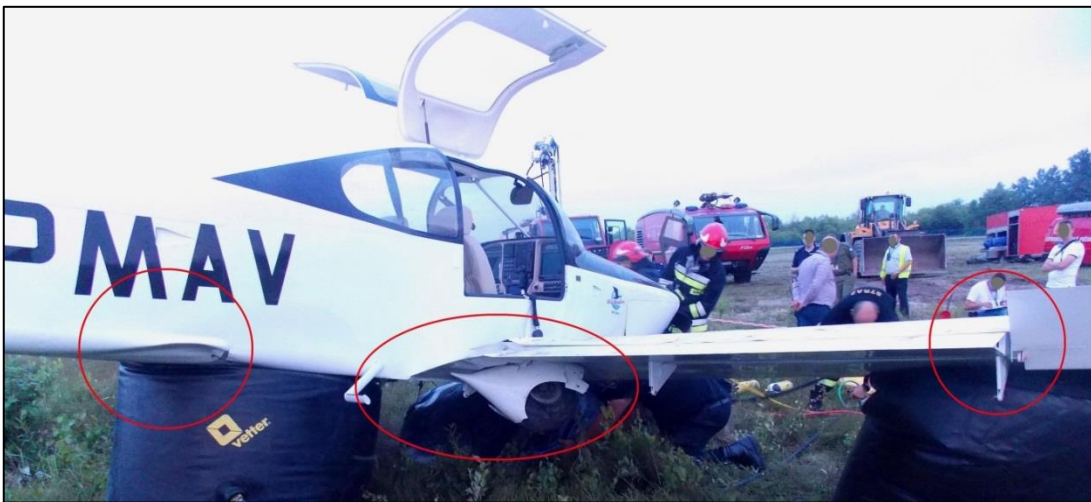
Fig. 5. Damaged airplane – right side view. Visible damaged right main landing gear, right wing, lower part of the fuselage and broken aileron. [source: PKBWL]

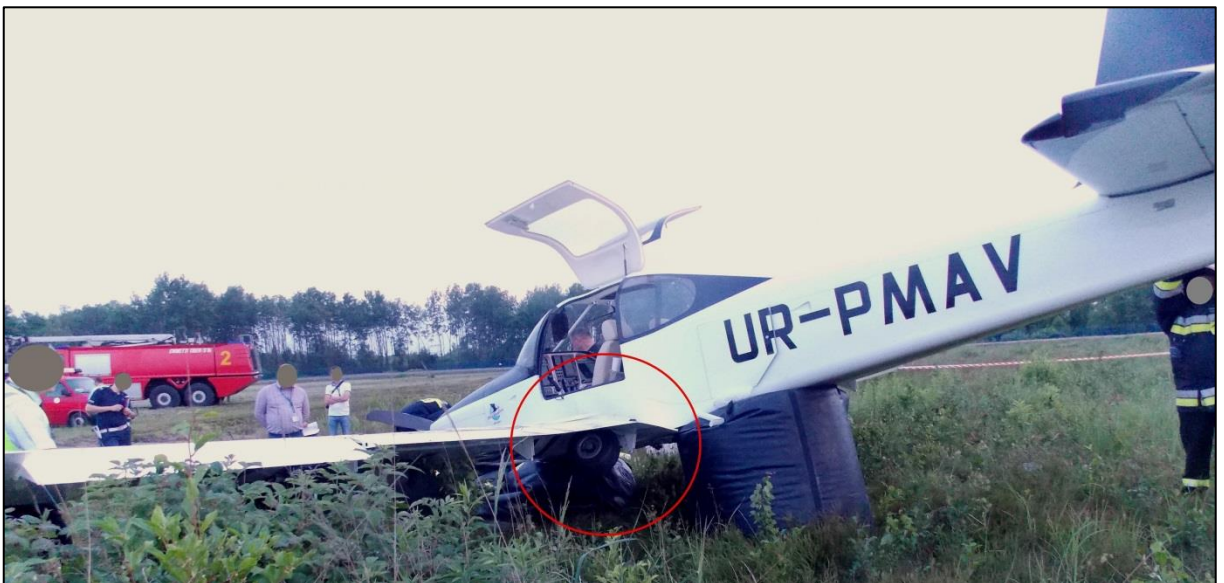
Fig. 6. Damaged airplane - left side view. Visible damaged the left main landing gear and left wing. [source: PKBWL]

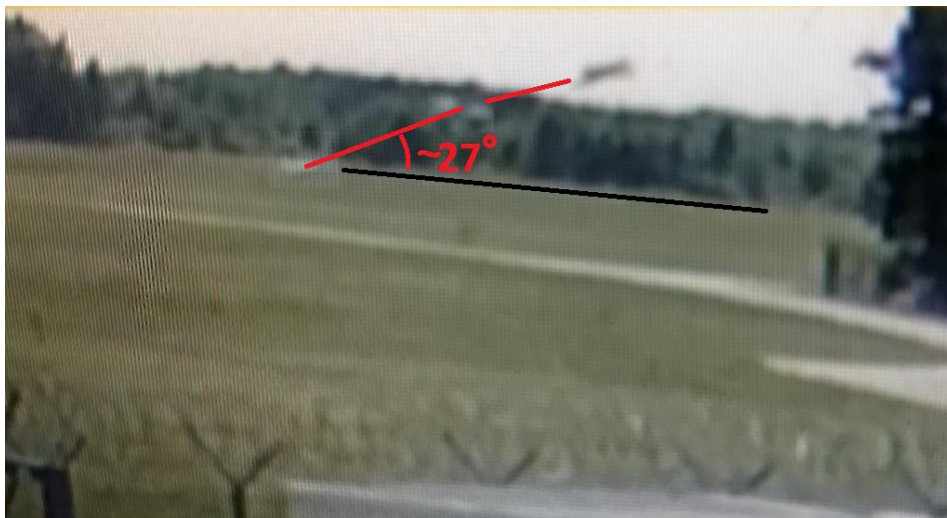
The plane collided with the ground at an angle of about 27°. The plane was in a stall. According to PKBWL, this was the first phase of autorotation to the right (Fig. 8).

Fig. 8. Last portion of the flight. [source: aerodrome management]

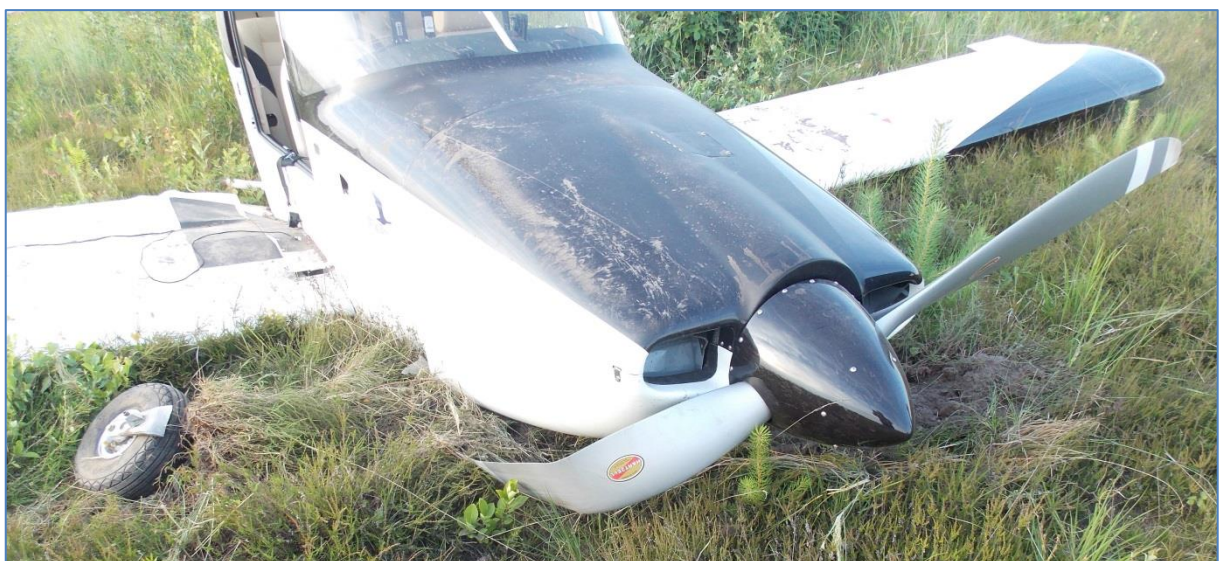
Fig. 10. Separated nose wheel and bent propeler blade. [source: PKBWL]

During the accident one of the aircraft propeller blades was bent (Fig. 10).

The nature of damage to the propeller shows that it was not rotating and the engine was not running at the time of the touchdown.

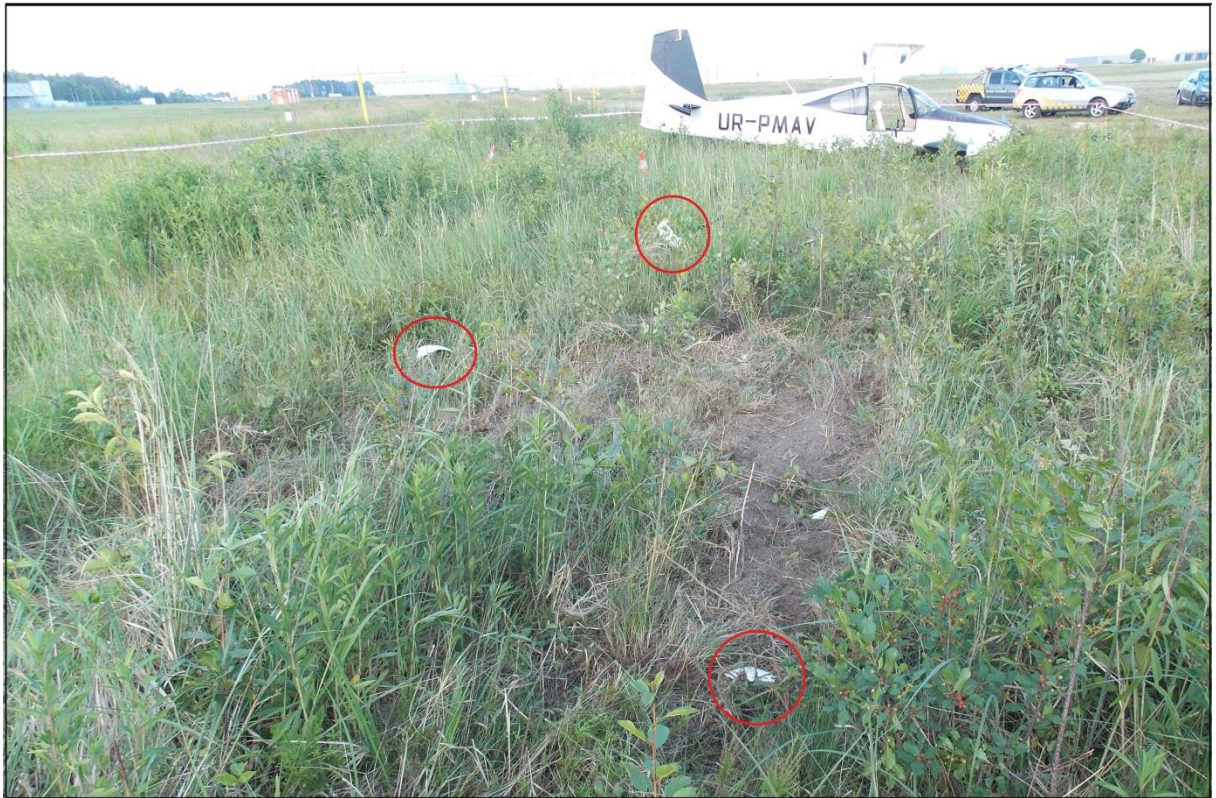
During the touchdown landing gear was broken. The plane came to rest after about 34 meters of the landing roll, during which it turned to the right by about 80° in relation to the direction of landing. The main landing gear did not separate from the plane, it was symmetrically broken backwards, its wheels damaged the wings of the plane. The fairings of the main landing gear wheels were destroyed, their fragments were found between the touchdown place and the wreck of the plane. The strut of the nose landing gear was broken and moved to the right during the rotation of the aircraft after the touchdown, the nose wheel was separated and was found next to the right wing (Fig. 10,11).

Fig. 11. Touchdown marks and fragments of the landing gear fairings [source: PKBWL]

The nature of breaking the main landing gear indicates that it was the first to come in contact with the ground. The touchdown occurred symmetrically at a high vertical speed.

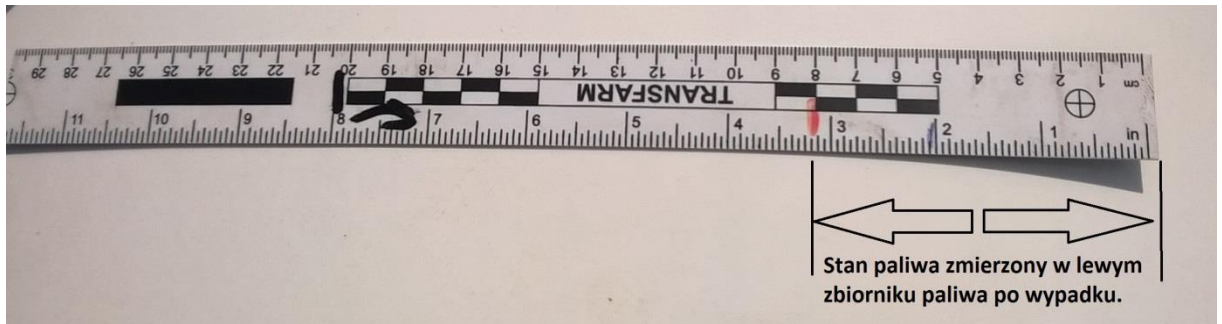
Upon arrival at the scene members of the Commission first checked the fuel quantity in the aircraft tanks. The right tank was empty, while the left one was filled with fuel to about half of its capacity. The fuel level in both tanks was measured with a ruler. After removal from the right tank the ruler was dry and after removal from the left tank the ruler was wet up to 8 cm on the scale. (Fig. 12).

Fig. 12. Level of fuel in the left tank marked with red line on the ruler. [source: PKBWL]

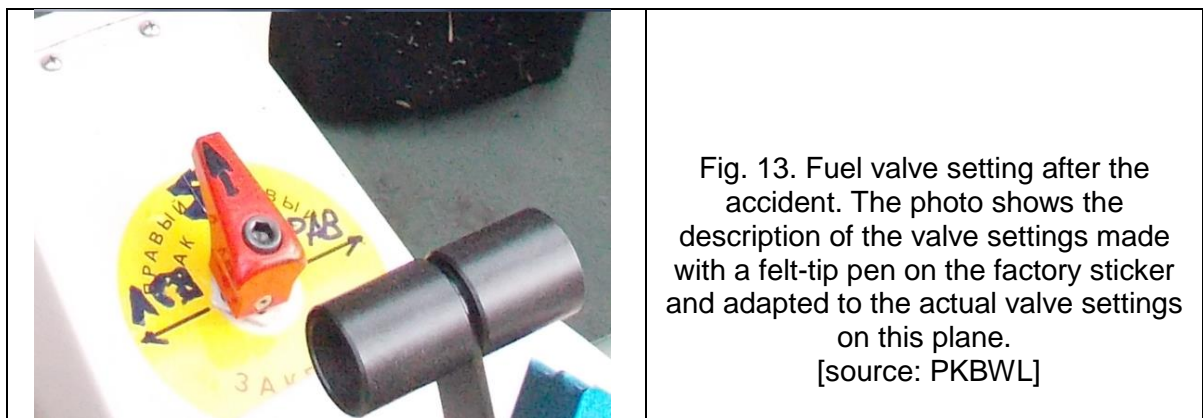
During inspection of the cockpit it was found that the fuel selector valve was set on the sum (Σ) setting. The description of the valve settings was made with a felt-tip pen on the factory sticker - not in accordance with the original (Fig. 13).

Fig. 13. Fuel valve setting after the accident. The photo shows the description of the valve settings made with a felt-tip pen on the factory sticker and adapted to the actual valve settings on this plane.
[source: PKBWL]

The State Commission on Aircraft Accident Investigation recommends that the State Aviation Administration of Ukraine (CAA of Ukraine) carry out a check of the consistency of the fuel selector valve description in the cockpits of RV-10 aircraft registered in Ukraine with the descriptions contained in their respective Pilot's Operating Handbooks.

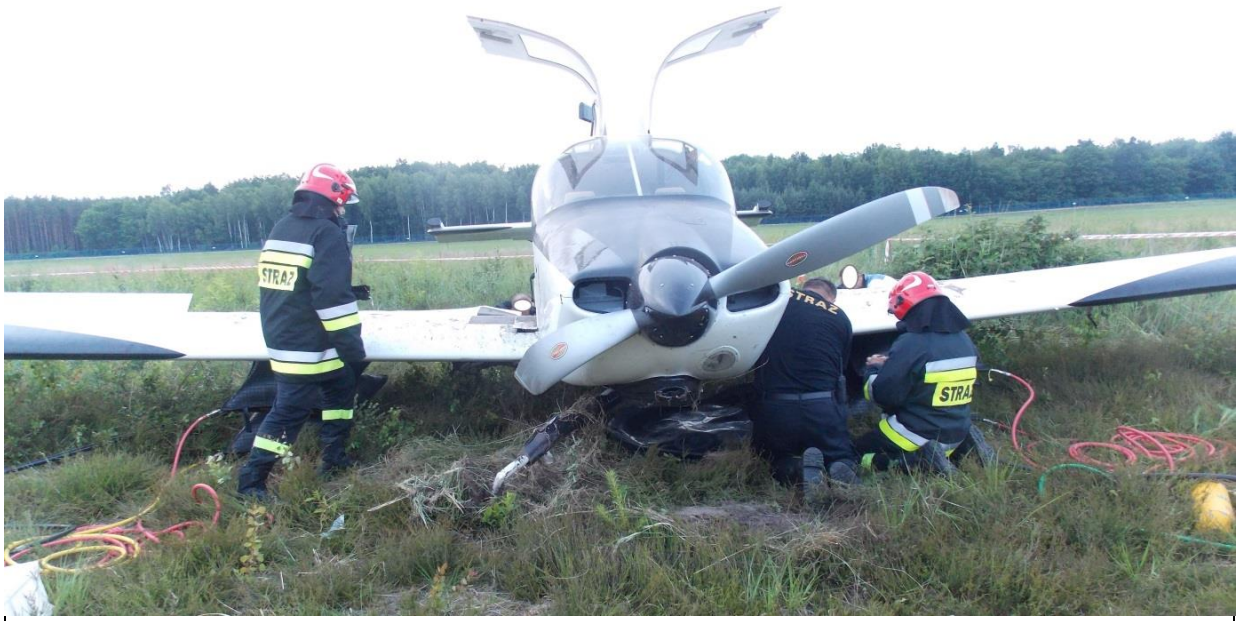
The quantity of fuel drained from the aircraft tanks (about 53 l) was close to the quantity in the left tank measured with the ruler after the accident. This indicates that all the fuel has been consumed from the right tank during the accident flight.

Fig. 14. Fire brigade in the course of emptying the left tank. [source: PKBWL]

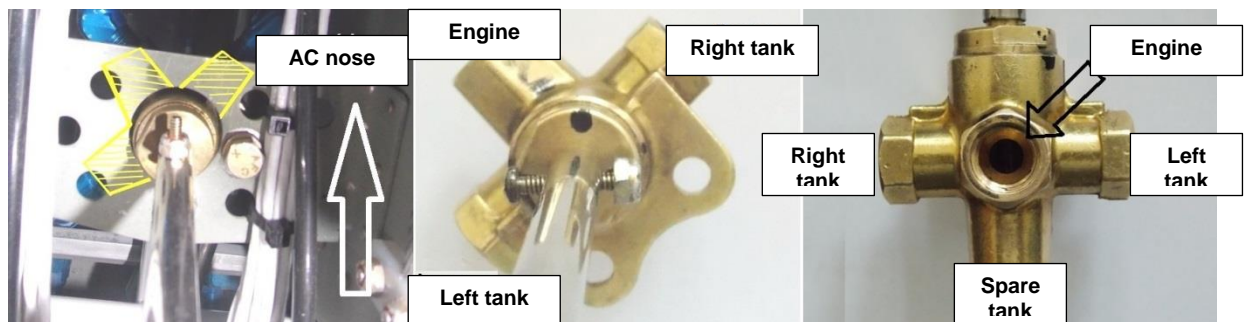
16. Connection of the fuel selector valve with the fuel system was checked and found as shown in Fig. 15.

Fig. 15. Connection of the fuel lines to the fuel selector valve [source: PKBWL].

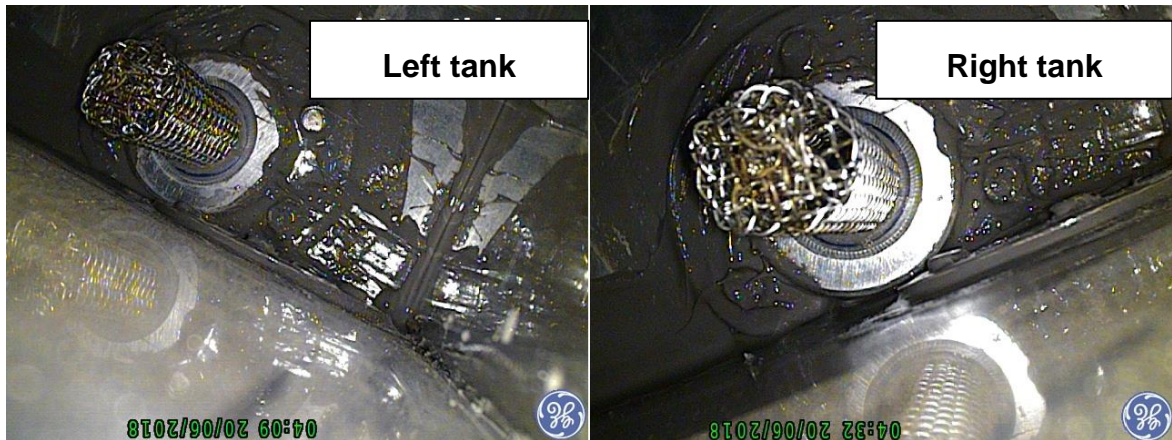
4. Inside of the fuel tanks was checked using an endoscope. No damage or contamination of the tanks was found during the above checks. The photographic documentation was made (Fig. 16).

Fig. 16. The inside of the left and right fuel tanks. Visible fuel mesh filters mounted on the ends of fuel lines [source: PKBWL].

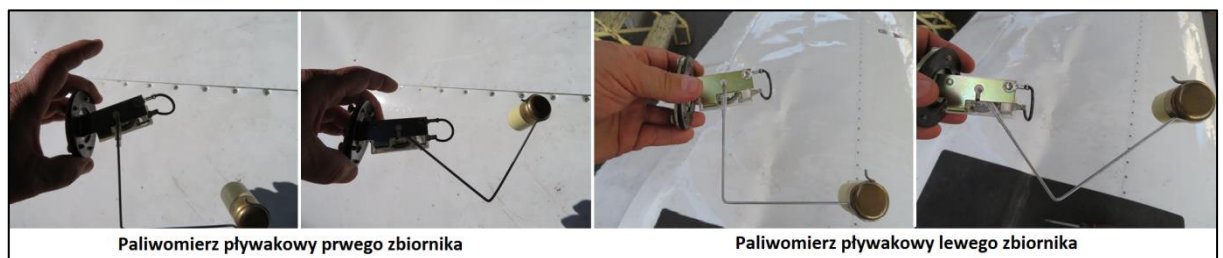
PKBWL members participated in the disassembling of the aircraft for transport to Ukraine. After removal of the wings, the Commission members once again checked the patency of the fuel lines and the venting of the fuel tanks with the positive result. Float fuel sensors installed in the fuel tanks were removed and checked, they moved freely without jamming (Fig. 17).

Fig. 17. Float fuel sensors after removal from fuel tanks [source: PKBWL].
