FINAL REPORT

DRAFT FINAL REPORT

OCCURRENCE NO— 2464/18

AIRCRAFT—glider, HPH 304 S Jet, D- KTGM

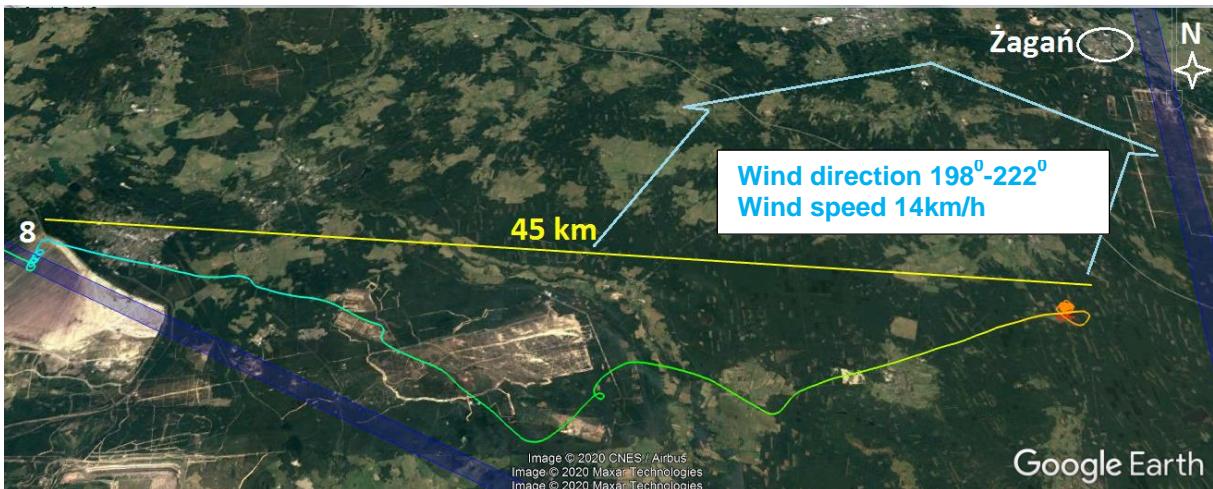
Having gained altitude in the last thermal column the pilot turned to the east. The recording shows that the glider was flying over the terrain that should have been thermally active. However, the storm that took place over Żagań (18 km from the accident site, Fig. 4) around 13:00, in the SCAA opinion, suppressed the thermals in this area. As the recording shows, during 45 km flight, the pilot only once met a weak lift (up to 1 m/s), which he did not utilize. On this section of the route, at the flight altitude, the wind was blowing at a speed of 14 km/h from a direction of 198 \pm 222 degrees.

Fig. 4. Final portion of the flight [source: PKBWL].

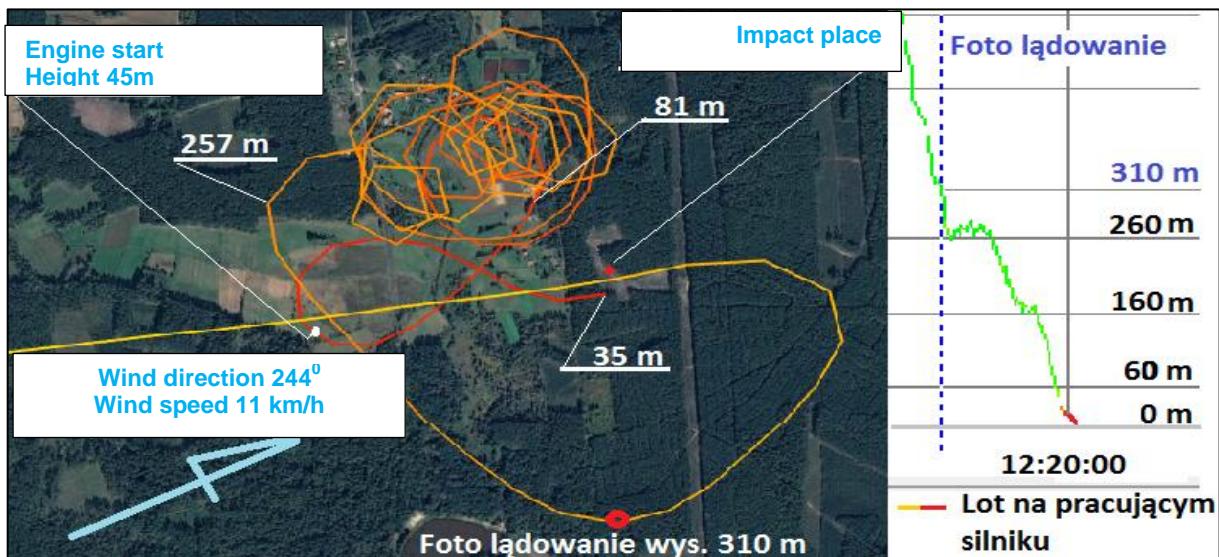
At 14:12 hrs (Fig. 5) when the glider was in the vicinity of Klików about 260 m AGL, the pilot started circling in a "weak" thermal column. Unfortunately he was not able to gain altitude and after about 7 minutes about 81 m AGL, the pilot abandoned circling and probably began the procedure for starting the engine.

Analysis of the recordings allows to assume that the engine started operating at the moment when the glider began a right turn (as shown in Fig. 5) and was about 45 m AGL.

Fig. 5. The final portion of the flight. On the right, on the height graph, the yellow and red line shows the engine operation as recorded by the recorder [source: PKBWL].

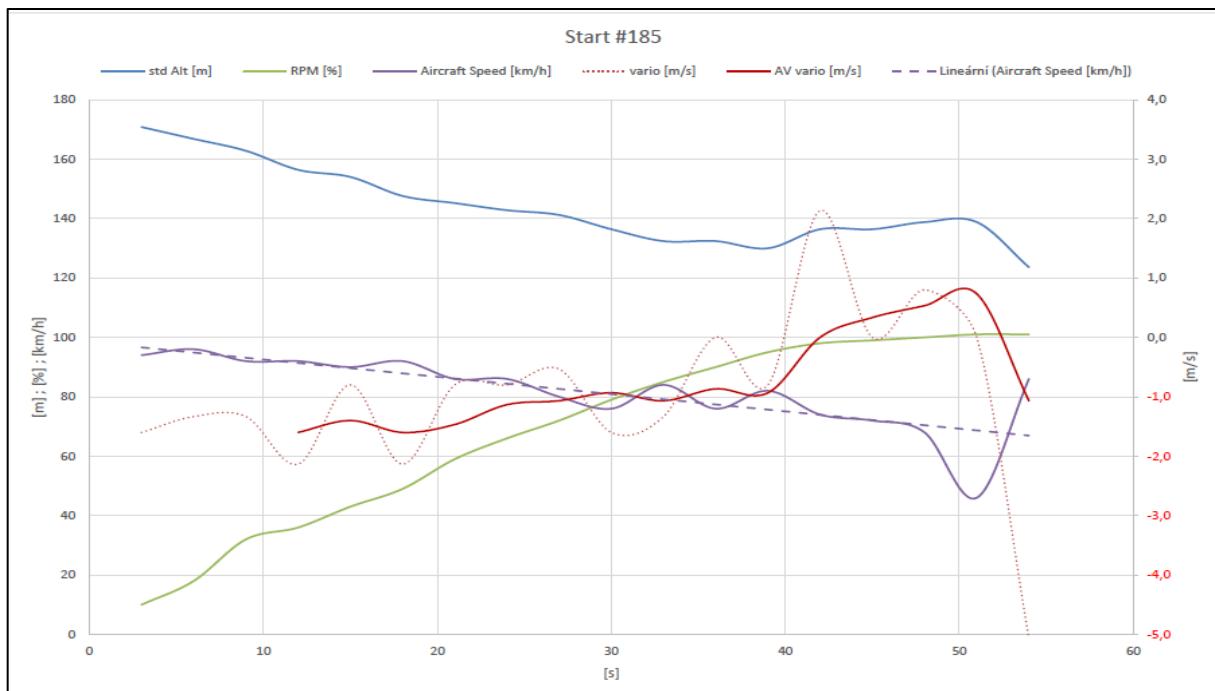
Fig. 6. The final portion of flight retrieved from DECU [source: glider manufacturer].

The engine started working at about 45 m AGL, when the pilot was making a right turn bringing the glider over a forest. Such action was illogical, incompatible with the procedure for starting a sustainer engine and with a good aviation practice.

graphs in Fig. 6, the flight speed continuously decreased, and the glider was also descending until the engine reached about 98% of its power. Then, for about 10 s, the glider was climbing slowly, while its speed was still decreasing.

In the SCAAI opinion, the pilot began climbing to avoid collisions with trees. About 40 seconds after start up the engine reached full thrust, however, the flight speed dropped to 45 km/h and a moment later the speed began to increase while the glider descended rapidly.

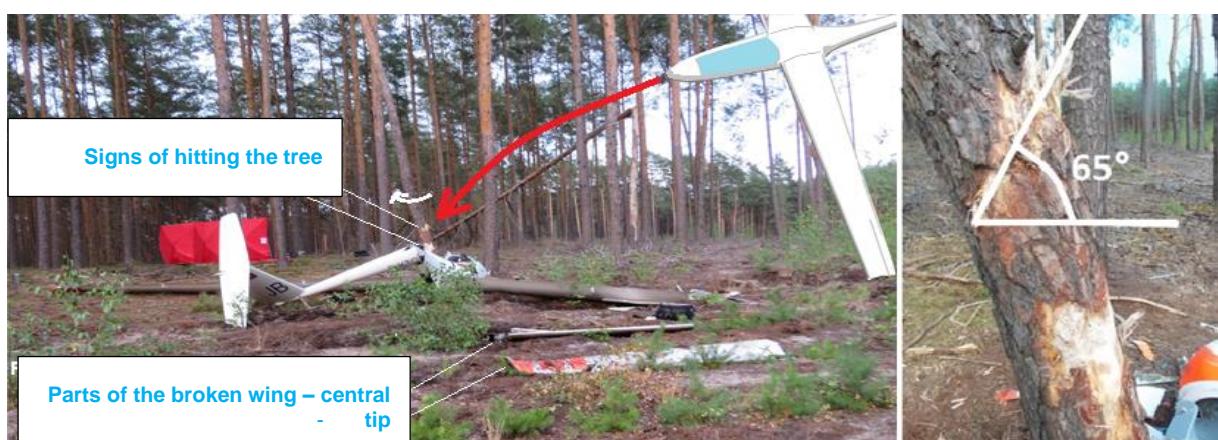
In the SCAAI opinion, that was the moment when the glider was in the firebreak and in order to avoid collision with trees, the pilot started a sharp left turn. During the turn the glider was stalled and hit the ground with the left wing in the first phase of the spin. The wing broke in two places, i.e. the place where the tip was attached and in the area of the brake.

During the collision the left wing was stopped while the right one was still moving and producing lift, which caused the glider to turn around its longitudinal axis by the angle of 65° and hit a tree with the right and then the left side of the cockpit (Fig. 7). While hitting the tree, the nose part of the glider was stopped and due to inertial forces the rear part began to rotate to the right (Fig. 7 - white arrow). During the rotation the right wing hit a tree (Fig. 8) and most likely the tail beam broke at that time.

Fig. 7. Probable course of the final stage of the accident. [source: PKBWL].

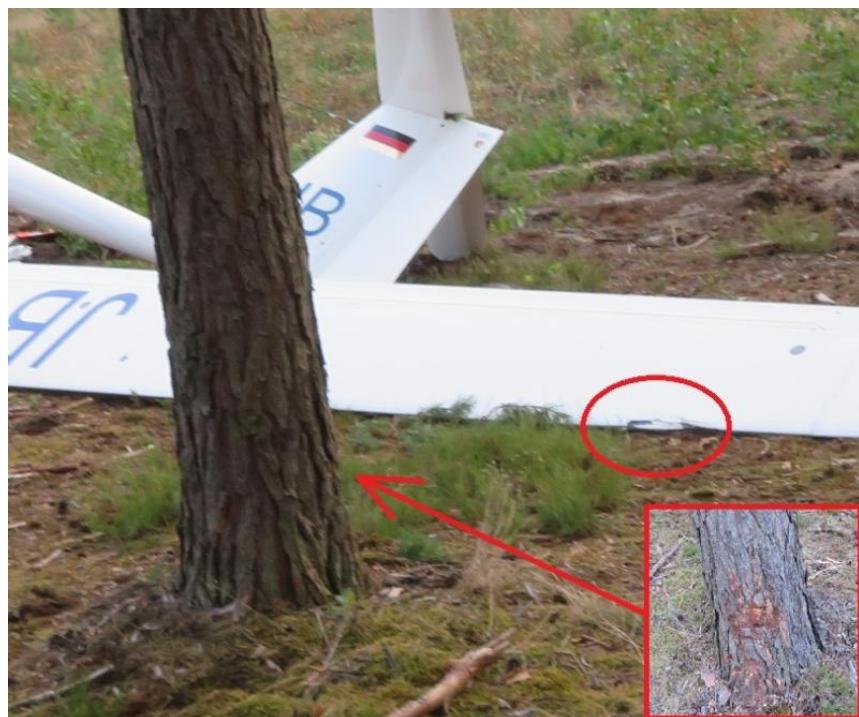
Fig. 8. Indentation of the leading edge of the right wing and traces on the trunk where the wing hit the tree [source: PKBWL].
