FINAL REPORT

2018-169-4

Accident

PW-5 "Smyk"

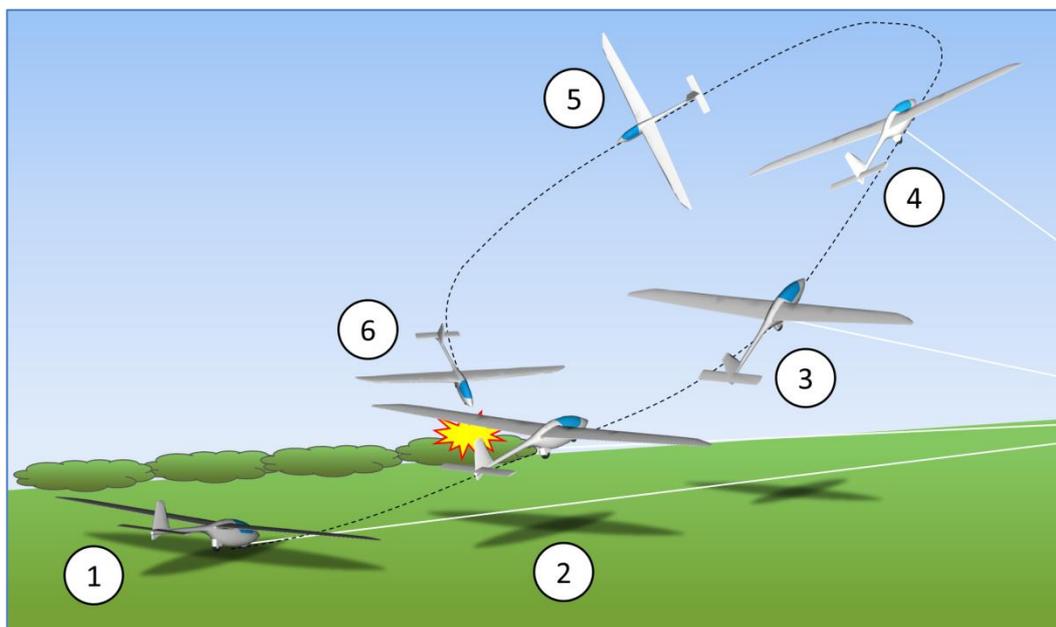
Figure 3: Flight path of the HA-4070 (drawing not to scale)

According to the Student Pilot, he started the take-off by winch launch in a wind direction corresponding to the runway direction (Figure 3, [1]). After the lift-off, he perceived that his speed is higher than normal so, as he said, "*I pulled on the stick as well*", but then he found that the aircraft was getting close to an "*excessive angle of attack*" (Figure 3, [2]–[3]), and then, at the height of about 20-25 metres, the aircraft started a bank to the left.

He then attempted to recovery, but despite his efforts, the aircraft hit the vegetation, and finally crashed into the ground (Figure 3, [5]–[6]).

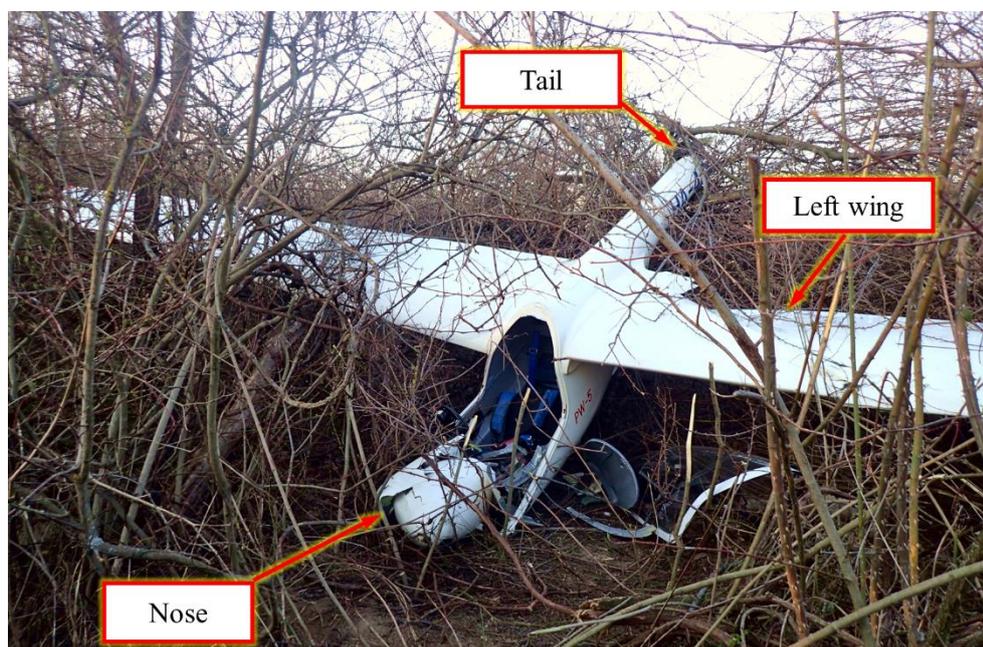
Figure 5: The wreckage at the accident site

The aircraft was damaged beyond repair. The nose of the sailplane was destroyed, but the pilot's seat and cabin remained in one piece (Figure 5). The canopy separated from the fuselage and was found left of it. The left wing separated from the fuselage at the wing root, and the mid-section of the leading and the trailing edges were damaged. The tail fractured but did not separate from the fuselage. The fuselage fractured at the numerical characters of the reg. marks, but the two parts did not separate. As a result of the impact, the horizontal stabilizers (together with the attach fittings) broke out of the tail, and the push rod moving the elevator broke at the stabilizer. The right wing remained in its place, showing no signs of damage.

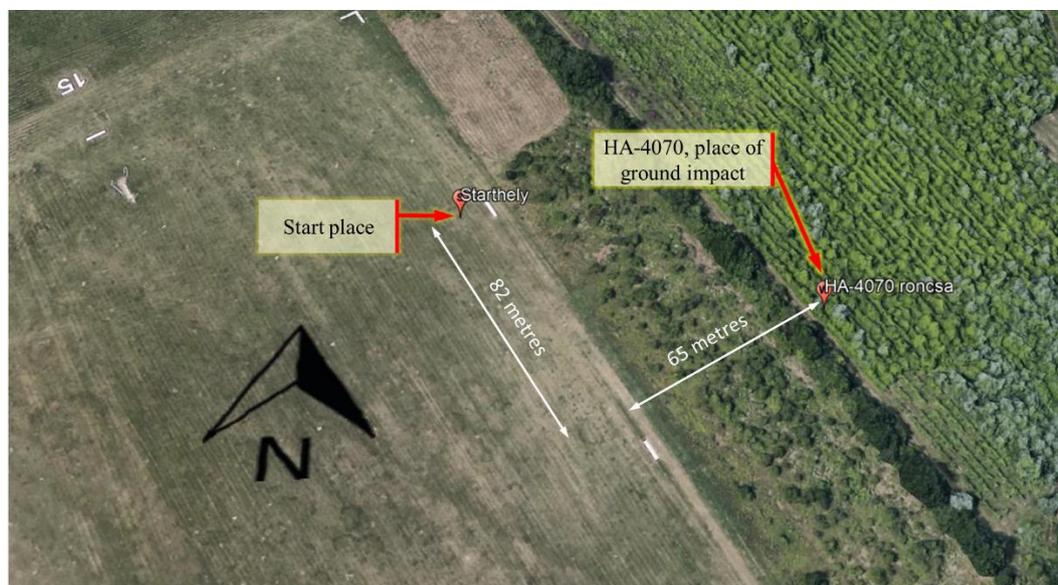
Figure 6: Situation of the wreck relative to the start place

According to the launch coordinator, the sailplanes launched from the estimated coordinates of 47.490004°N, 018.913033°E. The wreck of the aircraft was found ca. 82 metres from the start point towards the winch, and ca. 65 metres NE of the runway edge markings (Figure 6).

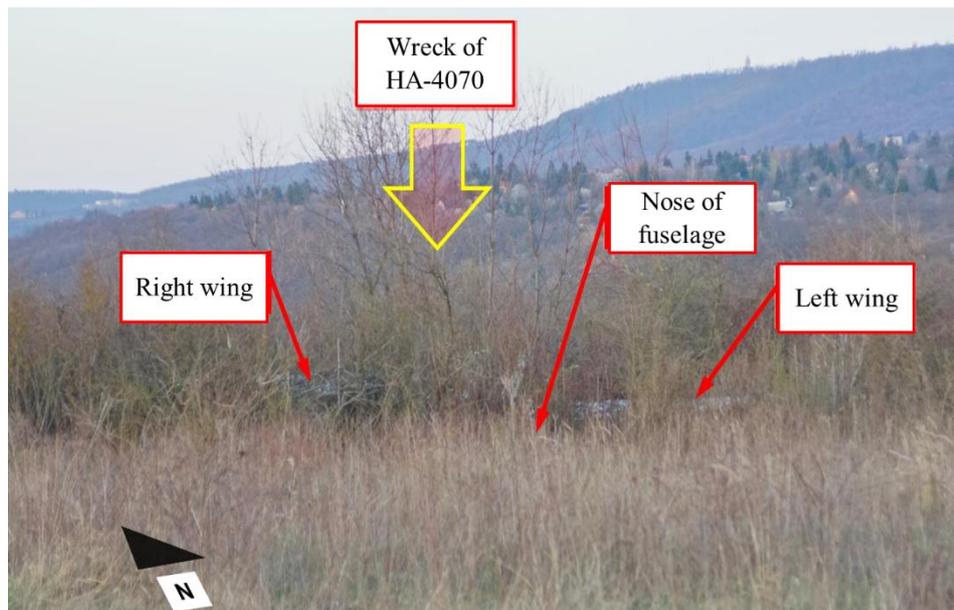
Figure 7: The spot of ground impact of the HA-4070

The touch-down spot was an uncultivated land next to the airfield, covered with trees and bushes. This thick and relatively tall vegetation (Figure 7) and the damage of the airframe absorbed a substantial portion of the kinetic energy. The damage of the cockpit was not so severe as to cause serious injuries to the Student Pilot.

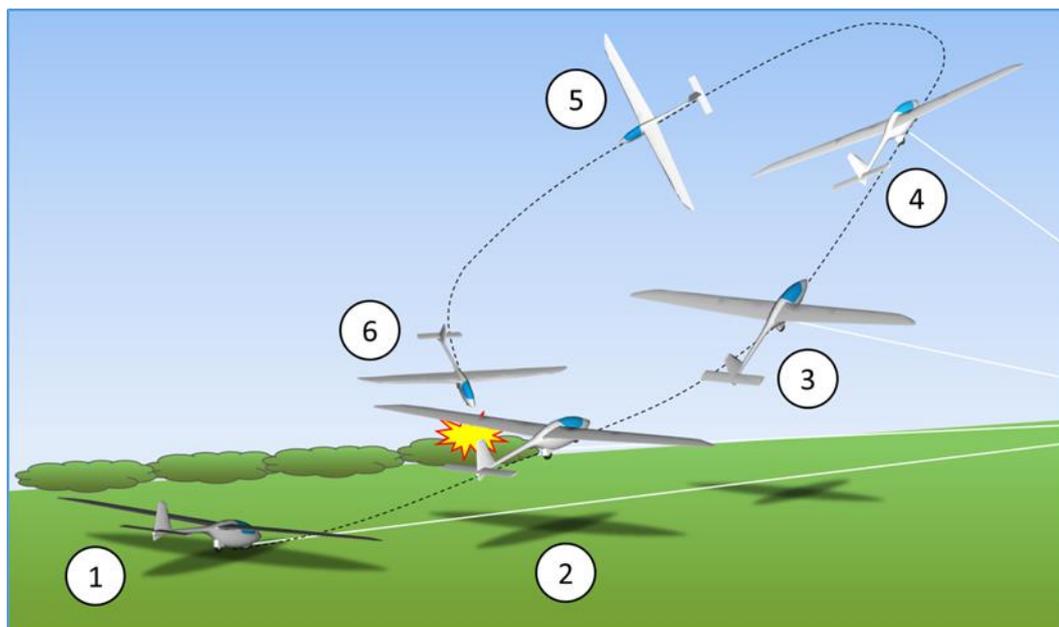
Figure 8: Flight path of the HA-4070 (drawing not to scale)

According to reports from witnesses and the fact that the aircraft crashed to ground left of the line of winching (Figure 8/ (2)), it may be stated that, during the stall, the airflow separated from the left wing first, thus creating an asymmetric lift distribution (Figure 8/ (3) and Figure 9). As a result, the sailplane deviated from the intended flight path in a left rolling movement (Figure 8/ (4), (5)), and finally it crashed to the vegetation and the ground.
