# Final Report

Accident with the helicopter Sokol W-3A,  
on 14.01.2019, at approx. 11:34 UTC at Bürglkopf,  
Gemeinde Fieberbrunn, A-6391, Tyrol,  
GZ.: 2021-0.905.481

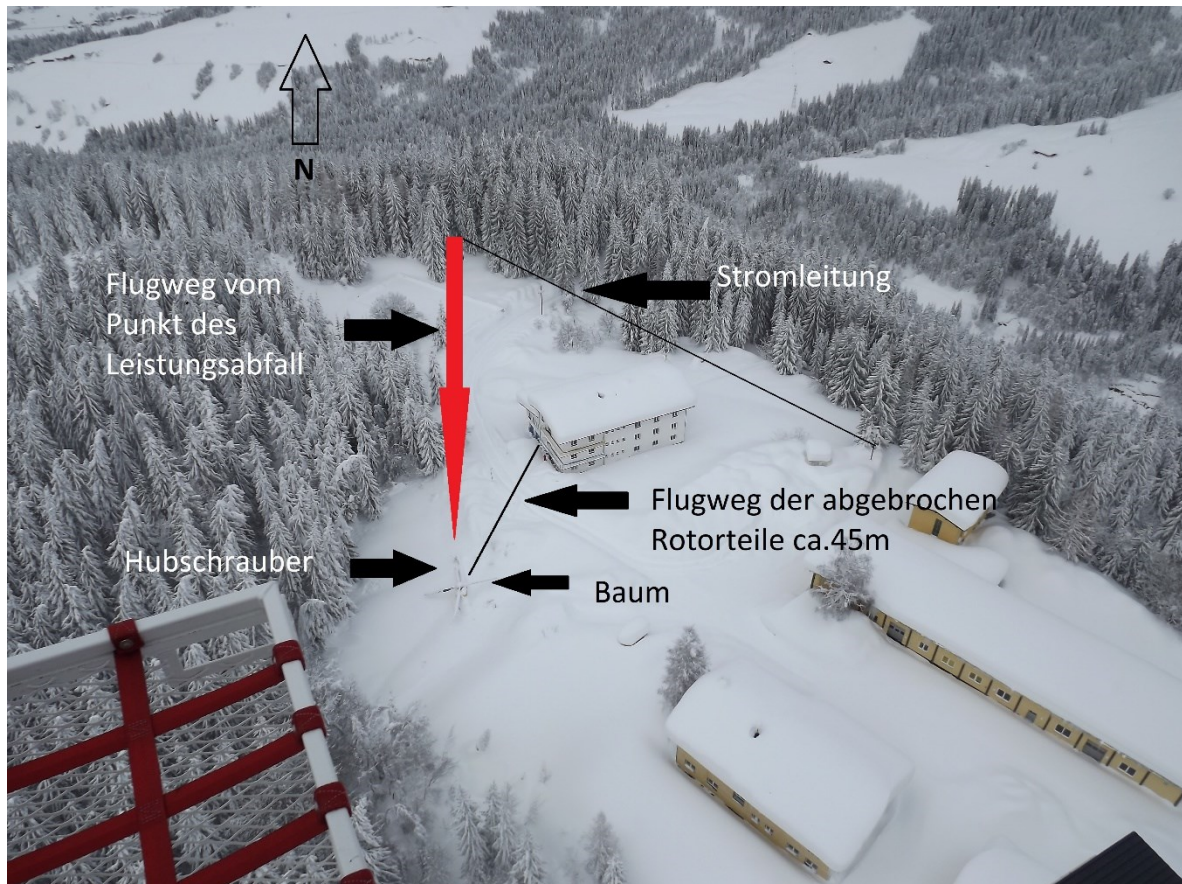
Figure 1: Overview of the emergency landing site

Shortly after reaching the Almgasthof, the pilot noticed an abrupt drop in the helicopter's performance. He was no longer able to maintain altitude, so he aligned the nose of the helicopter to the right and started forward motion with the stick to reach the later emergency landing area. The helicopter had a high sink rate. The pilot decided to land on the western side of the Almgasthof. When the helicopter touched down at around 11:34 a.m., it touched a tree on the left with its rotor blades. This damaged the main rotor blades.

The average distance between the rotor mast and the touched tree was about 6.4 m (see Figure 12). This distance corresponds approximately to the average length of the severed main rotor blades. Furthermore, the damage to the tail rotor and the vertical fin could be attributed to the severed main rotor blades. A part of a severed rotor blade damaged the front of a local house at a distance of about 45 m (see figure 1).

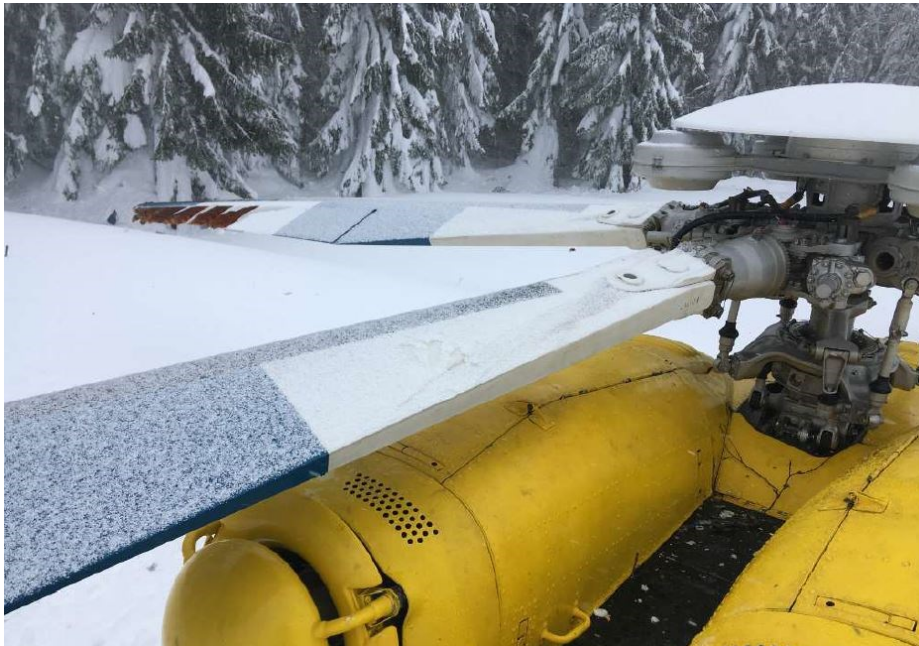
Figure 14: Picture was taken direct after emergency landing

(Figure 14) was fresh snow that was left on the aircraft after the helicopter was parked at the emergency landing site. No ice accumulations were visible on the main rotor blades. Slight ice accumulations were visible in the area of the forward landing gear fairing. Wet snow accumulations were visible above the engine cowling. (Figure 15).

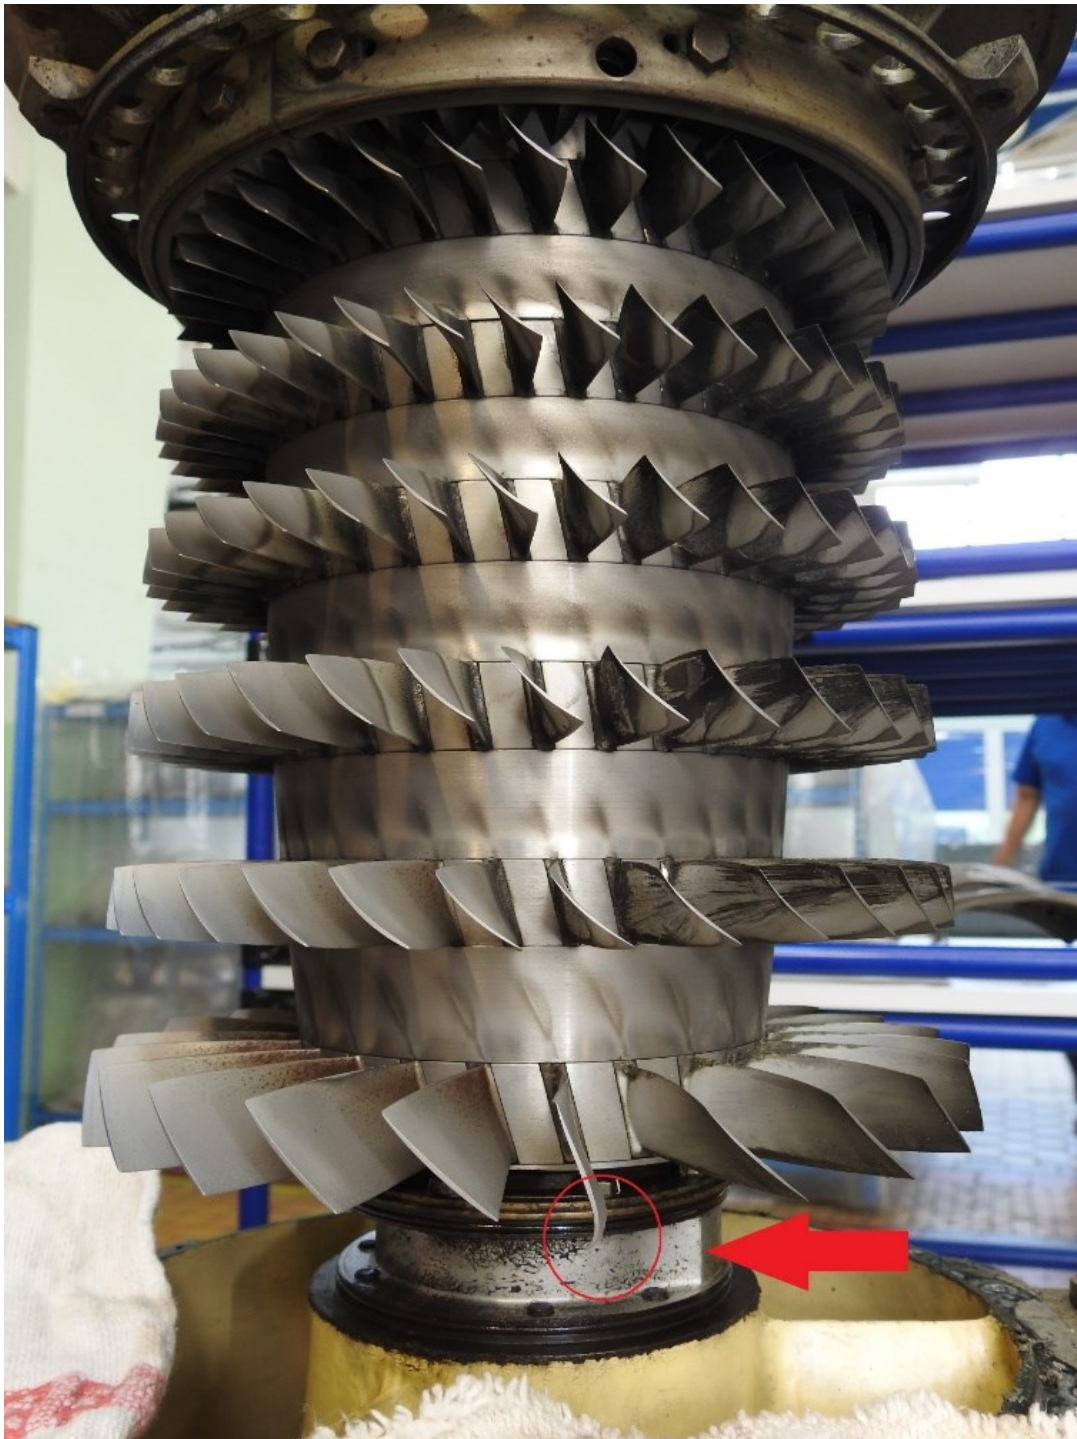
Figure 18: Compressor stage axial compressor

- *In the front axial compressor stage there was damage in the form of deformed compressor blades (2 pieces), and stator blades (11 pieces)*
- *Two Inlet Case Front Struts were painted with an atypical yellow paint; it was also found that this paint was subject to severe corrosion*

In the front axial compressor stage of the right engine (Engine 2), two compressor blades showed considerable deformation. (Position of the second compressor blade opposite).

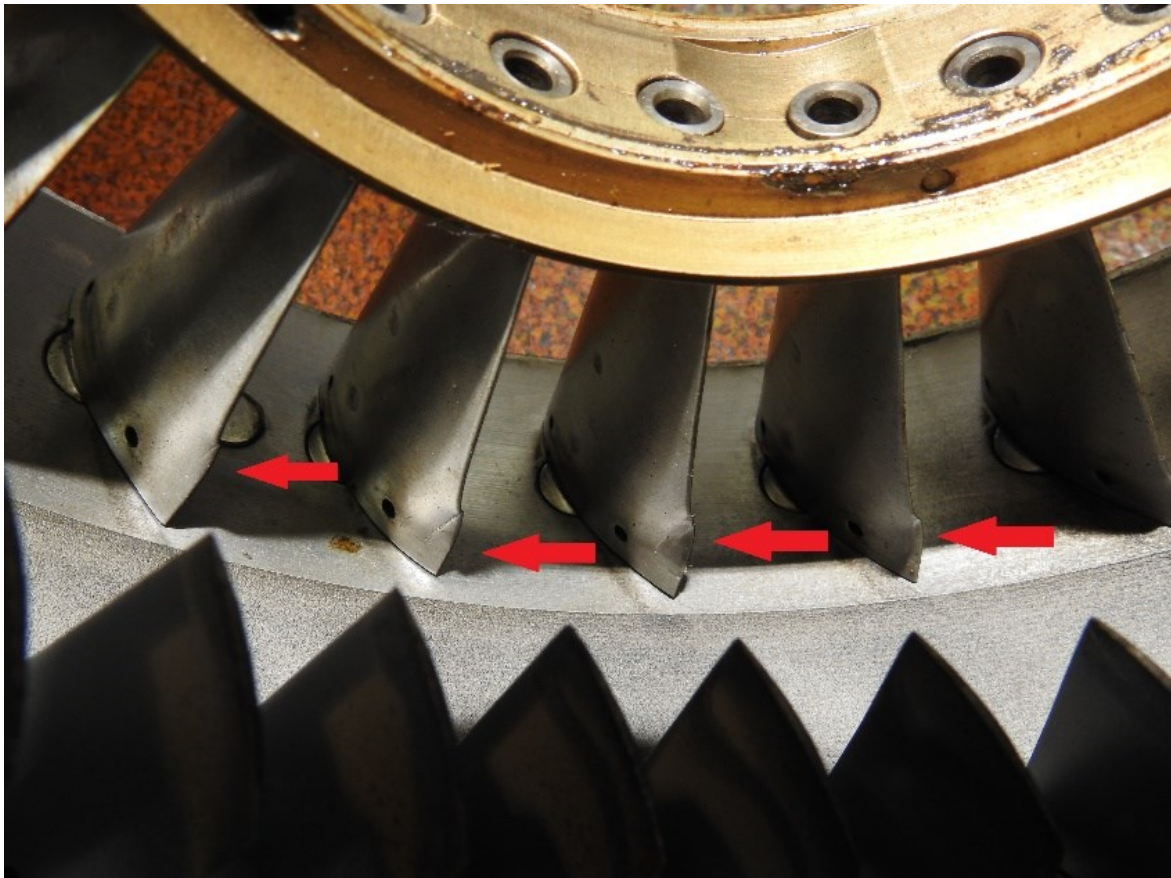
Figure 19: Stator blades of the first axial compressor stage

Eleven stator blades of the first axial compressor stage of the right engine (Engine 2) exhibited deformation.

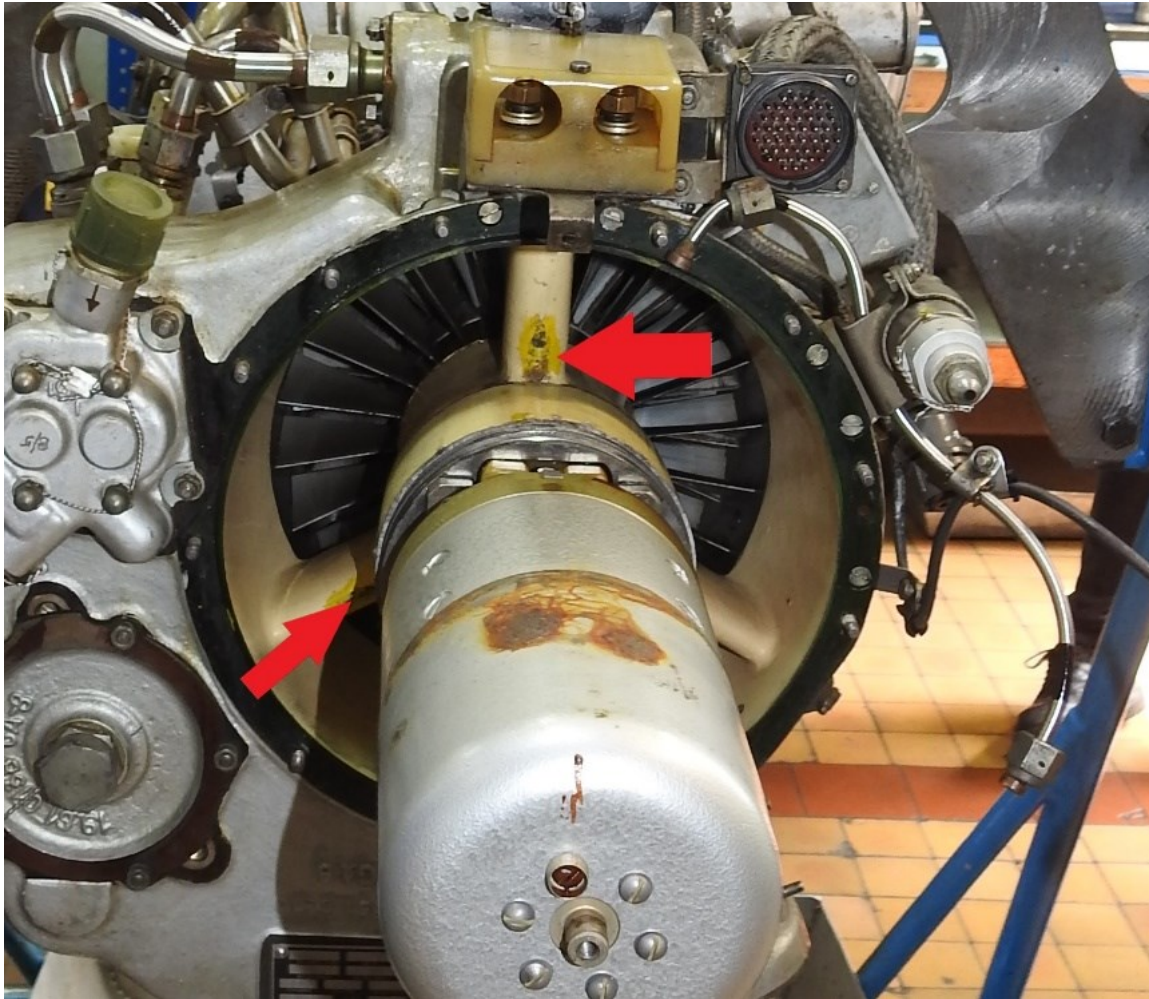
Figure 20: Anti-icing airflow ducts in intake casing

- *Openings in the two Inlet Case Front Struts referred to in the previous point, through which hot air was supposed to flow out to prevent ice build-up, were closed due to the corrosion referred to above*

At two inlet case front struts in the engine air intake cowling (Figure 15 + Figure 16), through which combustion air (hot air from the engine combustion chamber) is passed to prevent ice build-up in the engine inlet, corrosion was detected to such an extent that those openings through which the hot air was to flow out were closed. Further visible in the form of yellow paint on two inlet case front struts of the inlet case assy indications that the repair in this area was carried out improperly. According to the engine manufacturer's instructions, such repairs in this area are inadmissible and not intended, irrespective of any measures taken by the manufacturer.

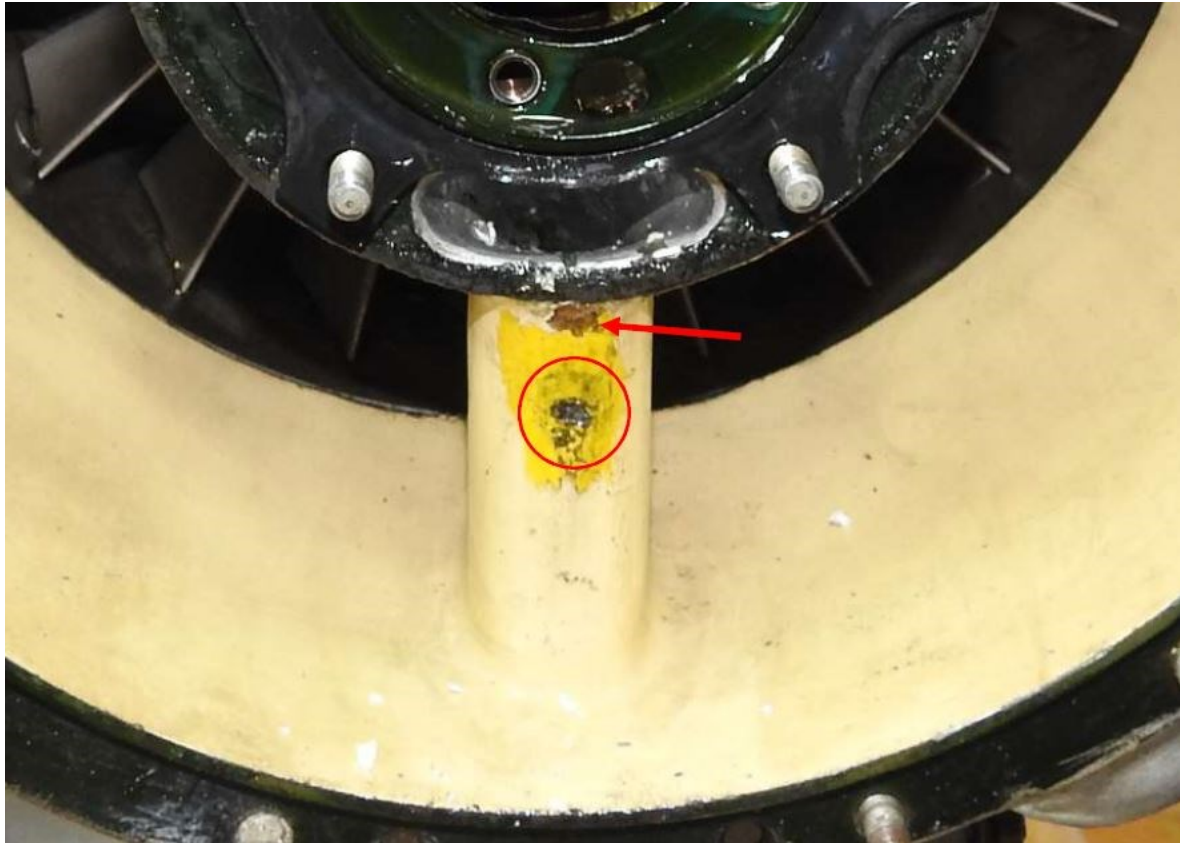
Figure 21: Corroded airflow ducts

- Corrosion formation at the outlet ducts in the inlet case front struts of the right engine was the reason for the partial failure of the ice prevention system.

- The formation of corrosion was not visible to the pilot either during the pre-flight check or during the flight.
- According to the findings of the engine manufacturer, however, there is a causal relationship between this application of paint and the formation of corrosion.

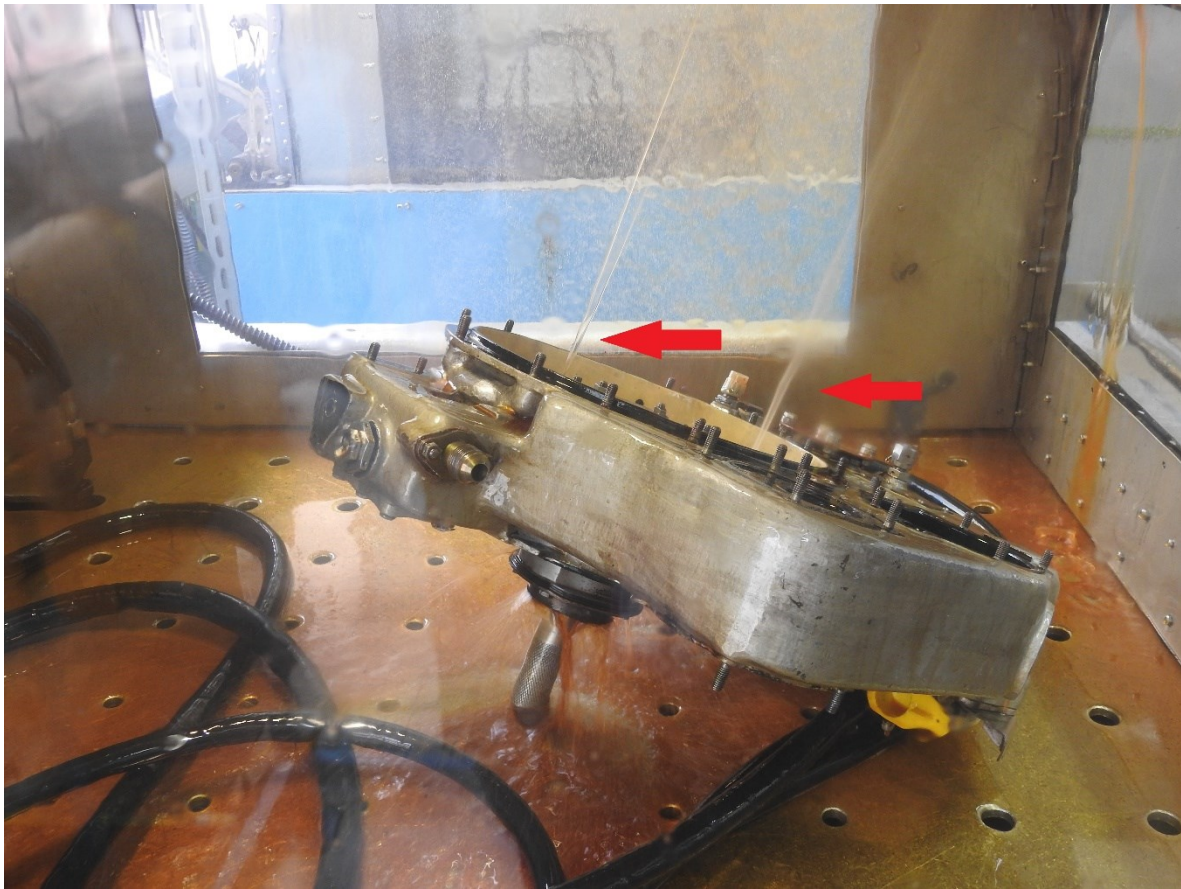
Figure 24: Test on the test bench after removing the corrosion from the opening holes

After removal of the corrosion detected at the opening boreholes, a new similar test on the test stand showed that oil could flow through as a test substance. Thus it was proved that corrosion was the reason for the partial failure of the ice prevention system.

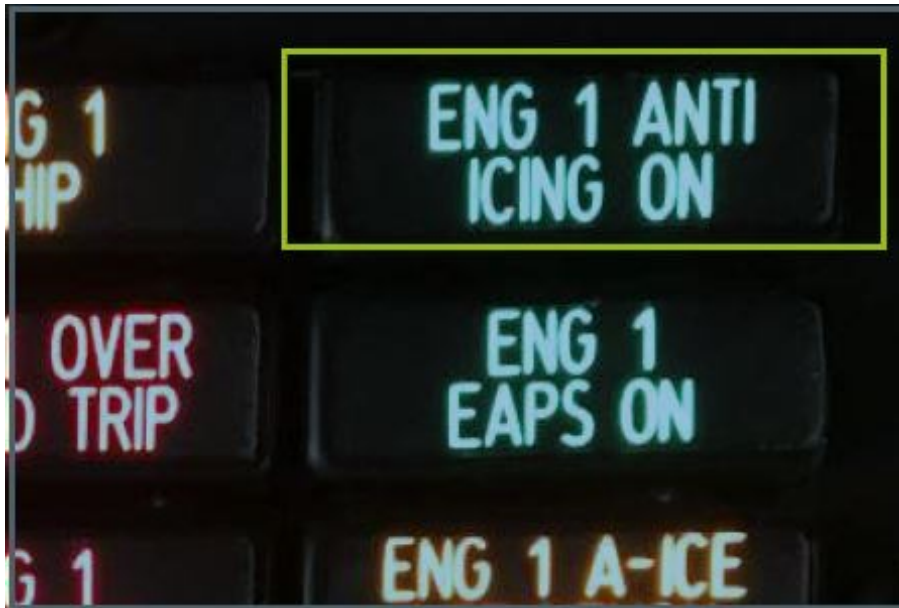
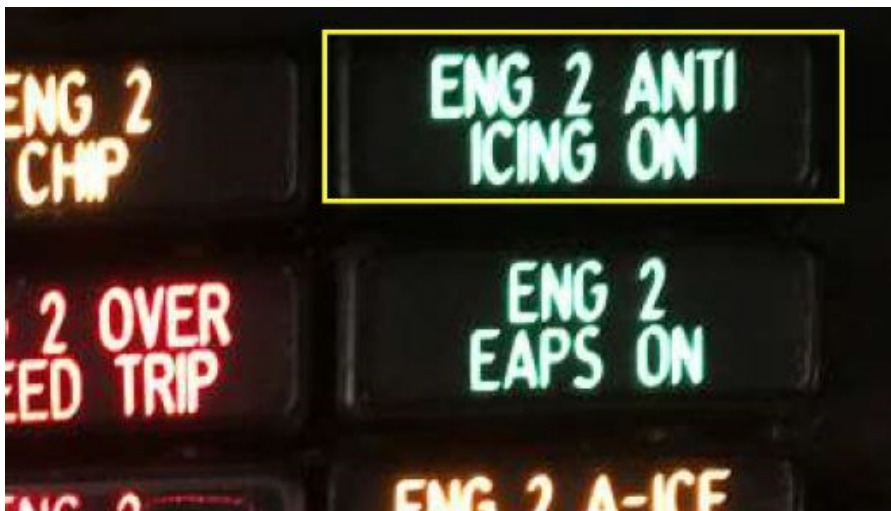
Partial constraints on the engine-anti-icing system, as in this case caused by corrosion, has no effect on the displays in the cockpit. The electromagnetically actuated valve opened and let the hot air (Combustion Air) pass up to the opening holes in the Inlet Case front Struts. Since these openings were closed by corrosion, no Combustion Air could escape to prevent ice build-up.
