FINAL REPORT

OCCURRENCE NO – 2019/436

AIRCRAFT – BOEING 777-258, 4X-ECC

DATE AND PLACE OF OCCURENCE – 15 February, 2019, EPWA

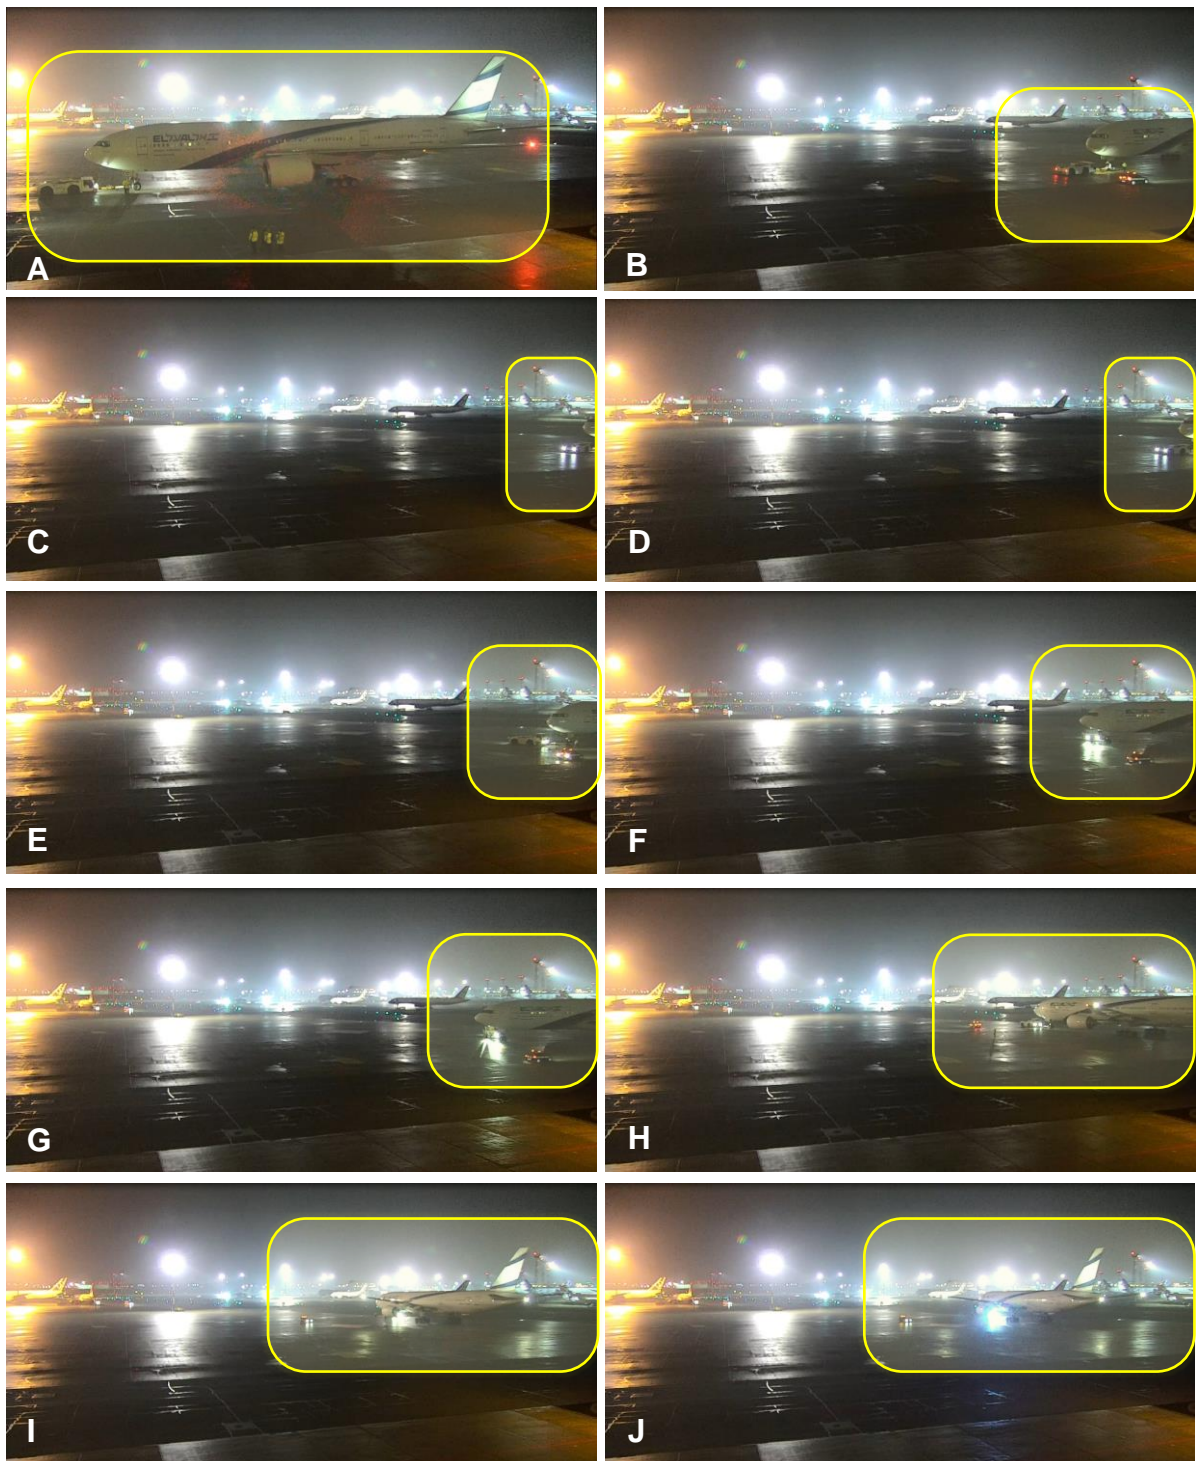
Fig. 1. Boeing B777-258, accident aircraft, during push-back and towing: A – push-back initiation; B – right engine start-up initiation; C – end of push-back; D – towing initiation; E – end of right engine start-up; F – left engine start-up initiation; G – shearing the left pin of the towbar; H – end of left engine start-up; I – tractor being pushed by the aircraft; J – collision (aircraft and tractor stopped)

When the tractor turned right, and the plane was still moving straight, the flight crew commenced the start-up process of the left engine. About 2-3 seconds later, the left (external in relation to the turn direction) towbar pin was sheared off.

At the end of the turn, the RPM of the left engine reached N1=18.5%. Eight seconds later, the tractor-aircraft combination accelerated to GS=2 kt, and after next 2 s it slowed down to the initial speed of GS=1 kt. A moment later the towing tractor operator started a right turn towards TWY Z3 of EPWA aerodrome, but the aircraft continued to move straight, accelerating to 3 kt. At this point, the towbar folded and its right shear pin and retaining bolt were sheared off, which caused that the aircraft-tractor connection lost its stiffness, and the separation of the aircraft from the tractor was no longer possible. The plane began to overtake the tractor, as a result the tractor got under its fuselage and, as a consequence a collision occurred. At this point, the towing operation was aborted.

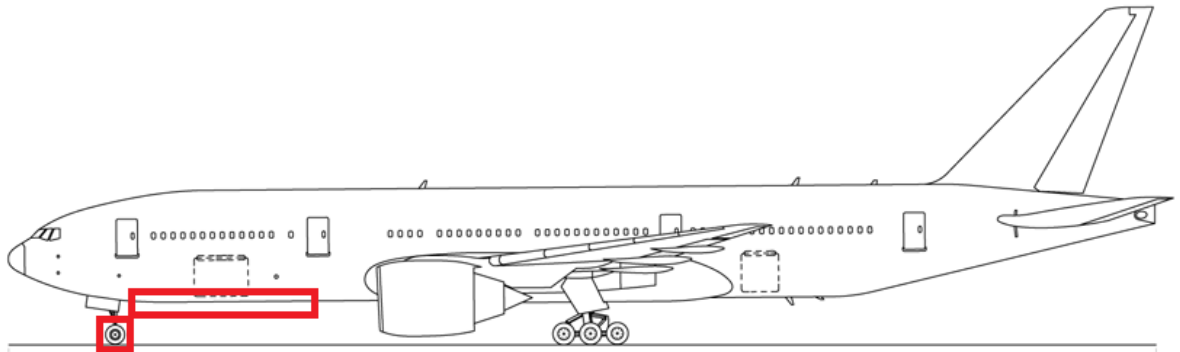
Fig. 2. Damage areas of the accident aircraft marked as red boxes.

- numerous dents and multiple tears in the skin of the fuselage that were a result of the collision with elements of the towing tractor’s roof, resulting in loss of pressurization of the fuselage in the baggage compartment area;
- numerous scratches on the lower part of the fuselage skin that were a result of collision with elements of the towing tractor’s roof;
- abrasions on the rim edges of the front landing gear that were caused by its contact with the towing tractor;
- multiple abrasions of the tire of the right front landing gear wheel caused by its contact with the towing tractor.

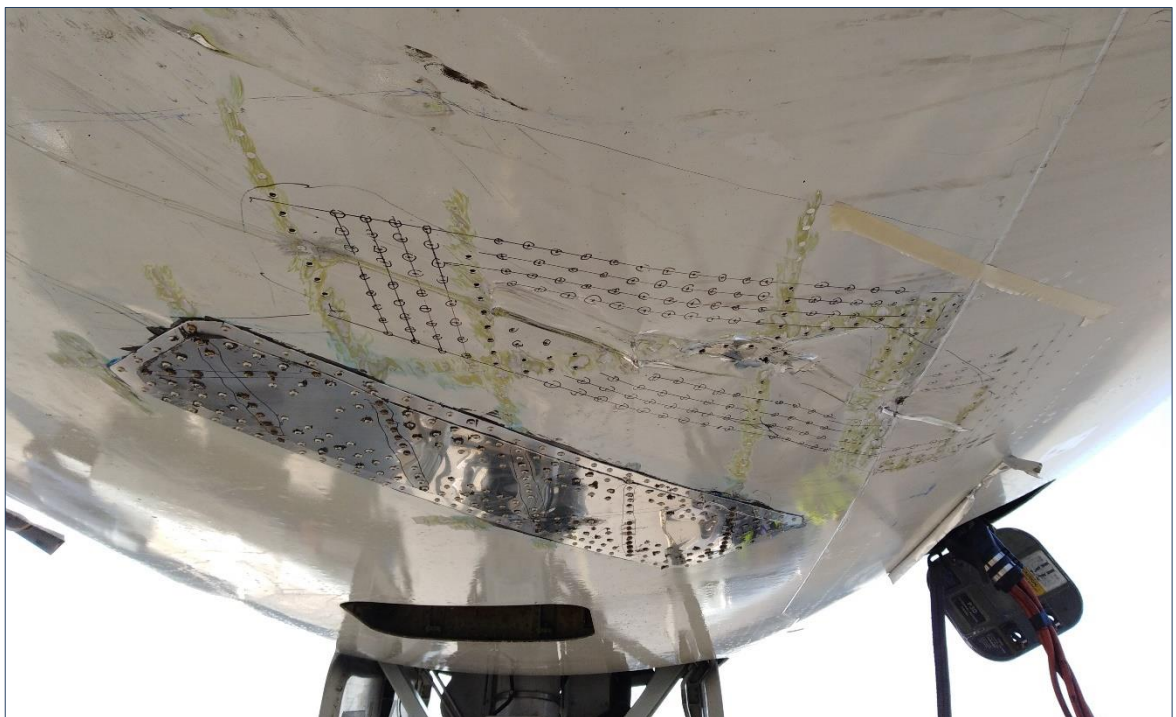
The towing tractor operator's cabin was raised during the towing operation, which resulted in damage to the lower nose part of the fuselage.

Fig. 3. B777-258, accident aircraft during repair at EPWA aerodrome – damage view

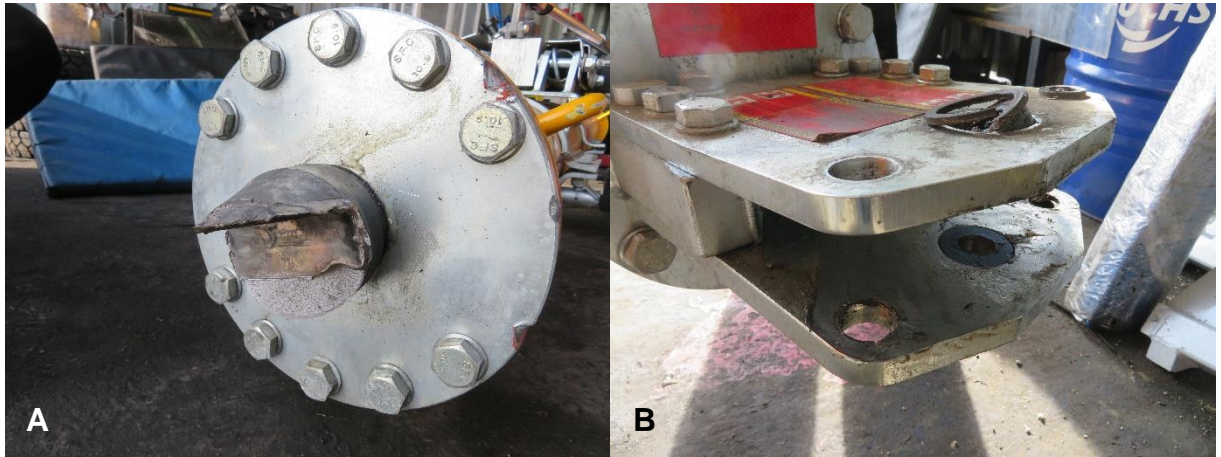
Fig. 4. J-TOWversa1-A towbar: A – damaged towing eye, B – damaged towhead

- 1) Breakage of the welds of the fitting connecting the towing eye with the tractor, which resulted in the separation of the fitting from the towbar. The fitting remained connected with the tractor after the occurrence.

- 2) The flanged fastening of the drawbar ferrule on the tractor side was locally deformed in three places.
- 3) The fastening of the towhead from the side of the aircraft was damaged by:

- multi-plane brittle fracture of the retaining bolt of the towhead mounting;
 - multi-plane, brittle fracture of both shear pins of the towhead mounting;

- local deformations of the metal sheet surface of the towhead mounting ferrule caused by fragmented pins and sleeves fixing the position of the pins in the ferrule.

- 4) The J-TOWversa1-A towhead was damaged as described below:
 - deformation of the bushings seats fixing the position of the retaining bolt and shear pins in the towhead;

- shearing off the two of four screws fixing the towhead in relative to the landing gear strut.
- 5) The collision of the aircraft and towing tractor damaged the coating of the towbar and caused slight scratches.

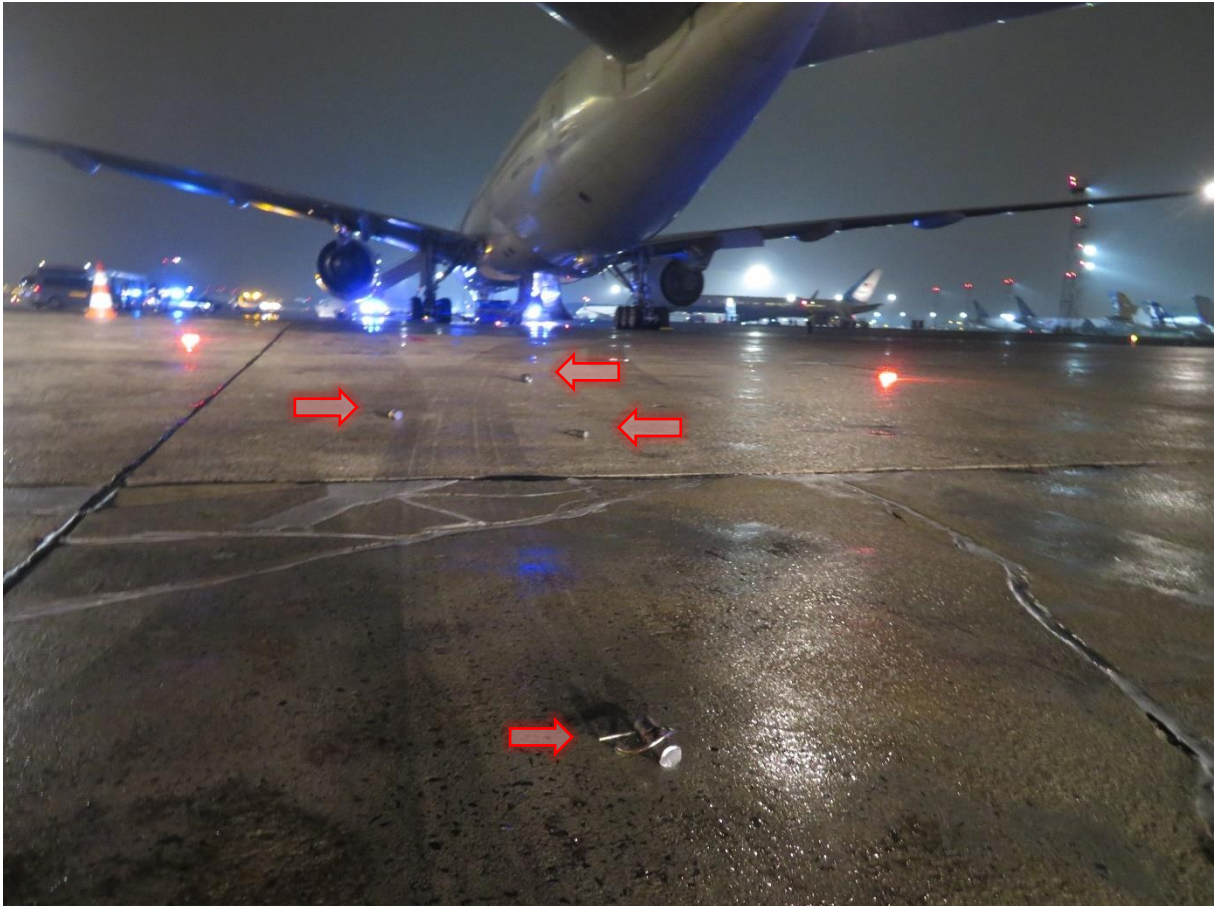
The sheared off fragments of the left pin of the towbar were found on the apron. The location is shown below (Fig. 5).

Fig. 5. EPWA aerodrome apron – the arrows show the fragments of the left shear pin (relative to the direction of the tractor-aircraft combination movement)

The left seating and fragments of the left pin were found on the apron (Fig. 5) in the place, where the tractor-plane combination made a right turn during towing (Fig. 1-G), which clearly determines the pin shearing location.

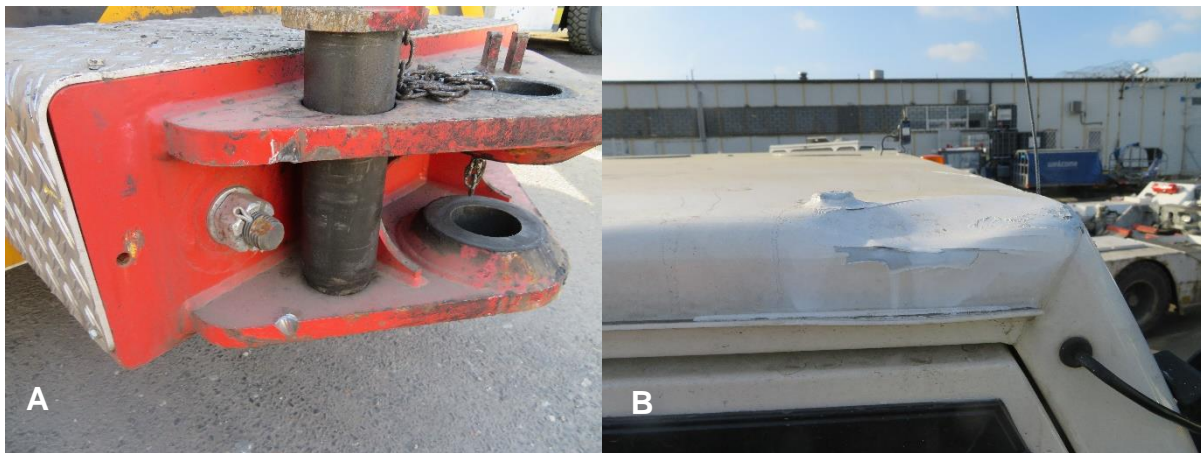
- radio antenna mounted on the roof – bent but working properly after straightening its mounting;
- two bolts torn out of the tractor roof – one of the pins got stuck in the damaged skin of the aircraft fuselage, while the other was found on the apron after the occurrence;
- slight, plastic deformation of the edges of the tractor front fittings used for mounting the towbar;
- abrasion of the right corner of the towing tractor front bumper;
- dent in the area of the right front part of the towing tractor operator cabin;

- minor paint abrasions on the right side of the towing tractor (side, rear right wheel arch), caused by the contact of the towing tractor with a broken towbar and the front landing gear of the accident aircraft.

Rys. 6. J-SCHOPF F210 towing tractor: A – coupling damage, B – roof damage

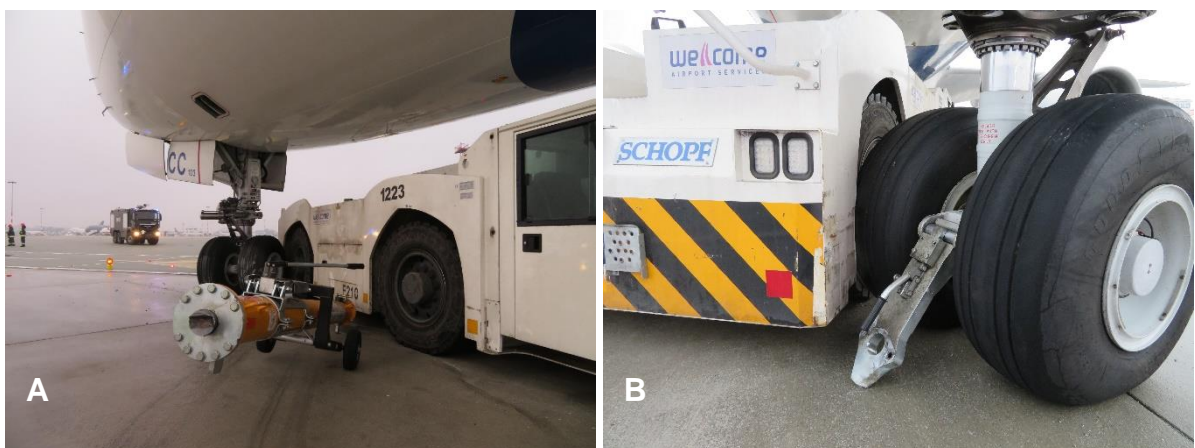
Fig. 9. Occurrence site: A – general view showing the positions of the aircraft, towbar and the tractor after the occurrence; B – collision of the nose landing gear with the tractor

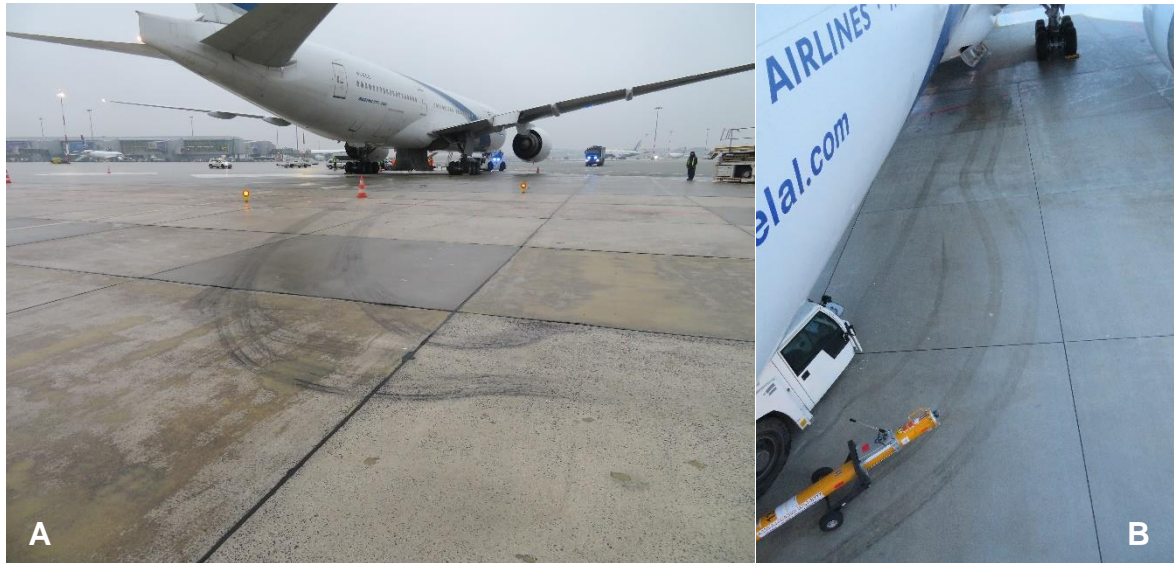
The site of the serious incident is shown below (Fig. 10). It presents the marks of the aircraft tires on the apron showing the radius of the turn and the last portion of the travel of the nose landing gear wheels prior to the collision with the towing tractor.

Fig. 10. EPWA apron: A – marks of the right truck of the main landing gear wheels;
B – marks of the front landing gear wheels

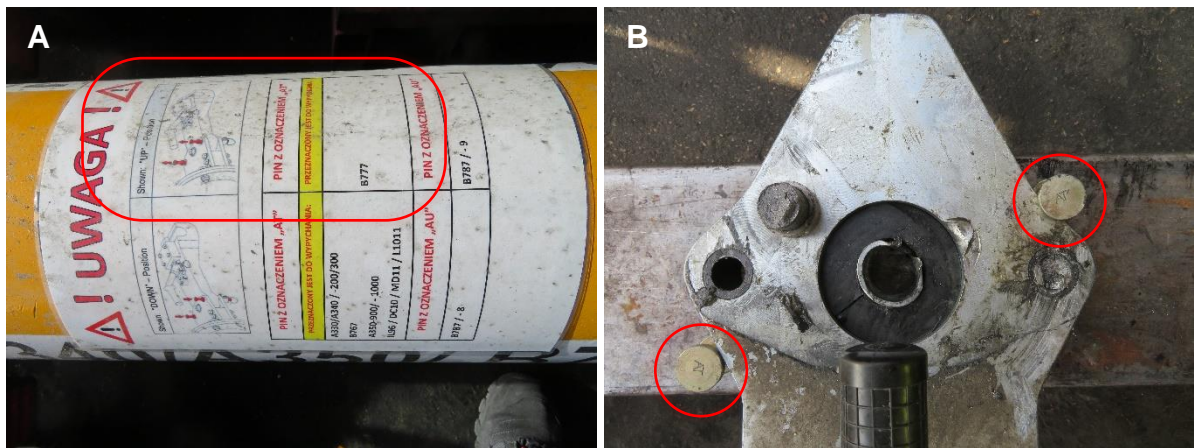
Information regarding the pins marking and setting was clearly printed on the towbar (Fig. 14-A). The markings of the pins used in the investigated case were in accordance with the manual (Fig. 14-B).

Fig. 14. J-TOWversa1-A towbar: A – type and positioning of pins information; B – sheared pins with visible markings

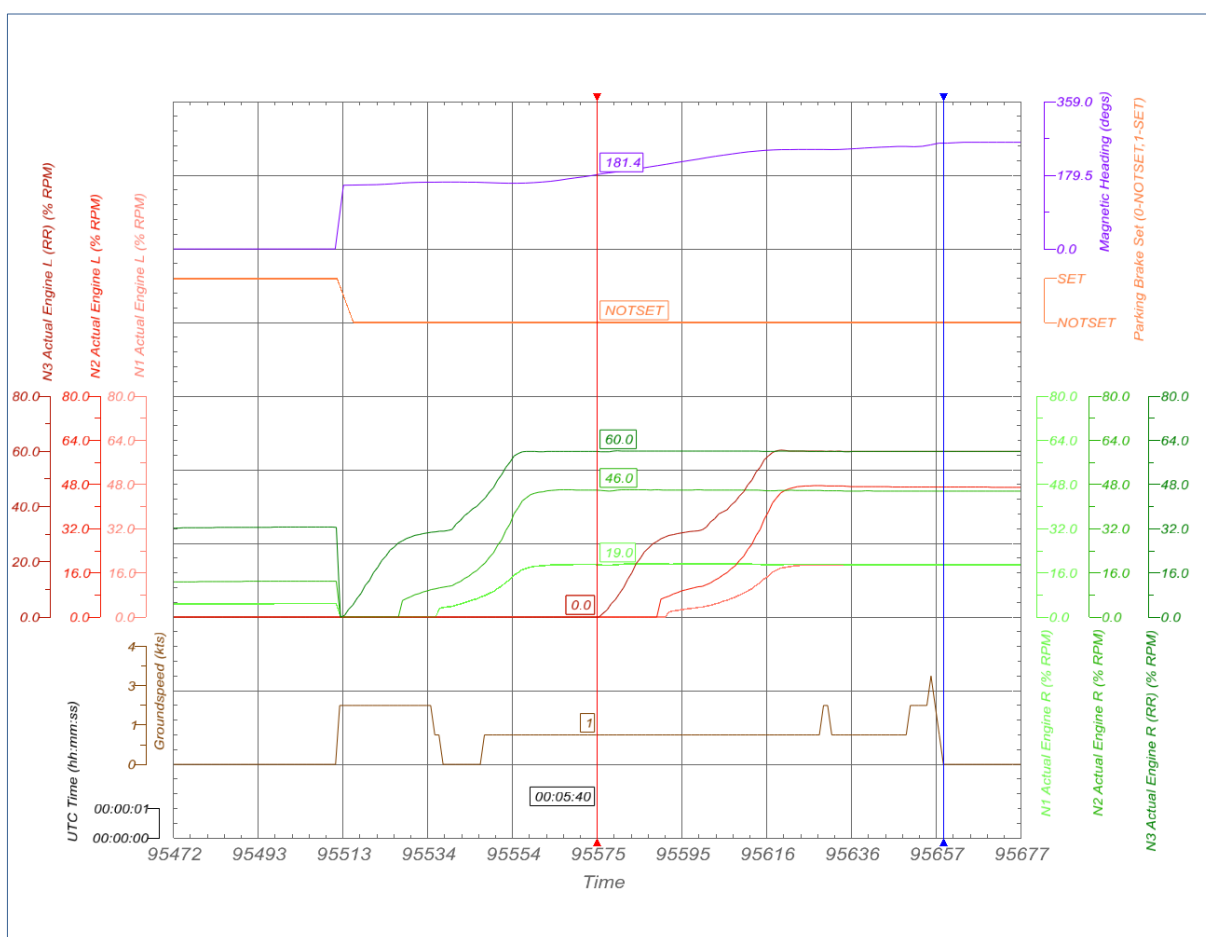
Fig. 16 shows selected parameters of the airplane during push-back and towing, obtained from the FDR recording. The revolutions of the left and right engine compressors (N1, N2 and N3) (left – red, right – green) show the course of their start-up. The red vertical line shows the beginning of the left-hand engine start-up, and the dark blue line shows the time of the tractor-airplane collision. The horizontal orange line shows the release of the airplane parking brake, the brown line shows the speed during push-back/towing, and the purple line shows the change of the magnetic heading.

The figure below clearly shows that both engines reached the IDLE RPM during push-back/towing operation. A while before the collision, the tractor-aircraft combination accelerated from 2 to 3 kt, then stopped.

Fig. 16. Selected parameters during push-back and towing of Boeing B777-258 4X-ECC [source: FDR]

When during towing an additional force (the thrust of the engines) was applied to the tractor-airplane combination – the speed of the combination increased (Fig. 16).

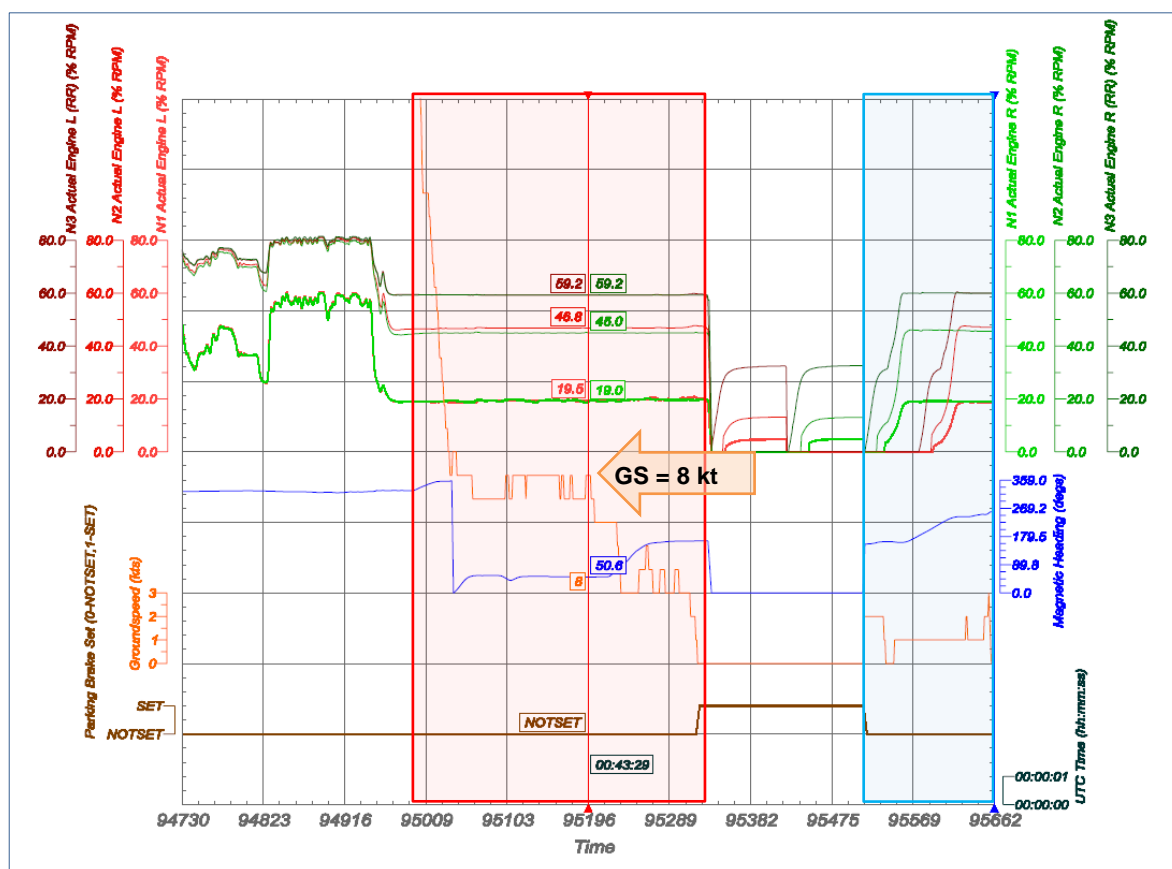
Fig. 17. Selected parameters of the Boeing B777-258 4X-ECC during taxiing (red frame) and during the occurrence (blue frame) [source: FDR]

Fig. 17 shows the course of selected parameters during the taxiing (red frame). For comparison, the blue frame shows the parameters during the occurrence. The analysis of the parameters shows that with both engines operating on IDLE setting, the plane was taxiing at a ground speed of 8 kt after landing (airplane ground speed (GS) – orange, left engine RPMs – red, right engine RPMs – green).

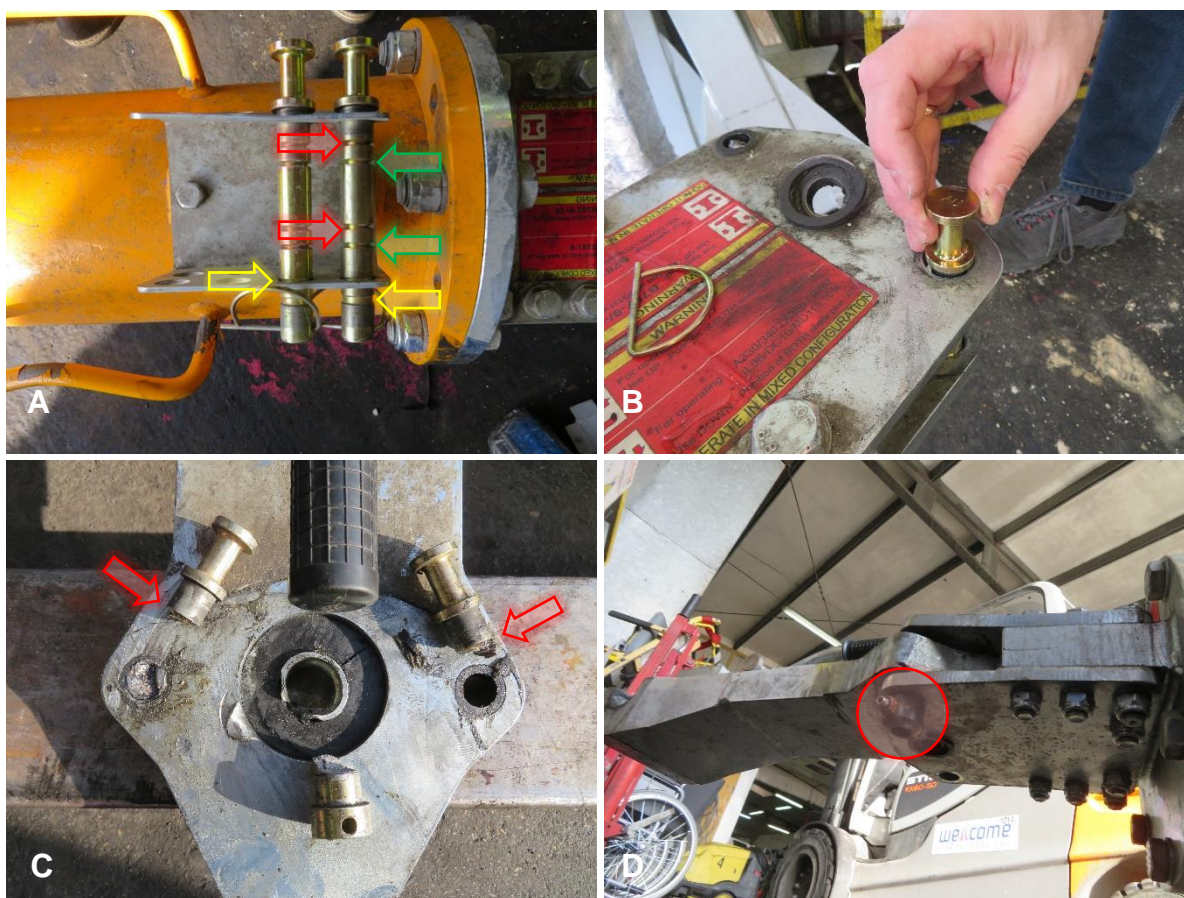
The shear pins of the towbar have circumferential grooves of various depths. Depending on the setting of the pins in the top or bottom position, the working cross-section area of the pin is greater for airplanes with greater mass (shallower groove) and respectively smaller for lighter planes (deeper groove). Therefore, the shear strength of the pins depends on their setting in relation to the head.

The position of each pin is locked with a ball lock in the bottom seat (Fig. 18-D). A spring presses the ball against the locking groove which is shown with yellow arrows in Fig. 18-A.

Fig. 18. J-TOWversa1-A towbar: A – undamaged shear pins (green arrows show the grooves at which the pins are sheared in the top setting, i.e. correct for B777; the red arrows show the grooves at which the pins were sheared during the occurrence; yellow arrows show the locking grooves); B – bottom position of the shear pin; C – upper fragments of the pins sheared during the occurrence; D – the lower seating of the right pin with a ball lock.

After exceeding the permissible load, the head of the towbar acts as a guillotine, shearing the bolts in the plane of the grooves. As shown above (Fig. 19-C) the pins have been sheared in the plane corresponding to their bottom position.
