FINAL REPORT

ACCIDENT 2019/2087

AIRCRAFT – Diamond DA20-C1 airplane, SP-KWG

DATE AND PLACE OF OCCURRENCE – 10 June 2019, EPMO, Poland

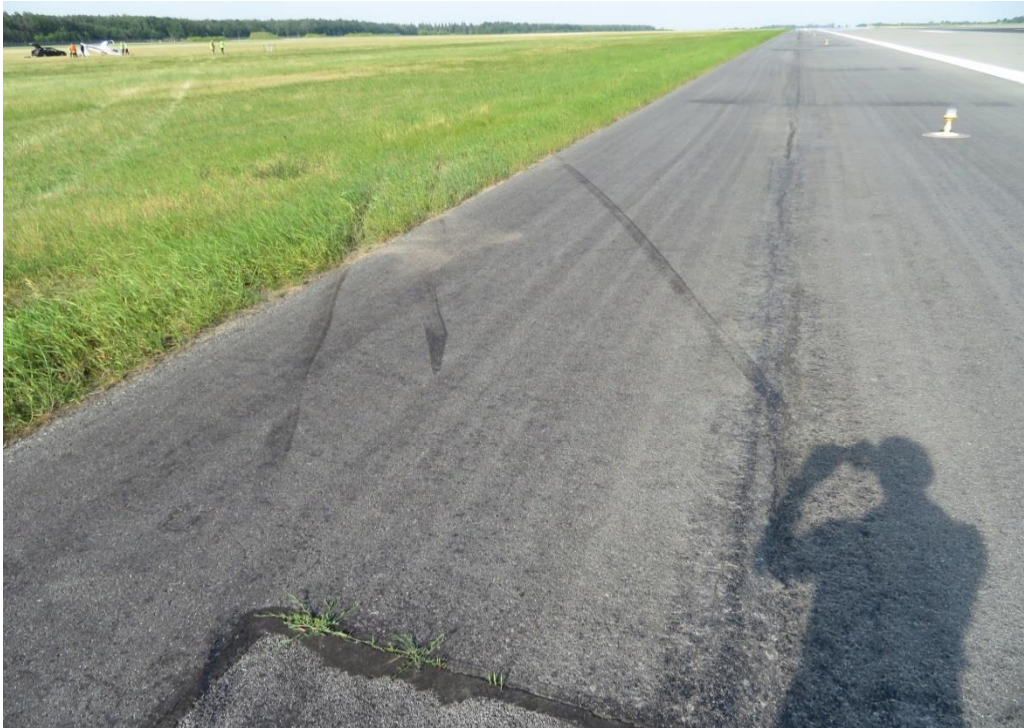
During visual inspection of the accident site and the analysis of recordings, it was found that the first touchdown took place on the left side of the concrete runway on its extreme part (Fig. 1), and then, after bouncing, the plane moved to the left, off the runway, onto the grassy part of the aerodrome. During the flight with the left bank, the left wing collided with the ground and the plane touched down probably with a negative pitch angle, which resulted in breaking the leg of the nose landing gear

Fig.1. Place of first touchdown [source: PKBWL]

In the fourth circuit, during roundout phase over a concrete runway, the plane began to deviate to the left, and according to the instructor's statement, he commanded *“aileron right and pull”*. Seeing that the plane was not responding and was rolling on the left wing, he took control of the plane and decided to go around. To do this, he increased the engine RPM to maximum and pulled the control stick towards himself. As a result, the plane touched down on the left edge of the runway, beyond the line of runway edge lights, with a deviation to the left of approximately 30°.

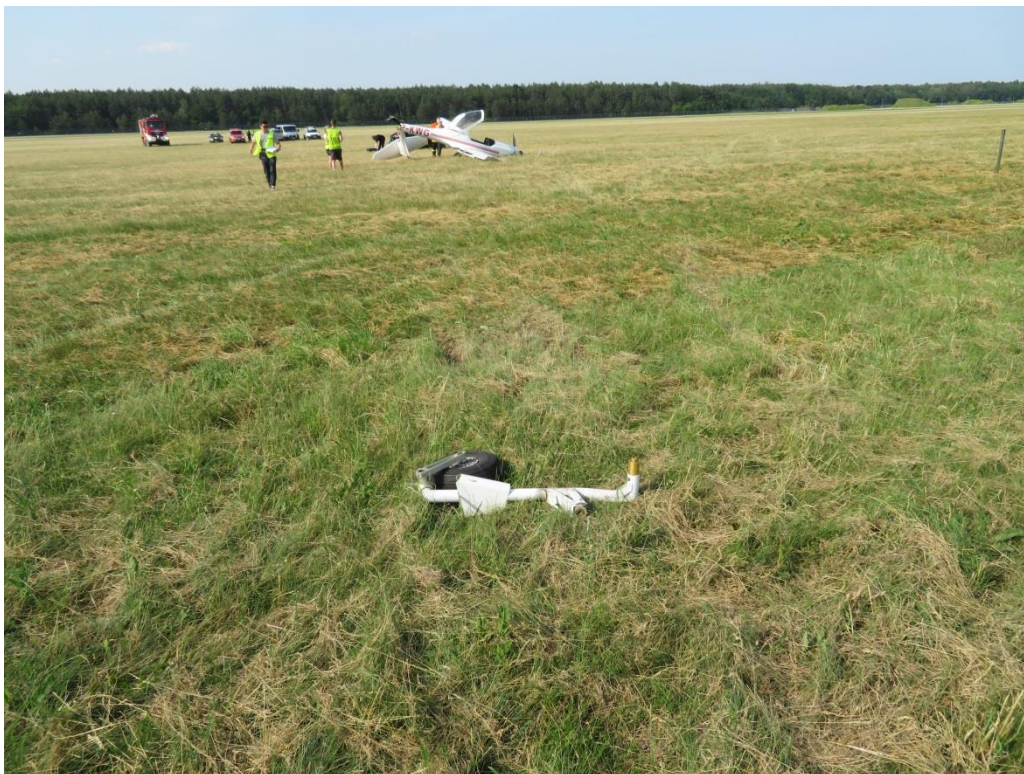
(Fig. 2). Then the plane bounced again and moving further left, hit the ground, breaking the right leg of the main landing gear and damaging the propeller and the fuselage structure (Fig. 3).

Fig. 2. Broken leg of the nose landing gear [source: SCAAI]

The nose leg together with the wheel separated from the airframe during the impact with the ground and was found at a considerable distance from the airframe. The right leg of the fixed main landing gear was detached from the fuselage, while the left leg was deformed and remained at the fuselage. On the lower part of the fuselage, protruding elements such as the steps to the cabin, antennas of aircraft avionics systems and drainage elements of the engine were deformed. The wings of composite structure did not detach from the fuselage, but sustained minor damage in many places. Cracks and delaminations of the wing structure were found, especially near the leading edge of both wings and the tip of the left wing. Similar damage was revealed in the tail area, in particular on the leading edge of vertical stabilizer and on the trailing edge of elevator.

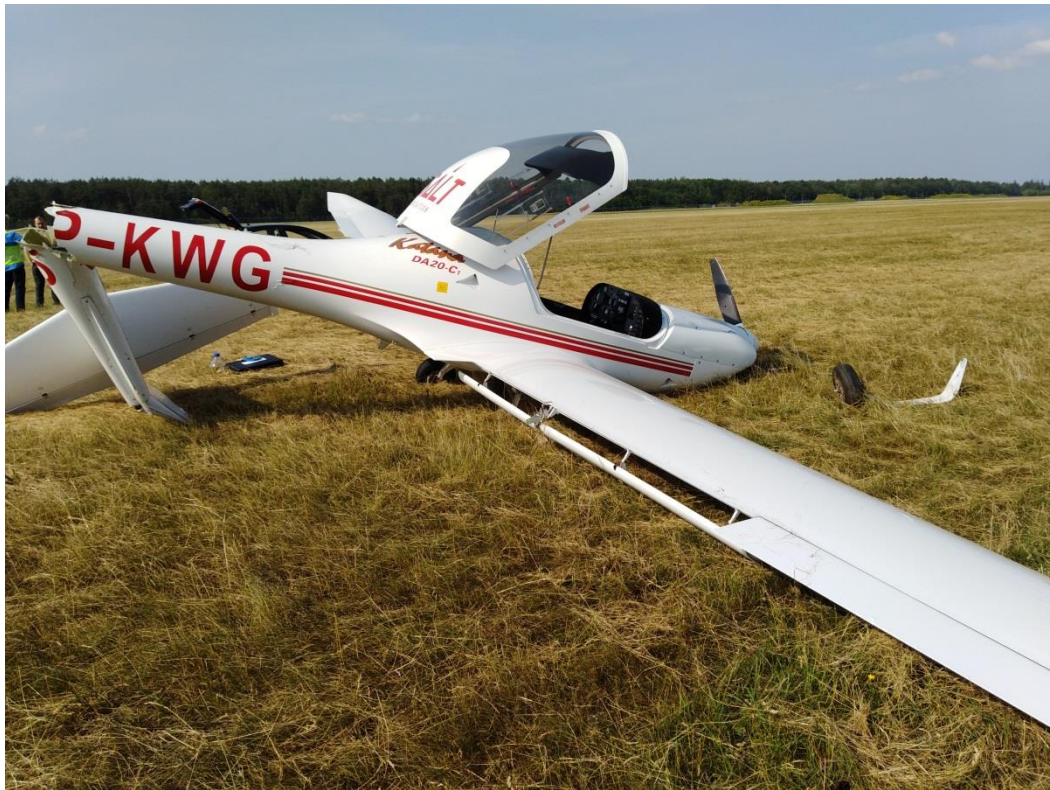
Fig. 3. The plane after the accident [source: PKBWL]

Cracks and delamination of the composite structure occurred on the upper and lower fairings of the engine, the lower part of the fuselage under and behind the cockpit, where the fuselage meets the tail part. The tail part, 0.5 m in front of the vertical stabilizer, broke and moved to the left.

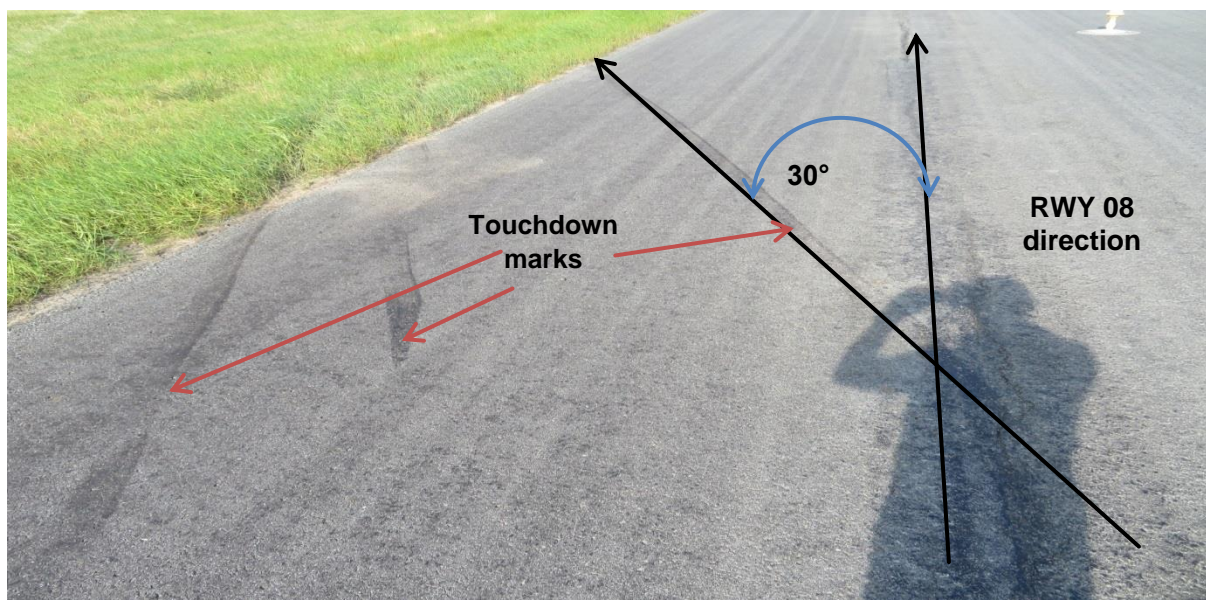
The plane came to rest about 90 meters from the north edge of a concrete runway on the grassy part of the aerodrome. During an inspection of the scene, it was found that the first contact of the plane with the concrete runway was approx. 800 m from the threshold of RWY 08, near aircraft parking stands on the southern side of the aerodrome. The airplane touched down on the left edge of the runway deviating approx. 30° from the runway centre line (Fig. 4).

Fig. 4. Touchdown marks left by the airplane [source: PKBWL]

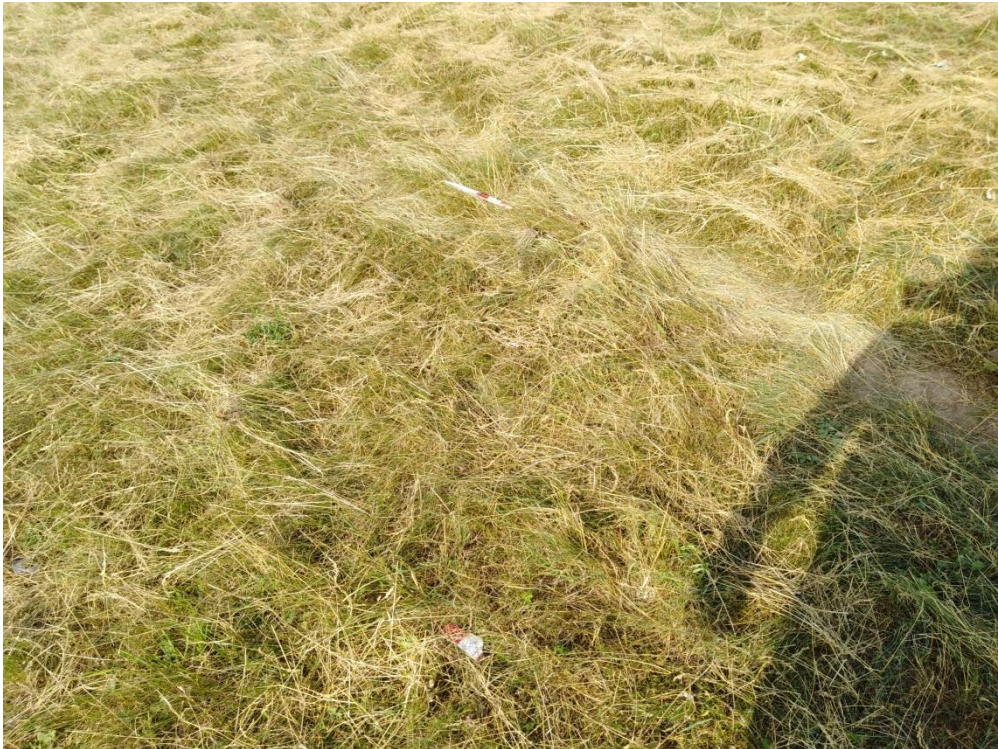
The wooden two-blade propeller and the nose landing gear were damaged.

The next marks of the touchdown were found approximately 60 m from the runway edge, on the grassy part of the aerodrome. It was the second touchdown, as evidenced by traces on the grass, detached nose landing gear and parts of its

mounting (metal and rubber discs), propeller fragments and small fragments of the aircraft skin (Fig. 5 and 6).

Fig. 5. Parts of damaged propeller [source: PKBWL]

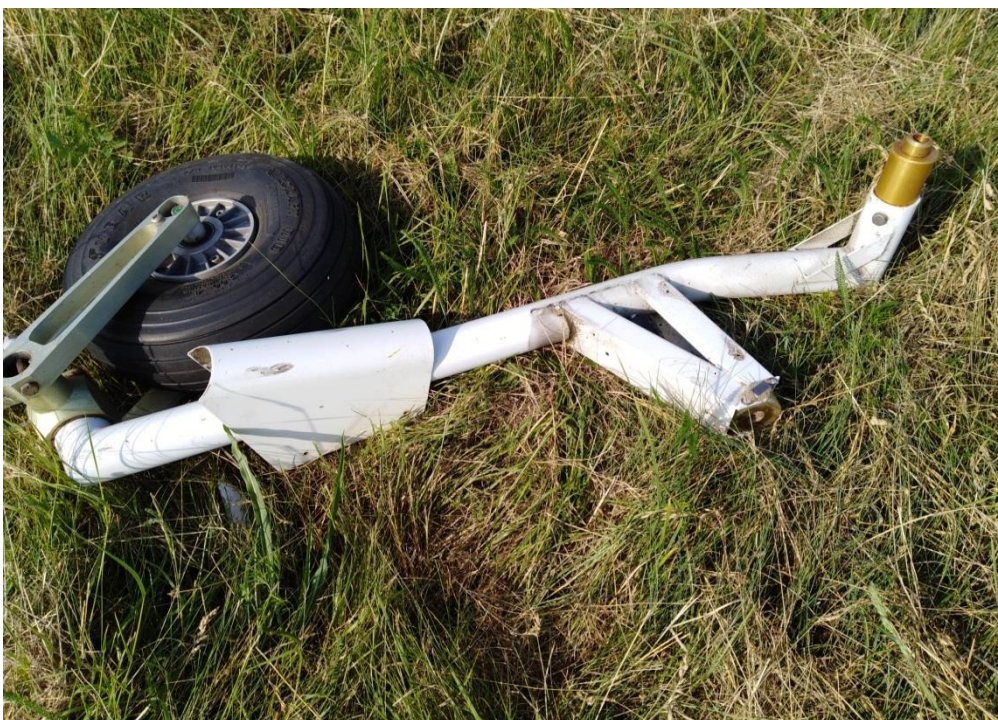
Fig. 6. Detached nose landing gear [source: PKBWL]

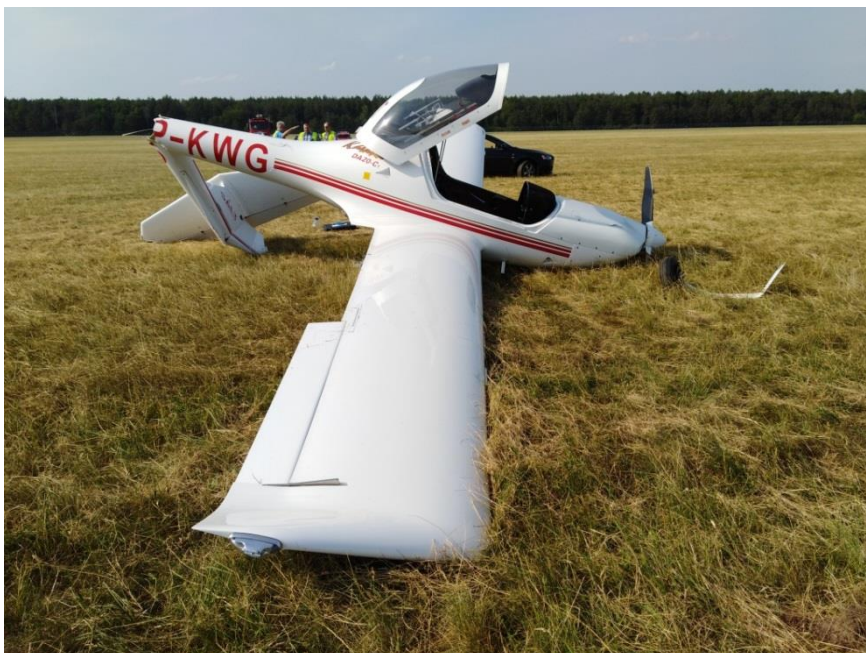
third touchdown resulted in the tearing off the right main landing gear leg, breaking the tail with empennage, damage to the fuselage and wings skins, and to the overall destruction of the aircraft (Fig. 8).

Fig. 8. Destroyed aircraft [source: PKBWL]

Then the plane lifted off again and traveled about 30 meters to the left, hitting the ground again. Analysis of the traces on the ground showed that the last touchdown was with the side movement to the left, the right main landing gear was torn off and the tail beam was broken about 1.5 meters behind the cockpit. The plane came to rest and the crew left it uninjured.
