Aviation 2021/07

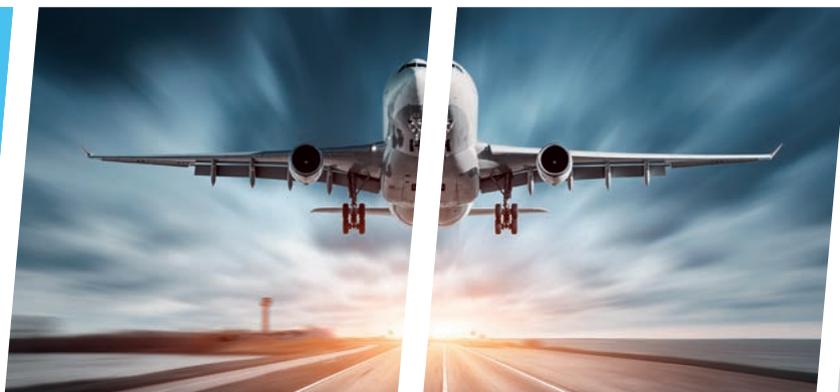
*REPORT ON THE AIR ACCIDENT IN
FOLLEBU, GAUSDAL MUNICIPALITY,
INNLANDET COUNTY, NORWAY ON
1 AUGUST 2019 INVOLVING A HUGHES
HELICOPTERS INC. 369D, SE-JVJ,
OPERATED BY FIRST EUROPEAN
AVIATION COMPANY SP. Z.O.O.*

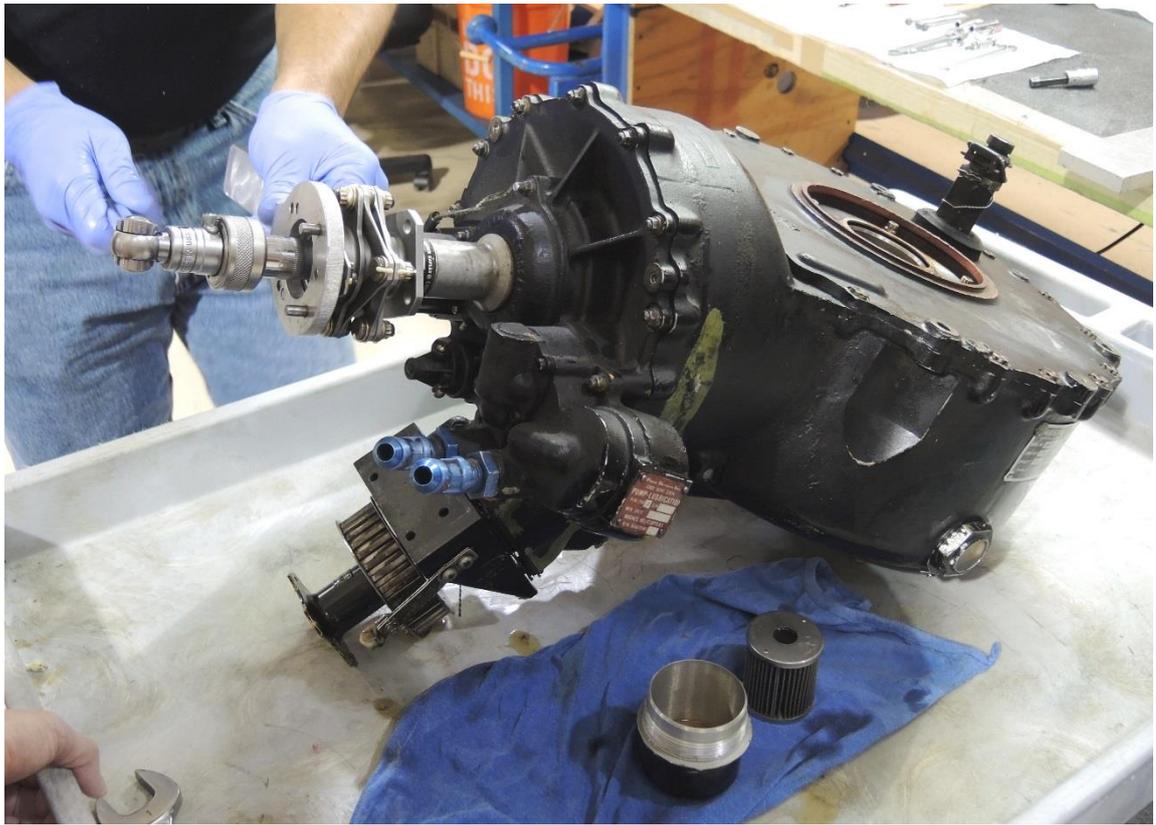
Figure 4: The main gearbox before it was disassembled at MD Helicopters in Arizona. Photo: NSIA

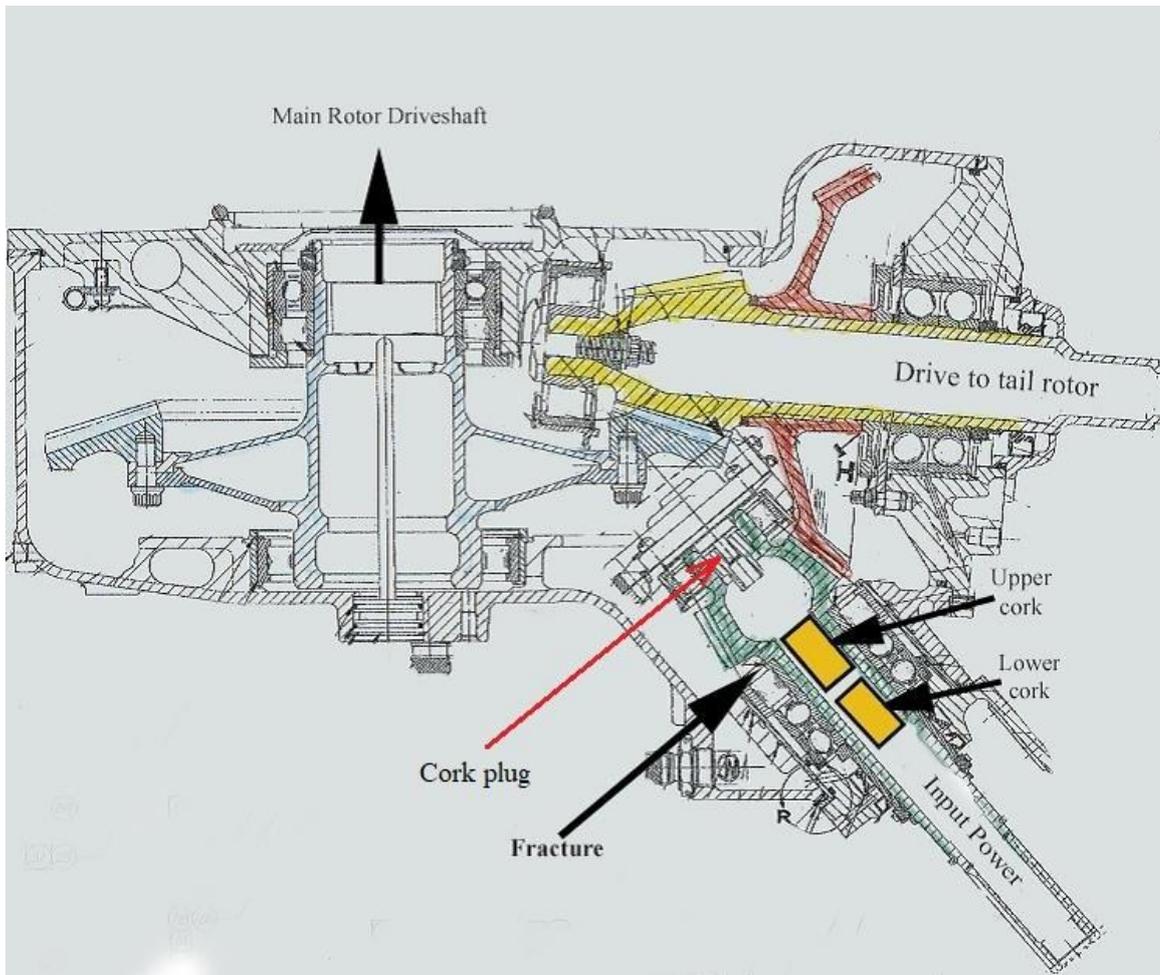
Figure 5: Drawing showing the main gearbox structure. The input pinion is shown in green. The black arrows show the fracture and the two irregular wine corks. The red arrow points to the bore inside the pinion that had originally been plugged using a natural cork plug. Source: MD Helicopters

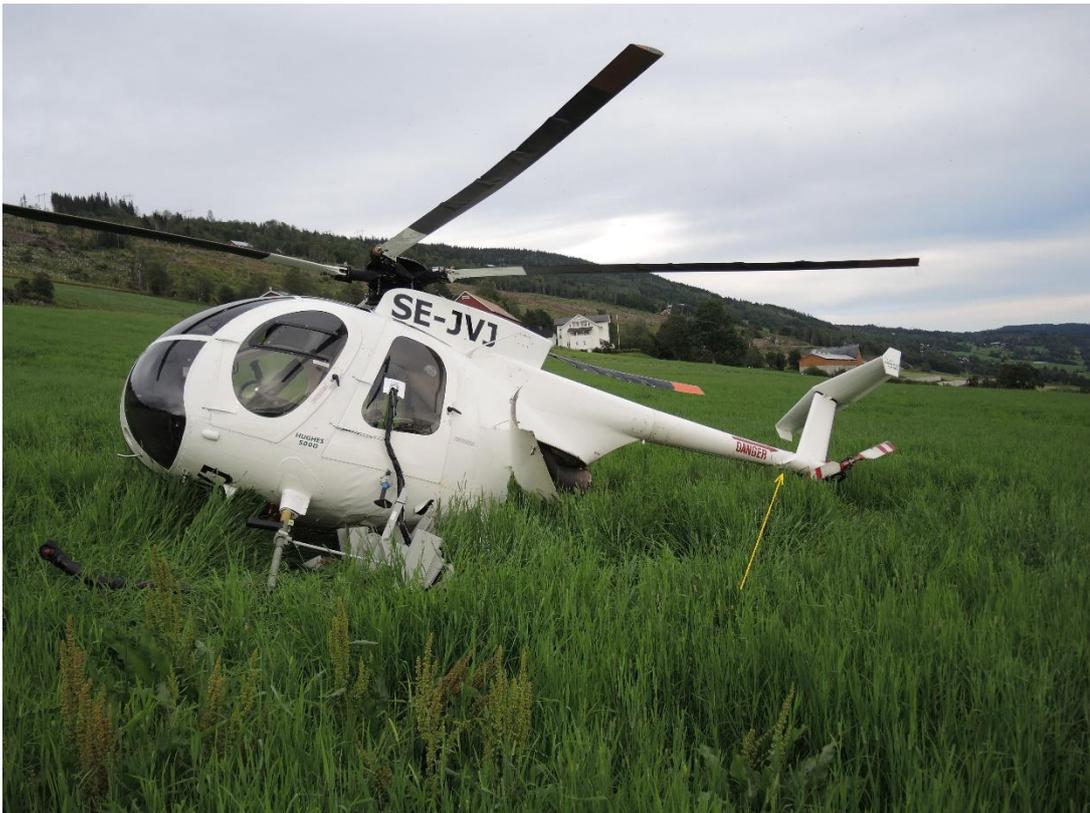
Figure 6: The rig with the mapping equipment and wrinkles in the skin on the helicopter's belly. The yellow arrow points towards the twisted tail boom. Photo: NSIA

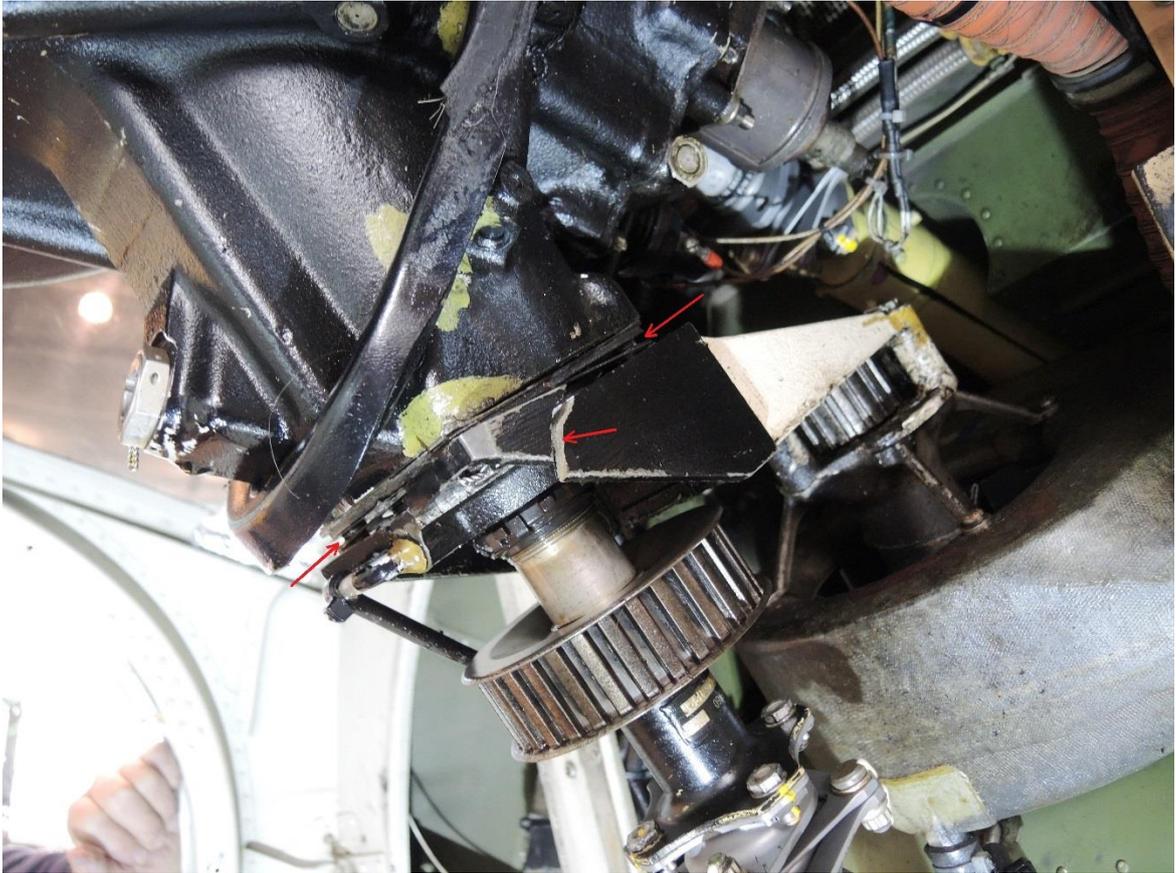
Figure 7: The main gearbox section where the shaft from the engine enters the main gearbox. The cooling fan drive belt has fallen off. The red arrows show a fracture and gaps. Photo: NSIA

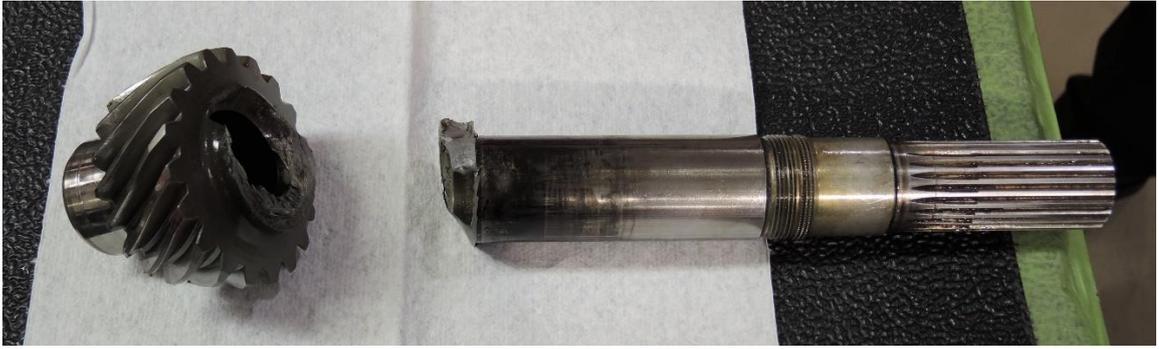
Figure 9: The split input pinion with the pinion section to the left and the shaft section to the right. Photo: NSIA

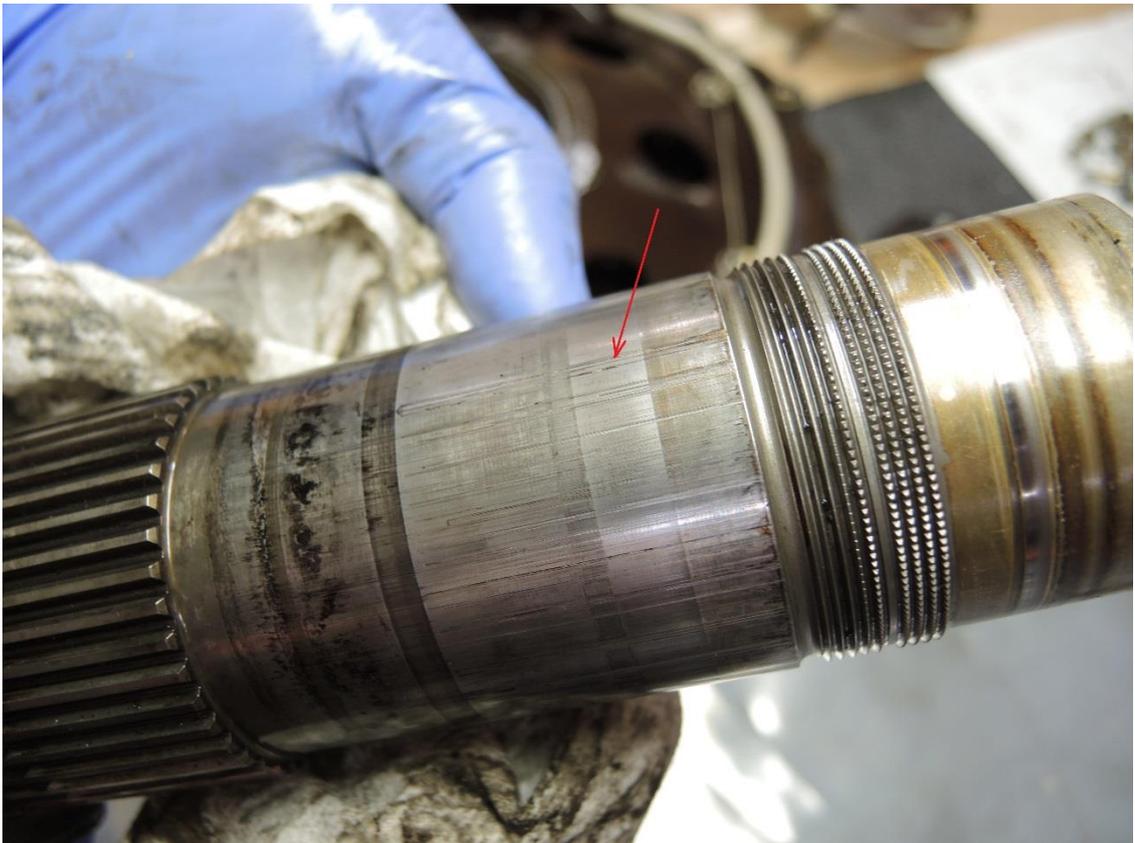
*Figure 10: Examples of scratches where the bearings sat on the pinion driving the tail rotor.
Photo: NSIA*

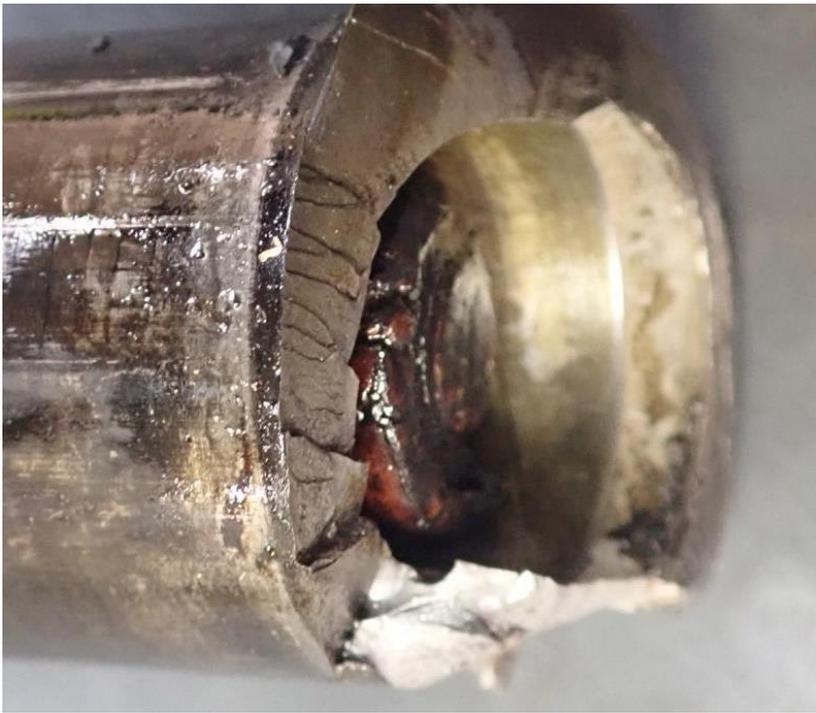
Figure 11: The fracture surface of the pinion showing the visible end of a wine cork. Photo: SEMTEC Laboratories

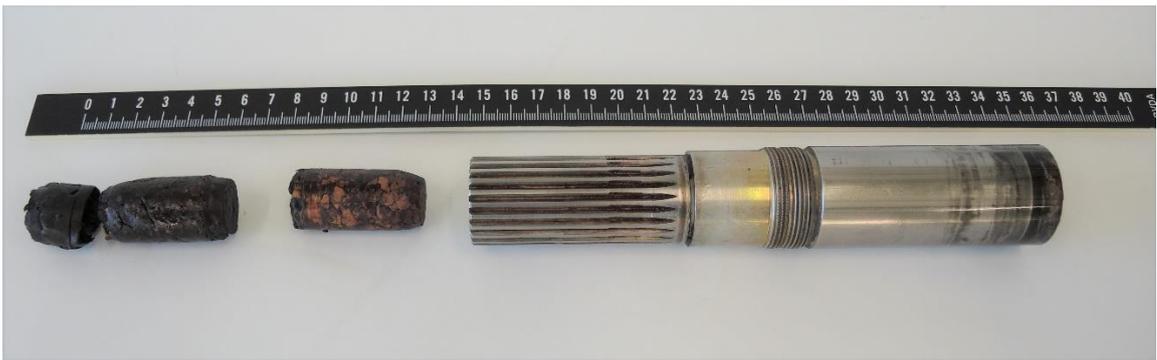
Figure 12: The input pinion after the end with the fracture surface was cut off. To the left two wine corks. The left cork is partly dissolved and has split in two. Photo: NSIA

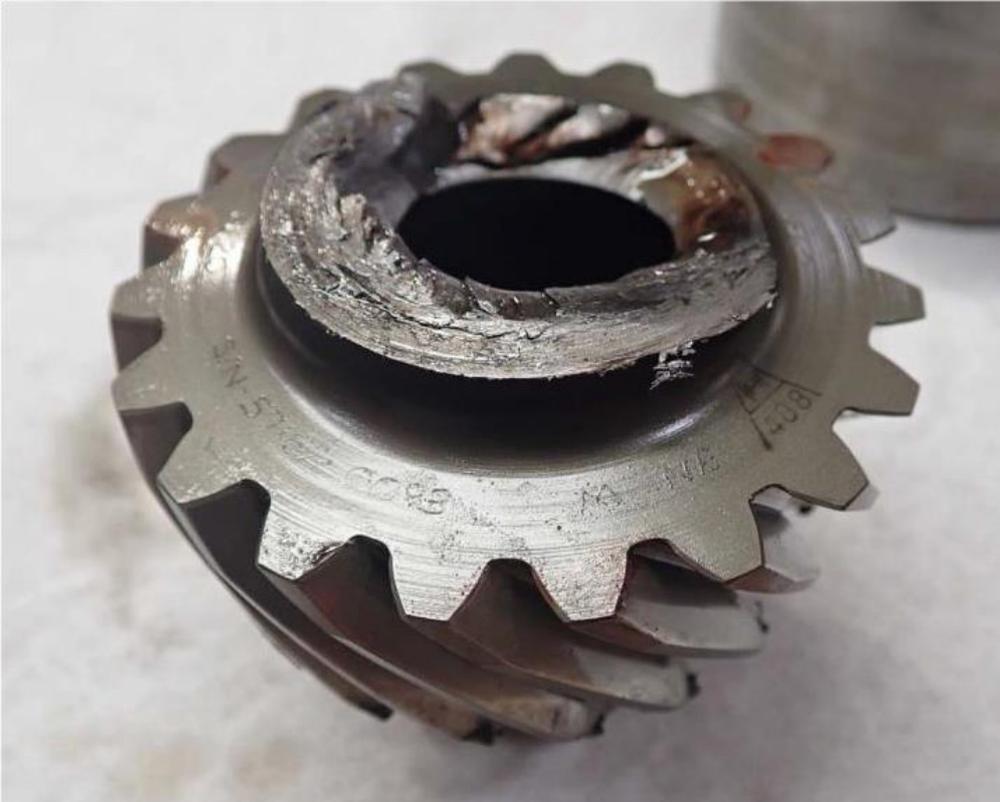
Figure 13: The fracture surface on the pinion part of the input pinion.
Photo: NSIA/SEMTEC Laboratories

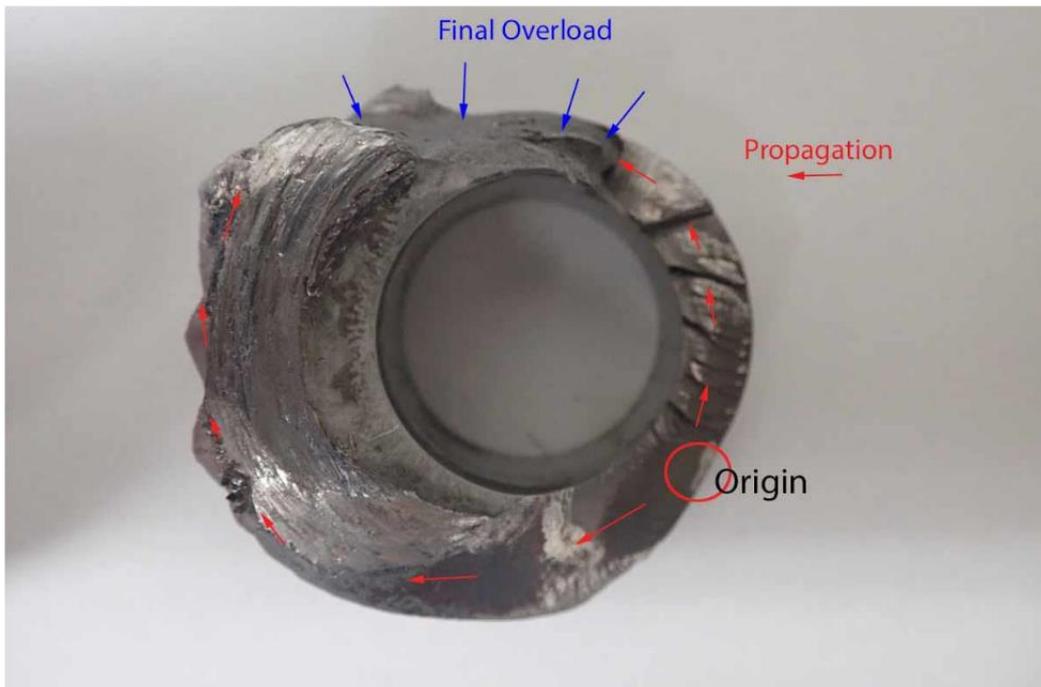
Figure 14: The fracture surface with the least secondary damage in the area where the fracture started (the shaft part). The assumed origin, propagation direction and final overload fracture are indicated. Photo: NSIA/SEMTEC Laboratories

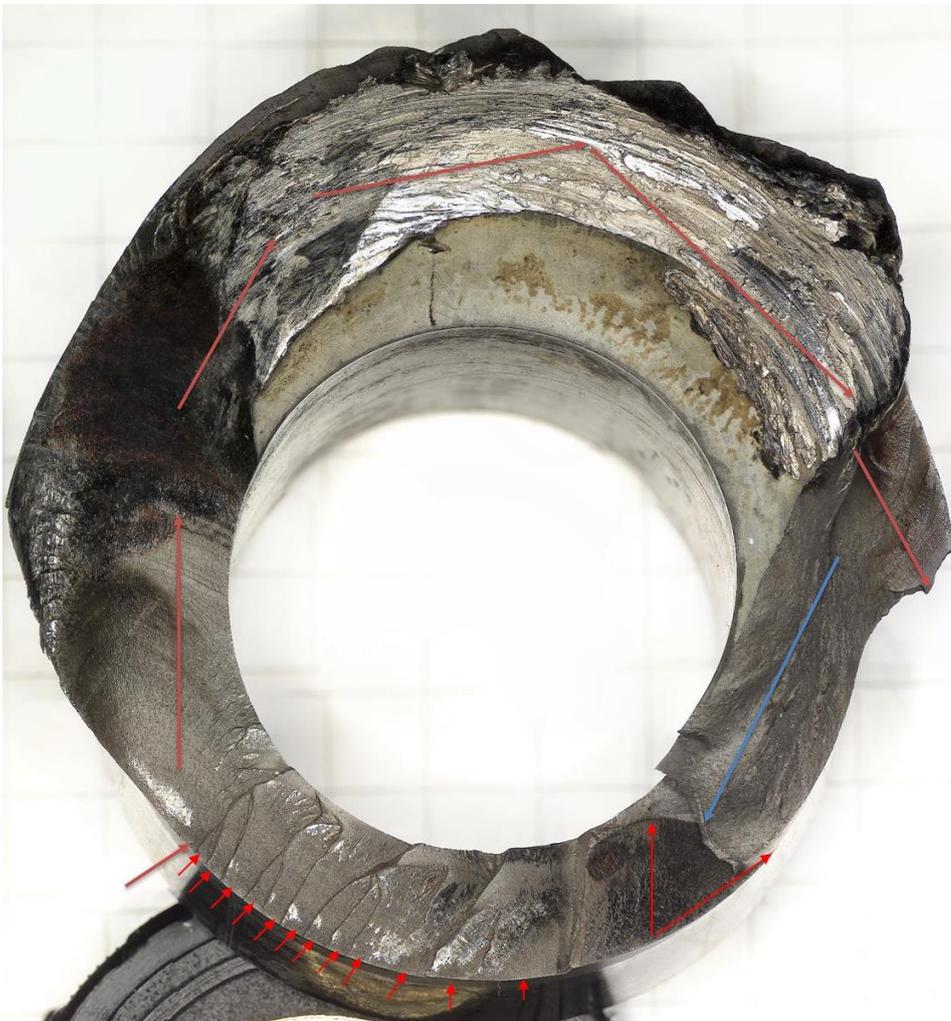
*Figure 15: Photo from a digital microscope showing the fracture surface with the least secondary damage in the area where the fracture started (the shaft part). The red arrows point to a number of initiation points for the fatigue fracture. The blue arrow illustrates the length of the final fracture
Photo: NSIA/FOLAT*

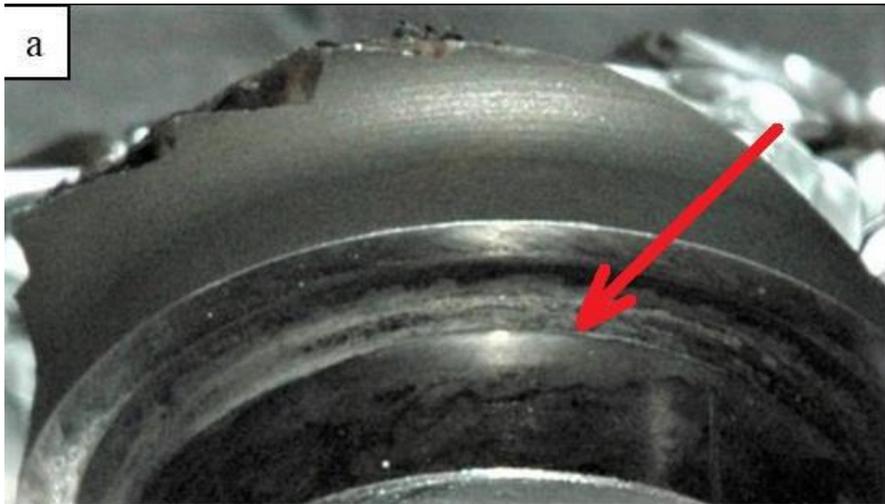
Figure 16: The arrow points to the radius at the transition between the shaft and the pinion. Photo: NSIA/FOLAT

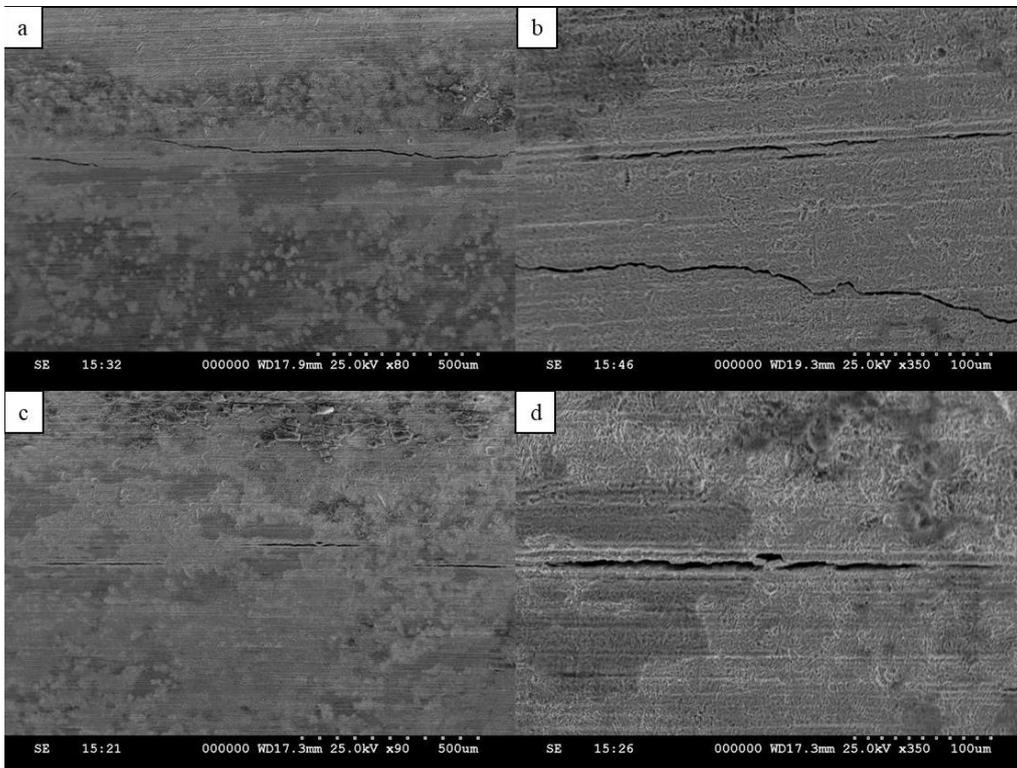
Figure 17: Images from a scanning electron microscope showing radial cracks in the area shown in Figure 16. Photo: NSIA/FOLAT

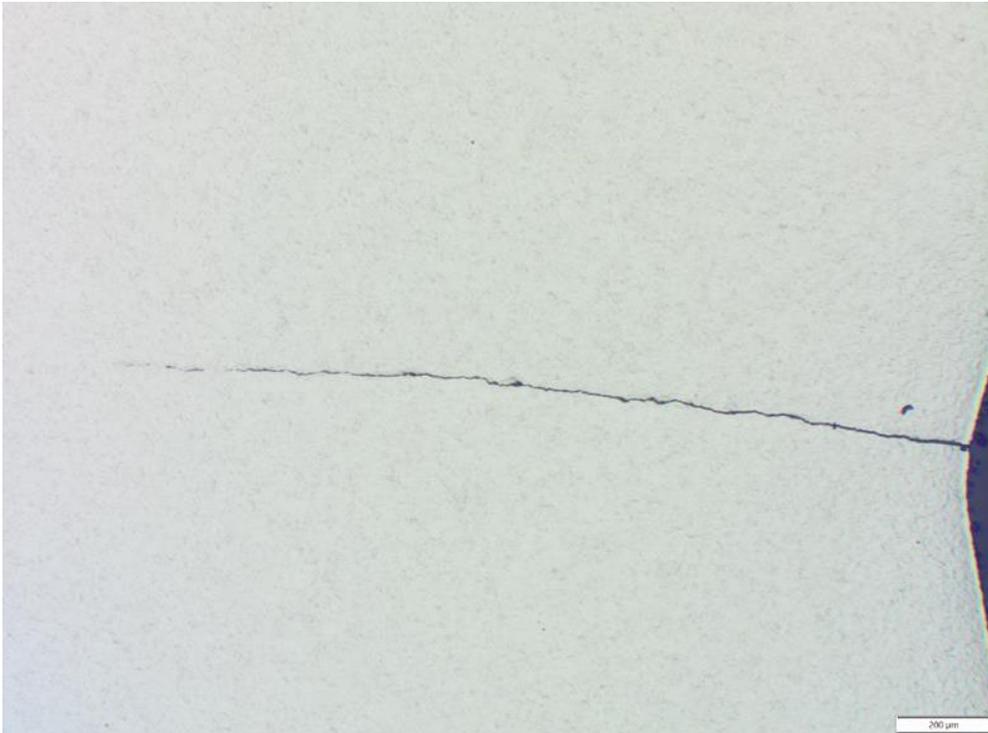
Figure 18: The photo shows the depth of one of the cracks. The fillet is shown on the right. The crack is approximately 1.8 mm long (deep). The scale in the lower right-hand corner is 200 μm long. Photo: FOLAT
