# FINAL REPORT

SERIOUS INCIDENT 2019/4048

OCCURRENCE NO – 2019/4048

AIRCRAFT – Bombardier DHC – 8 – 402, SP-EQG

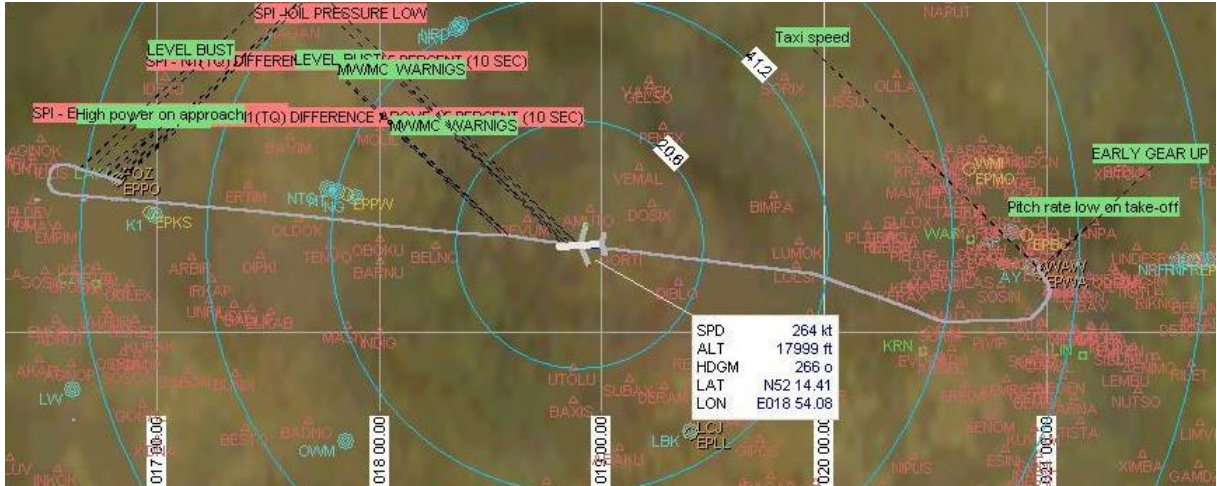
Fig. 1 The moment when the first symptoms of engine malfunction appeared (12:22).  
 [source: PLL LOT].

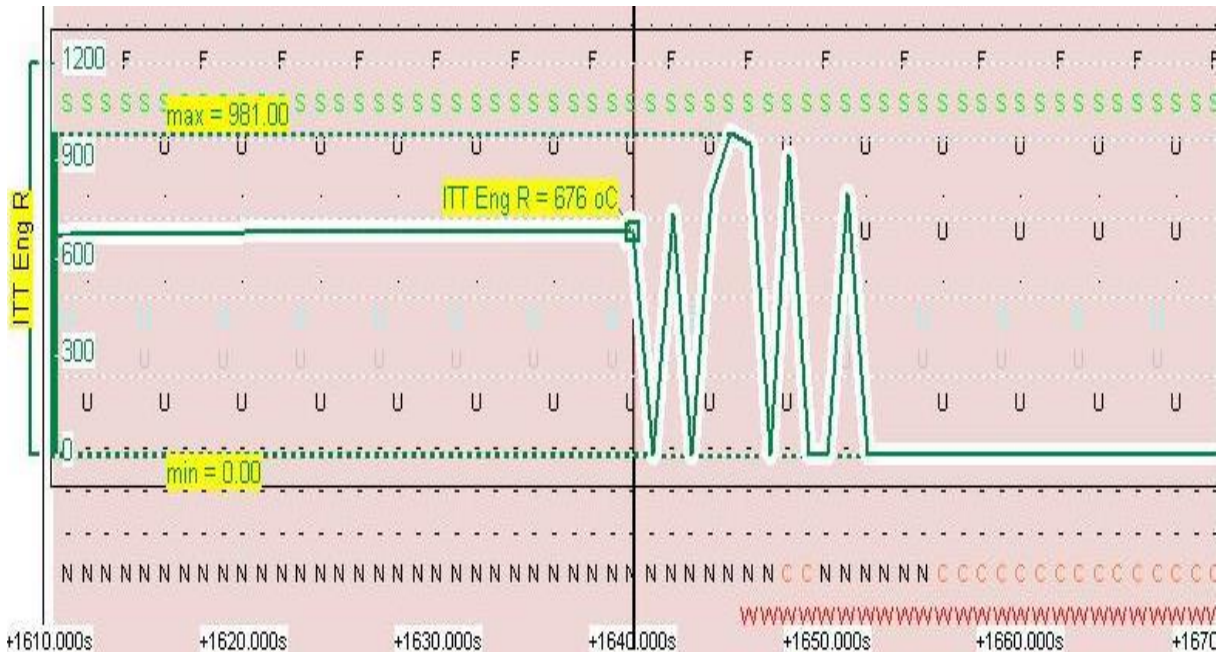
Fig. 2 Engine #2 ITT (12:22:29 – 676°C., 12:22:35 – 981° C, 12:22:41 – 0° C).  
 [source: PLL LOT].

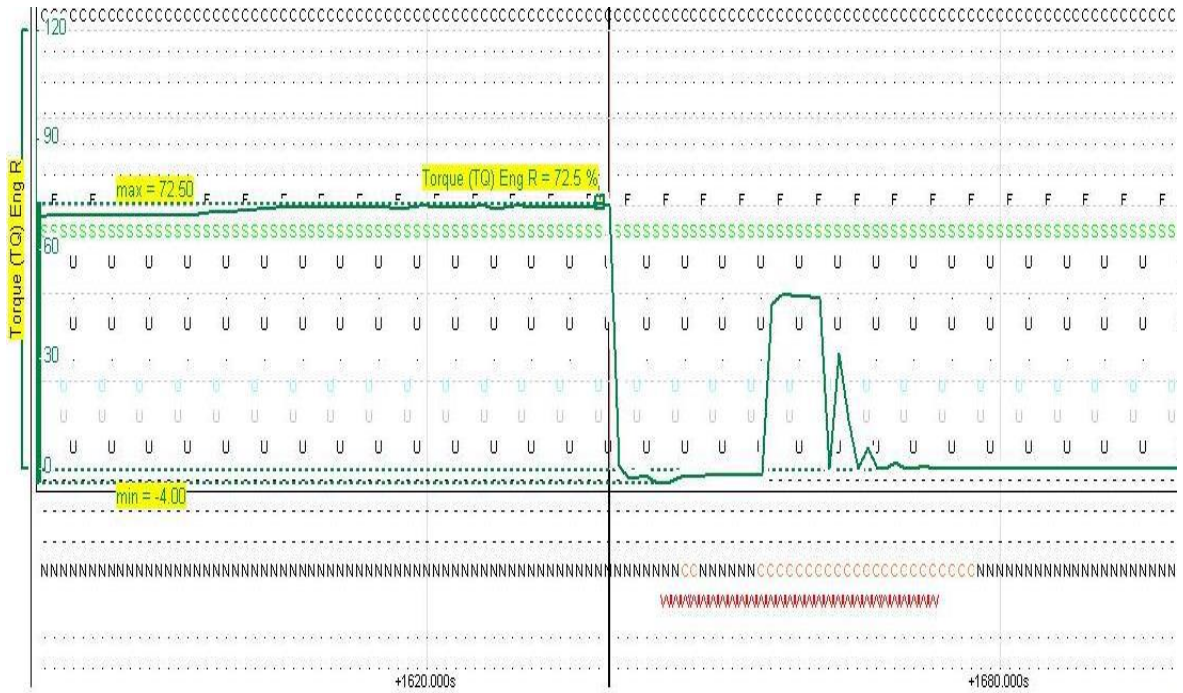
Fig. 3 Engine #2 TRQ (12:22:29 – 72,5%; 12:22:31 – 0%; 12:22:48 – 47,5%)  
 [source: PLL LOT].

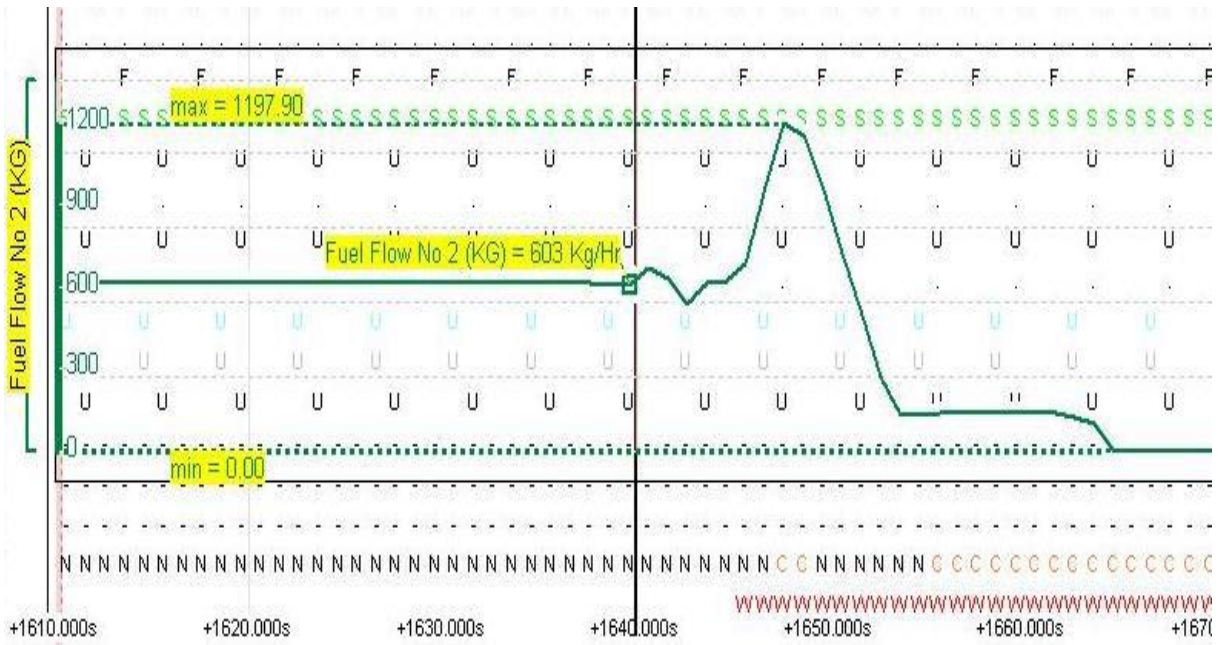
Fig. 4 Engine #2 FUEL FLOW (12:22:29 – 603 kg/h, 12:22:37 – 1197 kg/h, 12:22:54 – 0 kg/h).  
 [source: PLL LOT].

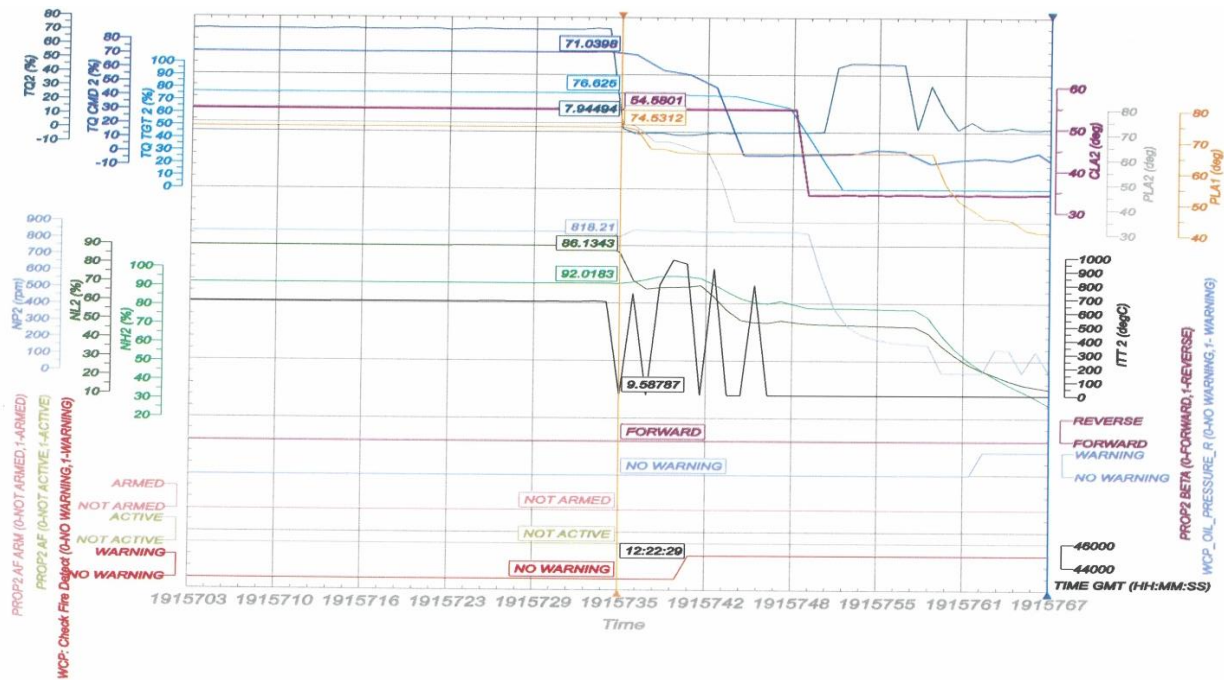
Eight minutes after achieving the cruising level, engine #2 began malfunctioning. The TRQ value dropped to zero and the engine temperature readings began to change abruptly, the FUEL FLOW value increased sharply. The plots of recorded parameters of engine #2 are shown below.

Fig. 5 Engine #2 operation parameters during the occurrence [source: PKBWL].

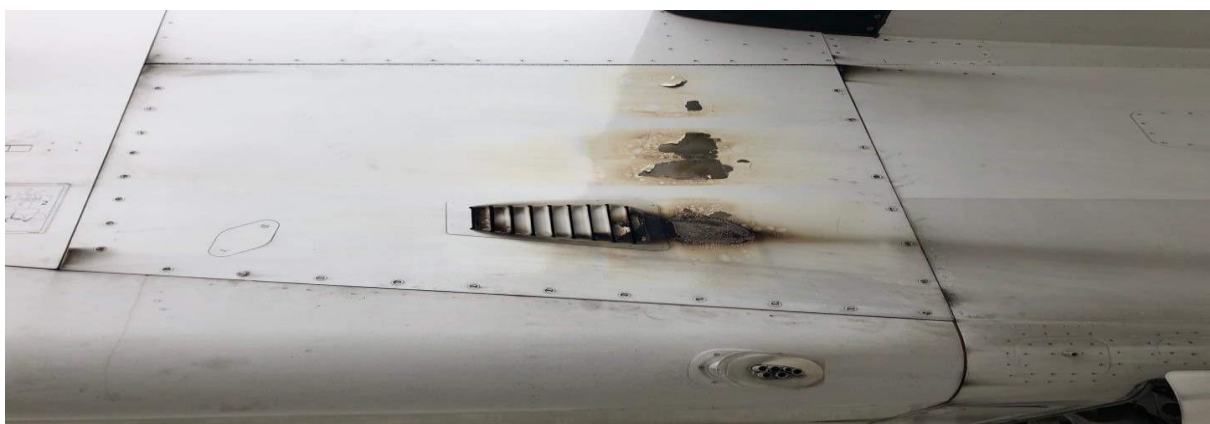
CC1 immediately informed CPT about the situation. CPT confirmed the right hand engine fire and after a while he ordered to prepare the cabin for an emergency landing which was planned within 7-8 minutes. LST engineer, who was on board, noticed the flames and burn marks on the cowl of the right hand engine nacelle (Fig. 6).

Fig. 6 Engine #2 – condition of the nacelle as seen by passengers on board [source: PKBWL].

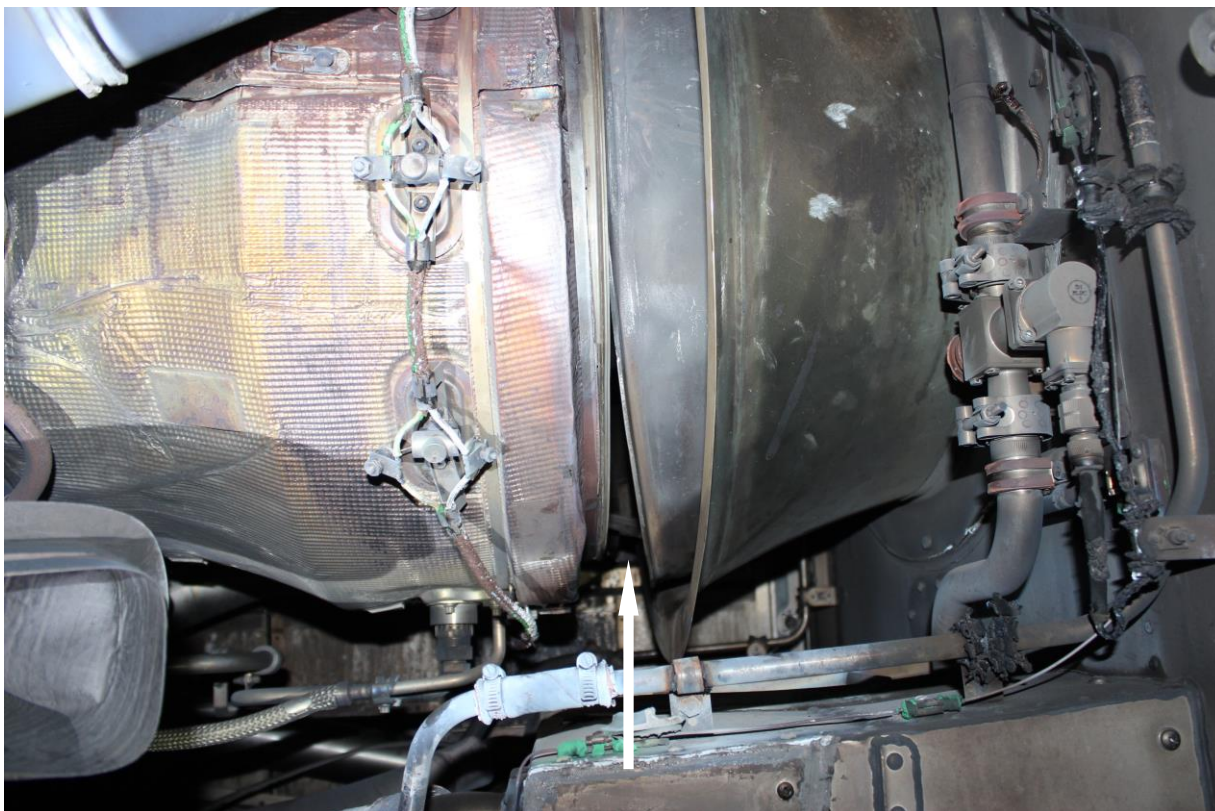
In addition, displacement of the exhaust nozzle occurred in the lower part of the linkage and a gap formed between the turbine body and the nozzle, caused the fragments of the turbine blades and other engine elements to come out. Significant amounts of metal debris were also found inside the engine. There were visible signs of fire on the inner surface of the engine cowl and the outer parts of the engine.

Fig. 7 Visible damage and signs of fire on the left side of engine no 2. [source: PKBWL].

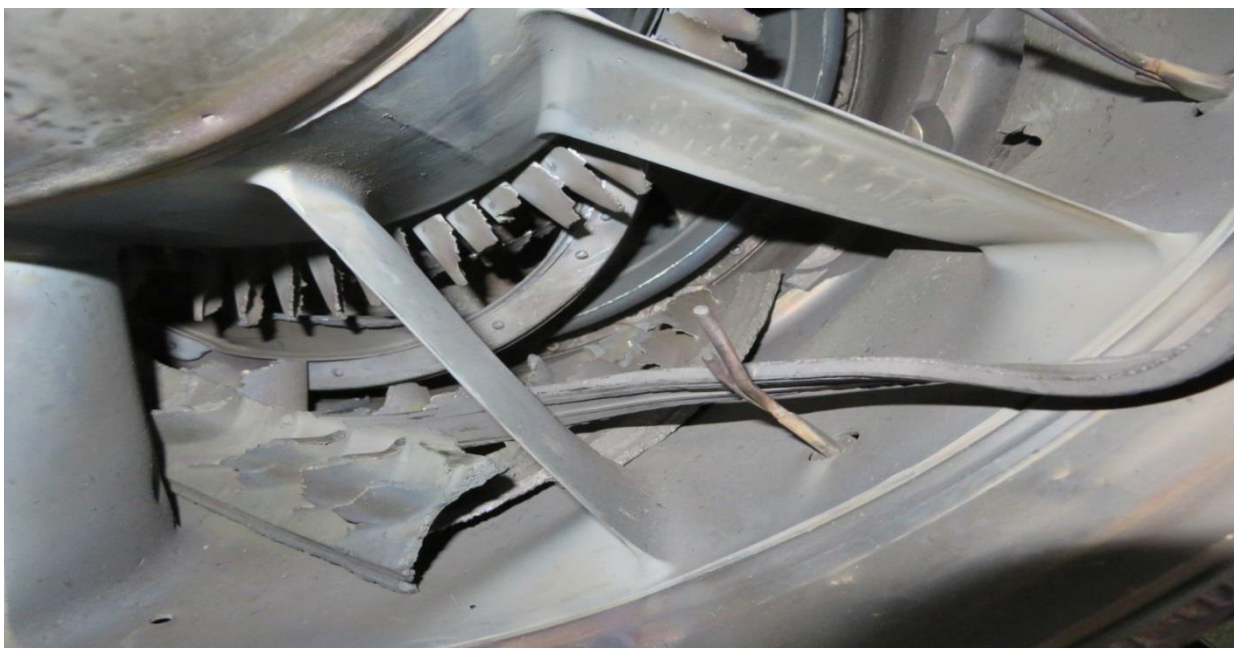
A boroscopic inspection of engine #2 was carried out on the night of 9 and 10 September 2019. Significant damage to the turbine blades and stators were found during the inspection. No damage to the compressor were found. After removing the engine, its mechanical condition was checked and significant damage to the turbine blades, stators and other parts of the engine were found (Fig. 8).

Fig. 8 Engine damage – view from the power turbine [source: PKBWL].

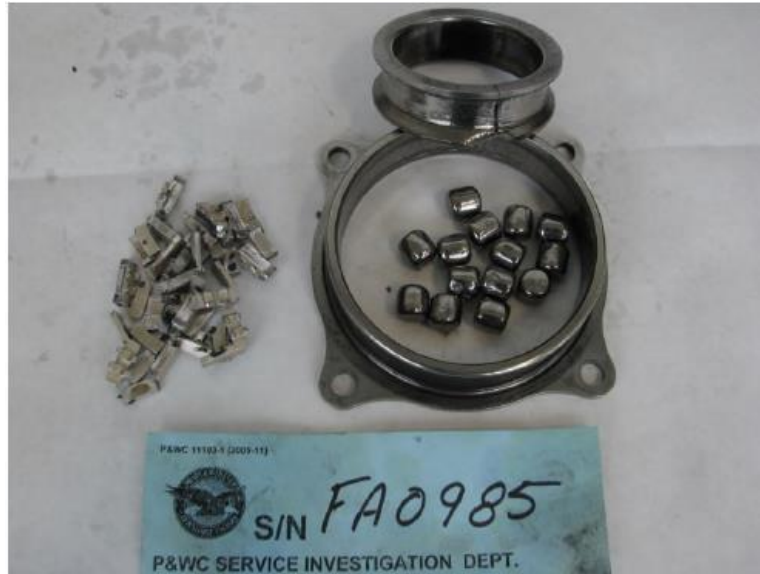
1. All elements of the no. 8 roller bearing (Fig. 10) were found significantly damaged. Pieces of its cage were found in the reduction gearbox (RGB). Microscopic damage the toothed wheels teeth were evidence of the movement of the cage pieces inside the gear. According to the manufacturer information, it has been the first case of damage of that bearing in that engine model.

Fig. 10 Elements of the damaged no. 8 roller bearing [source: P&WC].

The bearing #8 was found severely damaged and was comprehensively examined. The examinations showed advanced spalling and fatigue deformations on the roller surfaces.

Chemical research of the materials found in filters and chip detectors showed that their main component was M50 steel (high hardness steel) present in bearings. Due to the fact that during the investigation no other damaged bearing was found, those filings must have come from the bearing #8.

- 4.1. PKBWL has not proposed any safety recommendation after completion of the investigation.
- 4.2. OPERATOR'S PREVENTIVE ACTION ACCEPTED BY PKBWL: PLL LOT, as the airplane user entered the PW150A engines into the Oil AT program organised by the manufacturer for early detecting of oil system malfunctions based on tests of oil samples in specified periods.

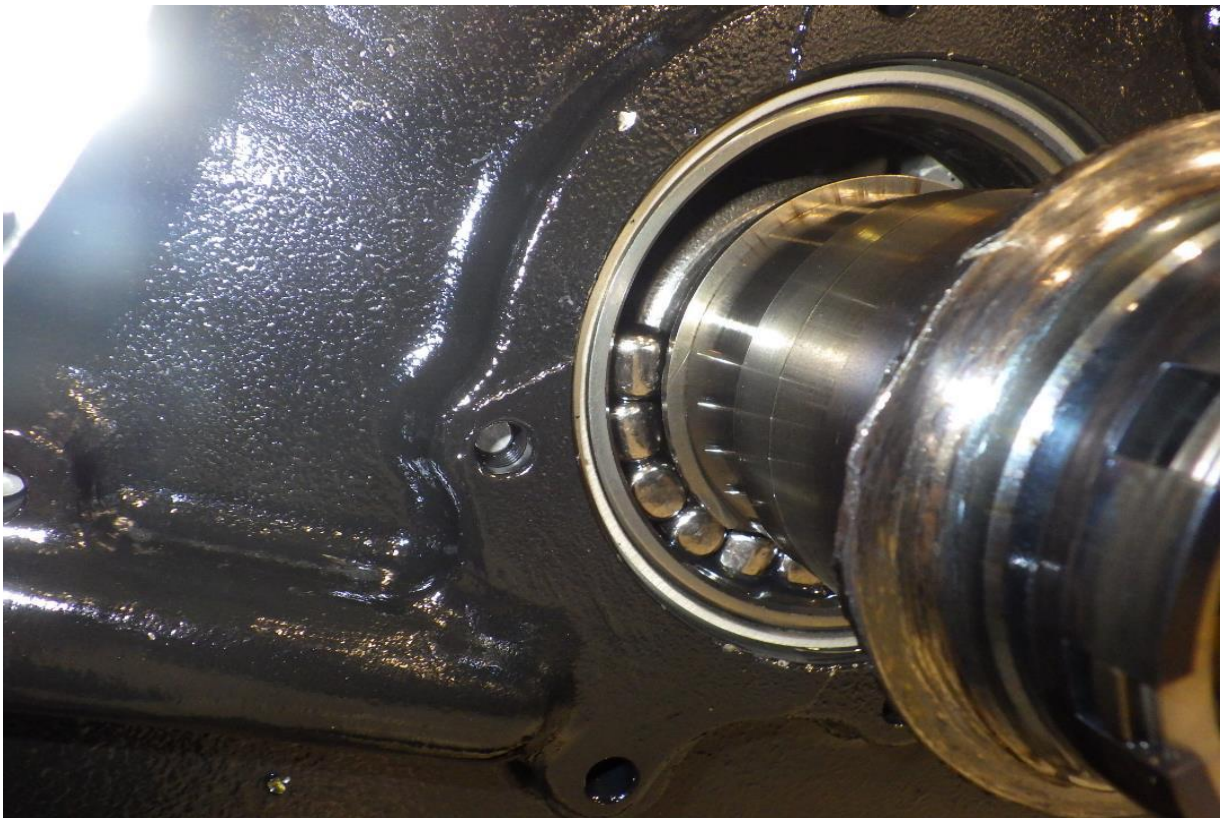
Fig. 11 View of the no. 8 roller bearing. The fractured flange of the diaphragm coupling can be seen in the foreground [source: P&WC].

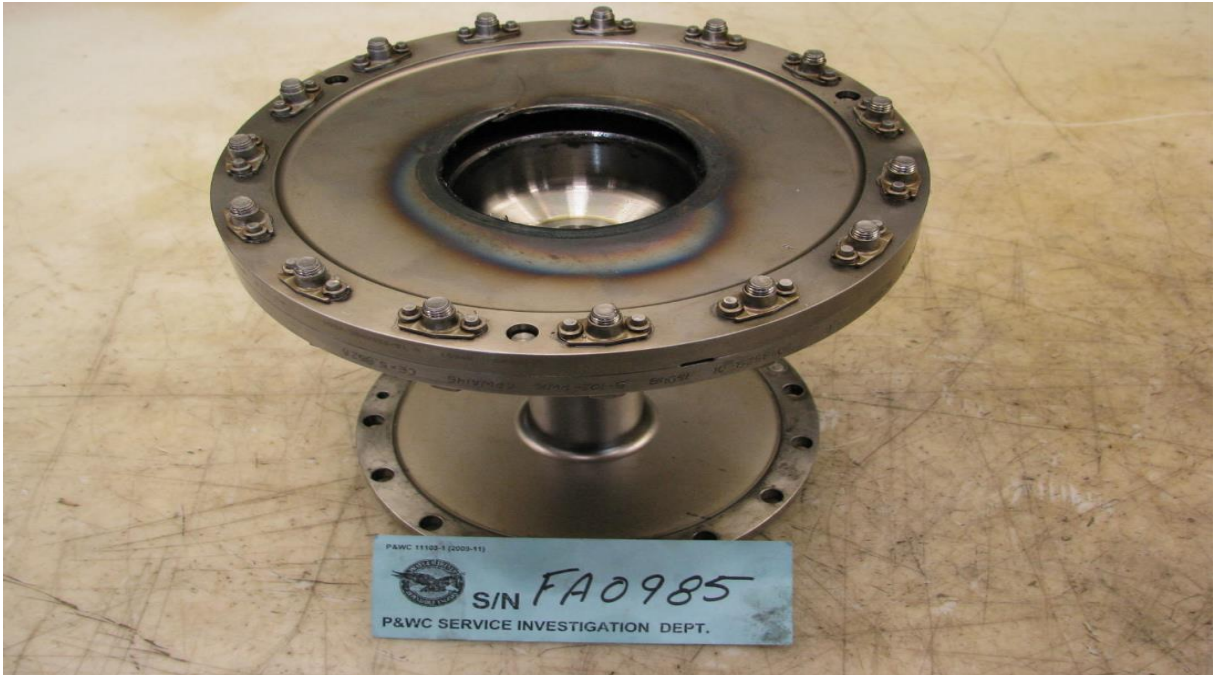
2. Fig. 12 shows the diaphragm coupling which is the element connecting RGB to PT. Torque is transmitted through flanges located at the end of PT shaft and at the output shaft from RGB. A fracture of this element on the flanges at its both ends made the torque transmission between PT and RGB impossible.

Fig. 12 The diaphragm coupling. View of the from the RGB side [source: P&WC].

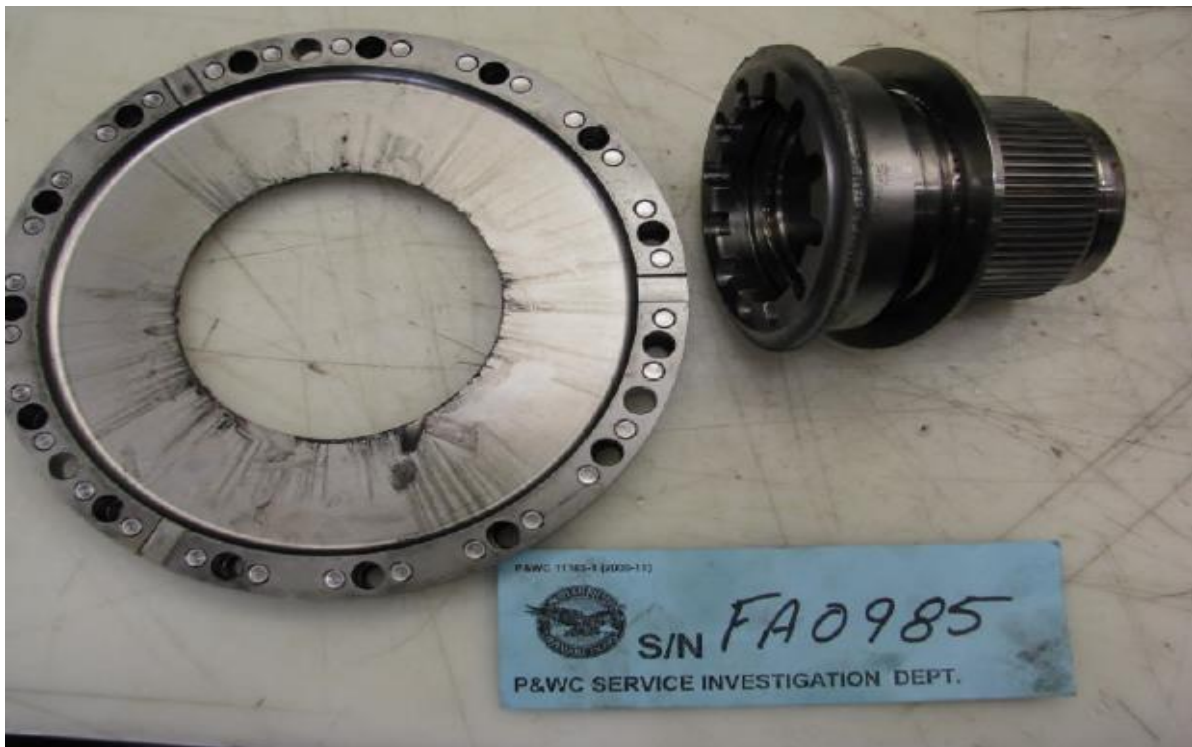
Fig. 13 The PT shaft tip and its cut flange [source: P&WC].

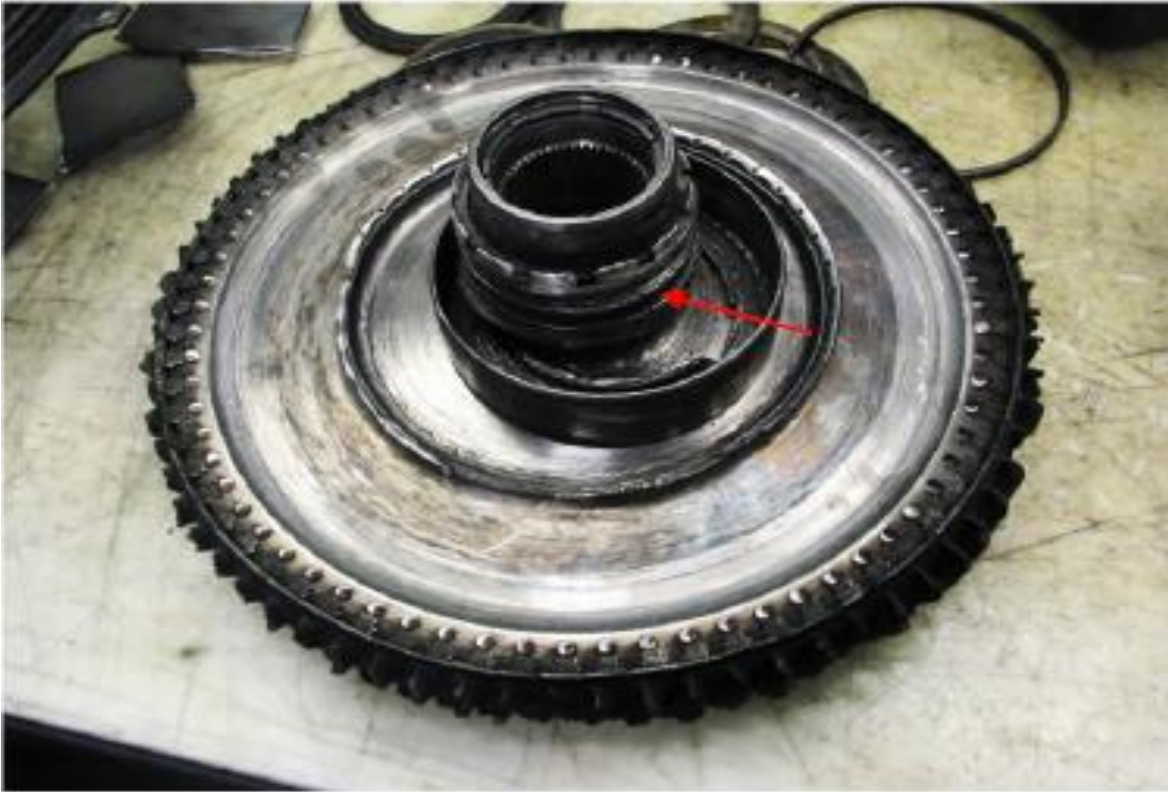
3. All the blades of the power turbine disc (PT1) were damaged. The disc together with the fragments of the blades was further tested to identify the cause of the damage.

Fig.14. View of the damaged blades of the PT1 turbine [source: P&WC].

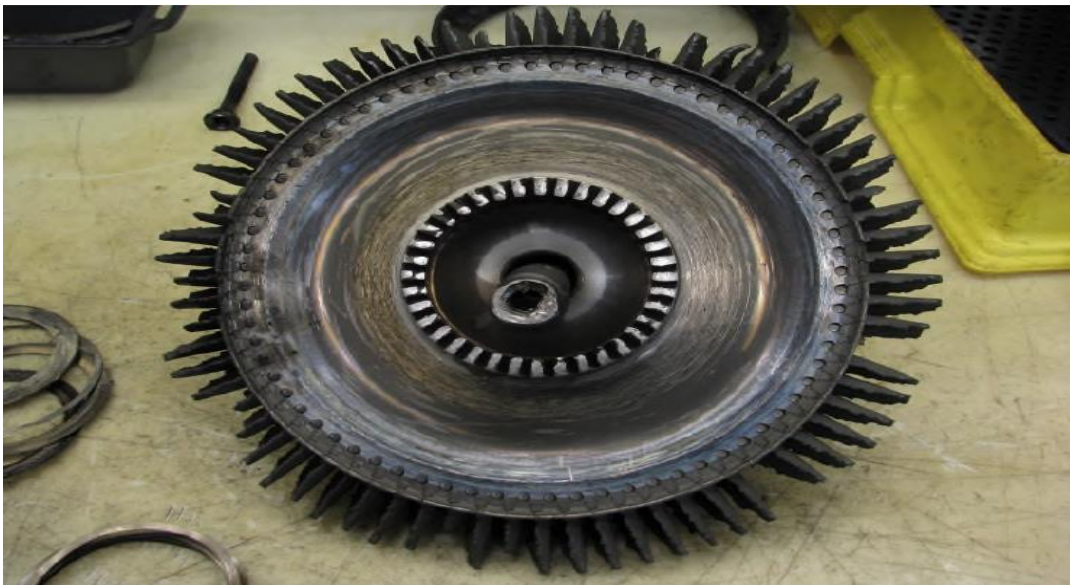
4. All the blades of the power turbine disc (PT2) were damaged. The shaft of that disc was broken by twisting.

Fig. 15 View of twisted PT2 shaft and its damaged blades [source: P&WC].

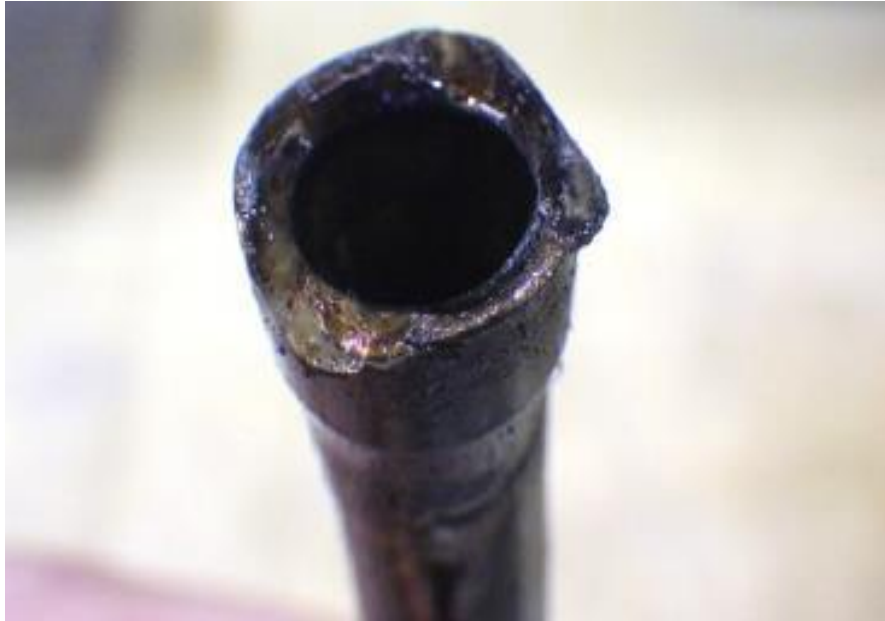
5. Fig. 16 shows the no. 6 and 6.5 bearings oil pressure transfer tube. This tube has been sheared and slightly bent. Through the cracked tube, oil got between the low-pressure turbine and PT1 (the temperature in this area is approximately 840°C).

Fig. 16 View of the damaged bearings oil pressure transfer tube [source: P&WC].

The engine fire was caused by a broken pipe supplying oil to bearings #6 and #6.5. Through the cracked tube, oil got between the low-pressure turbine and the PT1 turbine

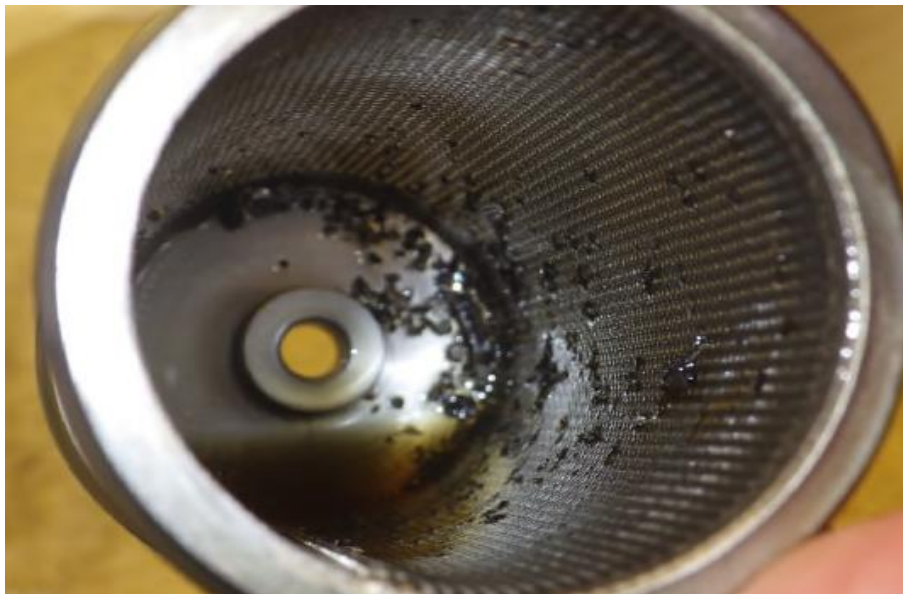
6. Significant amounts of filings and pieces of other damaged metal components were found inside the main oil tank strainer and the RGB (Fig.17 and Fig.18). The material found in the filters was subjected to laboratory tests.

Fig. 17 Filings inside the main filter of the oil system [source: P&WC].

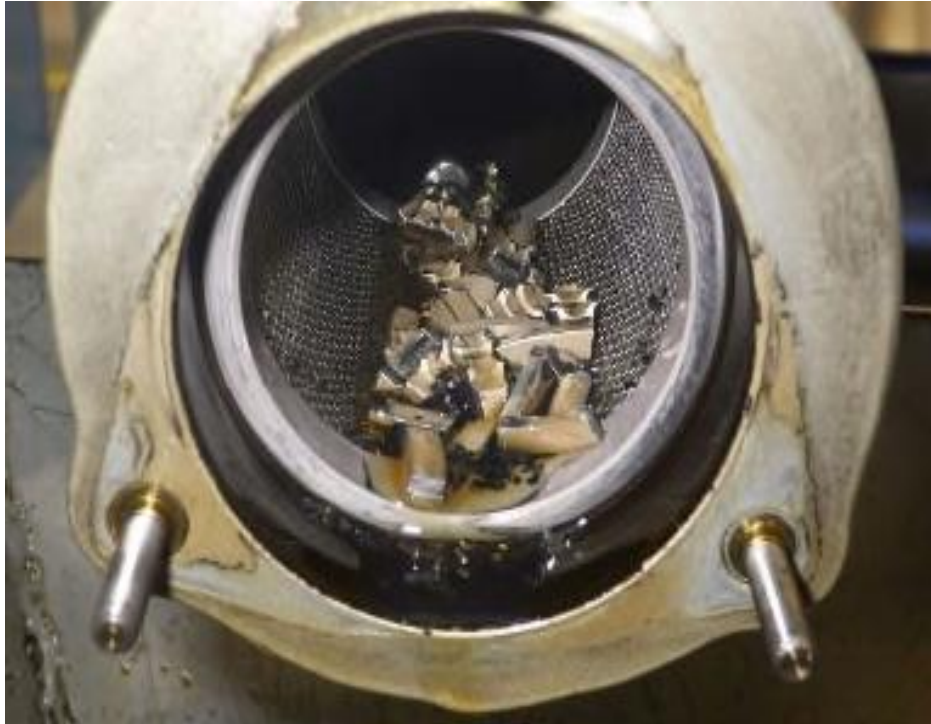
Fig. 18 Filings and metal debris inside the main filter of RGB [source: P&WC].

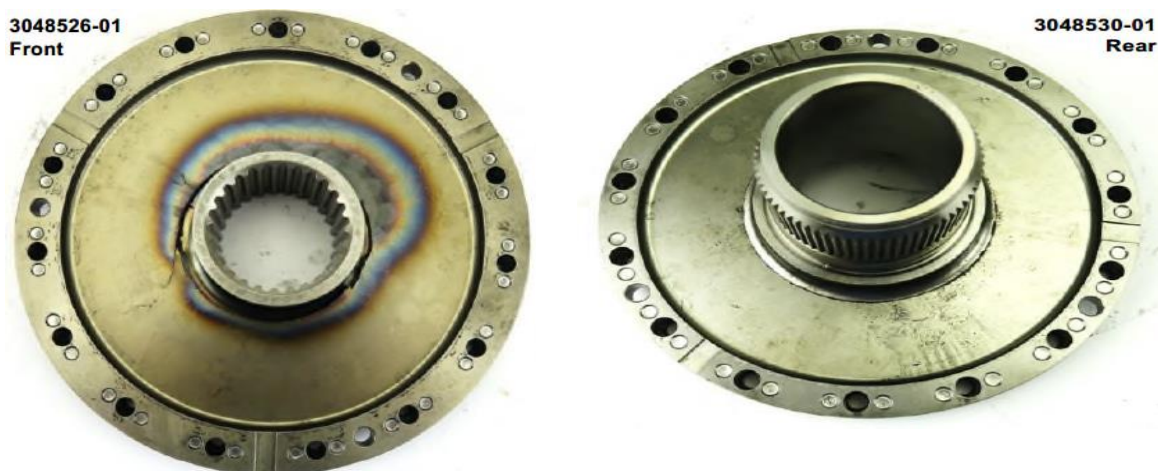
1. Visual inspection of the front and rear diaphragm coupling shafts showed circumferential fracture of both diaphragms around the shafts. Fig. 19 shows the fractured shafts placed in original position. Optical and scanning electron microscope examination showed fractographic features resulting exclusively from the shear and / or bending overload with no evidence of fatigue. The hardness and chemical composition of both diaphragms material were within the established requirements.

Fig.19. Fractured shafts of diaphragm coupling shown in original position [source: P&WC].

Under such conditions, the stresses produced by the rotating turbines caused breakage of the front and rear shafts of the coupling, and possibly at the same time shear of the drive turbine shaft (PT). The transmission of torque between PT and RGB was interrupted and the engine stopped. **The other engine damage was secondary.**

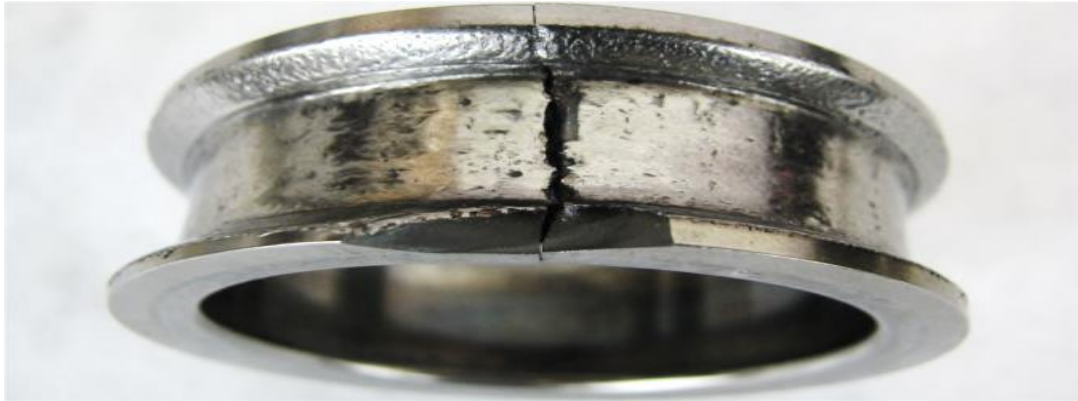
2. All elements of the no. 8 roller bearing were examined. The examination showed that the entire raceway for both rings showed plastic deformation and smearing of material. The inner ring showed a radial crack across the raceway (Fig. 20).

Fig. 20 A crack on the inner ring of the bearing [source P&WC].

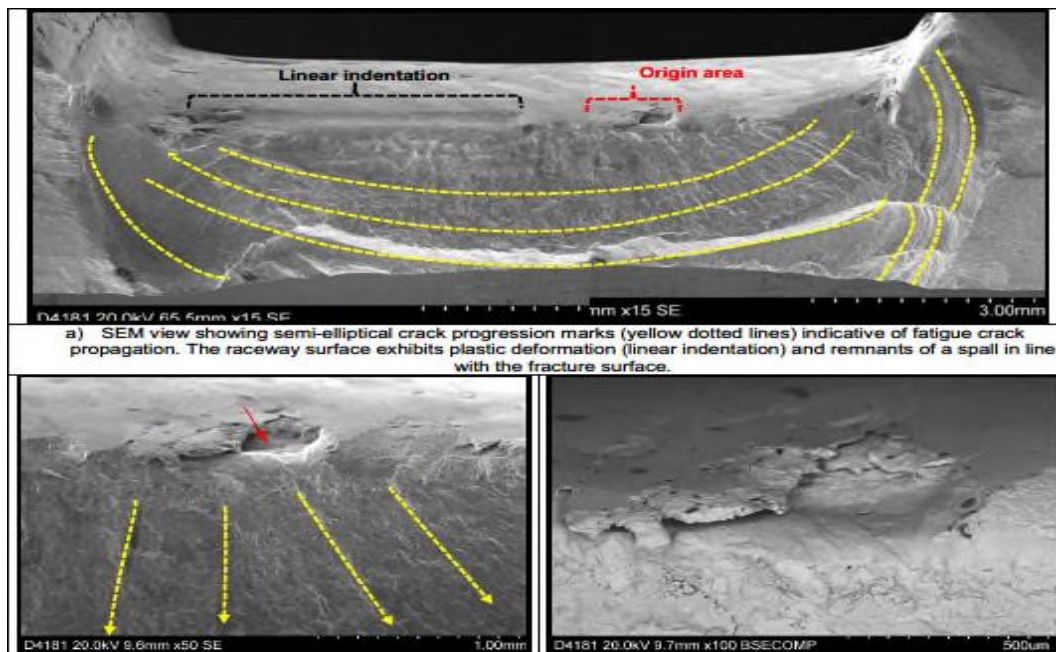
During examination of the inner ring by scanning electron microscope the fracture surface was checked and fractographic features of semi-elliptical crack progression marks, characteristic for the fatigue crack propagation were found on it (Fig. 21). The fatigue propagation was observed to originate from the surface radially inwards (yellow dashed lines, Fig. 21). The material hardness and the chemical composition of both rings met the drawing requirements. A cross-section taken through the rings showed that the material at the raceway surface was heat affected resulting in a “white martensite” layer. A tempered martensite is acceptable.

Fig. 21 Fatigue cracks on the inner ring [source: P&WC].

Due to significant damage to the surface of the rollers, the direct cause of the spalling has not been determined. The rolling surfaces of the raceways of both rings were also significantly damaged. The features of semi-elliptical marks revealed on the inner ring and the direction of crack propagation clearly indicate a fatigue crack. The process of destroying the bearing lasted quite a long time, as evidenced by the fact that on 26 August 2019 the operator detected filings on this engine and following the applicable procedure allowed the engine to be used further. Then, during laboratory tests, it was found that the filings were of M50 alloy, but they were present in acceptable amounts.

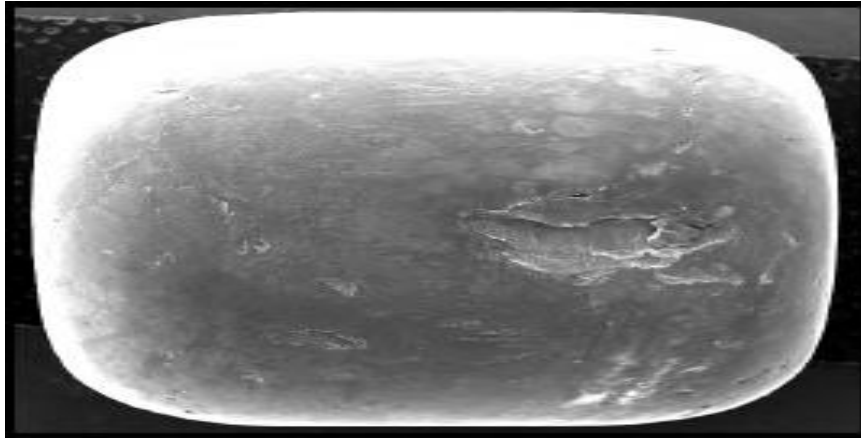
The contact surfaces of the rollers were found obliterated, plastically deformed and smeared. Several rollers also exhibited spalling (rolling contact fatigue) (Fig. 22). A cross-section showed that the material at the contact surface was heat affected

Fig. 22 Spalling (rolling contact fatigue) of the rollers surfaces [source: P&WC].

**The cause of the serious incident was the fatigue damage to the no. 8 roller bearing in the form of advanced spalling of the rolling surfaces of its rollers and deformations and cracks across the bearing raceway.**

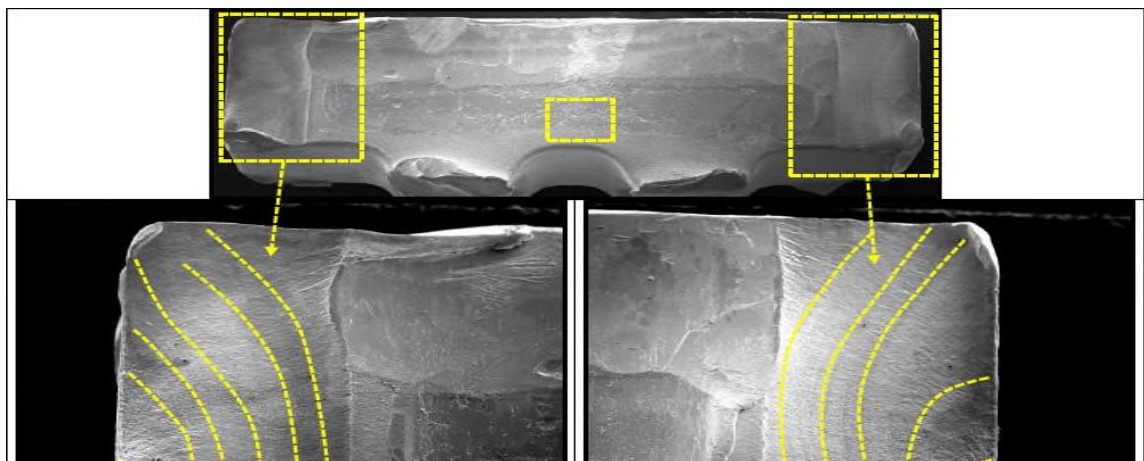
Fig. 23 Fatigue cracks of the RGB couplings on the shaft side [source: P&WC].

3. SEM analysis of the RGB couplings cracks on the shaft side showed fatigue marks, but these should be considered as a secondary damage consequential to the event most probably created by vibrations (Fig. 23).
4. **Optical examination of all the fractured first stage and second stage power turbine blades showed fracture features typical for secondary damage, with no evidence of fatigue.**
5. Chemical analysis of the filings and metal debris collected from the main oil system filter, the RGB filter and the magnetic chip detector was performed at the P&WC Chemical Laboratory. **Materials collected from these places showed that the iron-based particles mainly composed of M50 bearing material (high hardness steel).** The thermal discolorations were visible on a part of examined material.
