FINAL REPORT

ACCIDENT 5260/2019

OCCURENCE Ref. No – 5260/2019

AIRCRAFT – GYROPLANE ZEN1, OM-M393

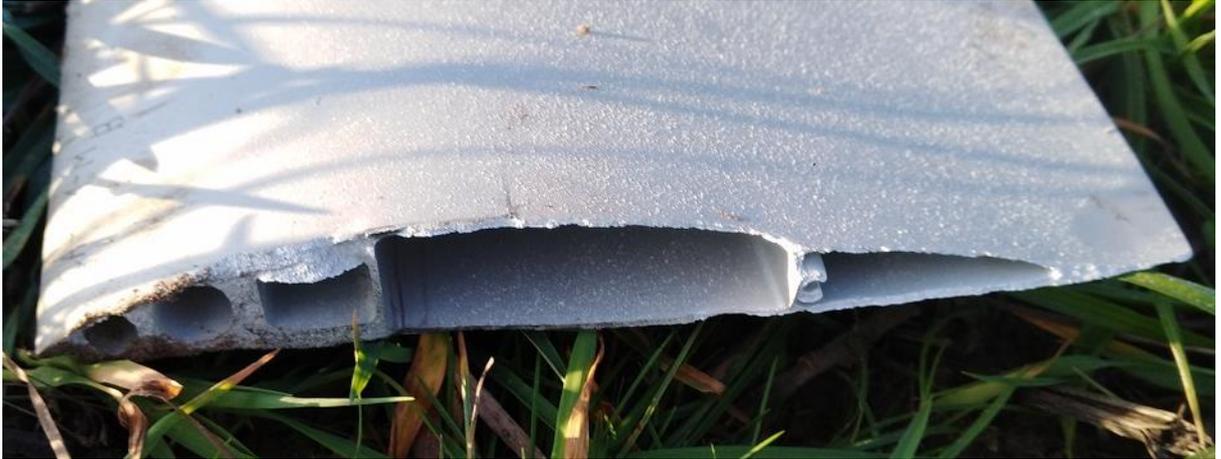
To the left of the runway, about 80 meters from its centre line, the first of the main rotor blades was found. The blade was broken at the end of the blade connector and was in one piece, with no traces of collisions with other objects. The description "CA-051-M_B" was found on its upper surface.

Fig. 4. Fracture of the main rotor blade, which was first detached from the connector [source: PKBWL]

- 1) Blade no. 1, torn off inflight, sustained a two-phase crack. In the first phase, a fatigue crack occurred, which resulted in reduction in the active cross-sectional area of the rotor blade, and then, as a result of stress concentration, a sudden fracture occurred, as a result of which the blade separated into two parts (the smaller part remained attached with bolts inside the hub blade connector, and the remaining part came off inflight);

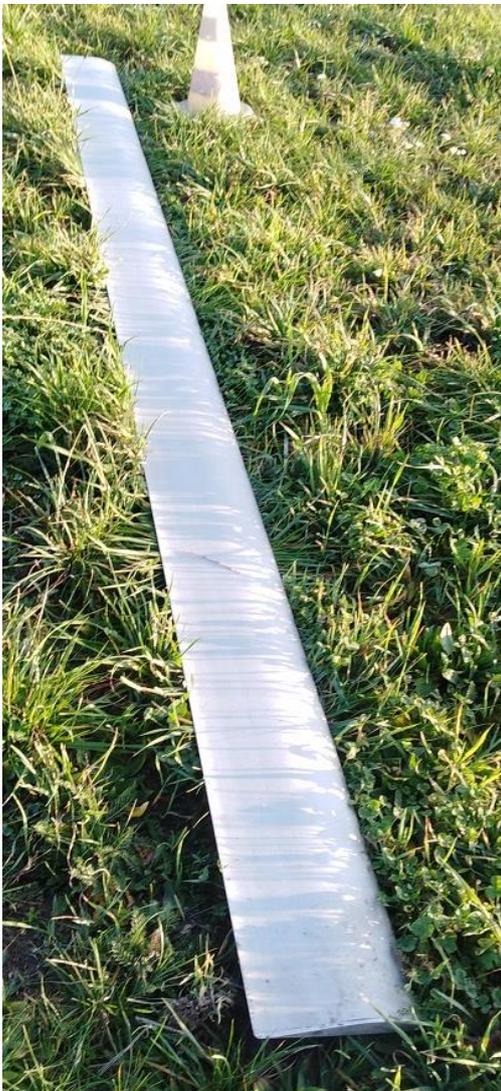
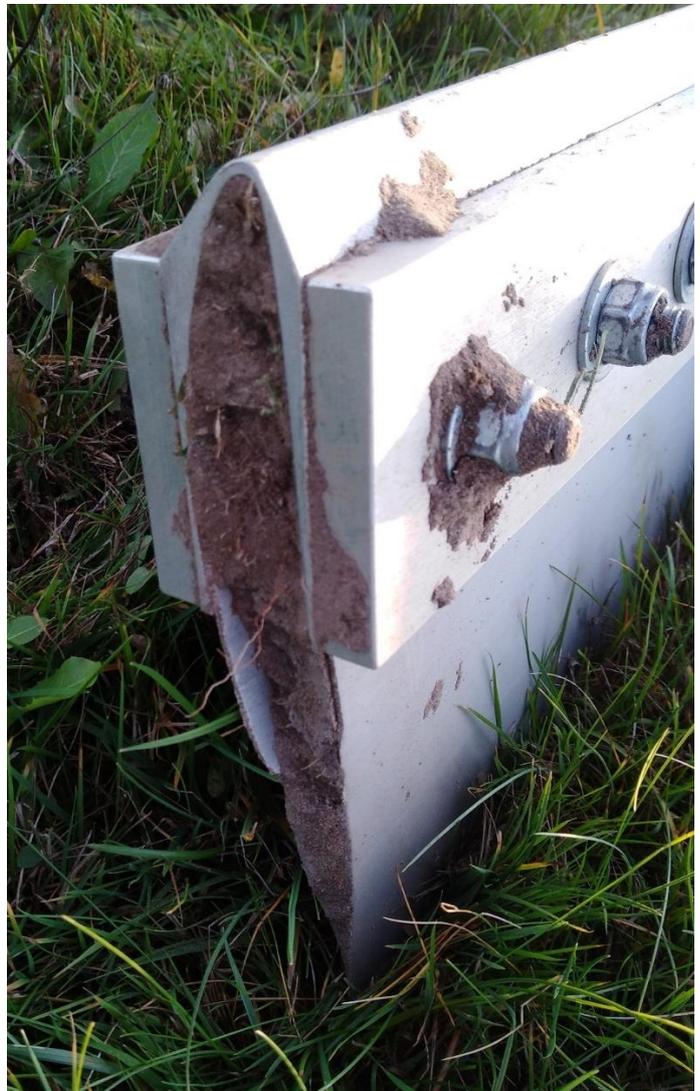
Fig. 5. Left: main rotor blade separated inflight; Right: blade connector on the main rotor hub - place where the first blade was separated [source: PKBWL]

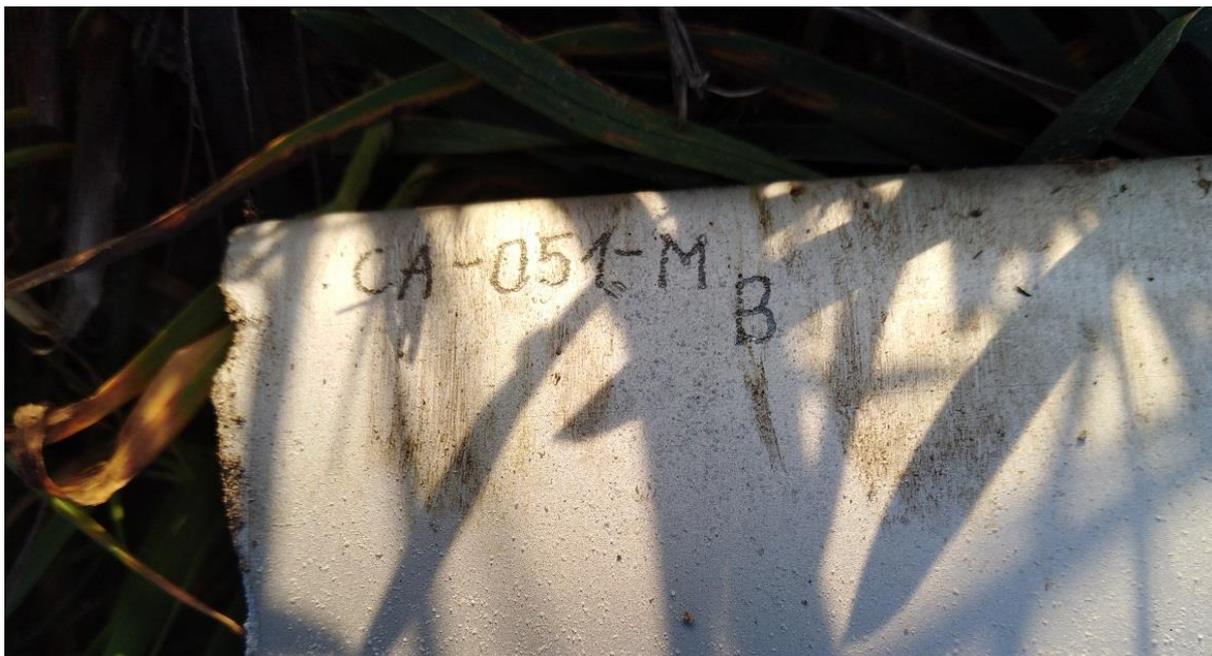
Fig. 6. Marking revealed on the separated blade found on the accident site [source: PKBWL]

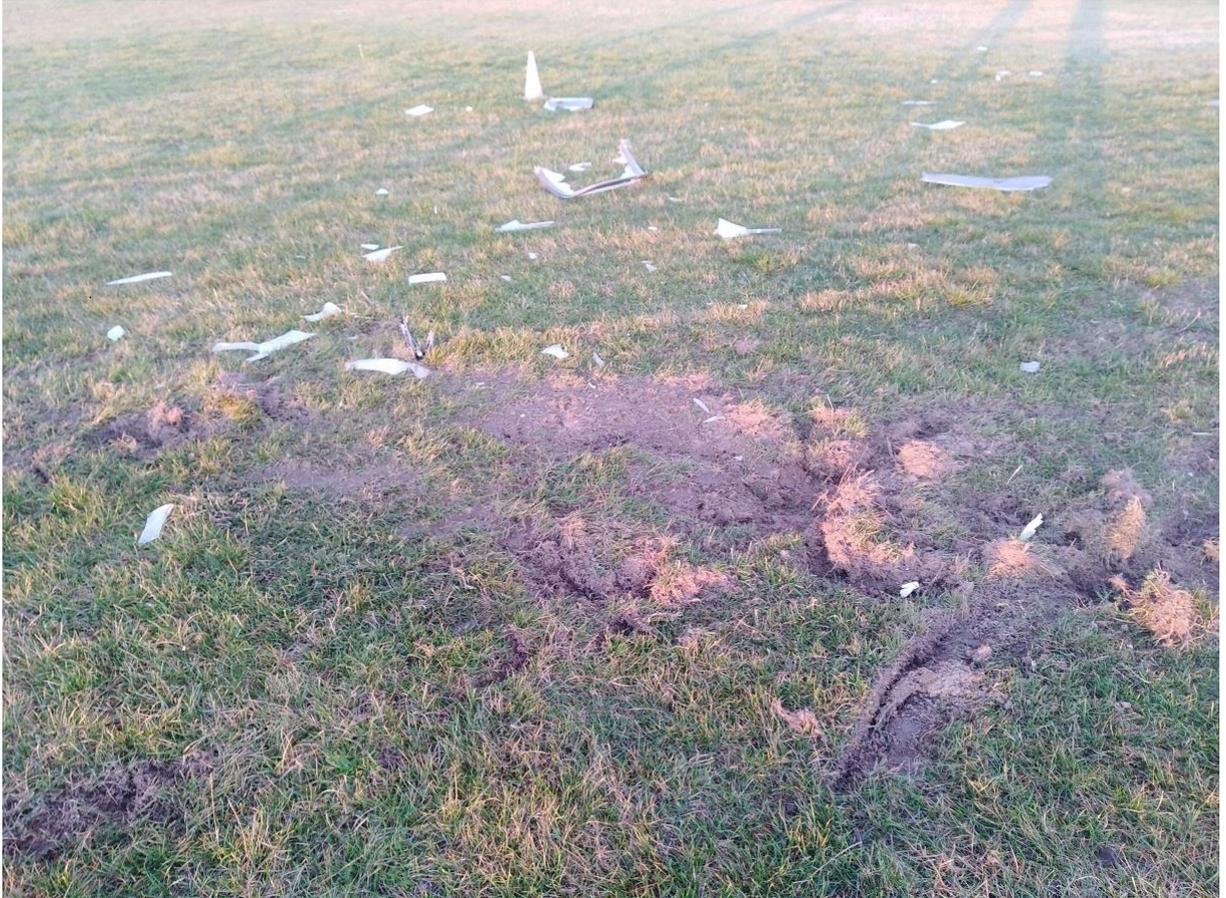
About 30 meters further in the direction of flight, there was a fuselage impact mark on the runway surface. Around this trail, in a radius of 10 meters, there was a cluster of scattered small fragments of the wreck, such as: fragments of the door and fuselage glazing, door elements with a gas spring, antenna, front wheel of the landing gear, elements of clothing and personal belongings of the crew. Further 15 meters in the direction of flight, a completely burnt gyroplane wreck was located. The student's burnt body was revealed in the wreckage. The instructor's body was about 8 meters away and was not burnt.

Fig. 7. Marks of the fuselage collision the ground [source: PKBWL]

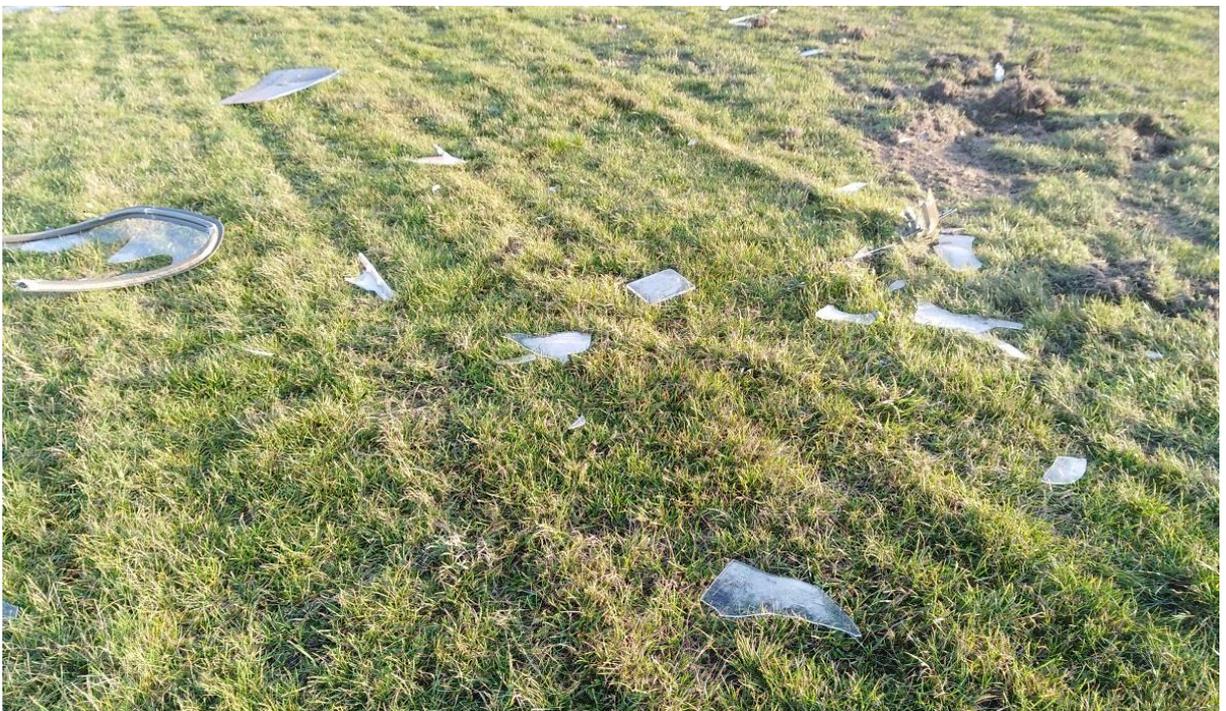
A cluster of scattered elements near the runway centre line in the direction of flight was found. They separated from the aircraft inflight. The larger elements included: the main rotor mast fairing (on the left of the runway) and a fragment of the left horizontal tail. The lower surface of the other blade showed numerous signs of collisions with the aircraft parts, and a complex, dynamic fracture traces were found on its part closer to the hub side. That blade was plastically bent towards the upper surface over most of its span.

Fig. 8. The cluster wreckage that fell to the ground after the inflight disintegration of the gyroplane [source: PKBWL]

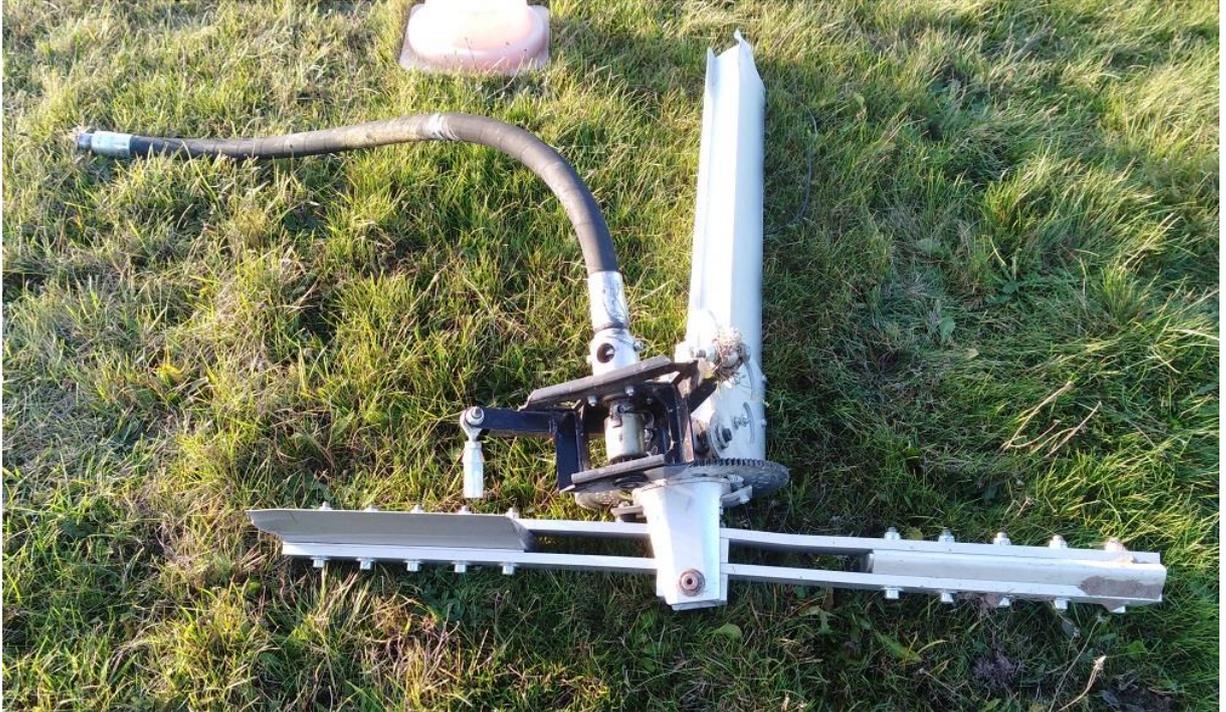
Fig. 9. The main rotor mast separated from the wreck [source: PKBWL]

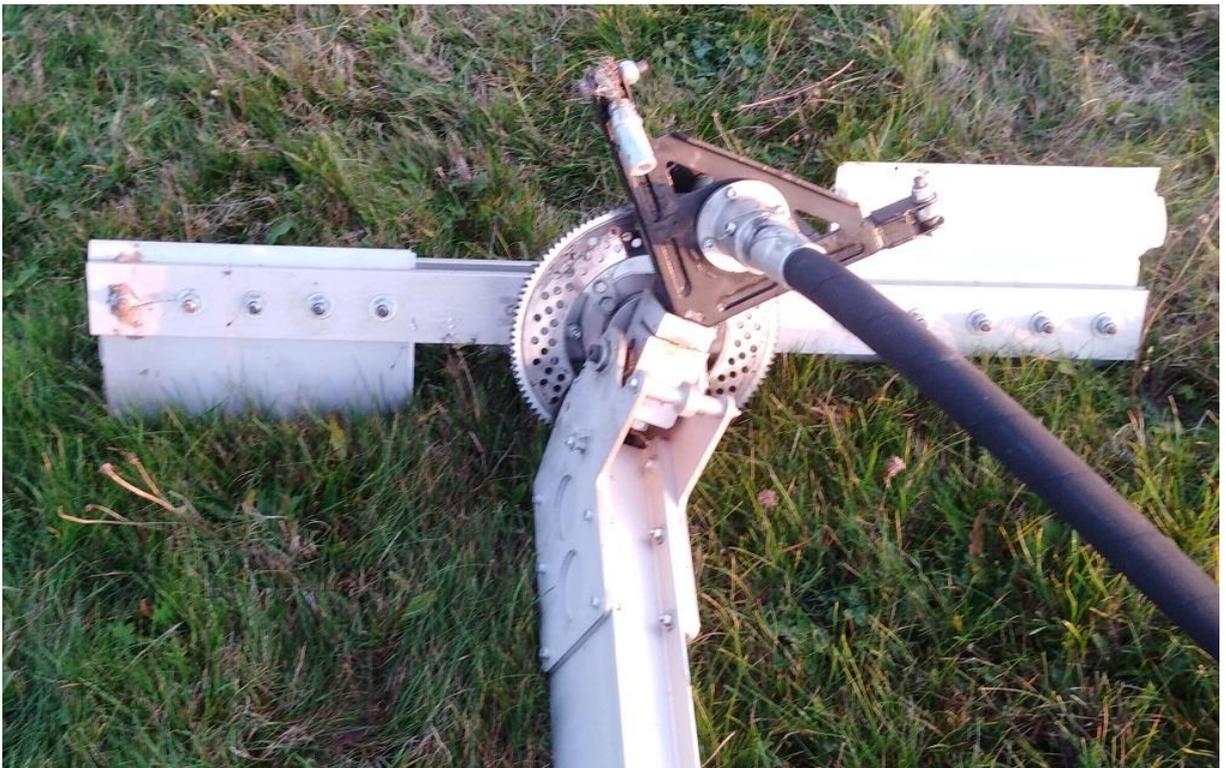
Fig. 10. The main rotor mast separated from the wreck - lower part of the hub. On the left, a fragment of the blade which was separated as first; on the right, a fragment of the other blade, damaged as a result of the accident [source: PKBWL]

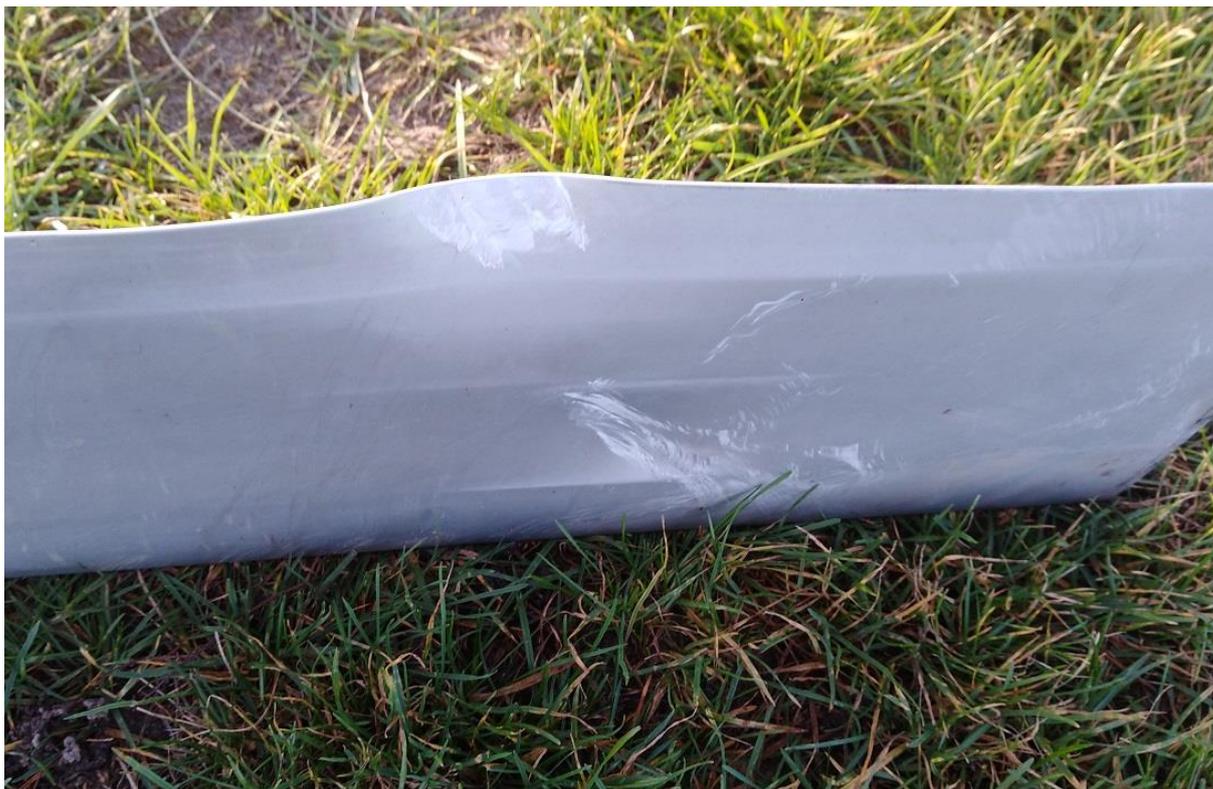
Fig. 11. The blade destroyed due to the accident [source: PKBWL]

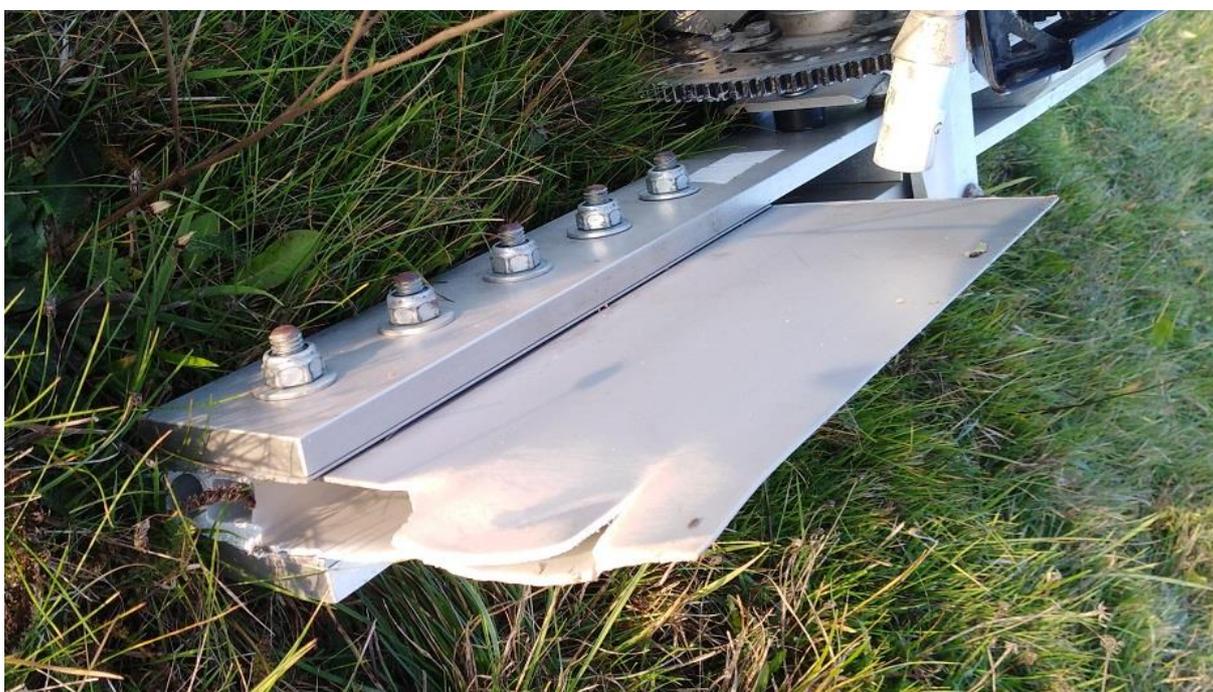
Fig. 12. View of the gyroplane rotor blades connector [source: PKBWL]

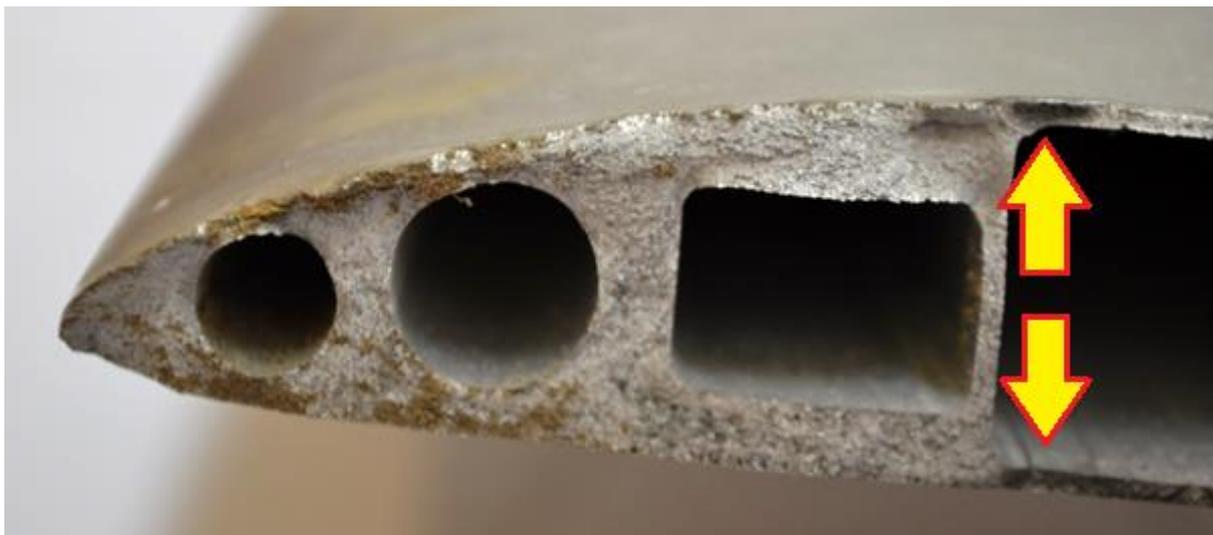
It was found that the blade which separated inflight has a fracture on its seating in the main rotor hub connector. At the fracture point, the greatest bending moment occurs during the operation of the main rotor blade. Based on visual examinations, it was determined, that the fracture had a variable topography, and the area that could possibly be the place of the crack initiation was selected for further research. The fracture area marked with arrows in Fig.15 was observed using a Hitachi S 4200 scanning electron microscope.

Fig. 15. The surface of the blade fracture. Places selected for examination with the scanning electron microscope [source: Silesian University of Technology]

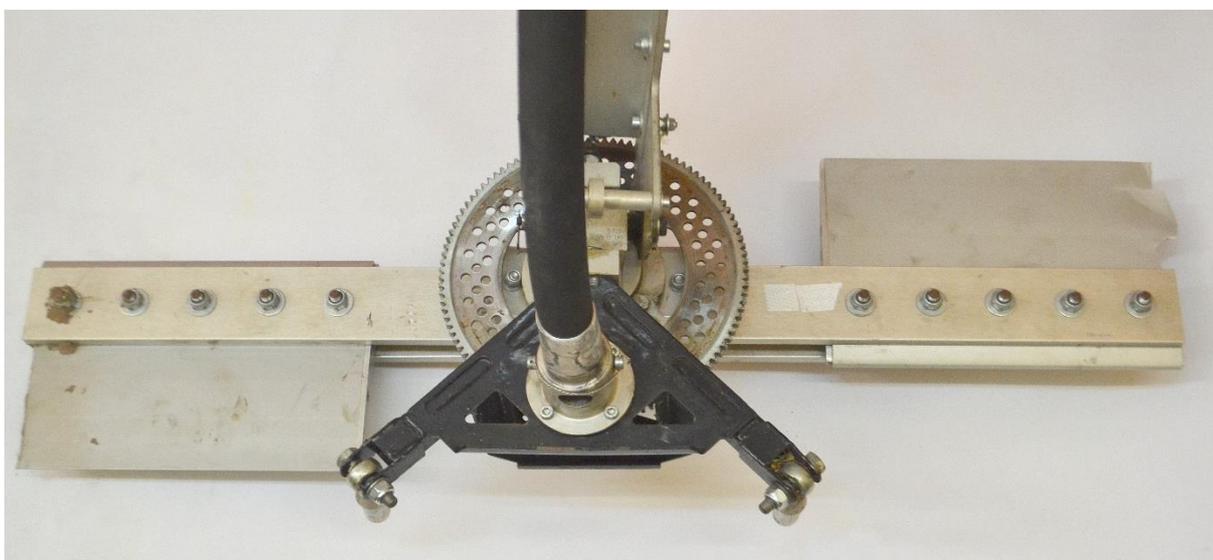
Fig. 16. The main rotor mast of the gyroplane subjected to the research - the lower part of the hub view. On the left, a fragment of the blade which was separated as first; on the right, a fragment of the other blade, destroyed due to the accident [source: Silesian University of Technology]

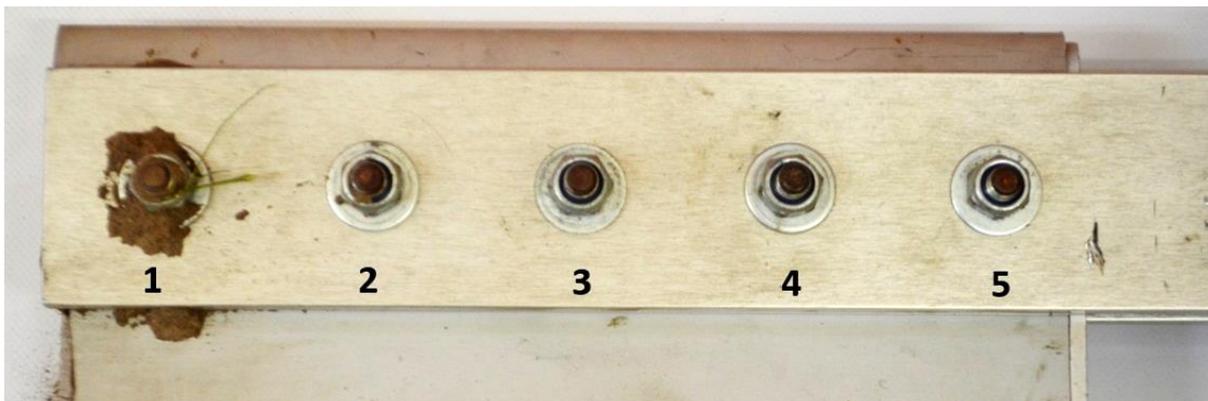
Fig. 17. Markings of the bolts of the blade detached as first [source: Silesian University of Technology]

Table 7. Results of measurements of the torques necessary for unscrewing the bolts showed in Fig. 17

Bolt 1	Bolt 2	Bolt 3	Bolt 4	Bolt 5
32,5 Nm	30,0 Nm	31,5 Nm	41,0 Nm	22,5 Nm

- 5) Tightening torques for the bolts of the blade No. 1 (causal for the accident) were different, which indicates improperly performed assembly, repair or maintenance works on the examined element. The low tightening torque of the bolts could have caused the blade vibrations, and consequently, formation of fatigue cracks determined during the examinations. Propagation of the fatigue cracks and the resulting change in the stress could have been the cause of decohesion (detachment) of the blade;

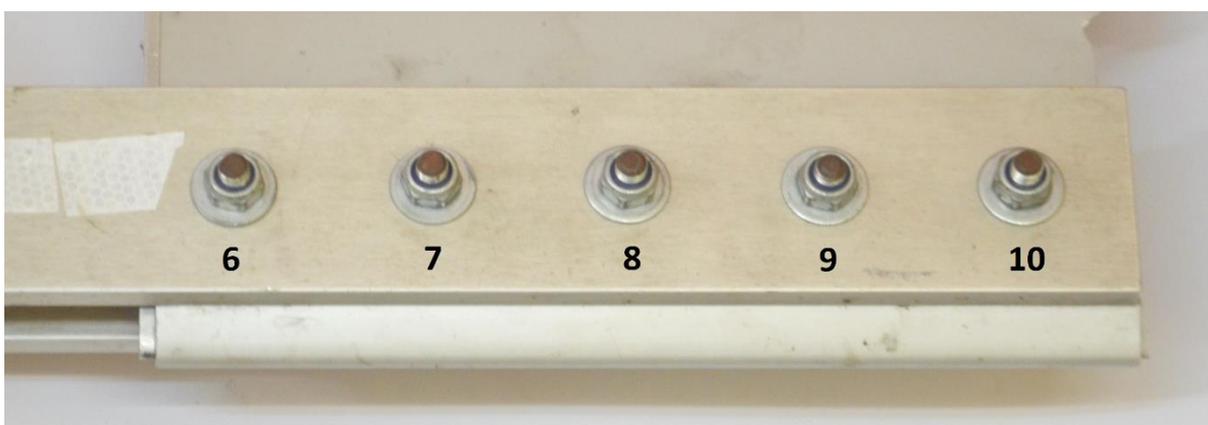
Fig. 18. Markings of the bolts of blade that broke due to destruction of the first blade [source: Silesian University of Technology]

Table 8. . Results of measurements of the torques necessary for unscrewing the bolts showed in Fig. 18

- 6) The tightening torques for the bolts of the blade No. 2 (damaged after the first blade was torn off) had very close values for all 5 bolts of this blade;

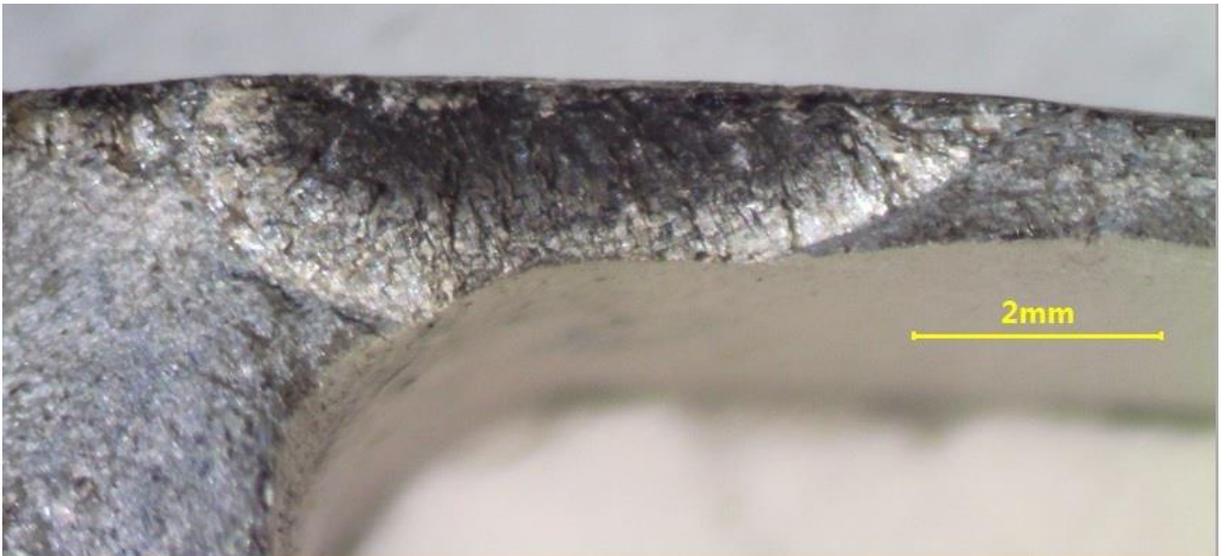
Based on the observation with a stereoscopic microscope, it was determined that the fatigue fracture occurred on the upper and lower blade surfaces. The results of the observations are presented in the figures below.

Fig. 20. Detail from fig. 19 - upper area. Visible place of the fatigue crack [source: Silesian University of Technology]

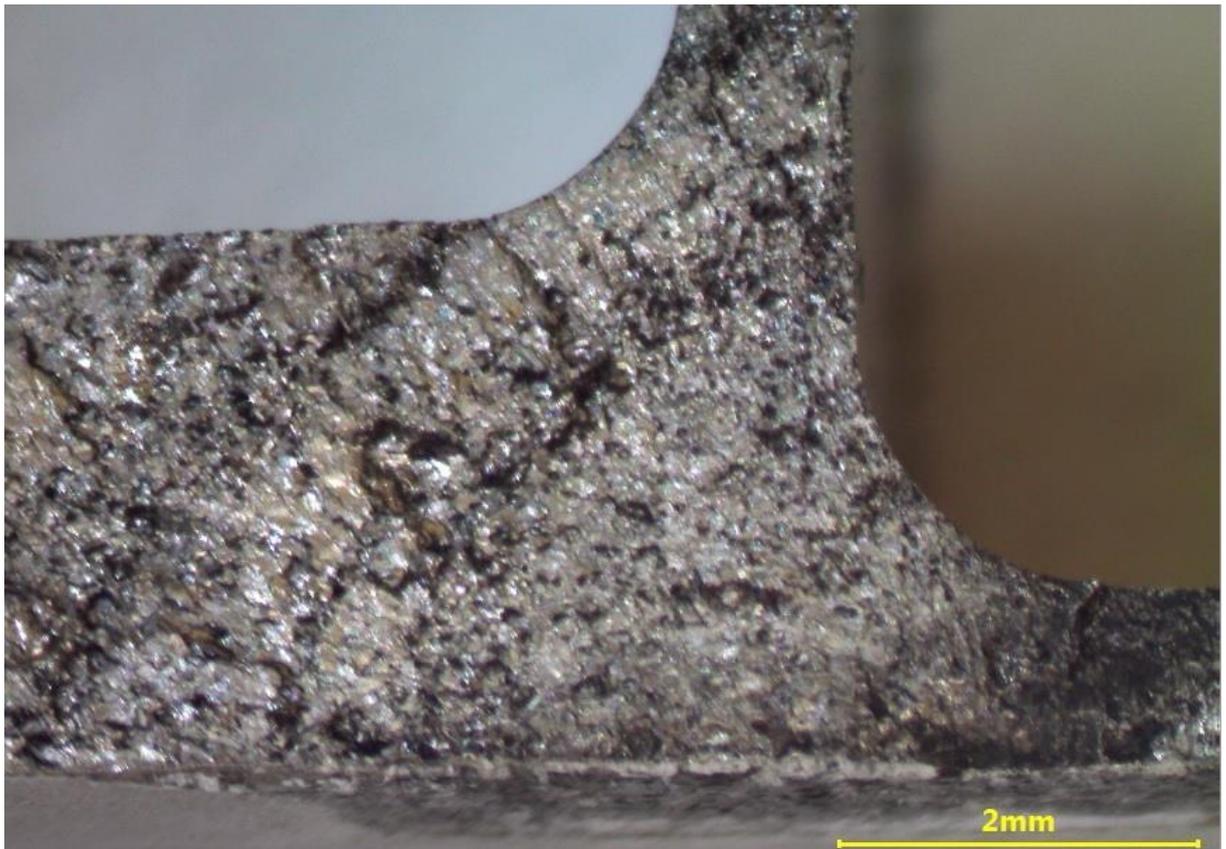
Fig. 21. Detail from fig. 19 - lower area. Visible place of the fatigue crack [source: Silesian University of Technology]

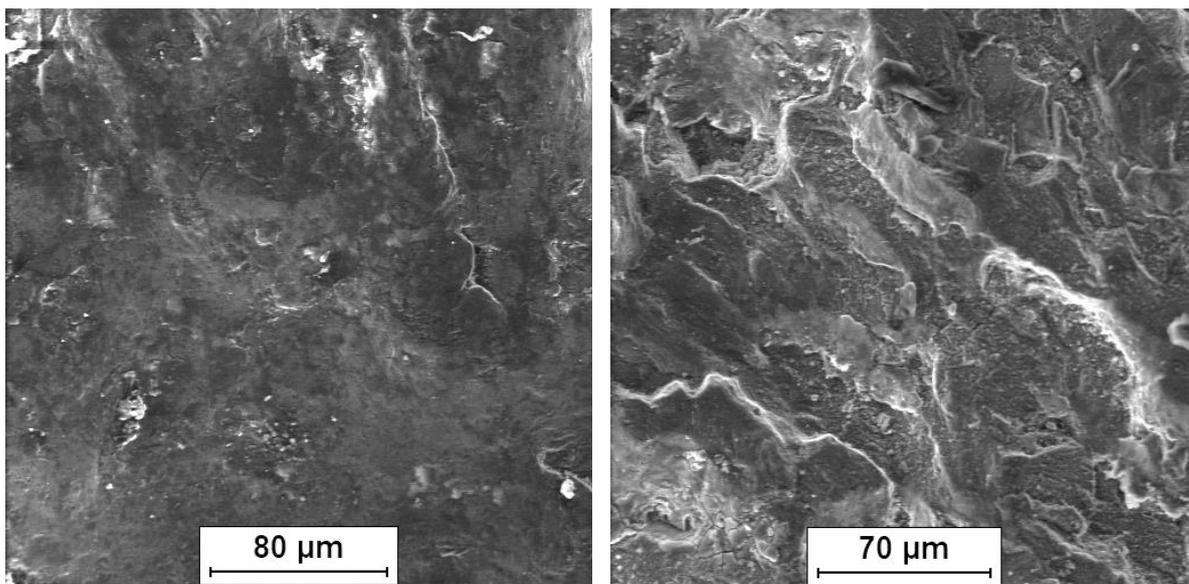
The surface examinations were carried out using the Hitachi S-4200 scanning electron microscope (SEM) together with the X-ray microanalysis of the chemical composition (EDS). The results of the observations are presented in the figures below. It has been shown that the material has a fracture typical of a fatigue crack. The focus point of the fracture is located in the outer zone of the blade in cases of both fatigue fractures.

Fig. 22. Fatigue crack from the upper area marked in fig. 20. Visible light fatigue striations [source: Silesian University of Technology]

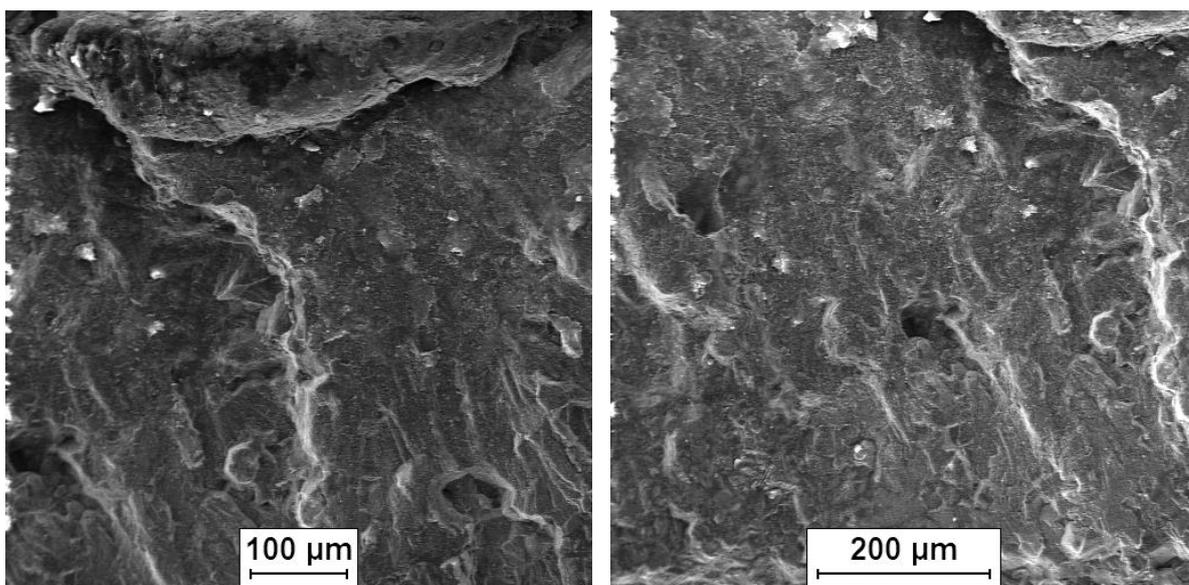
Fig. 23. Fatigue crack from the lower area marked in fig. 20. Visible light fatigue striations [source: Silesian University of Technology]

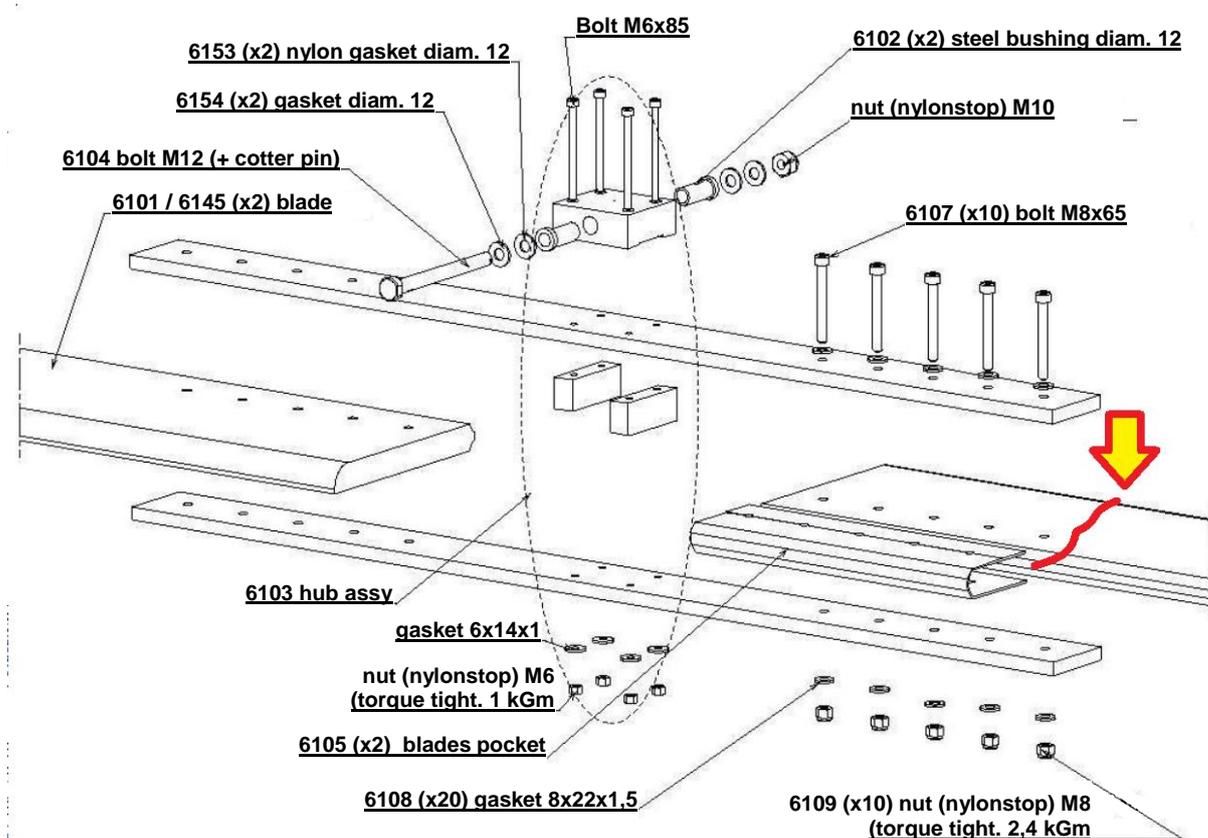
The Commission's doubts were raised by the design of the hub and the main rotor blade connector, which caused an excessive strength load on the rotor blades. The main rotor blades of the ZEN1 gyroplane are manufactured in the form of a profile shaped by extrusion from aluminum alloy. The blades made in this way have a homogeneous material structure, and a crack causes rapid propagation of the damage in the blade material and leads to its destruction. The blade is attached to the gyroplane rotor hub through the cap and pressed with assembly bolts between the elements of the blade connector made in the form of two parallel flat bars with a constant cross-sectional area.

Fig. 27. ZEN1 gyroplane rotor hub assembly diagram. The arrow marks the place of the blade fracture. [source: ZEN1 gyroplane maintenance manual]

When the blades are fixed as shown in Fig. 27, the blade bending moment reaches its maximum at the edge of the flat bars of the connector. In terms of the mechanical strength, this is a very unfavorable condition, generating a stress distribution in the blade material similar to the stress distribution resulting from the notch effect.

The blades rotating during the flight are subjected to many forces. The resultant of these forces act to arrange the blades of the working rotor in the shape of a cone, which is counteracted by a rigid connector fixing the blades to the rotor hub. The maximum moment bending the blades is produced at the ends of the rigid connector and this is the place where the blade fracture occurred in the accident investigated.
