ACCIDENT 2020/1515

STATE COMMISSION ON AIRCRAFT ACCIDENTS INVESTIGATION

OCCURRENCE No. – 2020/1515

AIRCRAFT – SOCATA MS 893 E-D, D-EGET

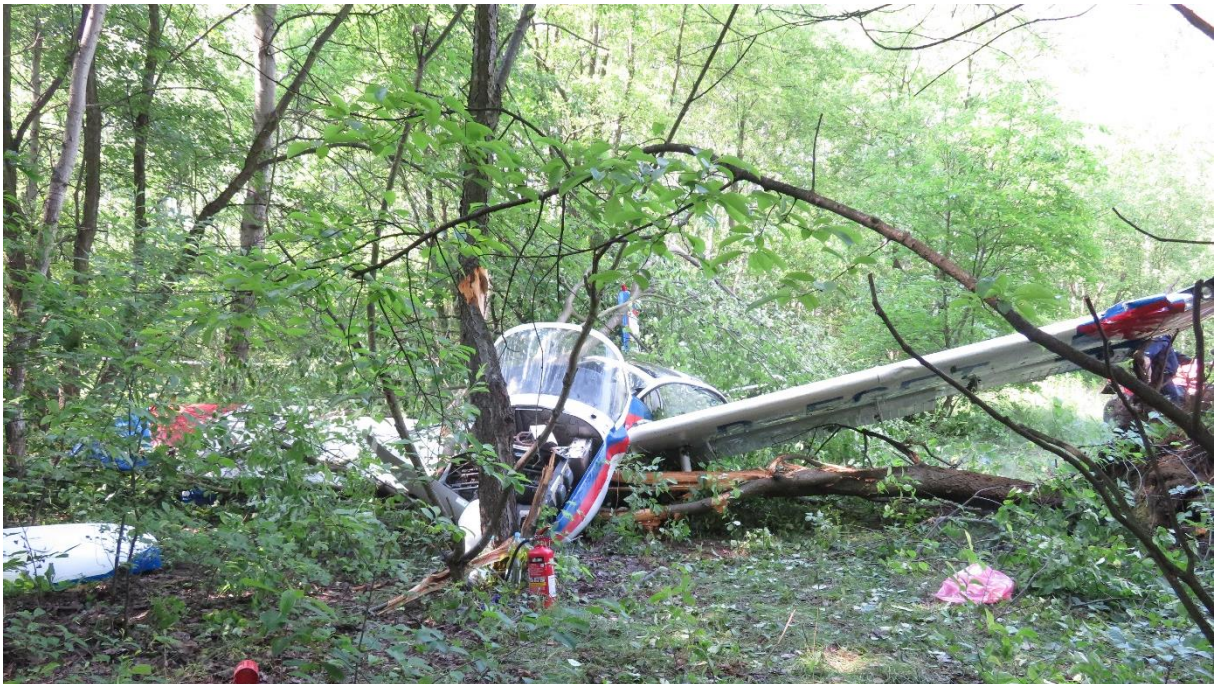
Fig. 1. SOCATA M.S. 893 E-D D-EGET at the crash scene³

As a result of the collision of the left wing with a tree, the tree was uprooted, and the aircraft turned about 90° left horizontally, getting in contact with another tree and then collided with the ground. There was no fire. Traces on trees prove that the engine was running and the propeller rotated till the contact with the ground.

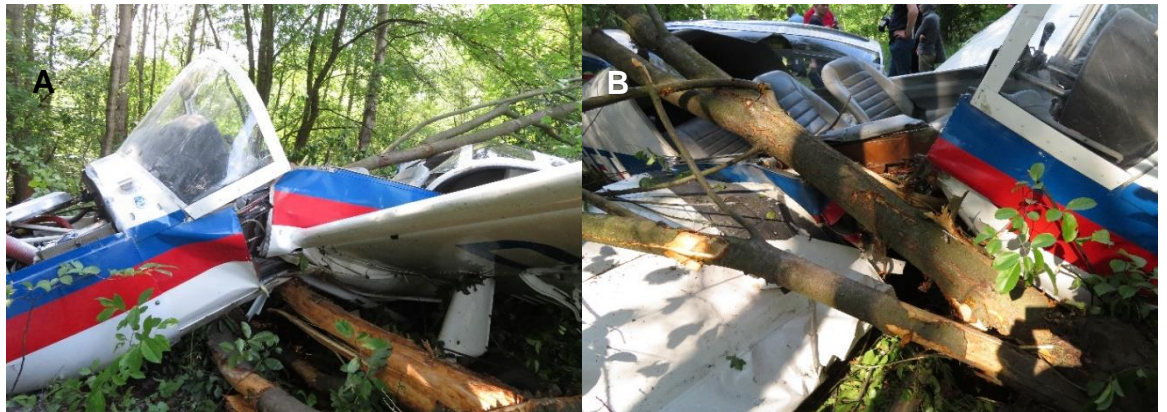
- a) The fuselage was broken at the place of pilot's seats. The canopy was destroyed. The right side of the cabin was pressed inwards, the nose and the right landing gear were broken (Fig. 2);

Fig. 2. SOCATA M.S. 893 E-D D-EGET aircraft, damage to the cabin: A – view from left, B – view from right

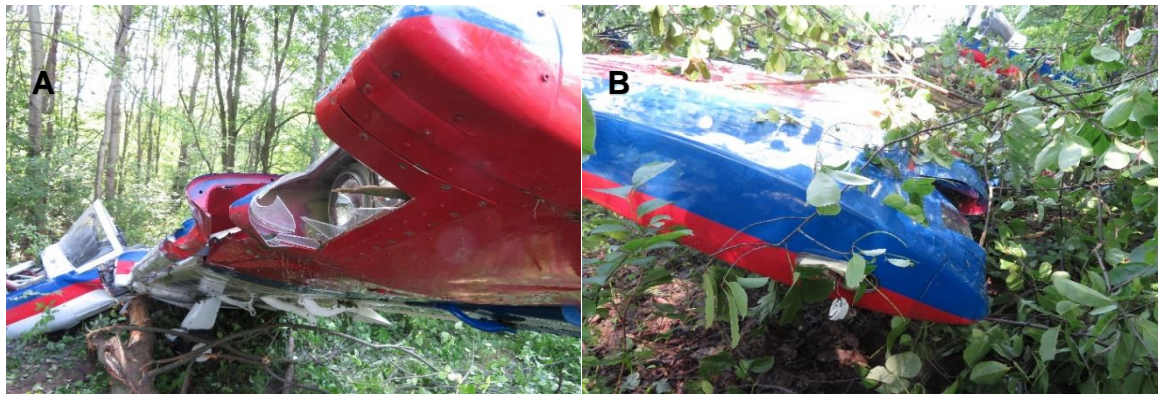
- b) Left and right wing preserved their geometry and connection with the fuselage, the leading edges and lights were damaged, the fuel tanks preserved their integrity. Flaps were found set at “take-off” position. The control systems of flaps and ailerons preserved their kinematic continuity (Fig. 3);

Fig. 3. SOCATA M.S. 893 E-D D-EGET aircraft, wing damage: A – left wing, B – right wing

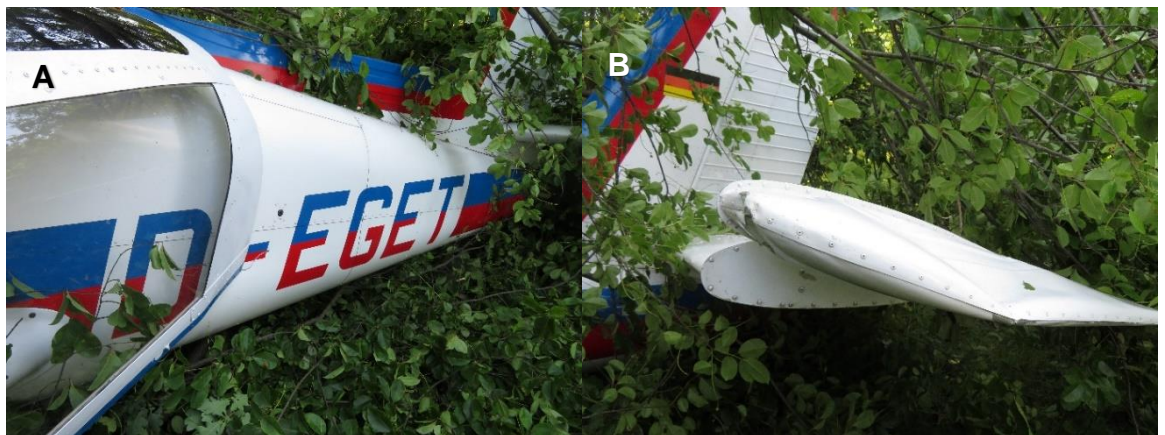
- c) The rear part of fuselage and the empennage were slightly damaged with scratches and dents. The kinematics continuity of the elevator's control was affected broken in the area of the fuselage' break. In front of the break area the cable drive and both yokes volantes were moving without jams, behind the break – the elevator and cable connected to it drive were moving freely in a full range. The rudder preserved its integrity and was following reacting on pedals movements. (Fig. 4);

Fig. 4. SOCATA M.S. 893 E-D D-EGET after the crash: A – tail with German registration marks, no visible damage, B – empennage with visible dents

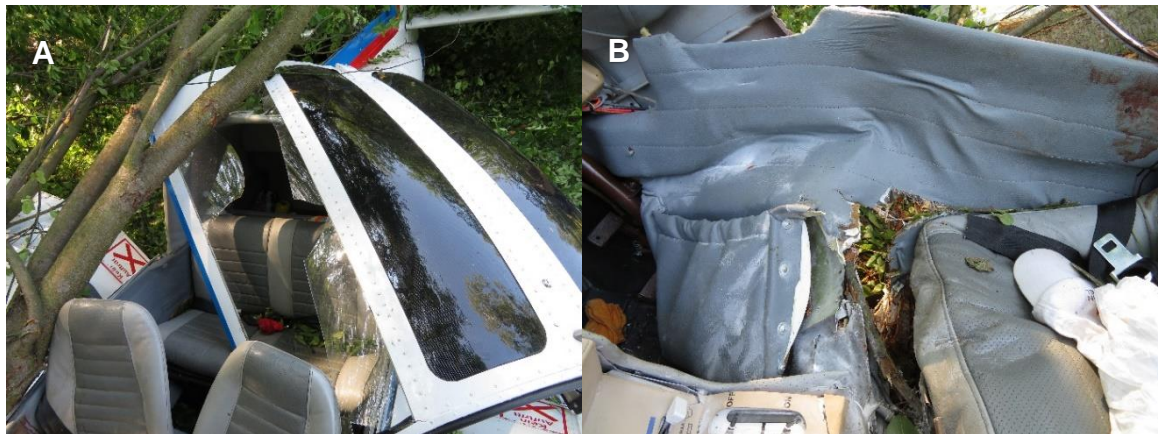
- d) The cockpit was deformed due to in result of fuselage break, the seats preserved their fixing to the floor, the rear part of canopy was destroyed (Fig. 5);

Fig. 5. SOCATA M.S. 893 E-D D-EGET cockpit after the crash: A – damage to the canopy, B – broken fuselage in the area of front seat

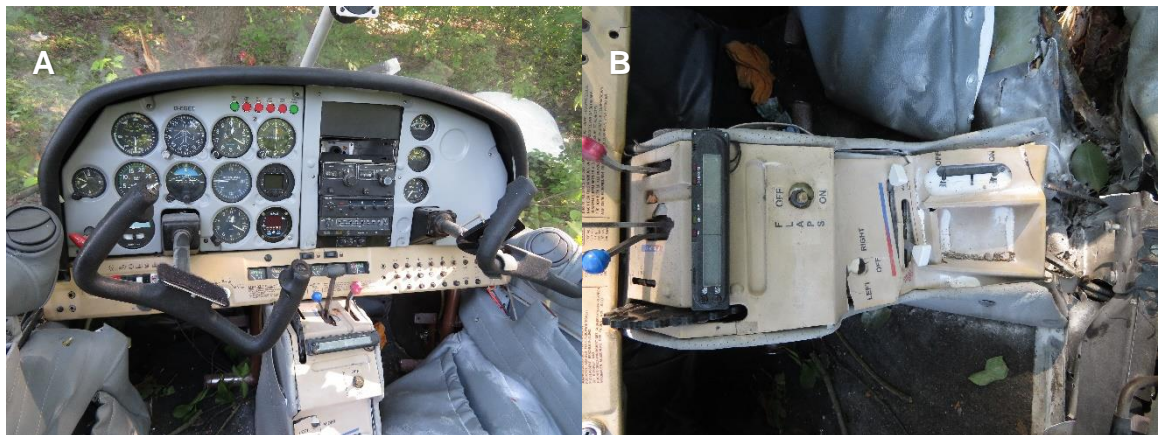
- e) The instrument panel did not sustain visible damages, the central mid panel with switches for flaps and heating was affected;

Fig. 6. SOCATA M.S. 893 E-D D-EGET cockpit after crash: A – instrument panel, B – central panel

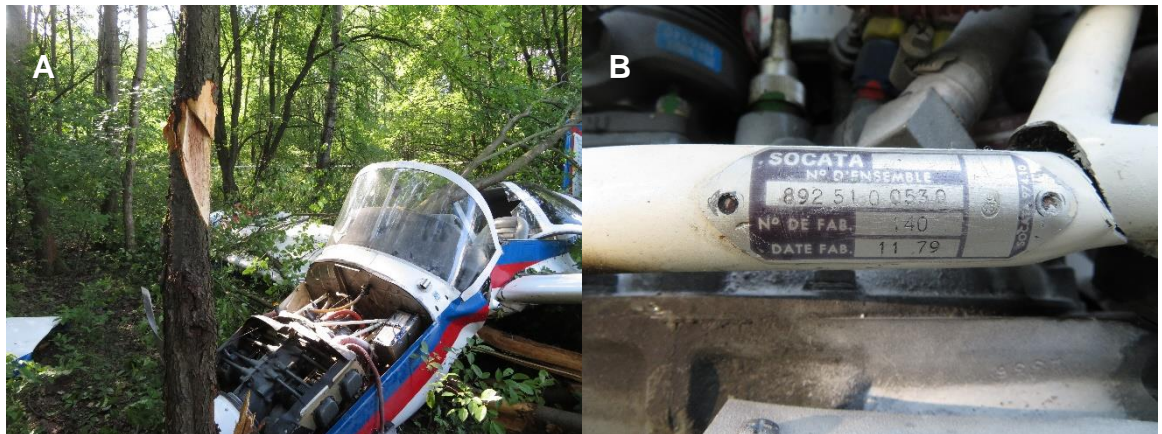
- f) The engine was without visible external damages, no leakages nor signs of overheating, no disconnected wiring harness, propeller fixed firmly – blades bent due to collision.

Fig. 7. SOCATA M.S. 893 E-D D-EGET engine compartment: A – general view (visible damage to the tree made by rotating propeller, B – broken engine mount)

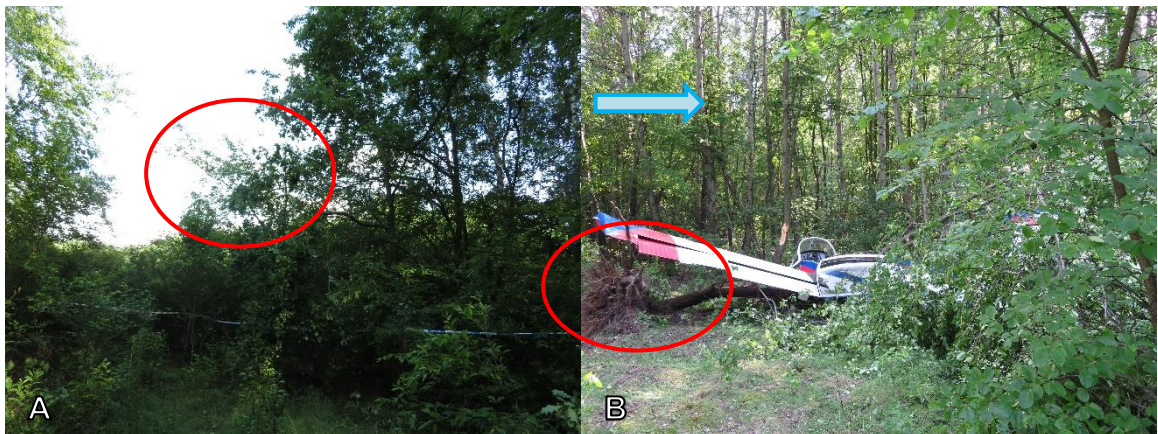
The first contact with trees took place a few metres above the ground, on the west side of the forest clearing, in the distance of about 500 m west beyond the fence of the aerodrome, on the extension of the runway centre line. The plane cut and broke several tree branches (Fig. 11). Next, after about 30 m in the air, the left wing (at the landing light) hit another tree and uprooted it, the aircraft turned left horizontally about 90°, and fell down to the ground from several meters. During the fall, the tree roots, located on the ground below the fuselage, caused the fuselage to break in the area of pilots seats.

Fig. 11. Crash scene of SOCATA M.S. 893 E-D D-EGET: A – broken tree branches on the west side of forest clearing (direction opposite to the flight direction), B – overturned tree and the wreck (blue arrow shows the flight direction)

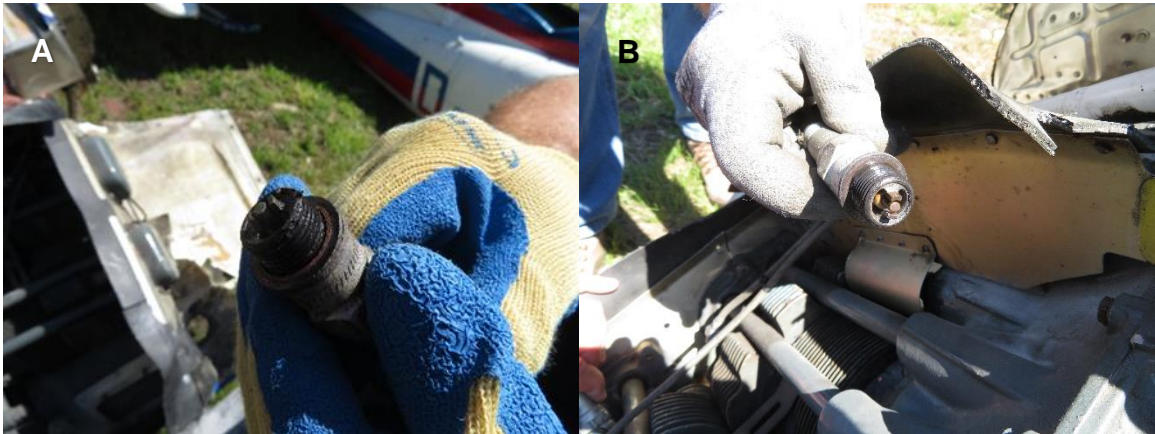
An inspection of spark-plugs and their torque moments was made. The connector of ignition harness of upper spark-plug of cylinder no. 4 was improperly tightened and more contaminated than the others. Fig. 12 below shows the upper spark-plug from cylinder no. 4 and, for comparison, from cylinder no. 3.

Fig. 12. Spark-plugs: A – cylinder no. 4; B – cylinder no. 3

- 8) The aircraft was refuelled with automotive gasoline with too low octane number which did not meet the requirement of the engine manufacturer.
- 9) The connector of one spark-plug was improperly tightened.

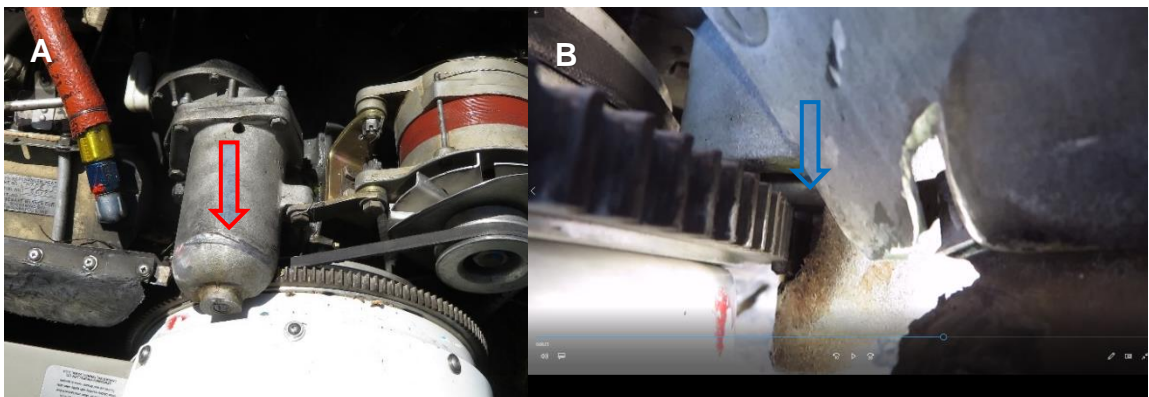
During the examination it was also found that the starter was coupled with the engine. The starter was taken for further examination. Abrasions were on the starter housing, probably resulting from long-time rubbing against the bottom engine cowling. No internal damage to the starter were found.

Fig. 13. Starter: A – general view (the red arrow shows the gouge); B – coupled tooth gears of an engine and starter (the blue arrow)

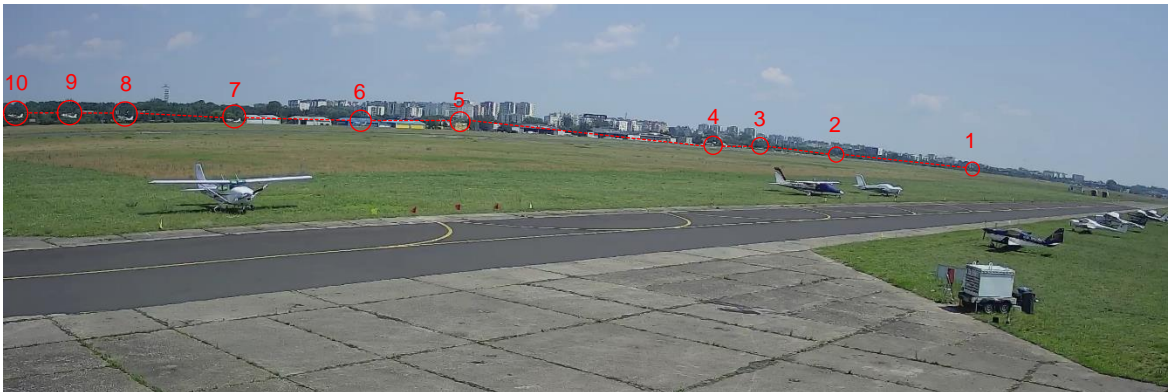
However, recordings of CCTV cameras on the airfield show irregularities from the beginning of the take-off. While airborne, the aircraft entered a mush and the further

portion of the climb was very slow (see Fig. 14). The camera's recording shows also that the climb was with a very large angle of attack.

Selected time-lapse shots have been combined into one picture as shown in Fig. 14. Since the plane itself is poorly visible, the particular phases of the take-off have been numbered and marked with red circles, in the following way:

- 1 – start of the take-off roll (11:25:05);
- 2 – lift-off (11:25:25);
- 3 – the highest point of initial climb (11:25:28);
- 4 – first mush of the aircraft (11:25:31);
- 5 – the highest point of further climb (11:25:37);
- 6 – second mush (11:25:39);
- 7÷10 – minimal climb on a high angle of attack (11:25:42÷11:25:45).

Fig. 14. Take-off of SOCATA M.S. 893 E-D, D-EGET, dated 28 June 2020

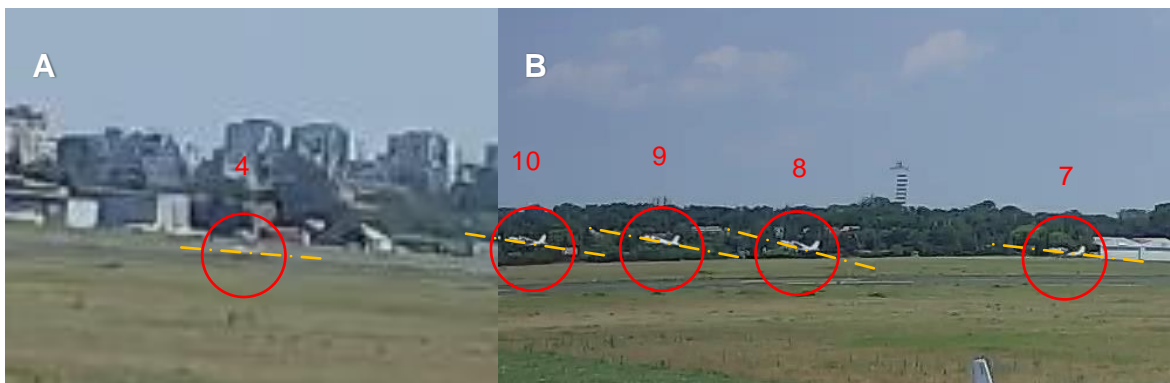
Fig. 15. Take-off of SOCATA MS 893 E-D D-EGET dated 28 June 2020 – close-up of selected shots from Fig. 14. (the orange line shows the longitudinal axis of the plane)

The pilot was increasing and decreasing the angle of attack, as shown on selected shots from Fig. 15 – B. It shows, that he was aware of problems with airplane performance, so decreasing angle of attack may be considered as a proper action to accelerate.

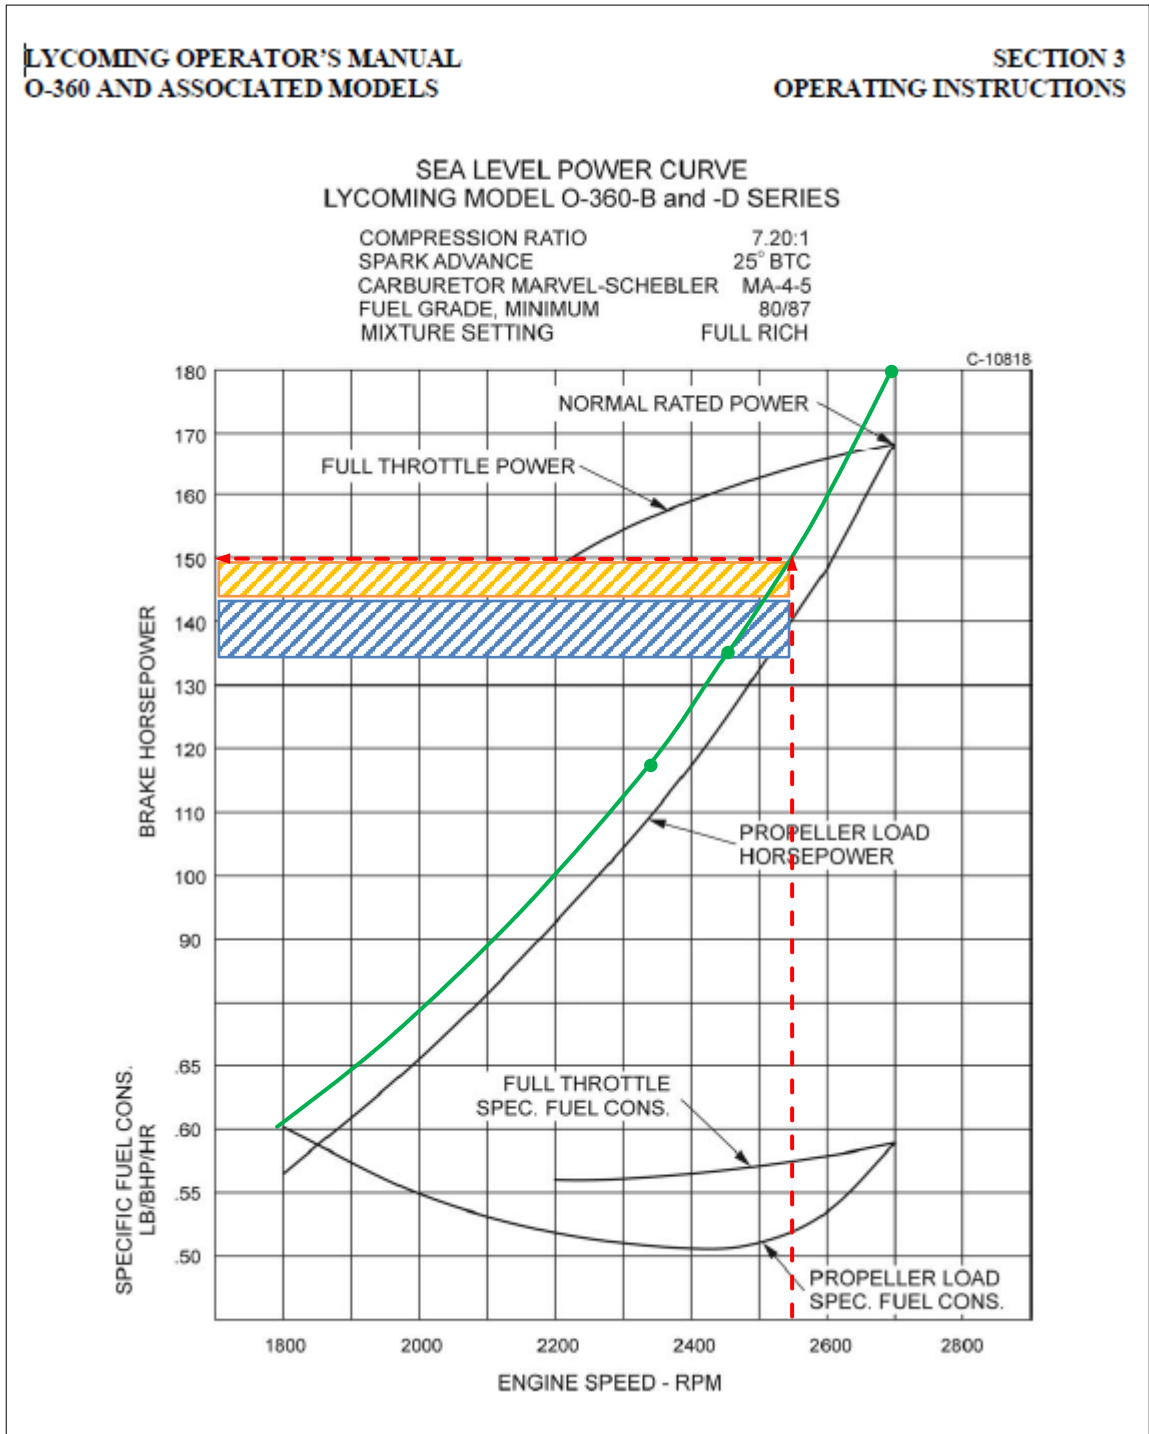
When determining the maximum engine power available during take-off, the drop in RPM caused by improper tightening the connector of one of the spark plugs and the power loss caused by using Pb 95 automotive gasoline instead of aviation fuel should be taken into account (a decrease in power of approx. 5 HP was assumed).

It should also be remembered that the maximum engine power is given for the standard temperature (15°C) at sea level and will decrease with increasing in altitude and temperature.

At an altitude of 500 ft AMSL, the maximum power is 98.5% of the power available at sea level. Therefore, the EPBC elevation of 352 ft results in about 1,0% loss of power.

Fig. 18. The relations between engine's power and its RPM for O-360 series B & D [source: O, HO, IO, AIO, HIO, TIO-360 Series Operator's Manual] – the green colour for A series, red represents the power of O-360 series A for approx. 2550 RPM, orange is an area of estimated power drop because of improper fixing of spark-plug connector and using automotive gasoline, blue is a power correction due to elevation and outside temperature.

The power correction due to temperature is about 1% for each 10°F. On the day of occurrence, the recorded temperature was 28°C, i.e. 13°C (55,4°F) higher than the standard one, what resulted in the drop of the engine power of 5,54%, i.e. about 9,97 HP.
