**State Commission on Aircraft Accidents Investigation**

**ACCIDENT 2020/1555**

**RESOLUTION**

<b>Type and model of aircraft:</b>	Ultralight helicopter, Phoenix UH-22
<b>Registration marks:</b>	SP-HBOG
<b>Date of occurrence:</b>	30 <sup>th</sup> June 2020
<b>Place of occurrence:</b>	Strzegom n. EPLB

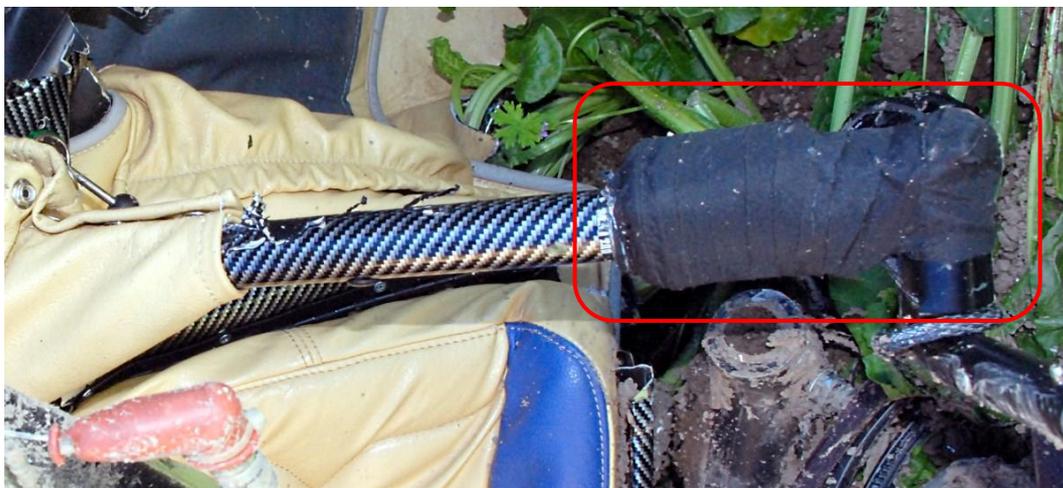
Prior to the replacement of the blades, the helicopter showed increased vibrations that were transferred to the control system. The owner did not remove the cause(s) of the vibrations, but attached a lead bar to the cyclic to suppress them.

**Fig 2.** Cyclic with visible lead bar attached with tape
