SLOVENIA SAFETY INVESTIGATION AUTHORITY

Case Number: 37201-2/2020/25

**SUMMARY OF THE FINAL REPORT
ON THE INCIDENT INVESTIGATION OF
ATR 72
SP-SPE
31st July 2020**

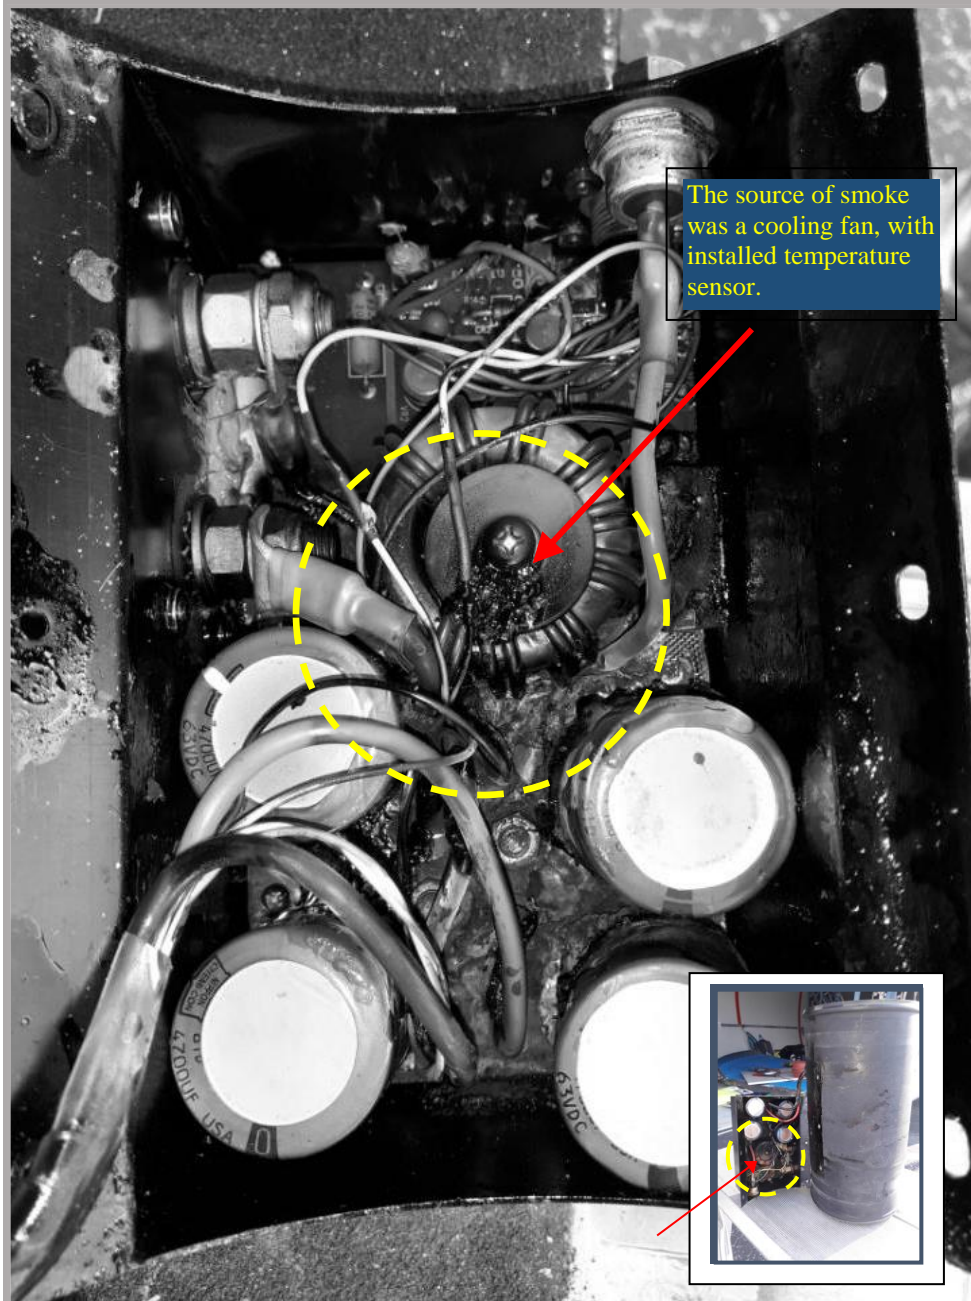
Figure 2: Avionics compartment - avionics cooling fan with temperature sensor

The aircraft was no longer airworthy as a result of the incident. The cause of smoke and odor was later determined to be an avionics cooling fan located under the cockpit floor panel.

- Due to the malfunction of the P/N 011260 Rotron fan and the associated temperature sensor, the flight returned to the airport. Failed fan induced high smoke concentration, odor and subsequent triggering of ELEC SMK warning message.

A review of the aircraft documentation reveals that all prescribed procedures for maintenance/replacement of the defective part were carried out in accordance with the manufacturer's recommendations¹ specifying the replacement of the fan, including the replacement of the temperature sensor in accordance with service bulletin number ATR72-21-1033 (Modification No. 04196 N2235). This modification is optional for operators, according to the manufacturer's instructions (Appendix 3).
