ACCIDENT 2020/2362

# FINAL REPORT

OCCURRENCE NO – 2020/2362

AIRCRAFT – Helicopter Robinson R44 Raven II, SP-SVW

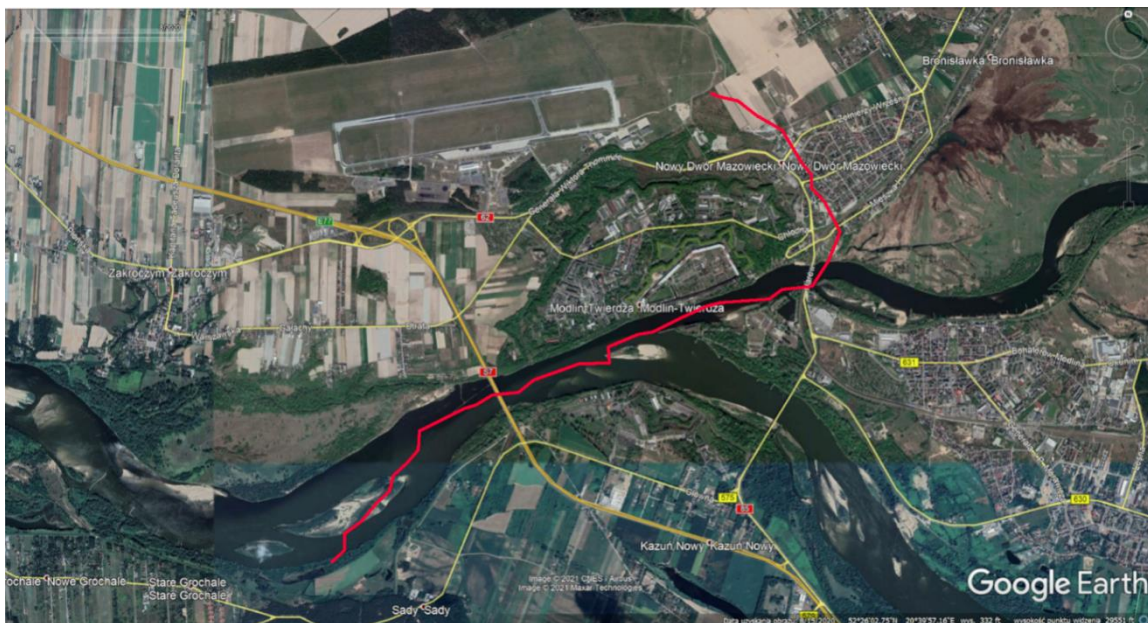
Fig. 1. Flight path recreated from radar markers [source: PKBWL]<sup>2</sup>

Based on the radar recording, the most probable flight path from the EPMO FATO to the accident site was recreated.

The recorded parameters of the helicopter just before the collision with water surface ( at 11:52:29 hrs UTC ) were: flight altitude 400 ft AMSL, speed 78 kt.

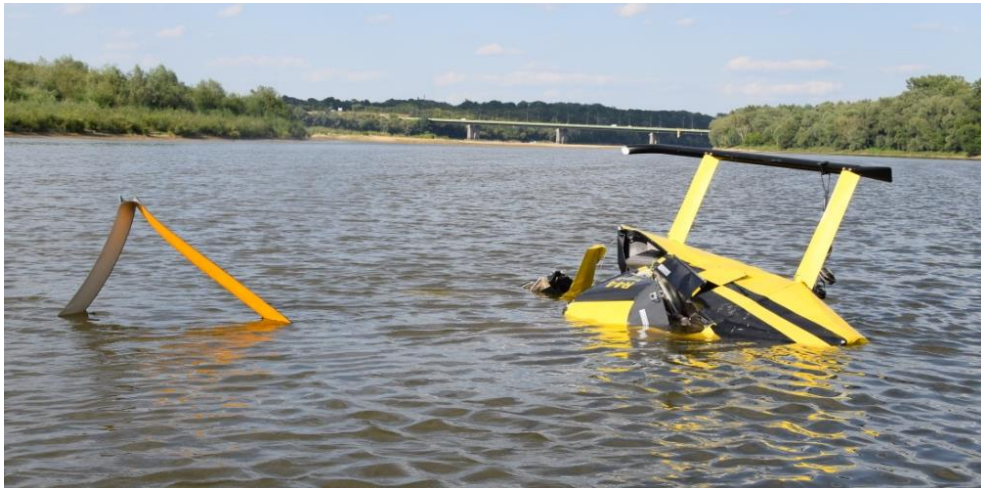
The helicopter was destroyed. At the site of the accident, the right side of the fuselage (without tail boom) protruding above the water surface was found with damaged cabin and main rotor blade.

Fig. 2. Helicopter wreckage - the bridge of the S7 route in the background

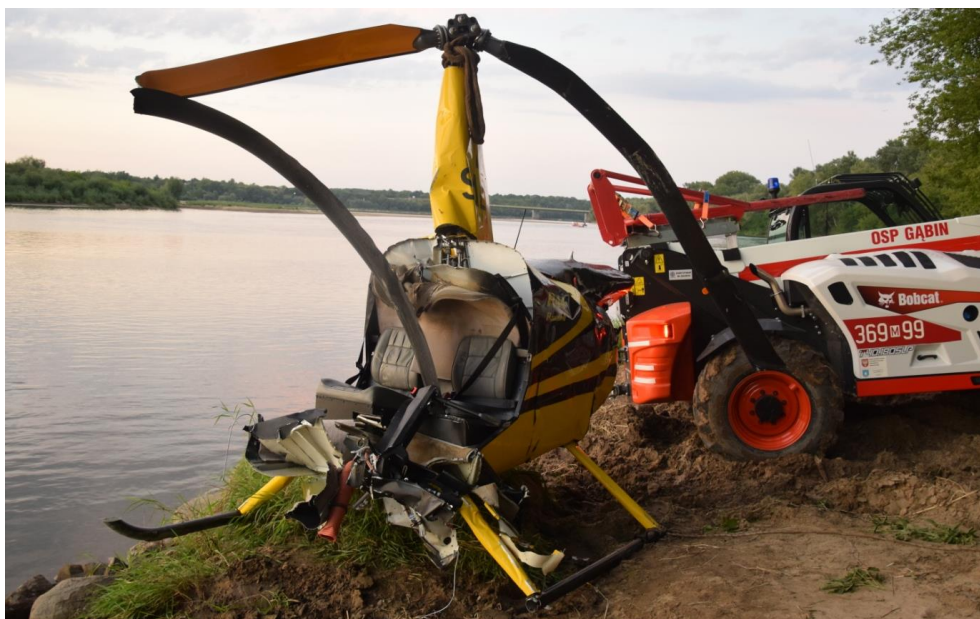
- front part of the cabin separation from the wreckage;
- destroyed cockpit separated from the cabin;
- main rotor mast deformation (from the base to the hub);
- deformation of the main rotor blades;
- deformation of the tail boom detached from the fuselage;
- deformation of the engine fairings ;
- front part of left skid break;
- destruction of the kinematic continuity of the helicopter flight control system.

Fig. 3. Helicopter wreckage after recovery from the river

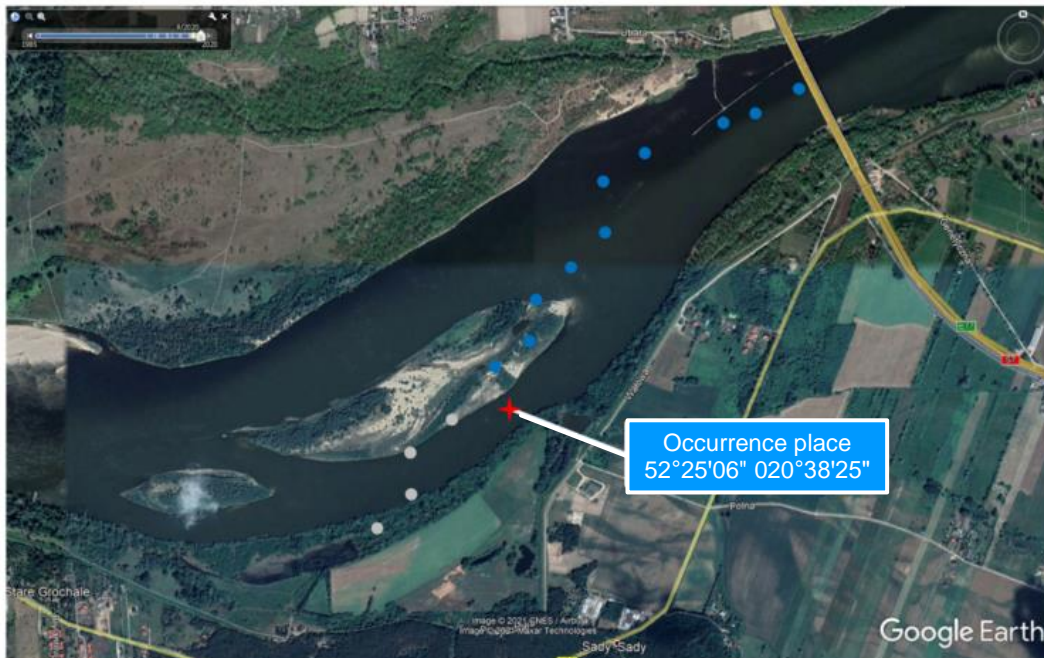
Fig. 17. Flight path recreated from radar markers (blue color). Predictive points calculated by the system (gray color) [source: Google Earth]

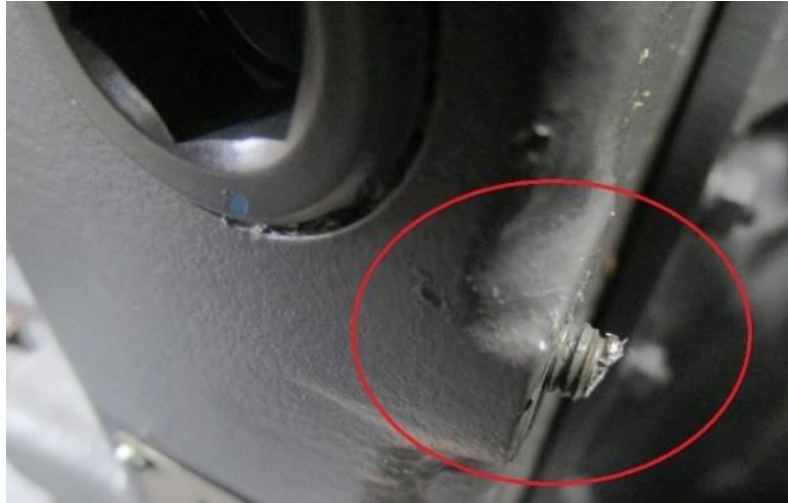
An external inspection of the engine revealed only a broken mounting of the oil sump.

Fig. 18. External engine damage

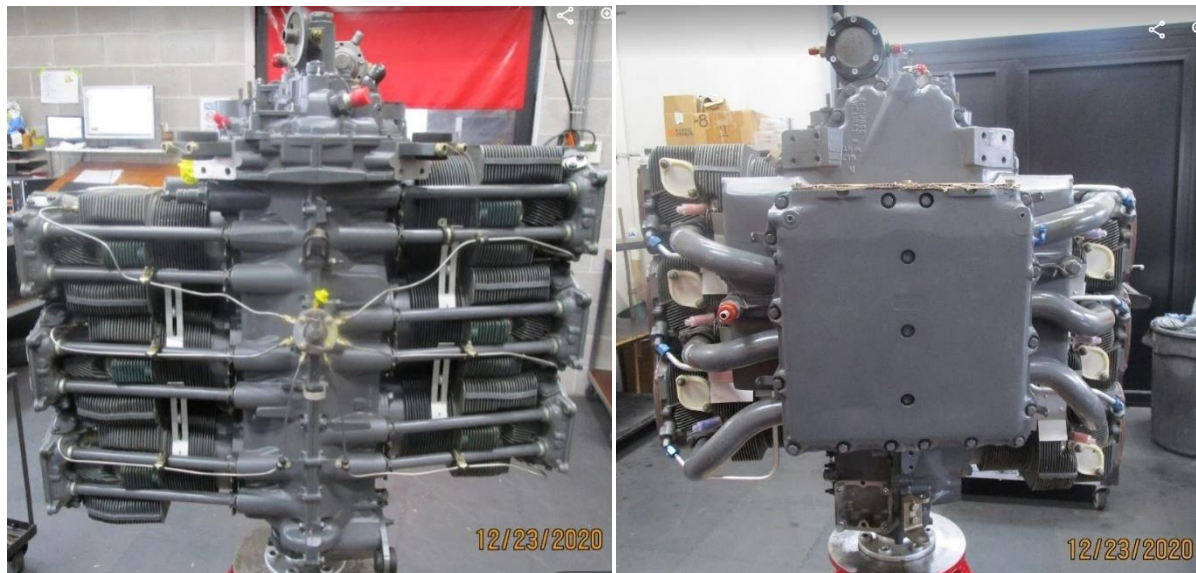
- no damage or excessive wear of cylinders, pistons, valves and valve guides, except for severe corrosion caused by water penetration into the engine<sup>3</sup>. Traces of sand (river silt) were also found in each cylinder;
- no damage or excessive wear of the camshaft, except for corrosion;
- no damage or excessive wear of the crankshaft. After non-destructive testing and verification, the crankshaft was reused in the engine being repaired;
- no excessive wear and no damage to the engine crankcase;
- no damage to the engine accessories.

Fig. 19. Engine ready for disassembly

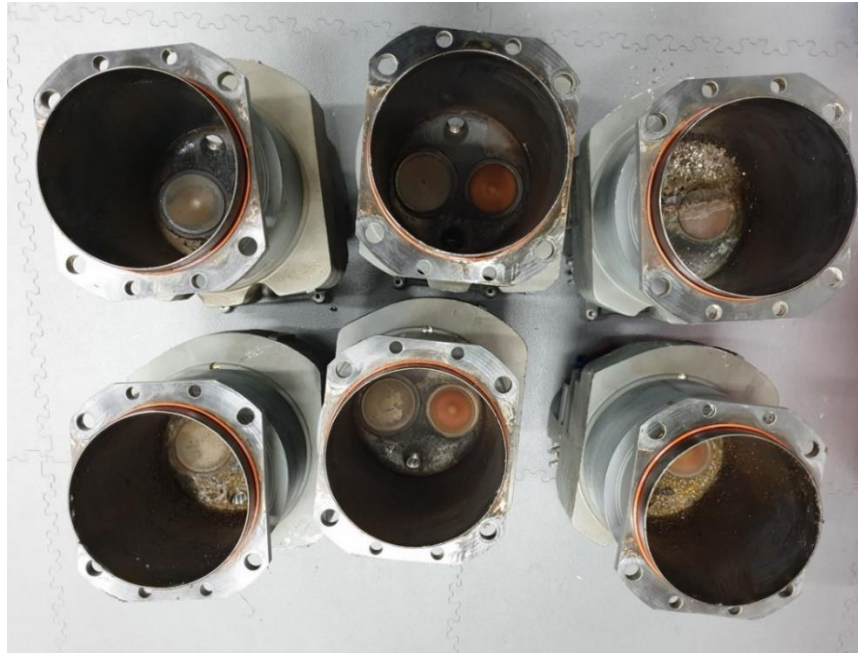
The inspection revealed that the engine was working properly until the collision with water. Water and traces of sand (river silt) were found in all cylinders and inlet manifolds. The presence of water, and especially sand, in all cylinders indicates that they were sucked through the intake system, i.e. the engine was running until the occurrence took place. As a result of water penetration into the engine and storage time of the wreckage, traces of corrosion appeared on most of the elements.

Fig. 20. Cylinders with signs of corrosion due to prolonged presence of water after accident

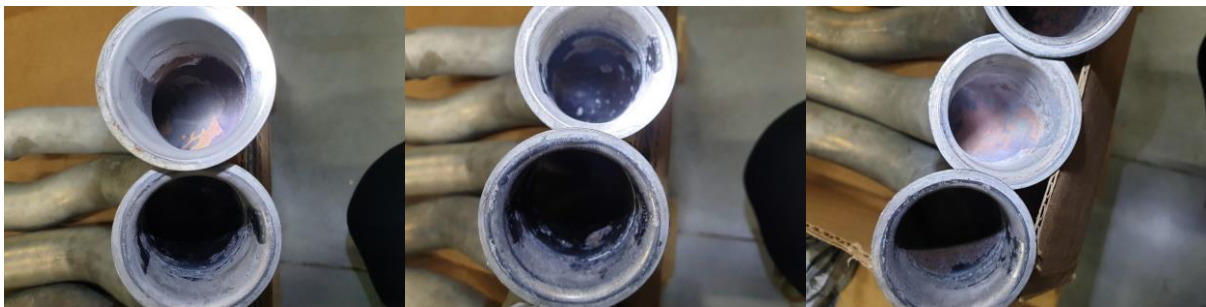
Fig. 21. Corroded engine inlet manifolds

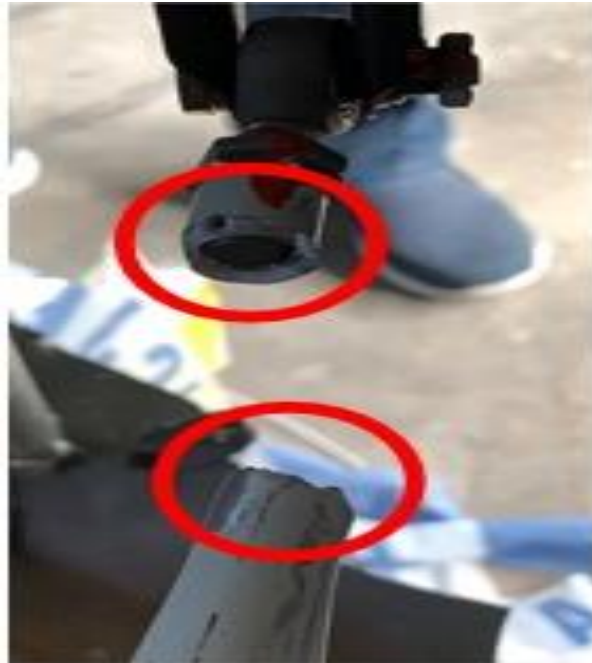
The kinematic lines were broken at the moment of the collision with water surface and the following destruction of the helicopter.

Fig. 22. Broken push-pull tube at the collective lever.

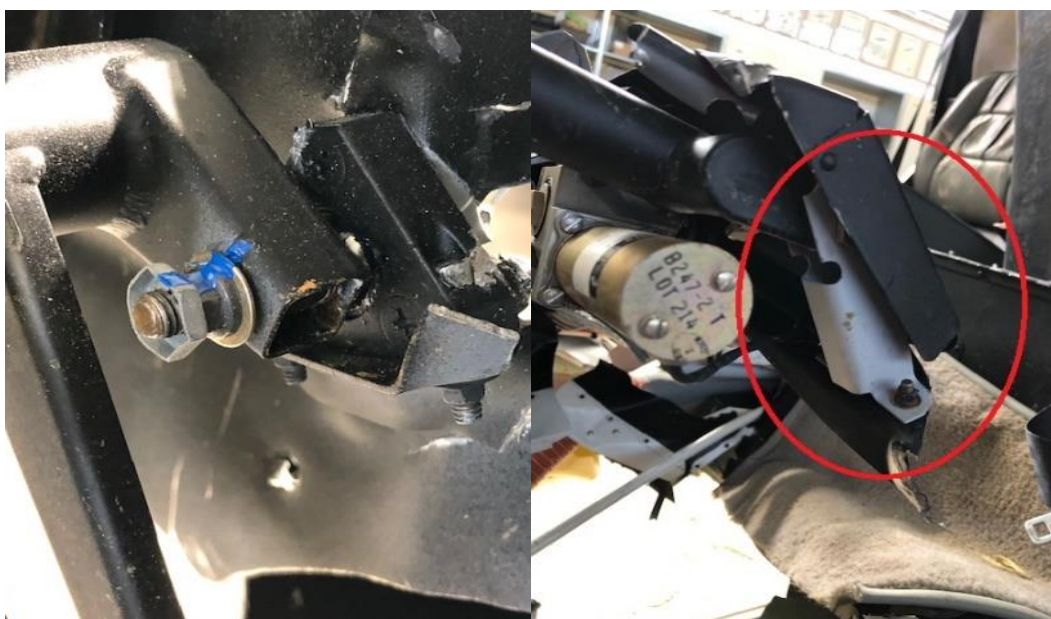
The mounting of the Aft Support Assembly and the dual system of the collective were not damaged.

Fig. 23. Collective suspension

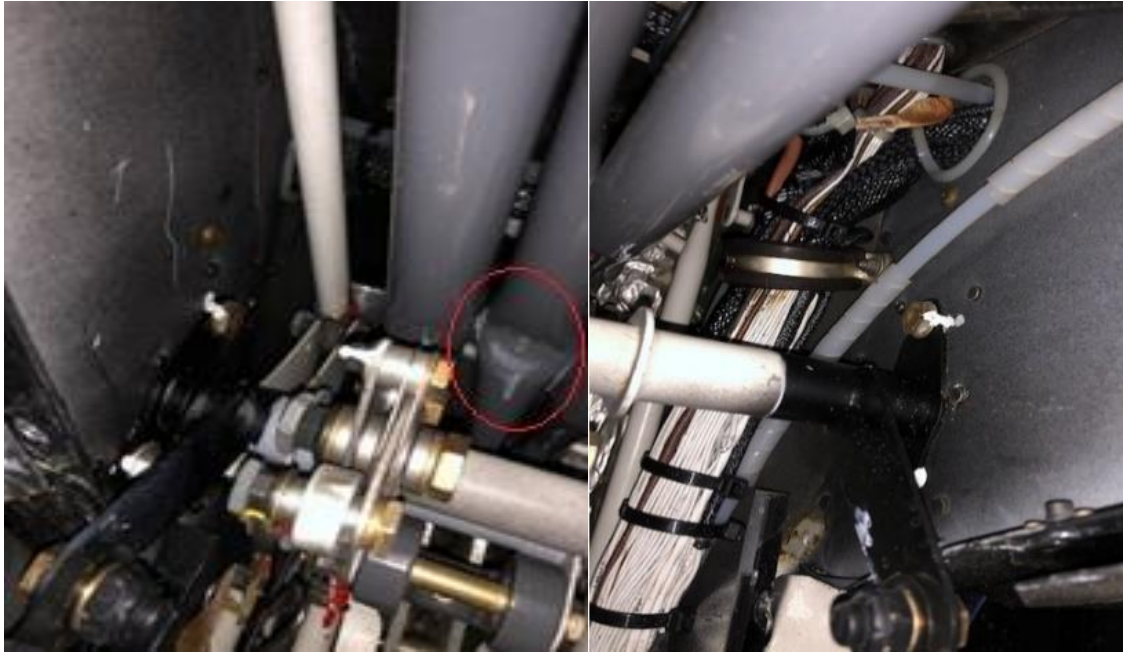
Fig. 24. The mounting of the Aft Support Assembly. Visible damage to the push-pull tubes resulted from the deformation of the fuselage during the collision

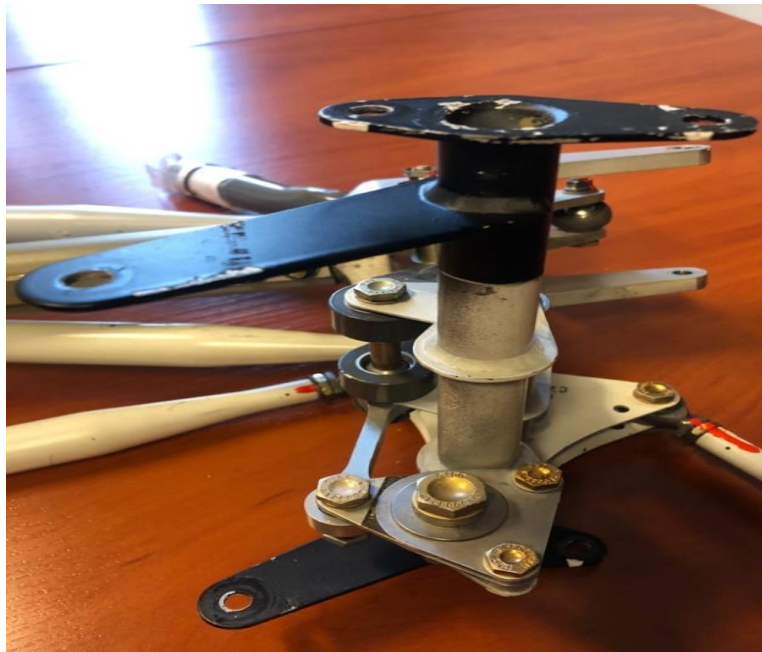
Due to the destruction of the helicopter structure, it was not possible to check the freedom of movement of the flight control system elements attached to the Aft Support Assembly. It was disassembled and tested in laboratory conditions. No damage to the elements was found, apart from the ones resulting from the impact with water. Functional test without concerns.

Fig. 25. Aft Support Assembly removed from the wreckage

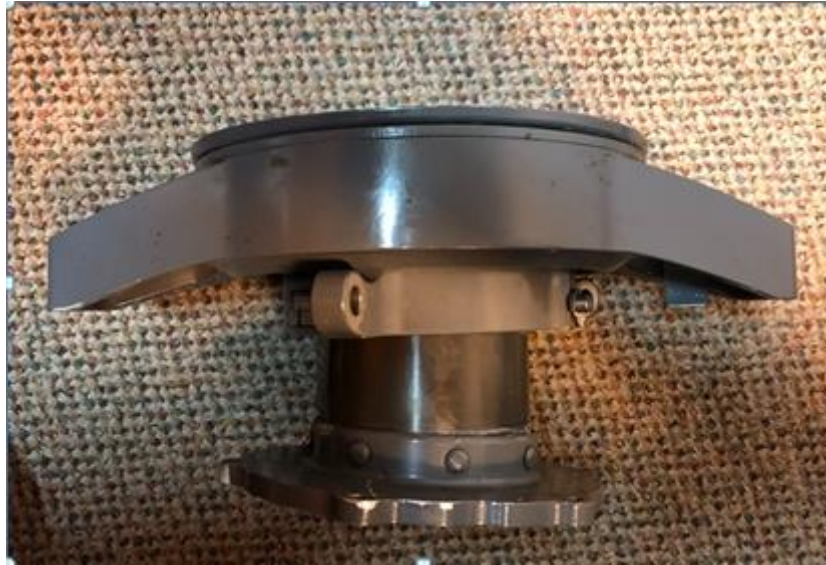
Fig. 26. The removed swashplate assembly with the sliding sleeve

- breakage of the mounting of the main rotor RPM sensor ;
- bending of the upper flange of the swashplate ;
- damage to the anodized layer of the sliding sleeve resulting from collision with the bolts of the swashplate;
- shearing 6 out of 8 rivets for securing the sliding sleeve to its base;
- bending of the upper part of the sliding sleeve;
- contamination of the entire assembly with sand.

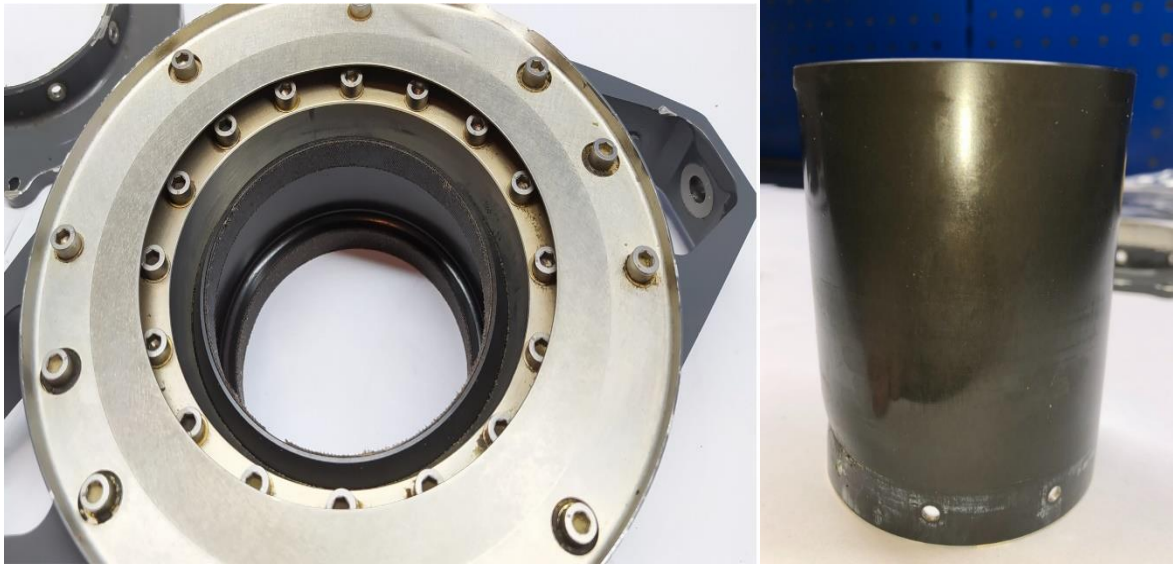
- no damage and no signs of wear of the teflon rings of the swashplate;
- no internal damage of the swashplate;
- no additional damage or excessive wear of the anodized sliding sleeve surface.

Fig. 27. The disassembled elements of the swashplate assembly

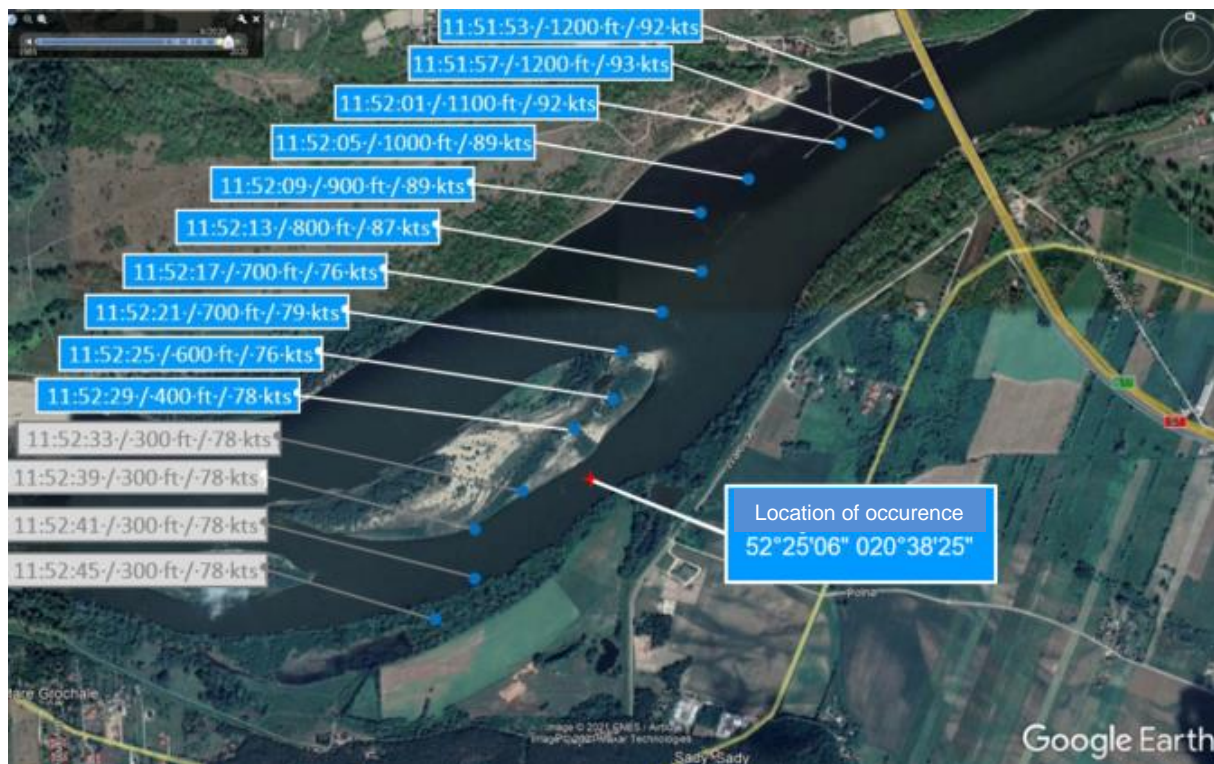
The screenshots from the secondary radar were analyzed and then transferred to Google Earth satellite maps. The radar recording allowed to reconstruct the helicopter flight path from the second take-off from FATO until the collision with the water surface. The following parameters of the helicopter were obtained: ground speed, altitude and geographical coordinates as a function of time. The accuracy of the radar altitude indication was 100 ft.

Fig. 28. Flight path with altitude descriptions (AMSL) based on radar recording

The recording also includes the predictive positions of the helicopter calculated by the system (items in gray).
