ACCIDENT 2020/3656

State Commission on Aircraft Accidents Investigation (PKBWL)

AIRCRAFT – Airplane, Cessna C-150, SP-KHD

DATE AND PLACE OF OCCURENCE – 24 November 2020, Brzóza

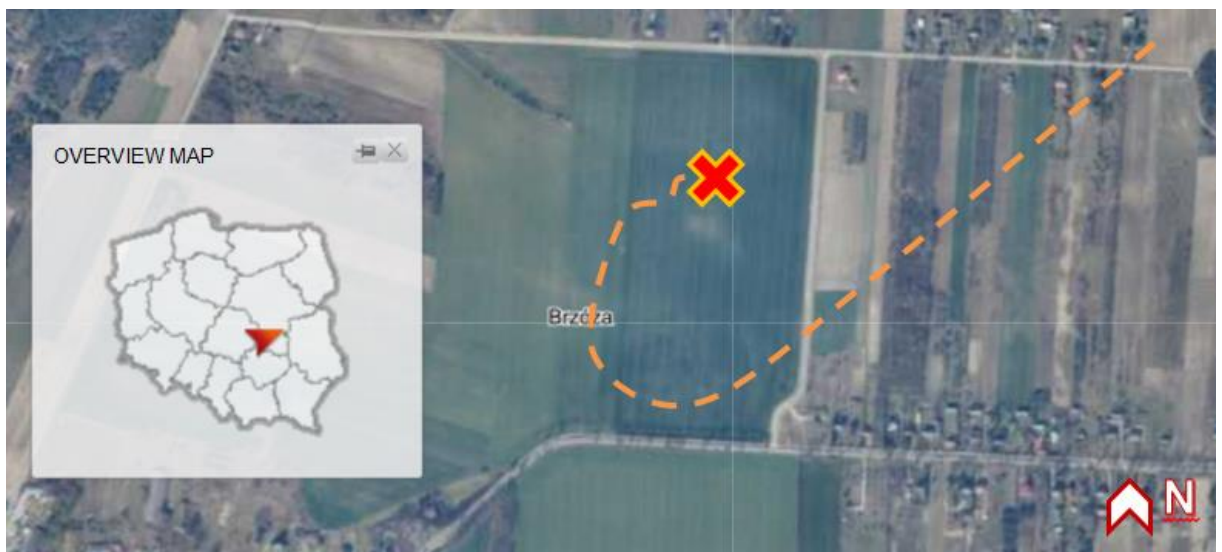
Fig. 1. Landing site – the probable flight path during off-field landing approach marked with dashed line, 1:10000 scale map [source: geoportal]

The student selected a field near the Brzóza village for landing, which she approached from a 180° turn. The landing was performed with tailwind. Just above the terrain, the student tried to deviate the flight path to the left to avoid a stone in front of her. Execution of a sudden manoeuvre at too low speed caused the aircraft to stall in the left turn, followed by uncontrolled touchdown and, consequently, a turnover. The marks left by the plane on the ground show, that the engine was not running at the time of the collision. The student could have adjusted the approach speed only by pitching the nose of the aircraft, but the attempt to avoid the obstacle led to an error in flying and the aircraft stalled during an emergency, off-field landing.
