Airprox, PZL-Bielsko SZD-51-1 "Junior", PH-980, Alexander Schleicher ASK 21, PH-1606, Venlo glider airfield, 22 October 2020

Classification: Serious incident
Reference: 2020096

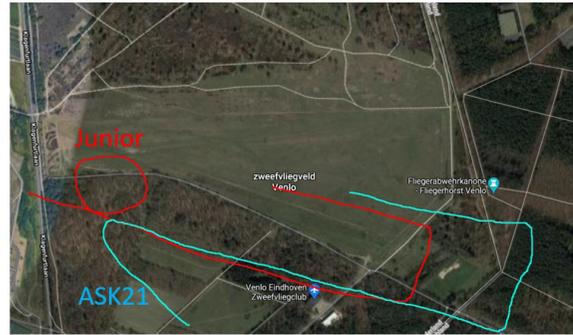
The Junior and the ASK 21 were simultaneously flying close to the circuit starting point to join the left-hand circuit for runway 29. Visibility was more than 10 kilometres. The Junior was flying at an altitude of 220 metres when the pilot observed the ASK 21 approaching from the right, at practically the same altitude. As a result, he felt obliged to initiate a 360 degree turn to the left, in order to avoid a collision between the two aircraft. The ASK 21 made a right-hand turn towards the downwind leg. The pilot of the Junior then followed the ASK 21 into the circuit and informed the occupants of the ASK 21 via the radio that he was flying behind them, low, and requested them to take the outside bend. Having received no response on the radio, on the base leg, he flew past and in front of the ASK 21. Both gliders completed a safe landing.

The pilot of the Junior stated that he had only seen the ASK 21 at the last moment, because the aircraft was approaching him head on. Previously, no movement of the ASK 21 had been visible to him, until the aircraft made a right-hand turn to join the circuit. In addition, from the point of view of the Junior, the visible surface of the ASK 21 was minimal. The instructor and trainee in the ASK 21 subsequently declared that they had not seen the Junior close to the circuit starting point. The minimal contrast between the white gliders and the pale blue/white sky (in the background) probably also represented a factor in the late observation or non-observation of the aircraft.

Flight paths completed by both gliders. (Source: Gliding club)

The airprox occurred because the pilots observed each other late or not at all, respectively. Thanks to the adequate evasive manoeuvre by the pilot of the Junior, a collision was avoided. In accordance with the right-of-way rules²⁰, he was also required to give way to the ASK 21, since it was located on his right-hand side, and both aircraft were at intersecting headings, at approximately the same altitude.
