FINAL REPORT

OCCURRENCE NO – 2021/345

AIRCRAFT – Helicopter, Bell 429, SP-KKS

DATE AND PLACE OF OCCURENCE – 22 February 2021, EPPY

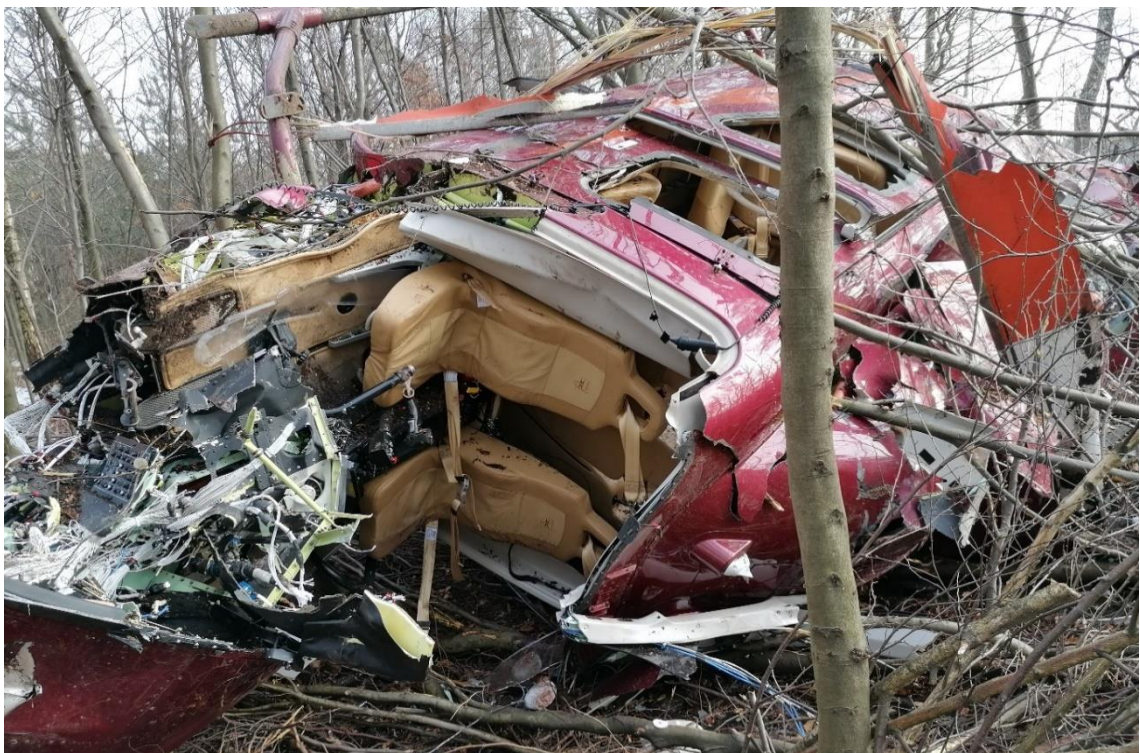
The Bell 429 helicopter was destroyed. The nature of the damage is shown in Fig. 1, 2, 3, 4. The nose part of the fuselage was crushed as a result of the impact with the ground. The main rotor of the helicopter was damaged after contact with trees, and then it was damaged after the helicopter overturned to the left side - the rotor blades were broken and separated from the hub. During the accident, the tail beam of the helicopter was separated from the fuselage. The detached tail boom was additionally broken in the area of the tail plane. One of the vertical stabilizers was also separated from the tail. The passenger cabin has maintained its integrity. No helicopter part detached inflight.

Fig. 1. Bell 429 helicopter fuselage at the accident site [source: PKBWL]

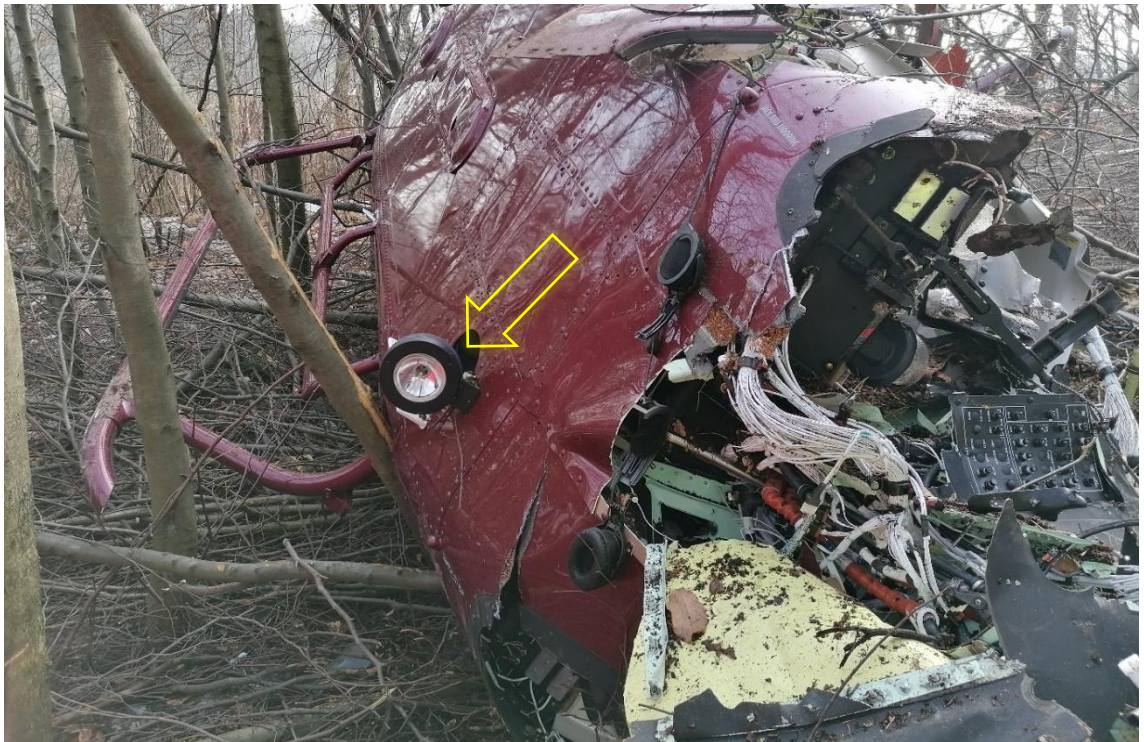
During the second attempt, the pilot turned on the landing light. According to the passenger's statement, the surrounding was "completely white", and a moment later the helicopter collided with trees and then with the ground.

Fig. 2. Bell 429 helicopter fuselage at the accident site – deployed landing light indicated by the yellow arrow [source: PKBWL]

During the second attempt to land, the pilot turned on the landing light, which, in the presence of fog, caused a temporary loss of visibility by the pilot (according to the passenger's statement, everything outside turned "completely white").

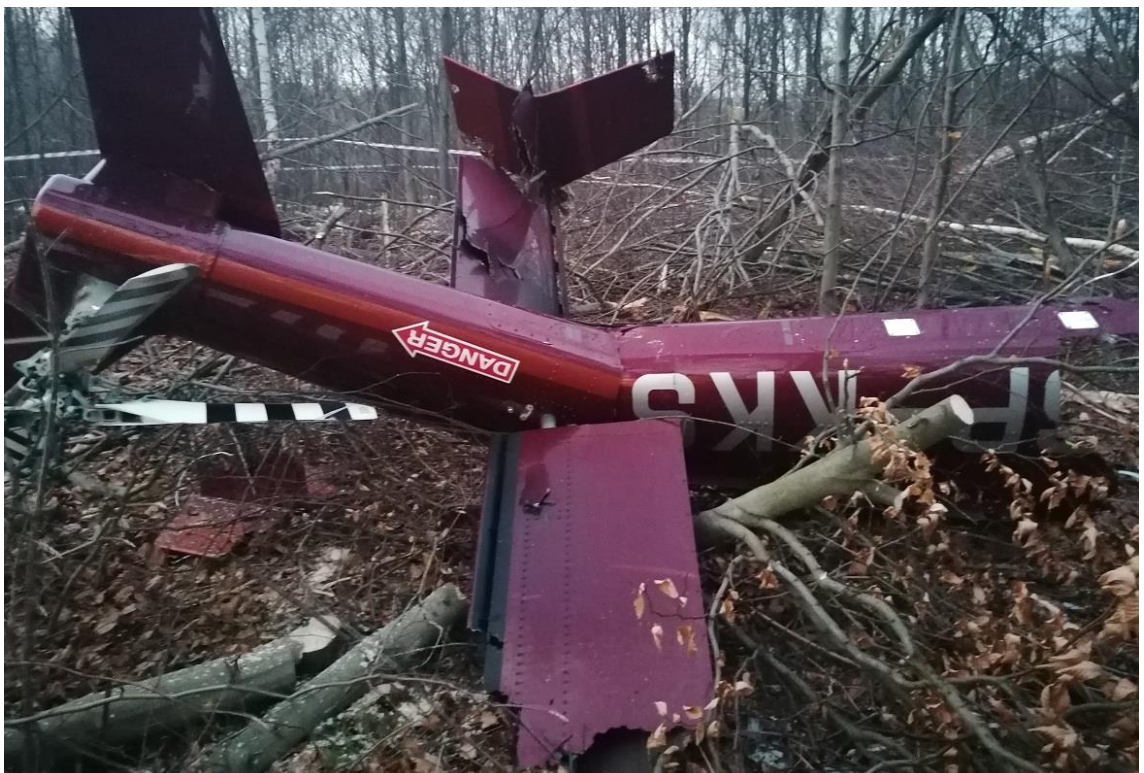
Fig. 3. Detached tail boom with tail rotor gearbox and blades [source: PKBWL]

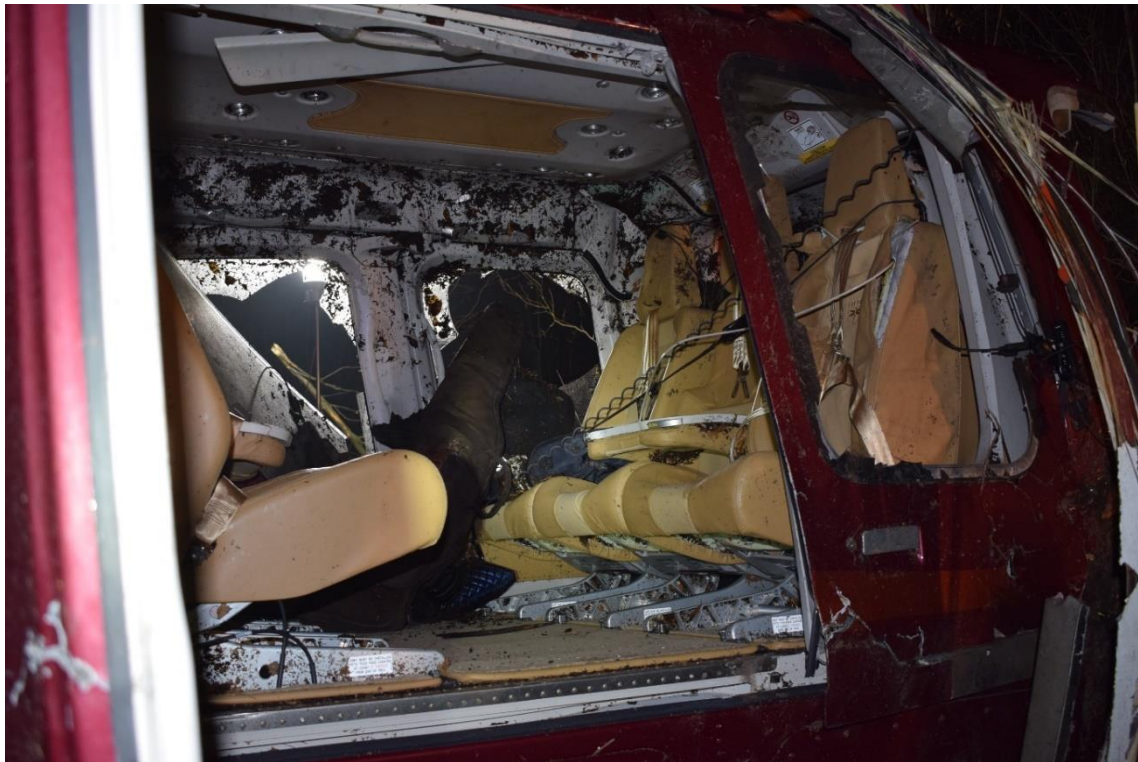
Fig. 4. Damaged cabin [source: PKBWL]

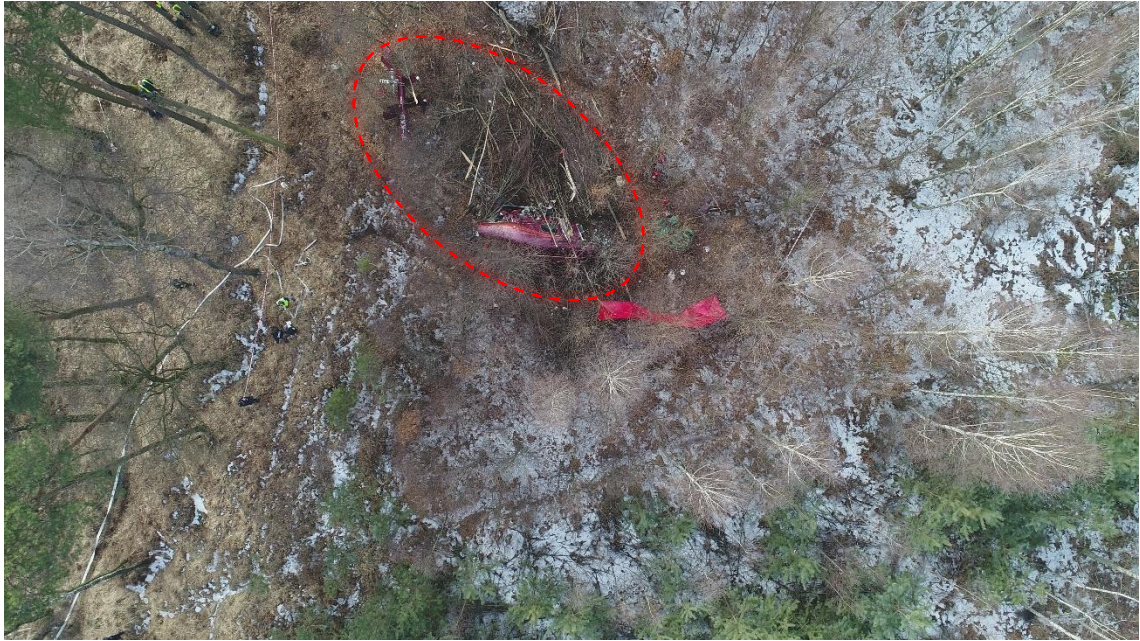
All the wreckage of the helicopter was found at the edge of the forest, in one area of several hundred square meters. No part of the helicopter was found to detach from it prior to collision with trees.

Fig. 18. Accident area – the red ellipse shows the dispersion of the main elements of the helicopter wreckage [source: PKBWL]

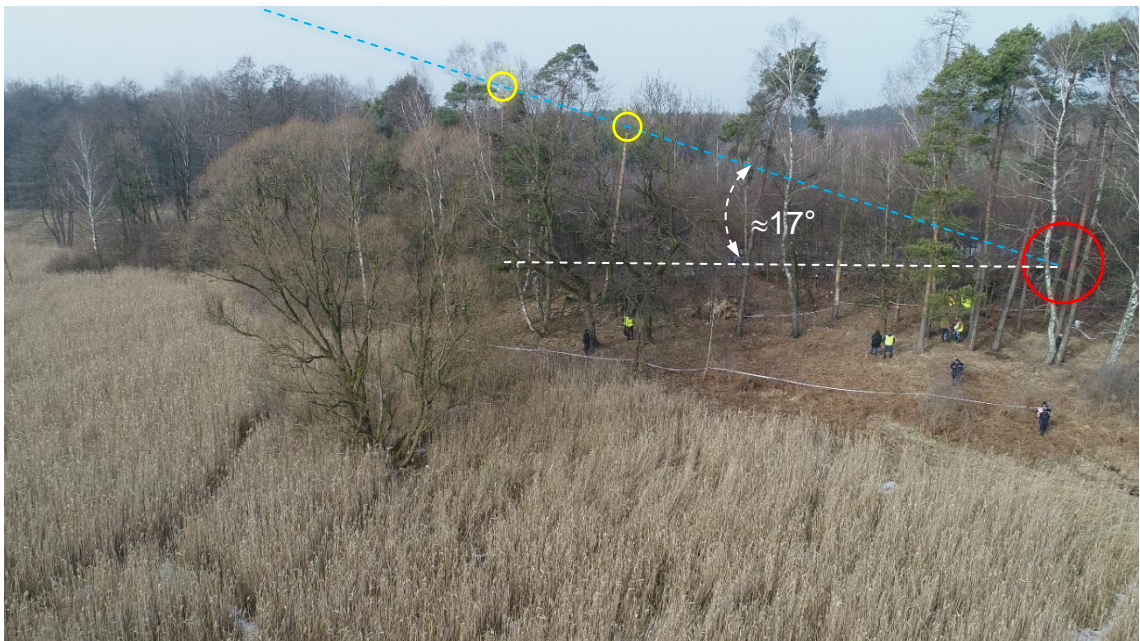
As a result of the collision of the main rotor blades with the trees (Fig. 19, 20), their tops were cut off at a height of about 14 meters. The young forest area of approximately 50 m² was also destroyed.

A few seconds before the accident, flying with a heading of about 270° , the helicopter made a right turn of about 160° in climb, and then, in a straight diving flight it collided with trees at a speed of about $GS \approx 50$ kt (Figs. 19 and 20).

Fig. 19. Accident site – vertical plane through the helicopter flight path: the blue dotted line connecting two boughs with cut tops (yellow circles) shows the angle of descent (about 17°), the helicopter wreckage is marked with the red circle [source: PKBWL]

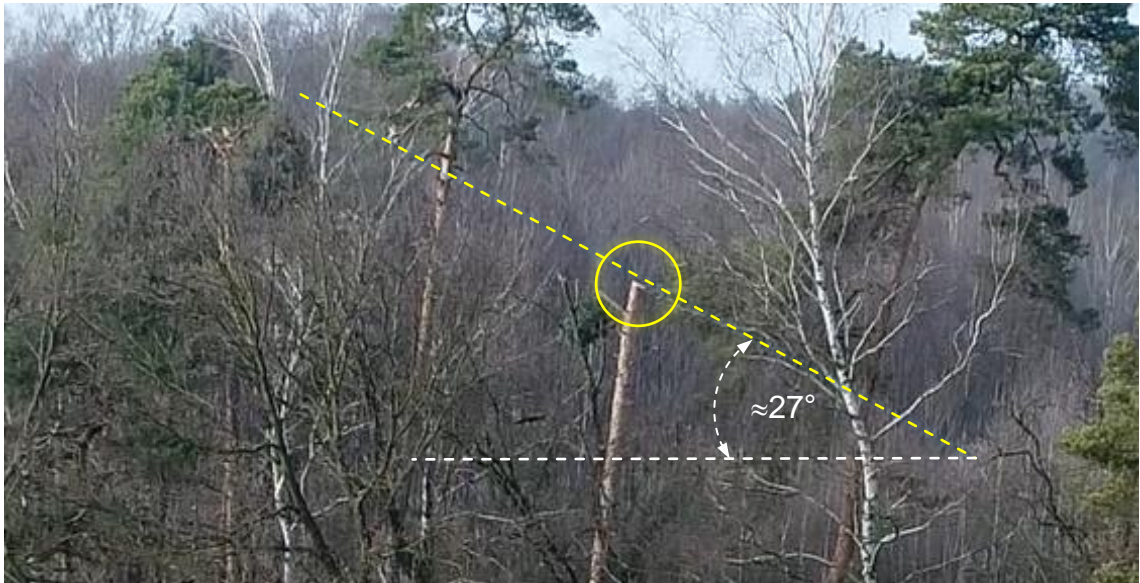
Fig. 20. Accident site – close-up of the cut bough (yellow circle) with the cutting plane marked (dashed yellow line) at an angle of approx. 27° [source: PKBWL]

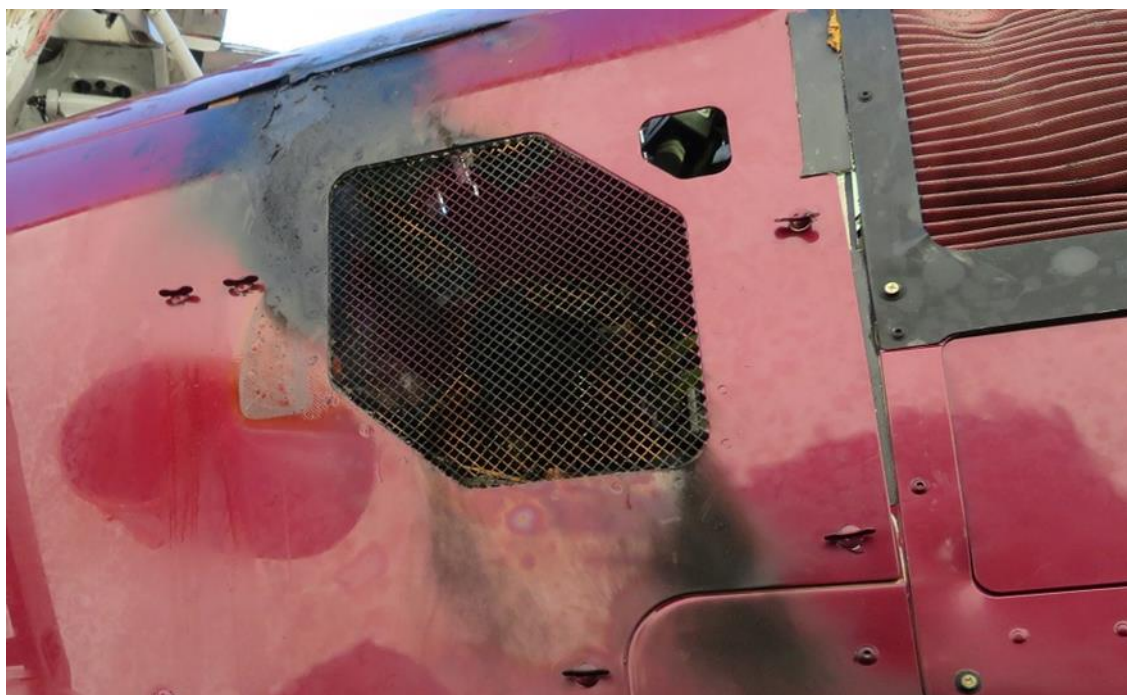
Fig. 21. Signs of fire found in the area of the left engine cowl [source: PKBWL]

The source of the sooting of the left engine cowl was an oil leak from the damaged oil system on hot engine parts. The nature of the damage is shown in Figs. 21, 22 and 23. The fire extinguished by itself.

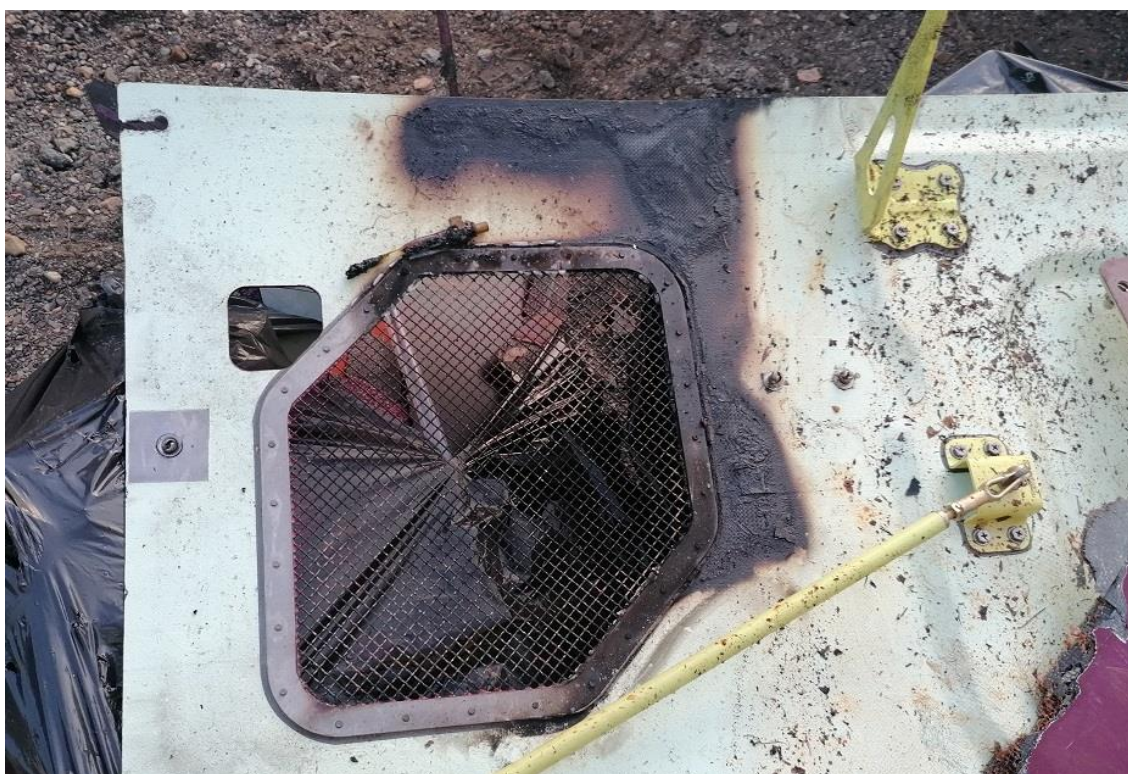
Fig. 22. Left engine cowl [source: PKBWL]

The composite, left engine cowl was partially burnt. Signs of fire in the form of soot and burning of fuel line covers were also revealed.

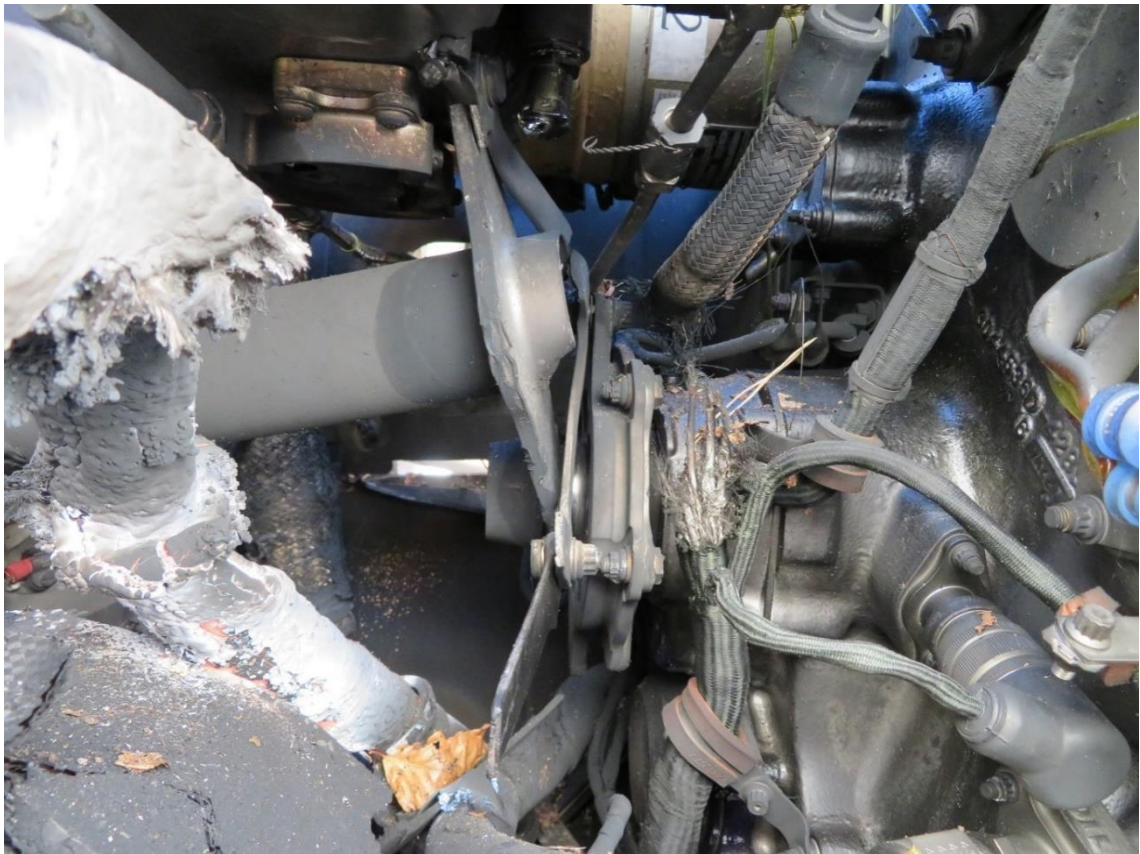
Fig. 23. Signs of local fire in the area of the left engine - view after the engine cowl removal
[source: PKBWL]

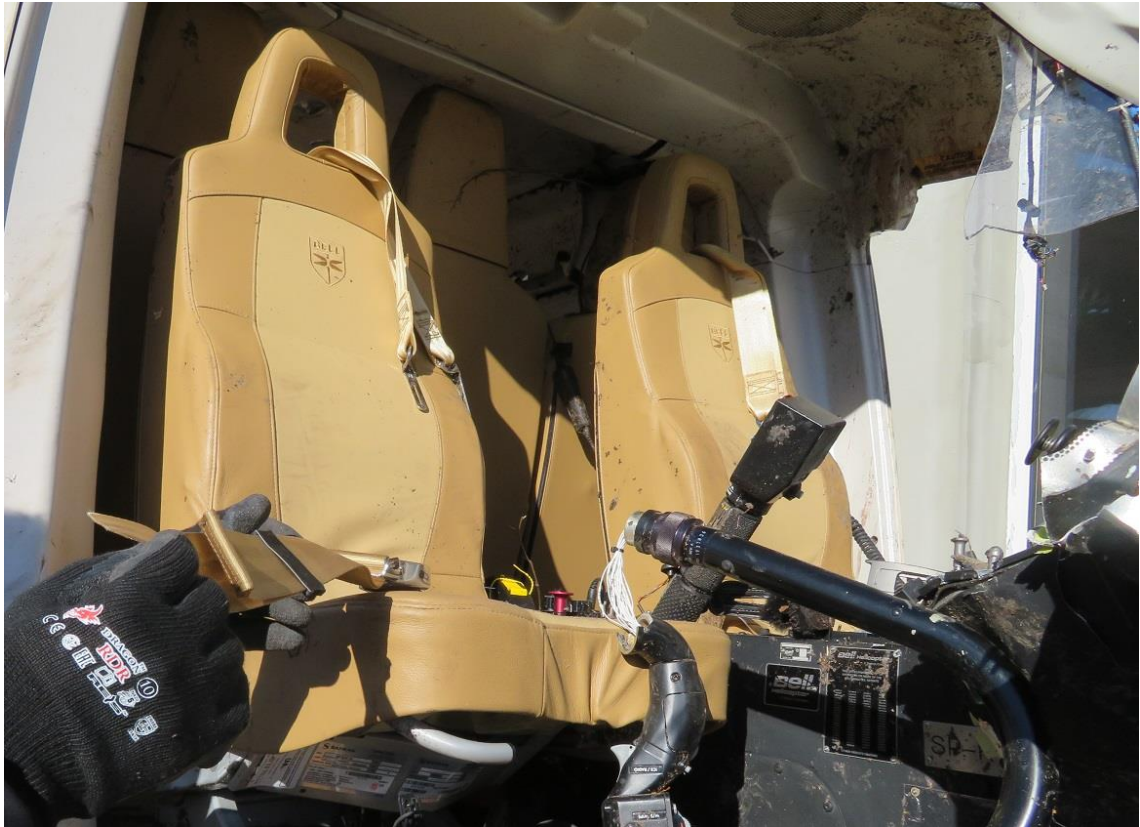
All seats inside the helicopter were in good condition after the accident. The brackets attaching the seats in the cockpit to the floor were partially deformed. It proves that the structure of the seats absorbed some of the energy of the helicopter collision with the ground.

Fig. 24. Bell 429 cockpit seats after the accident [source: PKBWL]

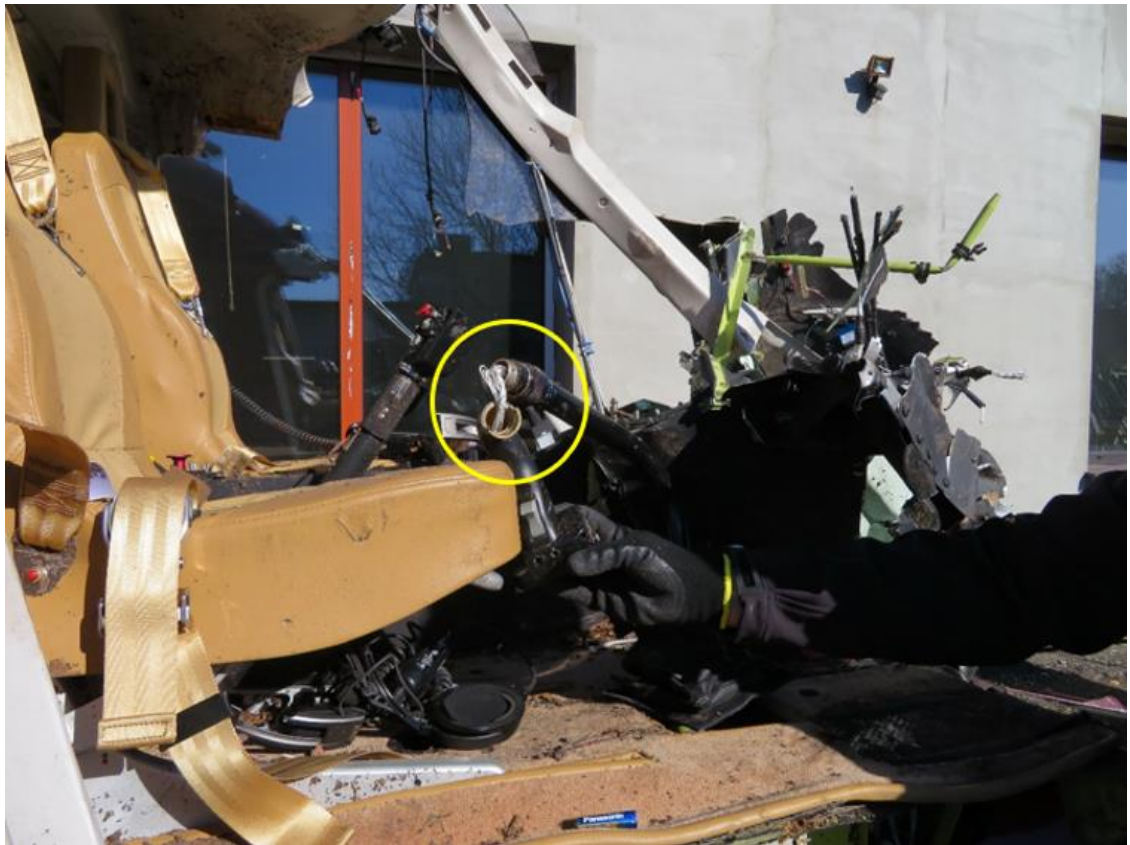
Fig. 26. Pilot's seat: visible, broken control stick, marked with a yellow circle. [source: PKBWL]

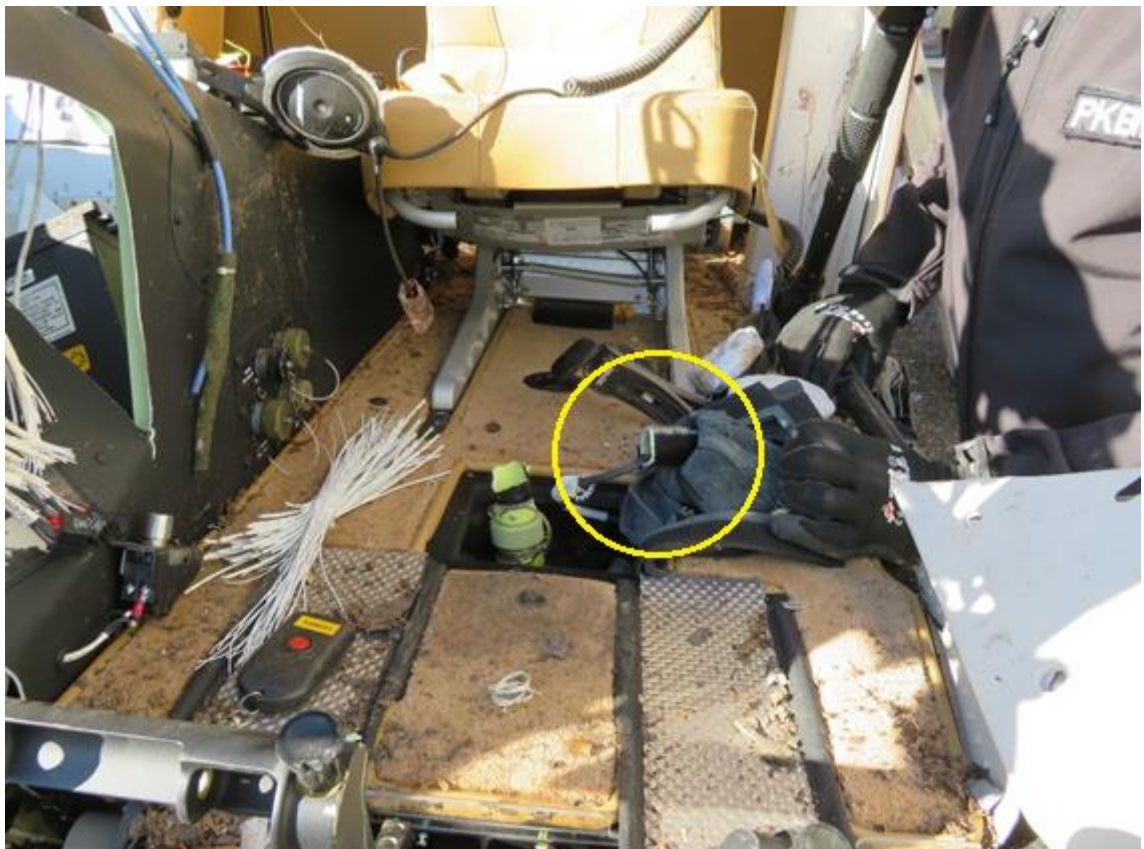
Fig. 27. The front passenger's seat: visible, broken control stick, marked with a yellow circle. [source: PKBWL]
