FINAL REPORT

OCCURRENCE NO – 2021/1052

AIRCRAFT – Airplane, EV-97 Eurostar SL, OK-YUA98

DATE AND PLACE OF OCCURRENCE – 9 May 2021, EPMX

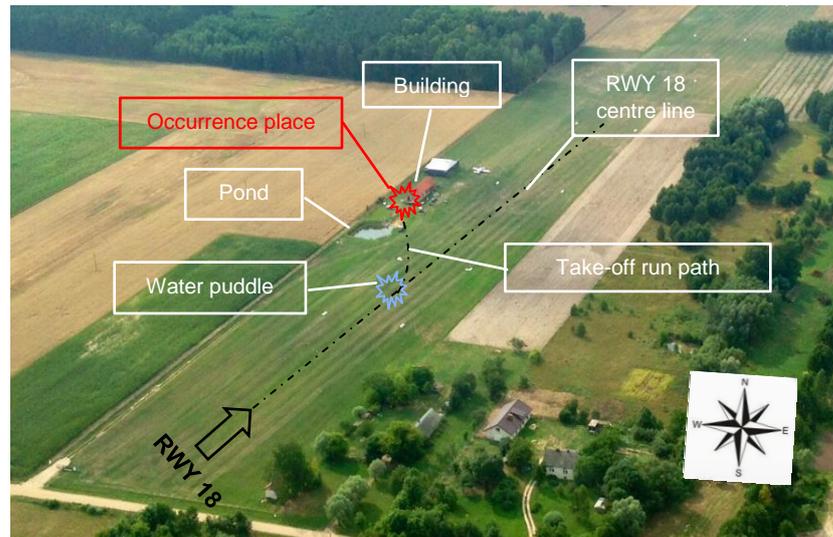
Fig. 1 Milewo Aerodrome (EPMX) – occurrence situational scheme. The intended take-off direction and movement path after loss of direction during take-off run is shown. [source: Internet]

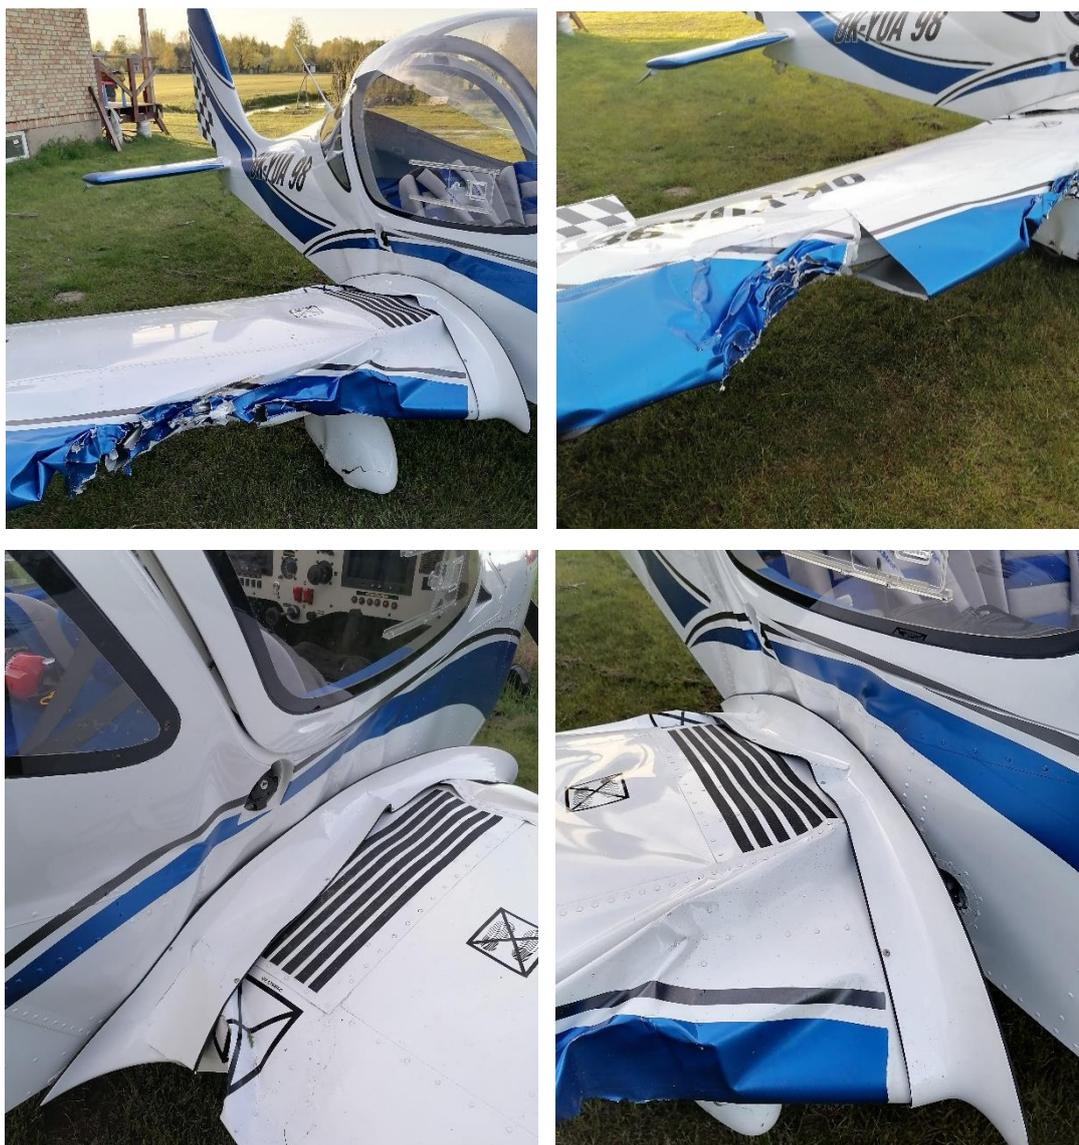
The aircraft was substantially damaged (Fig. 2)

The right wing and its mounting, the propeller were damaged. The fuselage structure, horizontal stabilizer, elevator and landing gear were seriously damaged. The engine was qualified for maintenance check.

Fig. 2 Aircraft damage caused by collision with building [source: PKBWL]

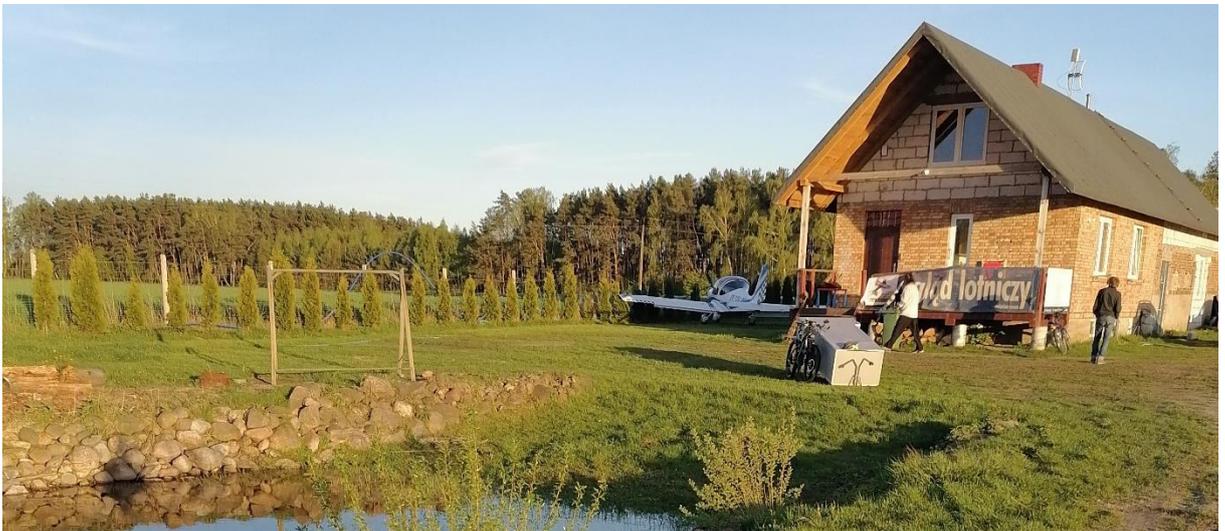
During take-off run on RWY 18, still below rotation speed, the aircraft hit a vast puddle of water. The airplane lost take-off direction and turned left, towards the pond and the building. At full take-off power the aircraft bypassed the pond and the right-wing tip collided with the against the terrace balustrade, while the wing torsion box hit the vertical beam supporting the roof of the building (Fig. 3). Then the airplane made a full vertical rotation and rested on the property's fence, damaging it. The engine of the plane stopped and there was no fire.

Fig. 3 Aircraft position after collision with the building and fence [source: PKBWL]

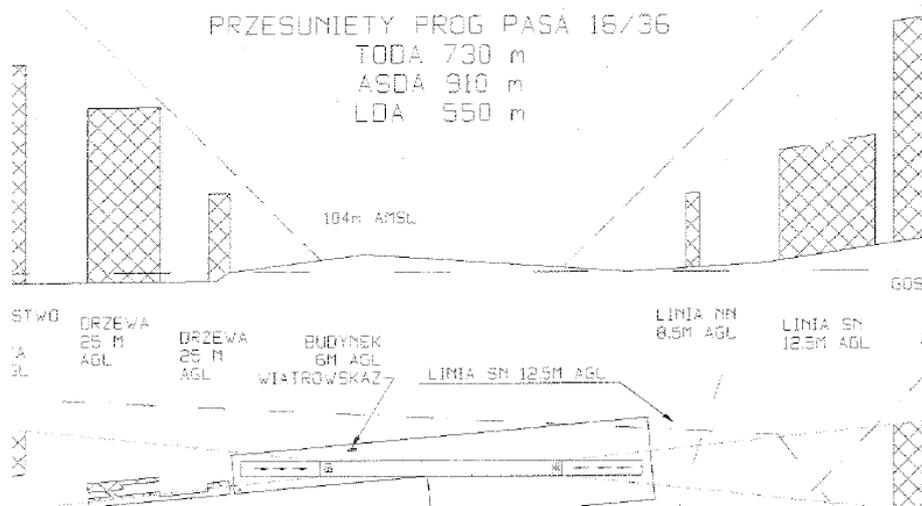
The grassy runway of the EPMX aerodrome is situated in the direction of 180/360 degrees and has longitudinal ditches to the east and west side (Fig. 4). The drainage of rainwater consists only in its dripping under the influence of gravity, and the unevenness of the runway surface may create local puddles.

Fig. 4 Profile of the EPMX runway. [source: aerodrome operational manual, http://milewo.pl/milewo/docs/IUL_Milewo_BW.pdf]

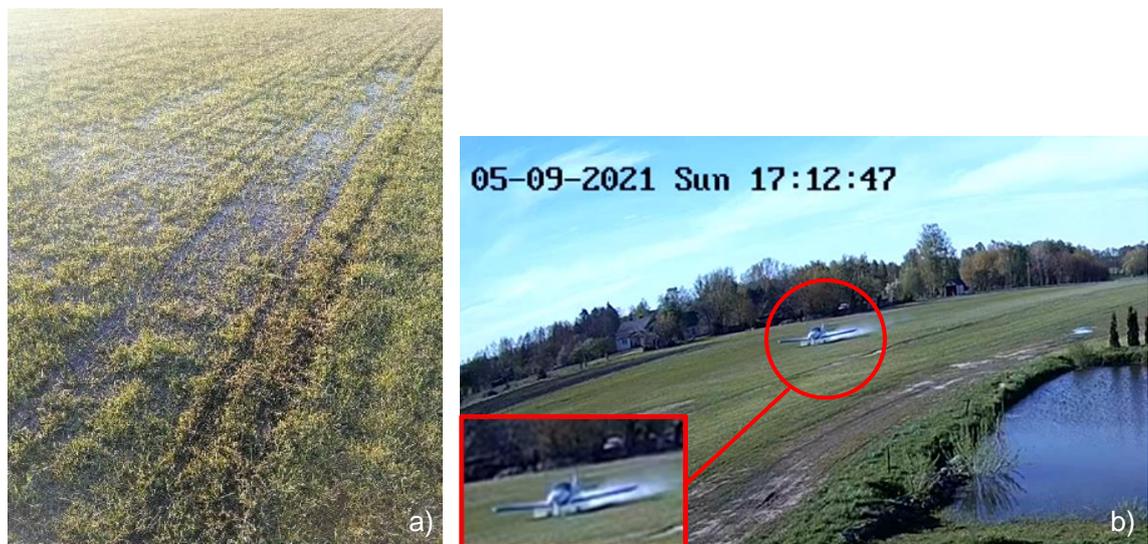
On the day of the accident, a puddle of water softening the surface, covered about 1/3 of the runway length from the runway 18 threshold, centrally in the take-off run direction (Fig. 5).

Fig. 5 a) Puddle of water on the runway and visible wheel tracks of airplanes on the day of the accident; b) Aircraft take-off. In the zoomed-in frame, a splash is seen during the aircraft movement through the puddle [source: PKBWL]

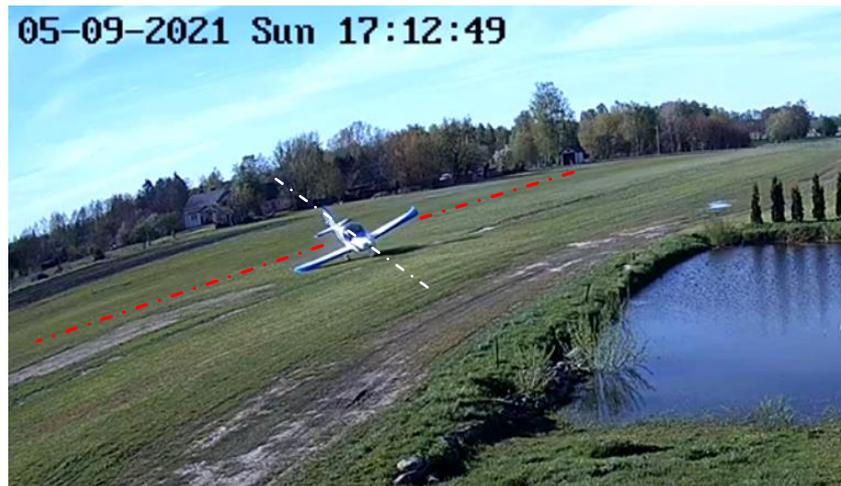
a temporary slowdown, aquaplaning⁴ occurred, and the plane - under the influence of the propeller torque - began to turn strongly towards the pond and buildings, changing its direction by about 45 degrees. During and just after passing the puddle, the pilot did not prevent the loss of direction. First of all, he did not abort the take-off, despite such a significant disturbance of its trajectory occurred. The first and only applying of the rudder is observed only 9 seconds after the start of the take-off (Fig. 6). It is firm, full and combined with the aircraft rolling to the right wing, which is the result of the of a centrifugal force occurring during direction change (in a turn). The airplane rolled and the right-wing tip hits the runway surface, which is seen on the video (Fig. 6).

Fig. 6 The aircraft rolling on the wing after losing direction. The dashed red line shows the correct, but not maintained take-off run direction [source: PKBWL]

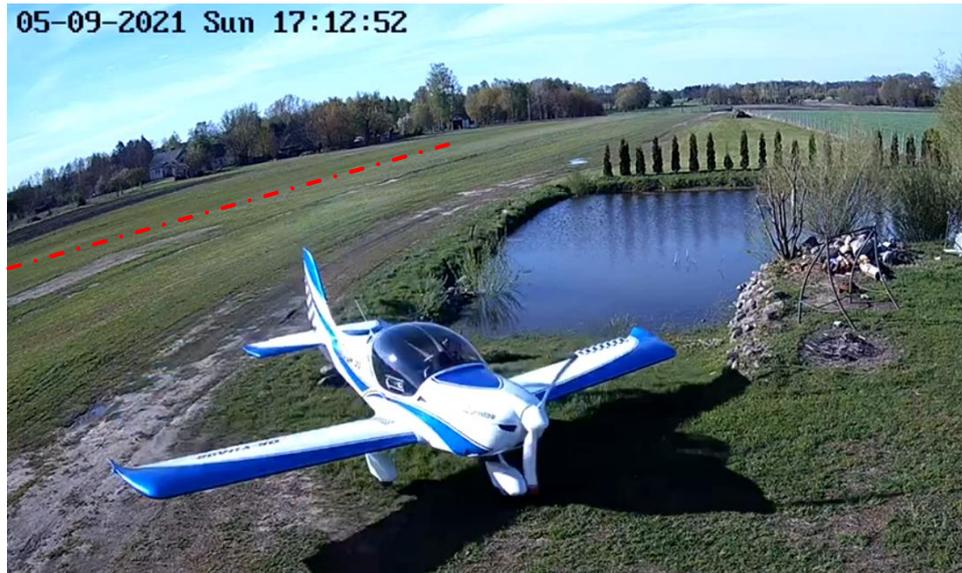
Fig. 7 Moments before the collision with the building: the applied left upper aileron and neutral rudder is visible [source: PKBWL]

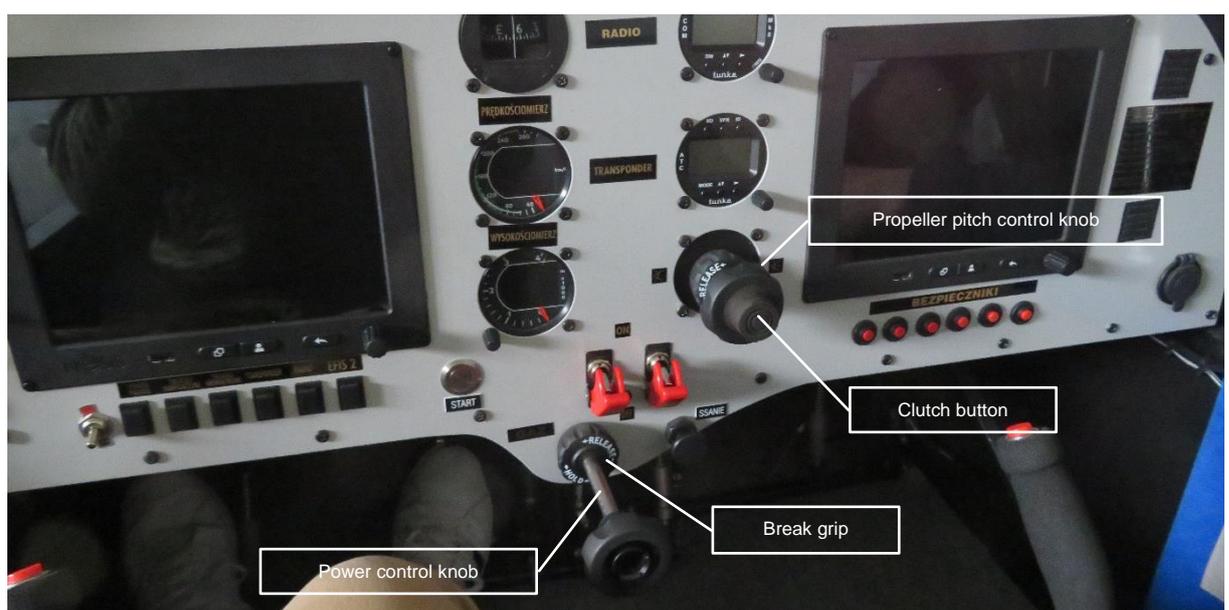
In the accident aircraft, the manufacturer equipped both knobs (propeller pitch control and power control) with brake mechanisms, allowing the position of the knob to be set in any position desired by the pilot (Fig. 8). The brake grip is located at the base of each knob, in the plane with the instrument panel.

Over tightening the brake makes it difficult or impossible to move the knob as long as the clutch release button is not pressed and held. Despite the twisted brake, the design of the knob allows precise forward/backward movement. However, this system does not work when a quick and extensive reduction (or increase) of rotation is required.

Fig. 8 Power control and propeller pitch control knob location on the instrument panel of EV-97 Eurostar SL aircraft [source: PKBWL]

By setting the power control knob to the maximum forward position (pressed knob) for take-off, it is highly probable that the pilot set it while applying the brake on the knob, or did not loosen the brake before initiating take-off. The take-off took place under full power (take-off power) conditions. The footage from two CCTV cameras shows that the pilot, when approaching the building and during collision, had his right hand on the power control knob. However, he did not withdraw his elbow (no backward movement of the hand) in order to reduce the rotation.

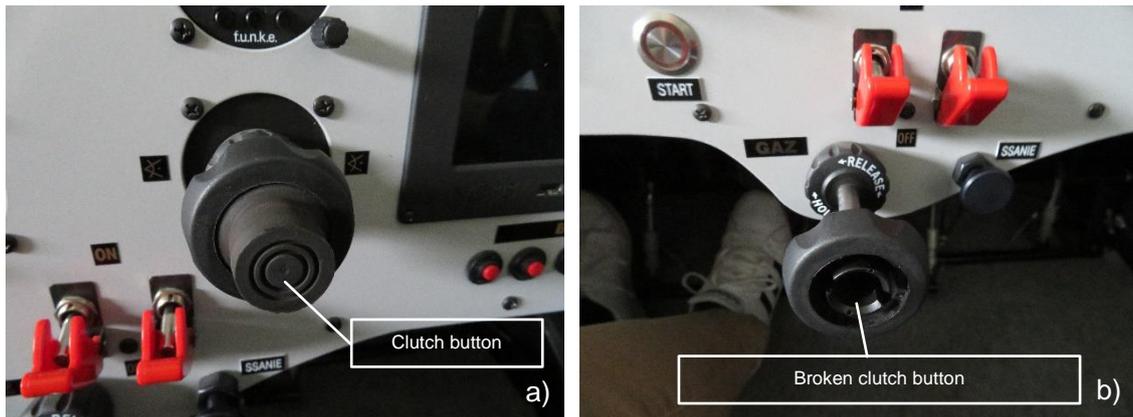
The fact that he could have had problems with pulling the knob is evidenced by the fact that - when struggling with it - the button for quick unlocking it broke off (Fig. 9).

Fig. 9 Knobs: a) not damaged (propeller pitch control), b) damaged (power control)

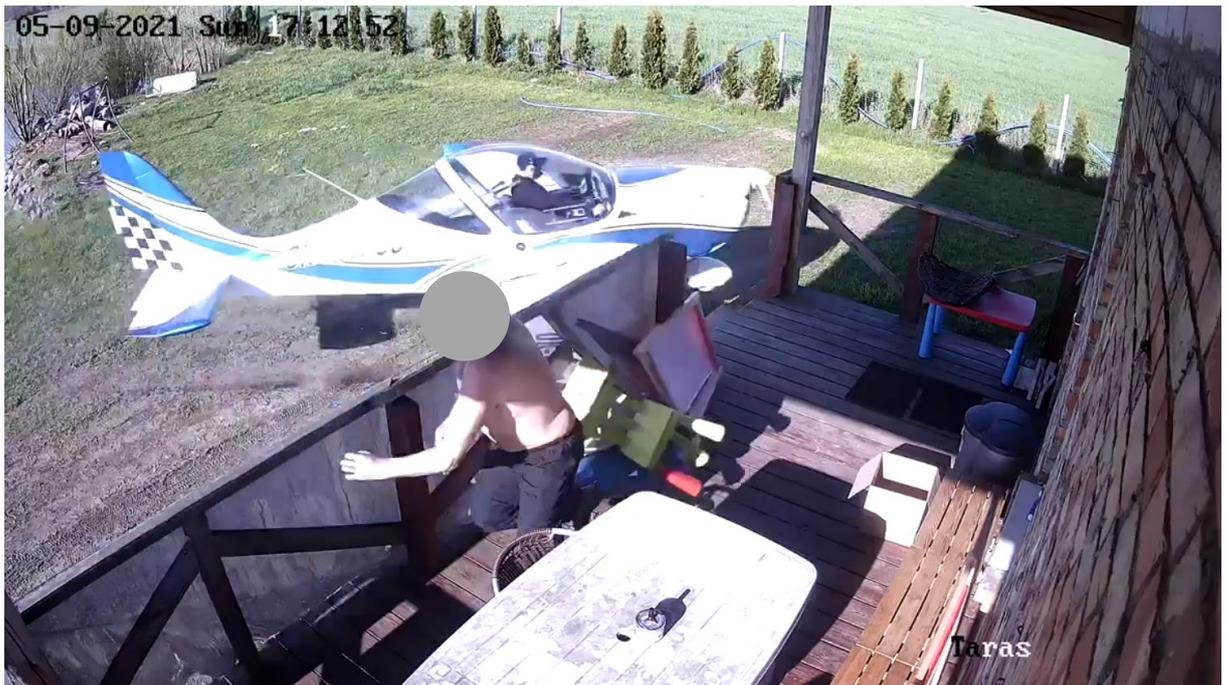
The direct cause of the accident was failure to control the aircraft during the take-off run phase, after a disturbance – passing through a large puddle, aquaplaning and loss of direction. Each of these factors should have determined the pilot to immediately abort the take-off and take all possible measures and efforts to avoid collision with obstacles on the aerodrome, that could result in the most serious consequences. These could be at least injuries of bystanders (Fig. 10) and a fire (including a building fire) that did not occur.

Fig. 10 A man was on the terrace during the collision with the building. The video recording shows the slight distance between the wing and this person. [source: PKBWL]
