# FINAL REPORT

## INCIDENT

OCCURRENCE NO – 2021/1141

AIRCRAFT – SR22 / UR-ISA, AT-3 R100/SP-RWF

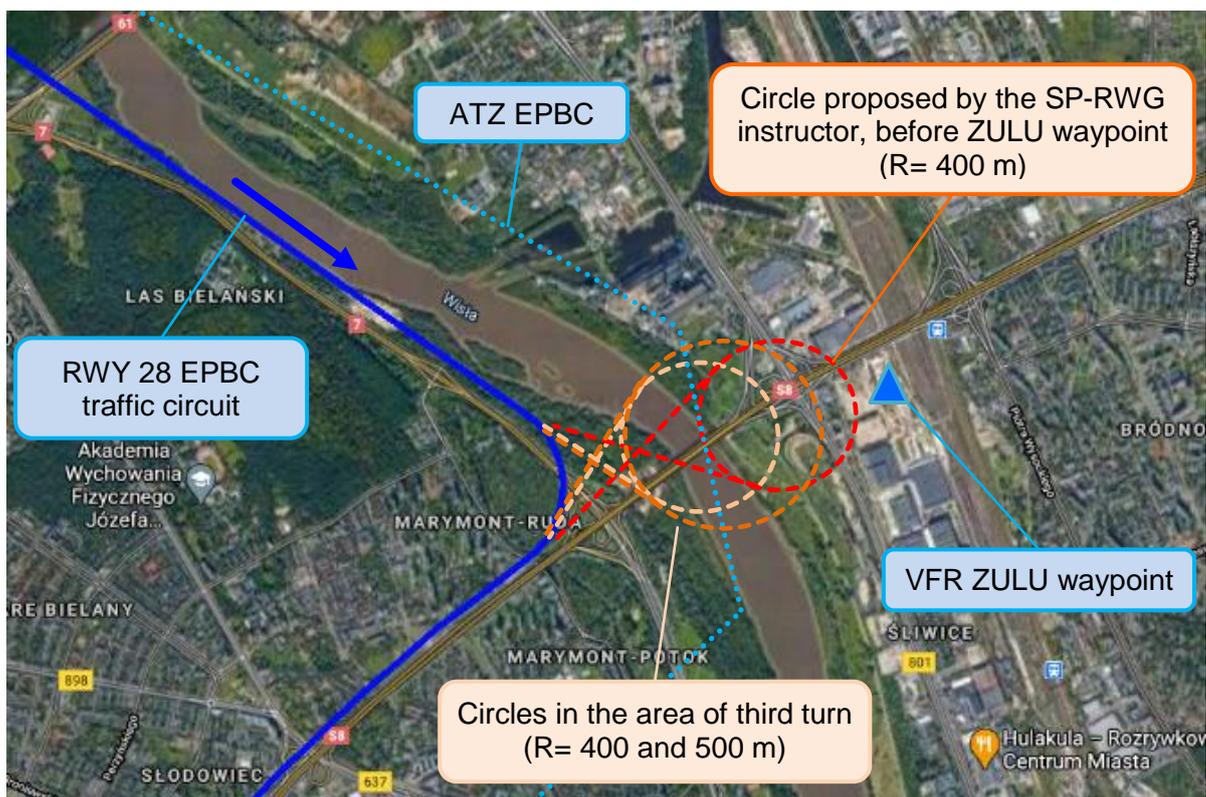
During the investigation of the incident, the SP-RWG instructor stated that for safety reasons, while performing a circuit flight, he does not wait and would not wait in any turn, especially over the EPBC aerodrome, which is characterized by exceptionally dense aircraft traffic. Moreover, he stated that if he had to make a circle to maintain the separation, he would have exited the circuit and make it in the area of the ZULU waypoint, keeping close to the northern side of the Vistula river until it was possible to join the circuit with a safe separation (Fig. 5).

Selection of such area for a circle would mean that an aircraft would be between the third turn of the circuit to RWY 28 and the ZULU VFR waypoint, on or near the EPBC ATZ boundary. This would mean making a circle in the place where aircraft leaving the circuit and arriving from the VFR ZULU waypoint to the third turn would routinely pass. For safety reasons, such a solution is unacceptable.

Fig. 5 Circling flight lap locations maintaining the separations between aircraft in the EPBC aerodrome traffic circuit – RWY 28 [source: internet, Google Earth, PANSA]
