# FINAL REPORT

OCCURRENCE NO – 2021/1985

AIRCRAFT – Helicopter, Robinson R44, SP-CCC

DATE AND PLACE OF OCCURRENCE – 6 July 2021 r., Mikołajki

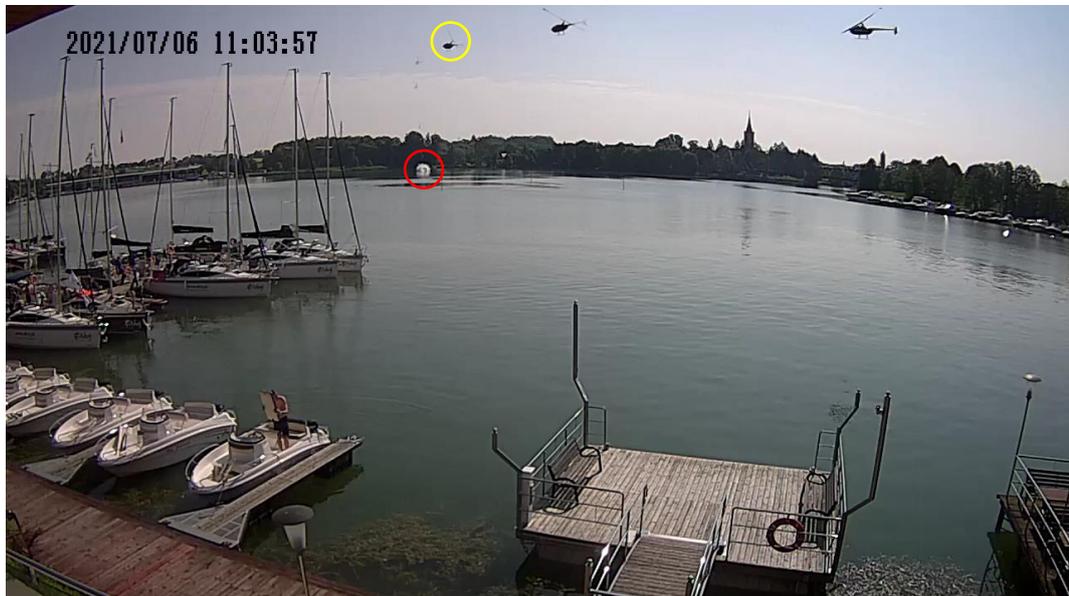
**Fig. 1.** Robinson R44, SP-CCC – course of the accident (time-lapse photos combined into one image); the yellow circle marks the position of the helicopter when the engine stopped, the red circle marks the place of the collision with water [source: CCTV camera of Gołębiwski Hotel in Mikołajki]<sup>3</sup>. Note: the recording time in the upper left corner is incorrect.

The course of the accident was recorded by CCTV cameras installed at the Gołębiewski hotel in Mikołajki – the time-lapse recording is shown in Fig. 1.

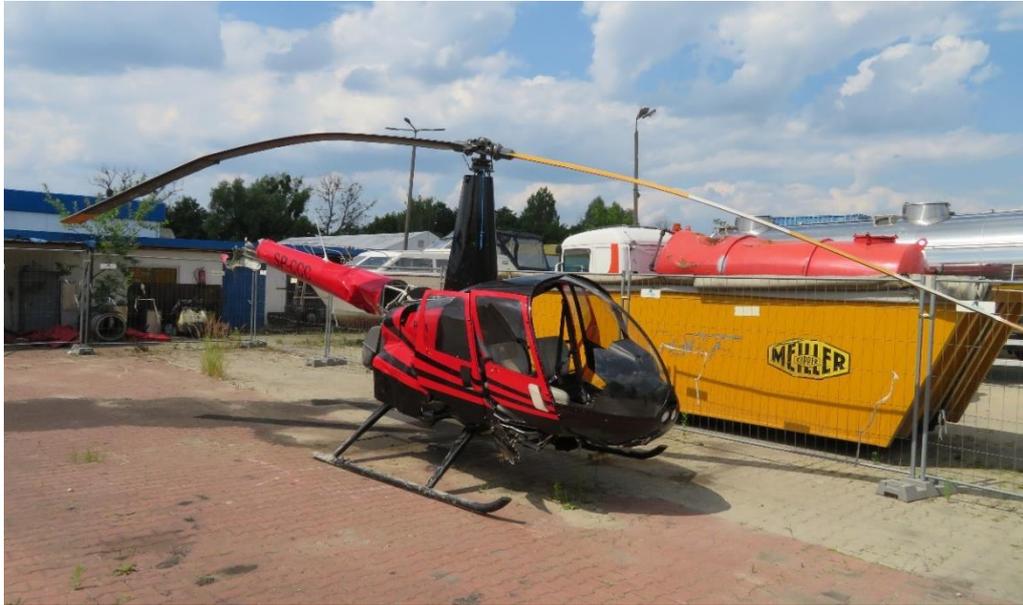
The helicopter was destroyed. All damage to the helicopter resulted from its collision with water. No other visible damage was found, including the engine and drive train, which may have occurred earlier. The main damage is shown in the figures below.

**Fig. 2.** Robinson R44, SP-CCC – helicopter wreckage after recovery from the lake (visible numerous damage to the structure, including deformed cockpit with broken windshield and bottom skin of the fuselage torn out)

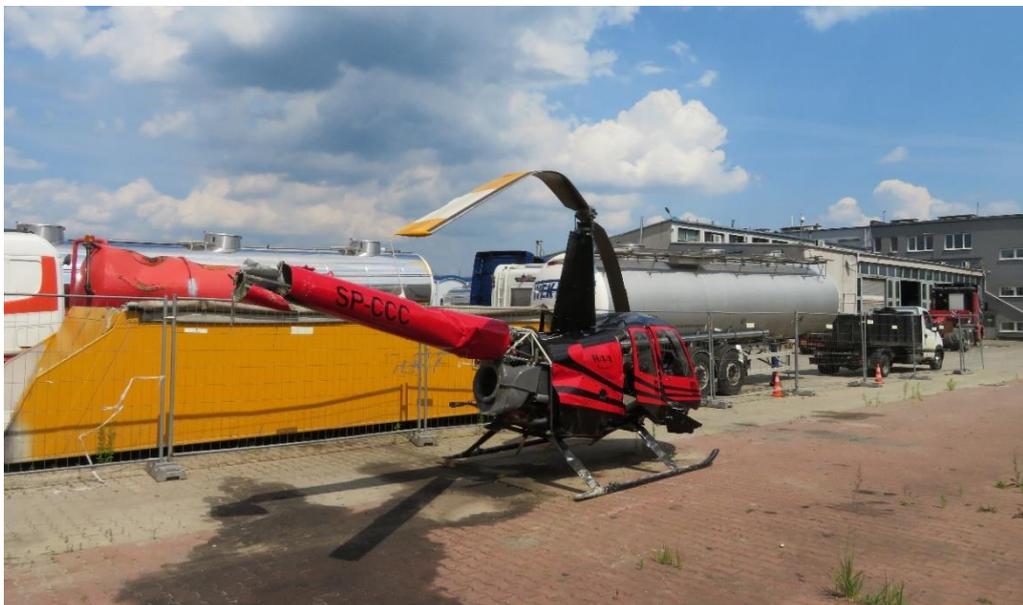
**Fig. 3.** Robinson R44, SP-CCC – helicopter wreckage after recovery from the lake (visible numerous damage to the structure, including deformed engine compartment and tail boom, tail rotor with gearbox, vertical and horizontal stabilizer, tail rotor cover and tail skid broken)

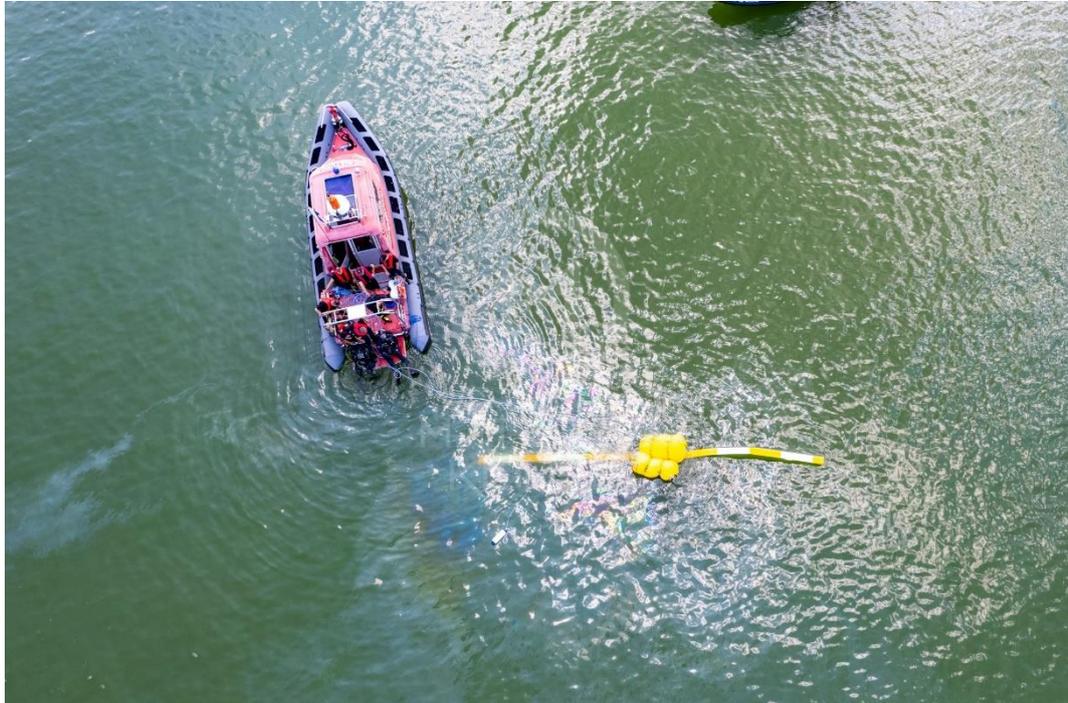
As a result of the accident, the water in the Tały lake was locally contaminated with fuel and engine oil.

**Fig. 4.** Accident site – recovery of the Robinson R44, SP-CC helicopter wreckage (stains of fuel and oil are visible on the lake surface) [source: Police]

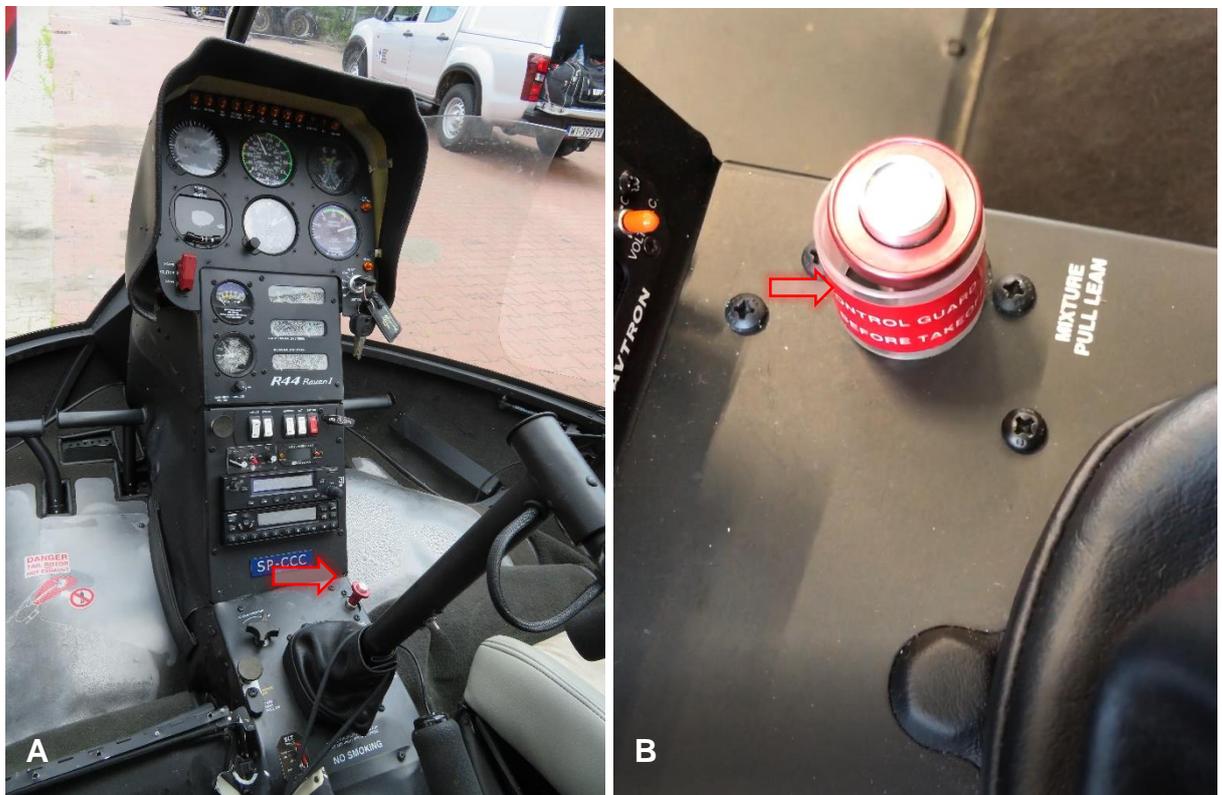
The mixture control knob should not be moved during flight. The knob has a double protection against accidental pullout (guard/ring and button). Throughout the flight, the knob should be pressed and secured with a guard as shown in Fig. 6-B.

**Fig. 6.** Mixture control knob: **A** – general view of the knob location in R44 SP-CCC cockpit; **B** – close-up of the pressed knob with a visible guard protecting it against accidental pullout (photo taken inside another helicopter)

The inspection of the helicopter before its recovery from the water was recorded on video footage. The recording does not show that the knob had the guard. The guard was also not found in the wreckage of the helicopter after its recovery. Since the guard was not attached to anything, it could have been lost during collision with water or during the recovery operation.

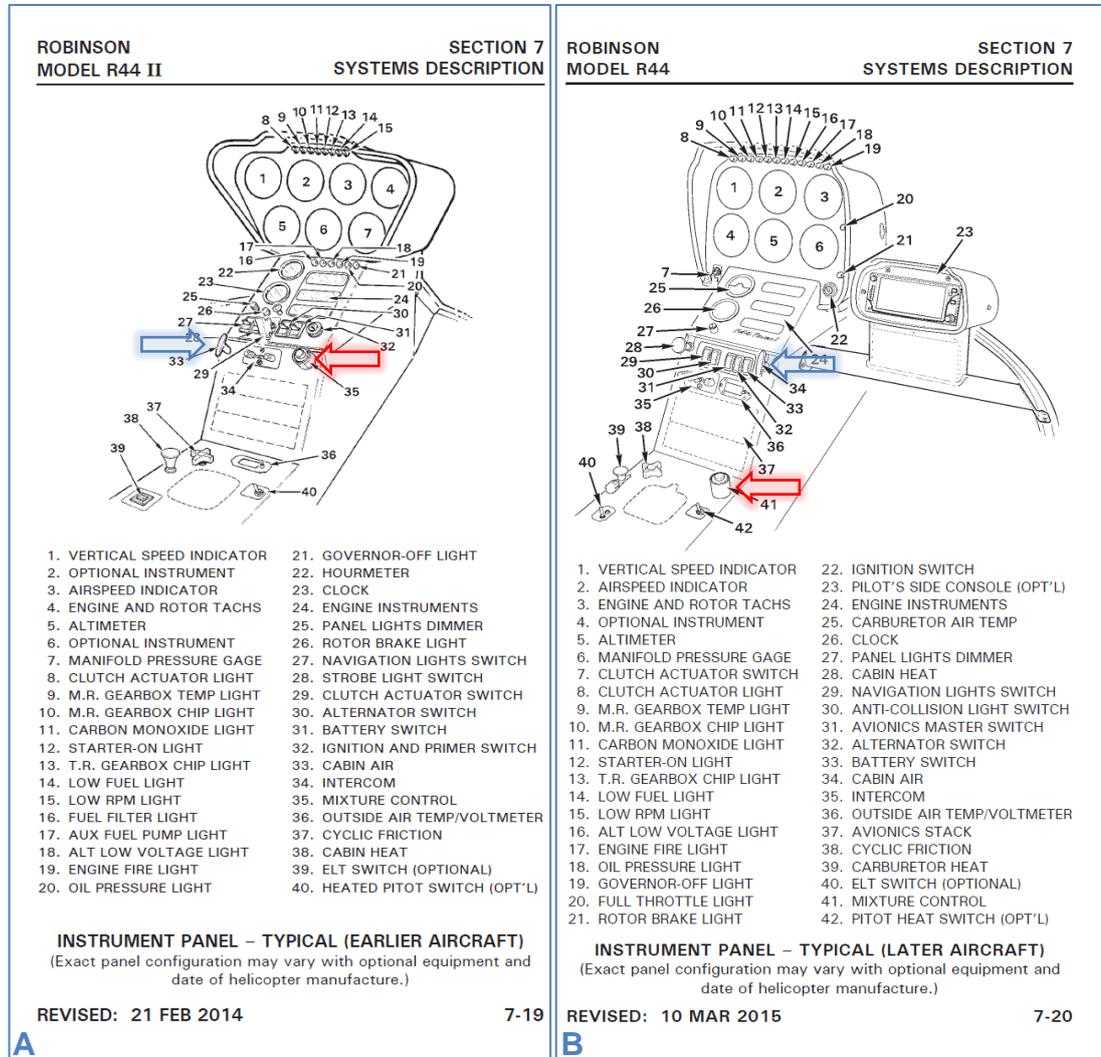
**Fig. 7.** Robinson R44 panels: **A** –R44 II model (the mixture control knob is marked with red arrow – number 35, the cabin air knob is marked with blue arrow – number 33 – blue arrow); **B** – R44 model (the mixture control knob is marked with red arrow – number 41, the cabin air knob is marked with blue arrow – number 34) [source: Robinson]

The pilot had previously operated two R44 II helicopters, in which the mixture control knob and cabin air knob were located differently than in the accident R44 model (Fig. 7). In R44, the cabin air knob is located in the place where the mixture control knob is located in the R44 II.

With high temperature inside the cabin, the pilot wanted to turn on the air supply, but mistook the knobs and instead of pulling the cabin air knob, he pulled the mixture control knob, which caused shutdown of the engine.
