FINAL REPORT

OCCURRENCE NO – 2021/3056

AIRCRAFT – Airplane, Diamond DA 42, SP-TRL

DATE AND PLACE OF OCCURENCE – 19 August 2021, EPMO

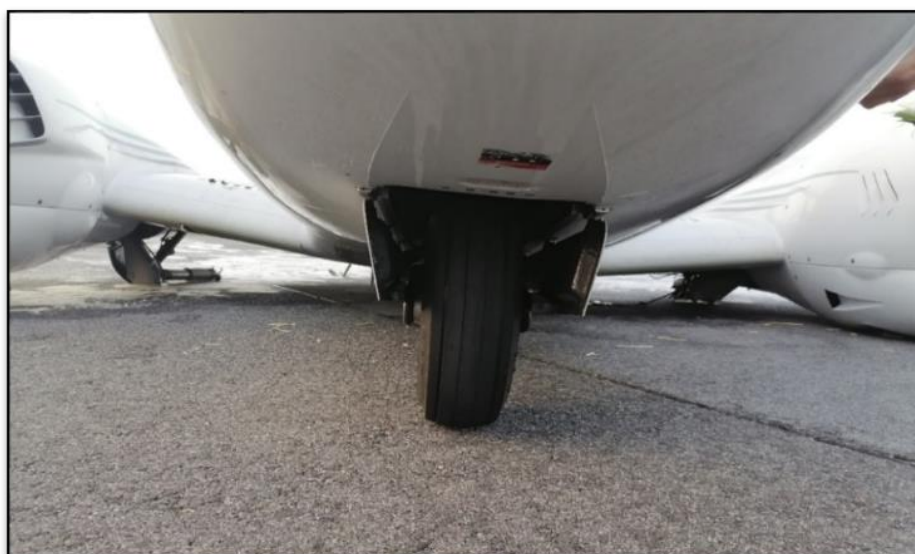
The plane was substantially damaged. The landing gear of the aircraft was damaged, the main landing gear struts were broken and the wheels detached from their construction. The nose landing gear strut and its wheel were pressed into the nose landing gear well.

Fig.3. Nose landing gear damaged

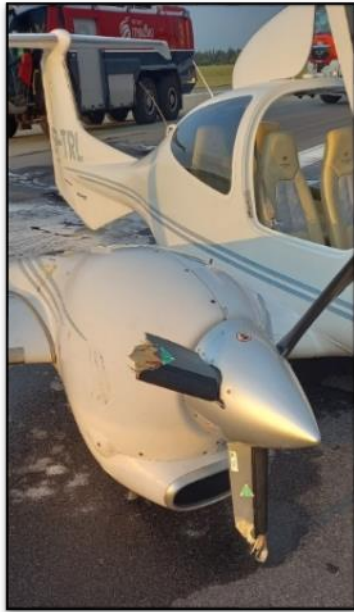
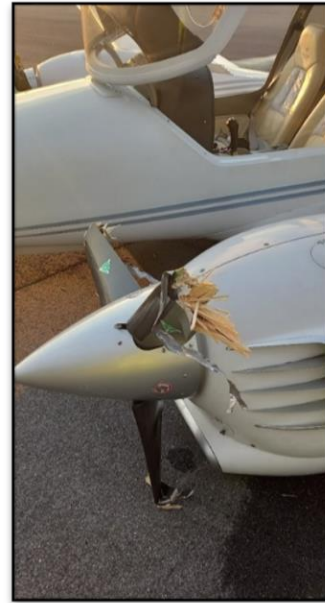
As a result of the destruction of the main landing gear, the plane rested on the lower part of the fuselage, which caused the rotating blades to collide with the runway surface. Their wooden structure was destroyed. The lower part of the fuselage was also damaged.

Fig. 4 and 5. SP-TRL aircraft with destroyed propellers blades of both engines.

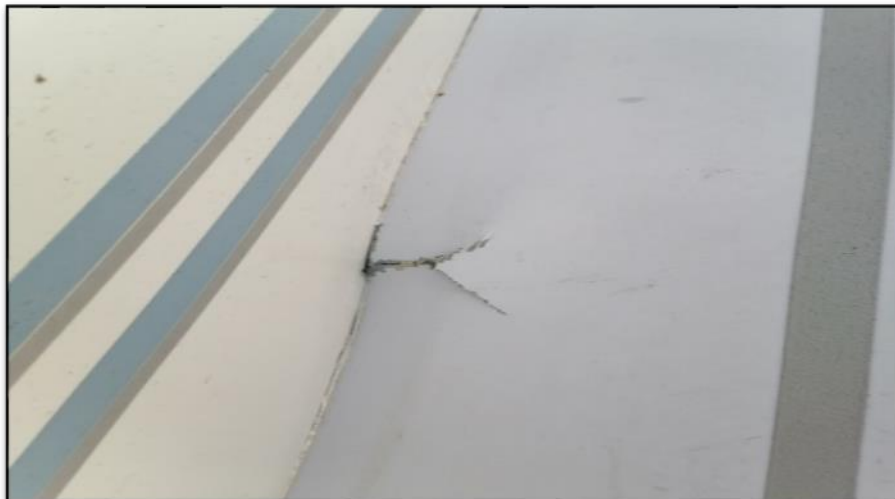
The wings did not detach from the fuselage, but were slightly damaged in many places. Cracks and delamination of the wings structures occurred especially at their roots.

Fig.6. Damaged airframe in the wing connection area.

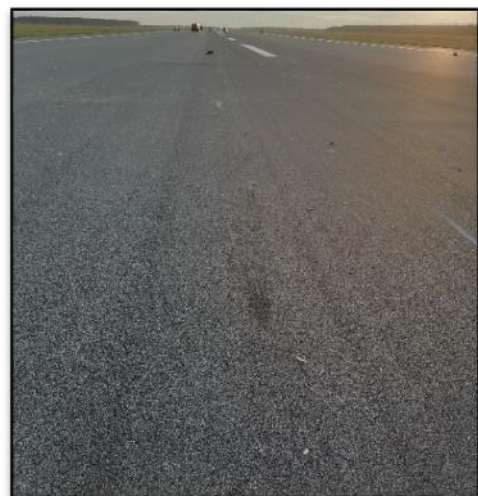
Numerous parts (sleeves, bolts, covering elements), mainly from the damaged nose landing gear and damaged fuselage and wing structures, were found scattered near the wreckage.

Fig.8 and 9. SP-TRL airplane framgents/elements on the runway

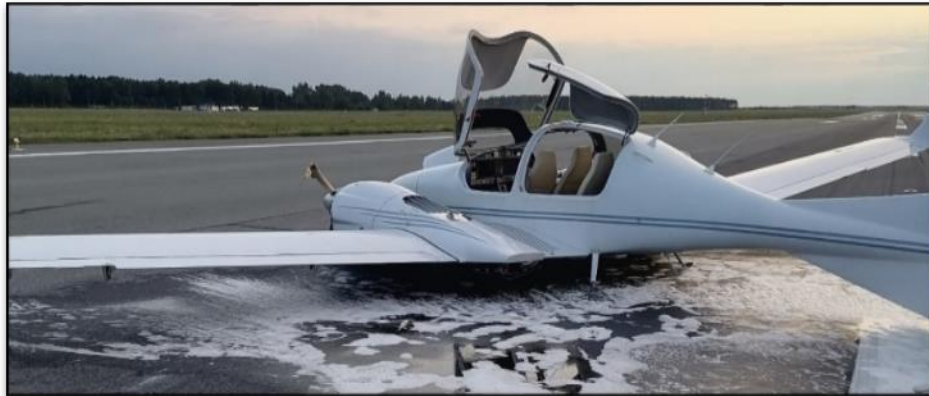
On 19 August 2021, during the accident site inspection, PKBWL found that after the collision with the runway surface, the plane moved to a distance of 268 meters from the touchdown place. The damaged parts of airframe, engine and landing gear were scattered along the length of 336 meters. The plane touched down in the middle of the RWY 26 along its centre line and came to rest with a deviation of about 45° from the runway centre line towards the airport terminal (Fig. 10).

Fig. 10 Accident airplane after it came to rest and was left by the crew [source: PKBWL]

The landing gear, propeller blades and the left engine were destroyed during aircraft movement on the RWY 26 surface.
