FINAL REPORT

OCCURRENCE NO – 2021/4567

AIRCRAFT – Airplane, Boeing 737 MAX 8, A6-FMC

DATE AND PLACE OF OCCURENCE – 11 November 2021, EPWA

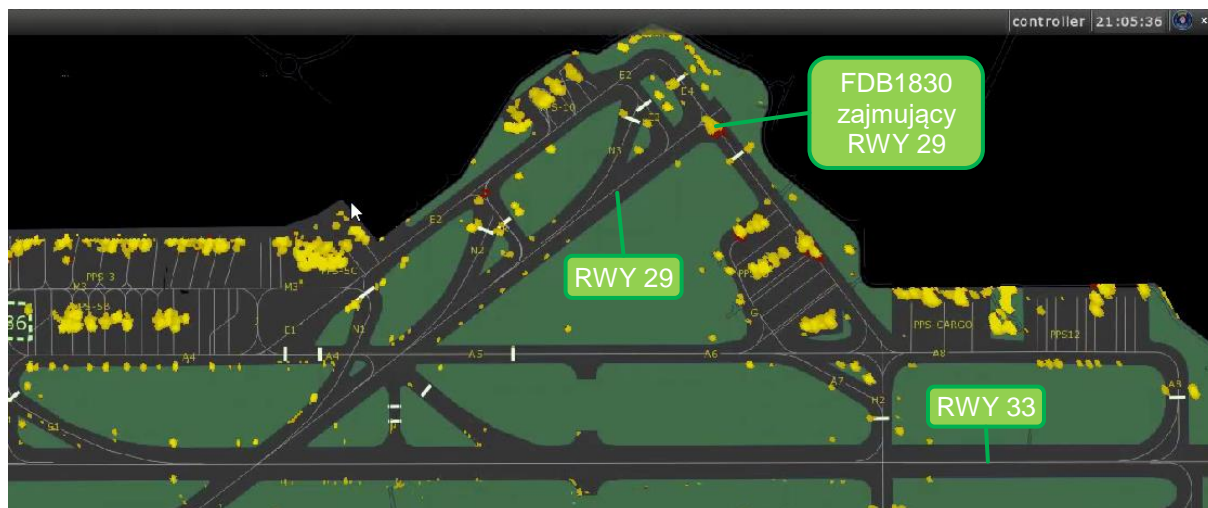
Before the FDB1830 aircraft reached the holding point, the TWR controller issued an instruction to its crew to line up RWY 29 and wait. The crew read back the instruction correctly. At 21:05:36 hrs, during taxiing on RWY 29, the FDB1830 crew asked for confirmation whether they should establish communication on the 128.805 frequency after departure. The TWR controller confirmed the frequency. At that time, the EPWA APP staff asked the TWR controller whether the FDB1830 was taking-off. TWR controller replied that it was not taking off due to landing of another aircraft.

Fig. 1. SMR radar display screen [source: PANSA]

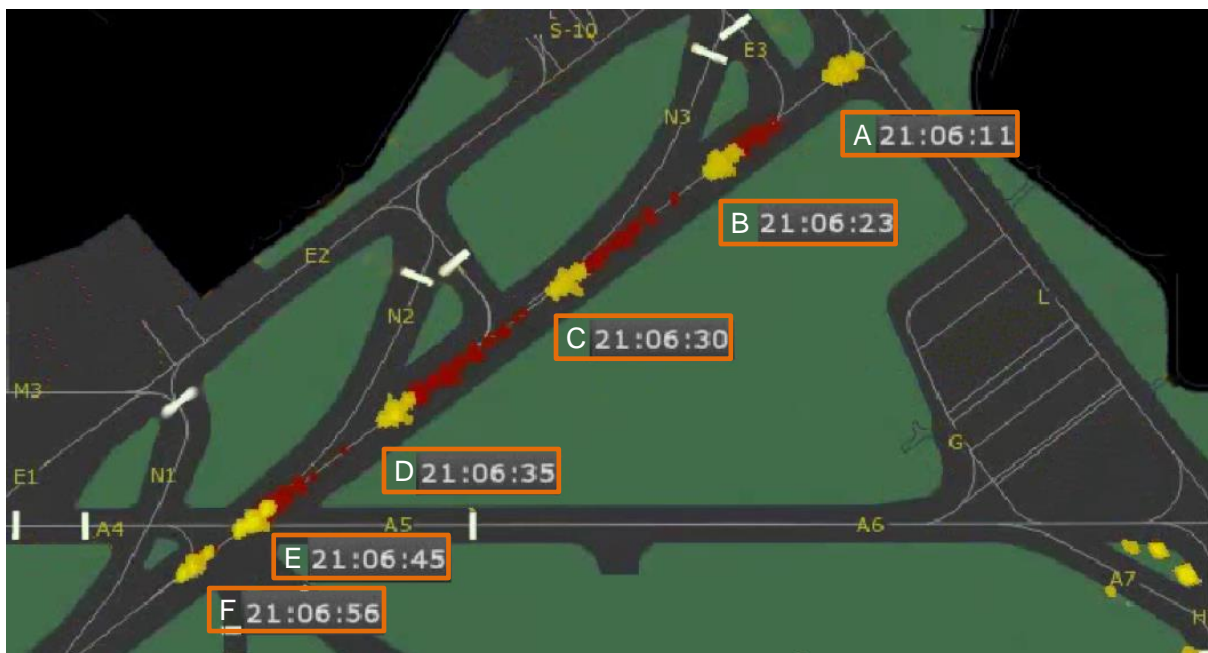
Meanwhile another plane was approaching the holding point short of RWY 29. The TWR controller issued its crew a conditional instruction to line up RWY 29 behind FDB1830. During that time, at 21:06:12 hrs, the crew of the FDB1830 started the take-off run. At 22:06:23 hrs TWR ordered the FDB1830 crew to stop immediately. The FDB1830 crew acknowledged the instruction. The take-off was aborted at the speed of 89 kt. The plane stopped at RWY 29 approximately 250 m from the intersection with RWY 33.

Fig. 2. FDB1830 aborted take-off: A – take-off run initiation, B – instruction to abort take-off, C – acknowledgement of the instruction, D and E – speed reduction, F - stop
[source: PANSА, PKBWL]

12 seconds after the beginning of the take-off run, the TWR controller, using urgent phraseology, instructed the crew to immediately abort the take-off. The crew acknowledged that instruction and stopped the plane at RWY 29, about 250 m from the intersection with RWY 33, where the LOT2MP was about to land. The actions of the TWR controller and the crew, related to the abortion of take-off were correct.
