Final Report

SERIOUS INCIDENT/2021/5037

OCCURRENCE NO. – 2021/5037

AIRCRAFT – Aeroprakt 22LS, SP-SENO

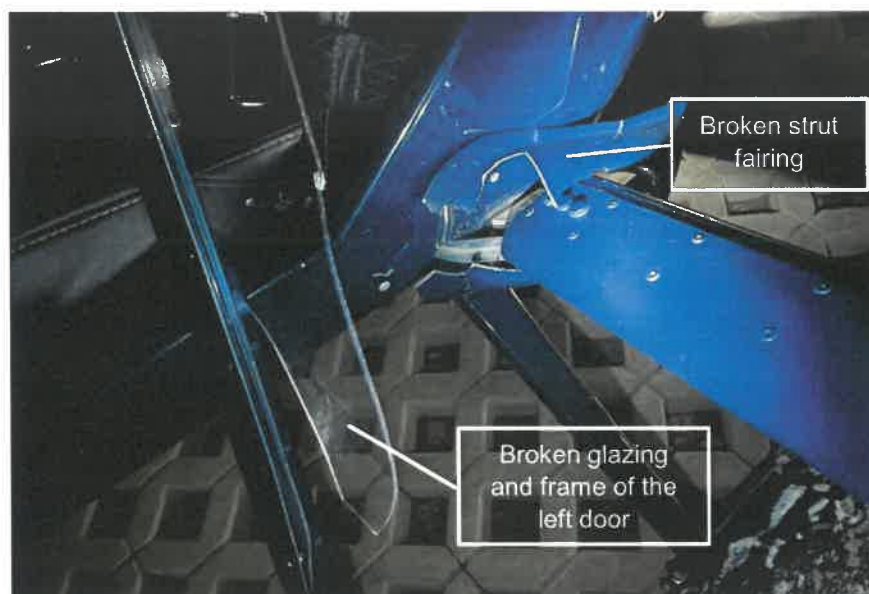
The perspex of side cabin doors were cracked/broken, the frame of the left door was twisted and the bottom fairing of left wing strut was broken (Fig. 3).

Fig. 3. Damage to the left cabin door and strut fairing [source: SCAA]

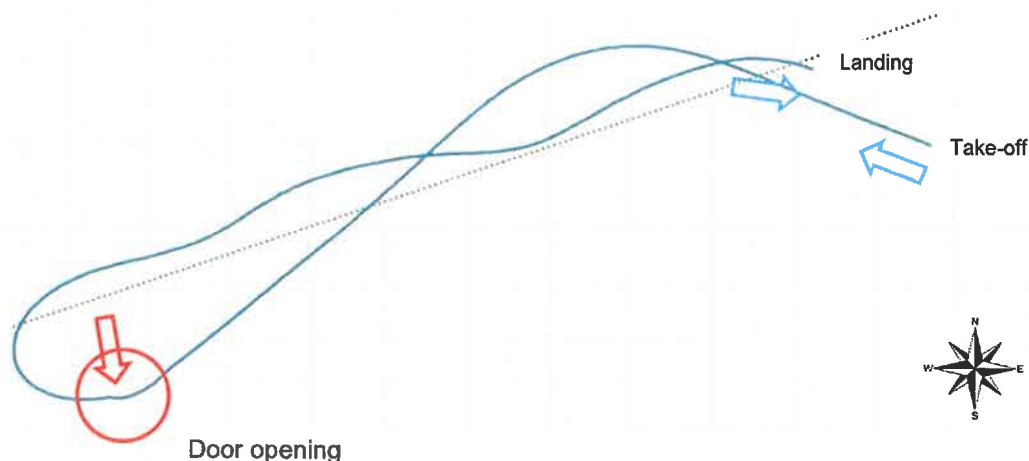
Fig. 4. Horizontal projection of the flight trajectory from take-off to landing, drawn based on flight data from Dynon Avionics (the scale preserved) [source: csv file]

strut and acted like an airbrake) slowed down the a/c rapidly and pushed its nose about 30 deg. down, below the horizon. Pilot immediately pulled the yoke backward what caused the load factor of 3,8 g. The corresponding part of the flight path was marked with a red circle in (Fig. 5a). The disturbed flight trajectory can be also seen on its horizontal projection and has been marked by a red circle and an arrow in (Fig. 4).

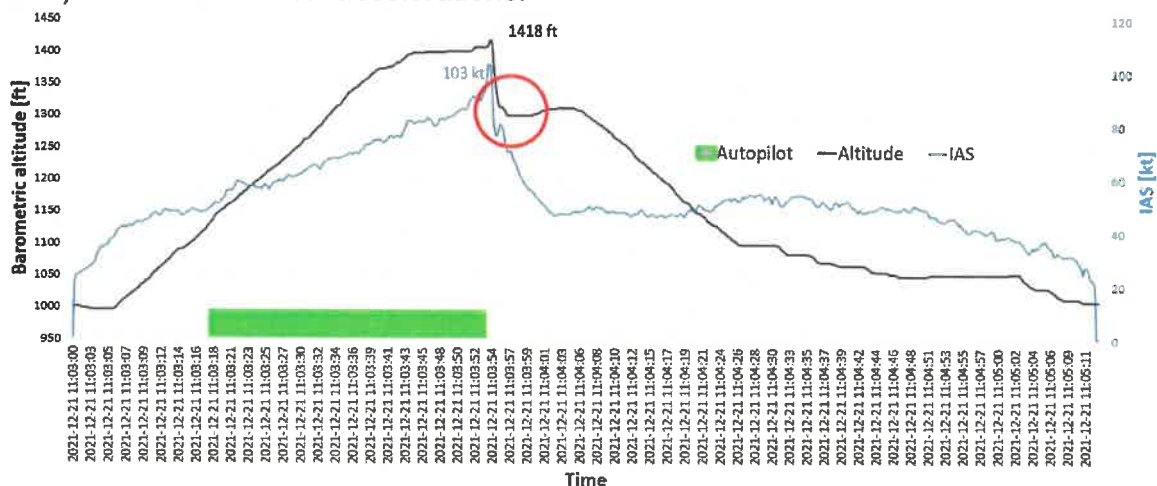
Fig. 5a. Barometric altitude and IAS. Autopilot engagement (“on”) marked in green

At the time of occurrence, at 11:03:54 hrs, the barometric altitude⁸ was **1418 ft**, i.e. about 420 ft above the landing strip – see plot (Fig. 5a).

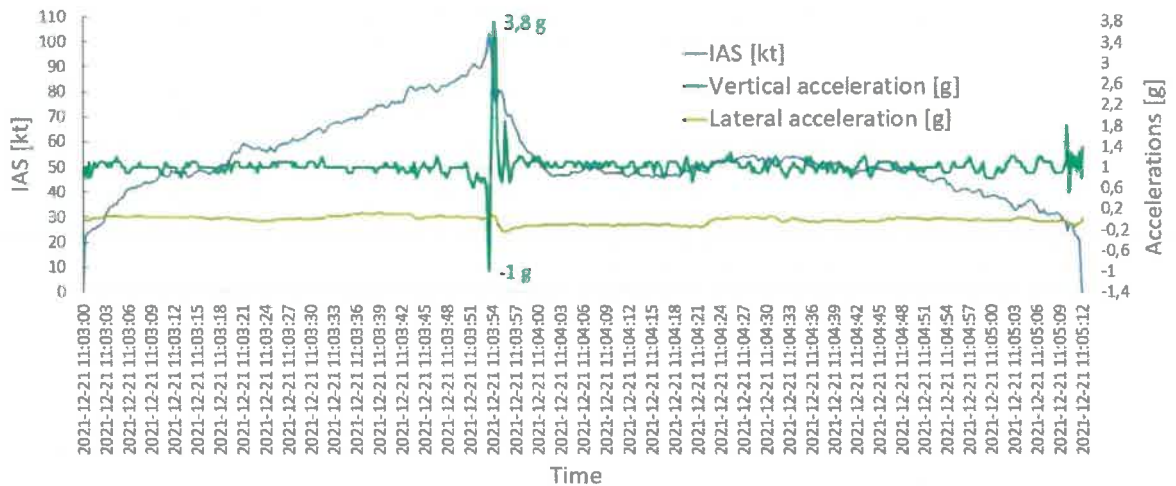
Fig. 5b. Accelerations and IAS

The pilot was increasing speed up to that height, with average climb rate of 2,3 m/sec. At 11:03:54 hrs the speed achieved **103 kts** (191 km/h) – see plot (Fig. 5b). All the time the full engine power (full throttle) was set, at max. RPM (Fig. 5c).

At 11:03:54 hrs the left and right doors, one by one, opened suddenly and the audible and visual warnings („GEES”) of the *Dynon Avionics* system were activated signalling significant airframe load factor. The total value of vertical acceleration increase was 4,8 g (from -1g up to +3,8g), (Fig. 5b). That was combined with a relatively small lateral acceleration (acting perpendicularly to longitudinal axis of aircraft). Left door opening and its rotation (the door were suspended on one upper hinge only, rested on the wing

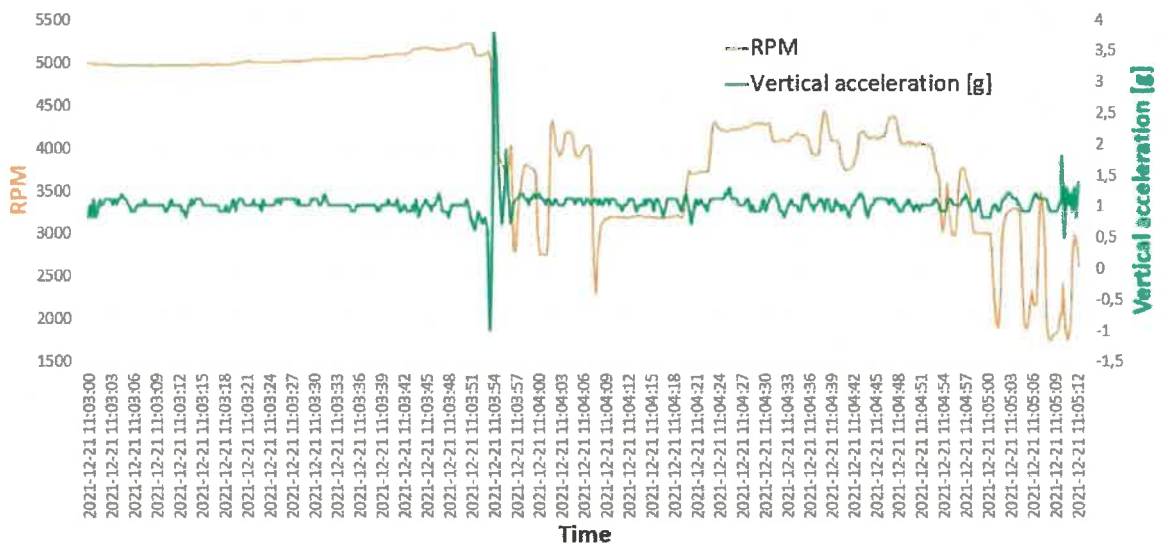
Fig. 5c. RPM and vertical acceleration

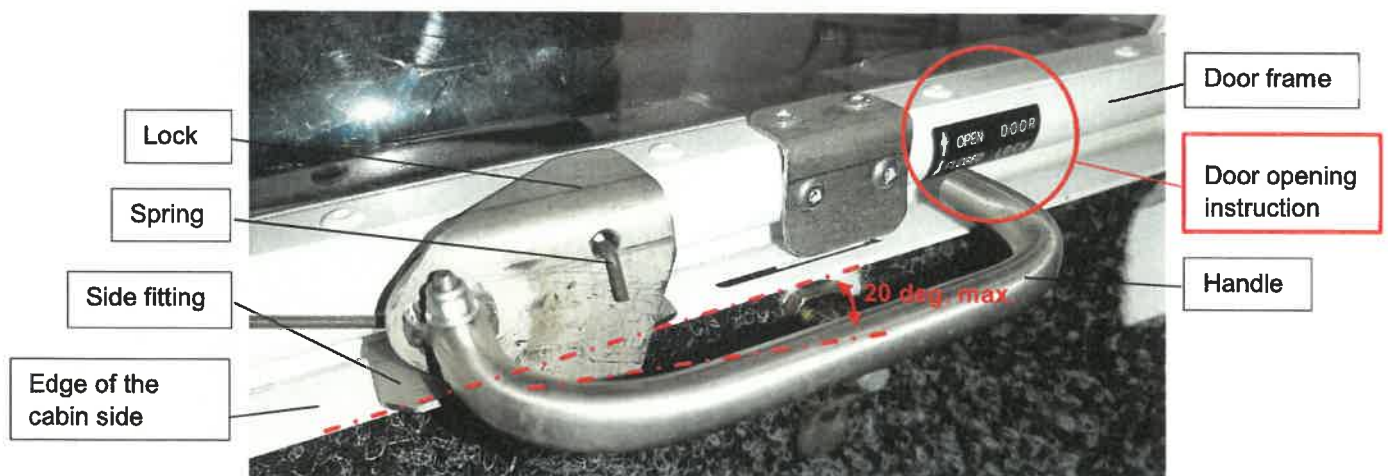
The door locking mechanism operation is based on a spring connected with a rotating handle, which is presented in Fig. 6. The spring moves the handle to the position „closed”, turning it down parallelly to the bottom frame of the door.

The lock is not secured against unintentional unlocking, it works easily and smoothly. With regard to wide range of whole handle movement from horizontal to vertical (90 deg.), the lock releasing angle is relatively small (about 20 deg.).

Fig. 6. Door locking mechanism (left door) with handle in closed setting. Also shown the range of engagement of locking mechanism [source: SCAA]

The investigation showed, that when the shape of the door is deformed and the lock handle is slightly turned (about 20 deg. up), the lock releases and the door opens. It leads the conclusion, that the door stiffness is too low and that on the front edge of the door an additional lock should be installed.

The Commission recommends that the aircraft manufacturer considers some changes in the design of the door locking system, to prevent unintentional, accidental or spontaneous door opening in flight.

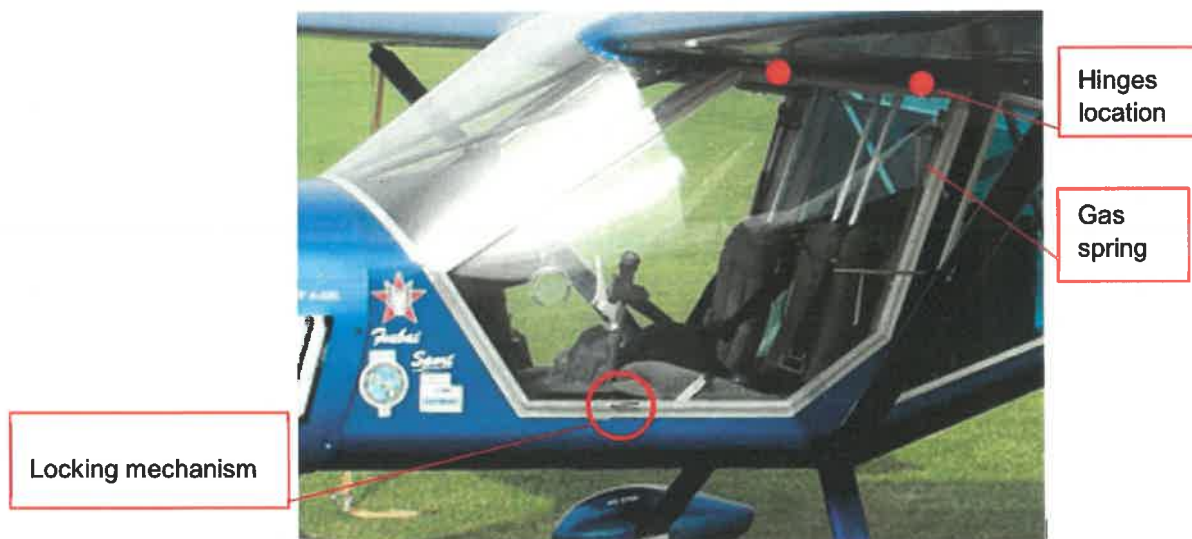
Fig. 7. Location of hinges and the locking mechanism on the door

- for each aircraft, the locking mechanisms were working in a similar mode: smoothly and springy, the releasing forces (to unlock the handle) were low and the releasing angles were the same (up to 20 deg.). The springs caused that each mechanism turned back to its „closed” position;
- the design provides for significant asymmetry between the hinges located on the upper frame of the door and the position of the locking mechanism on the bottom (Fig. 7.). This causes uneven distribution of forces around the door frame in case when an opening force is applied – particularly in the front part (see Fig. 8);

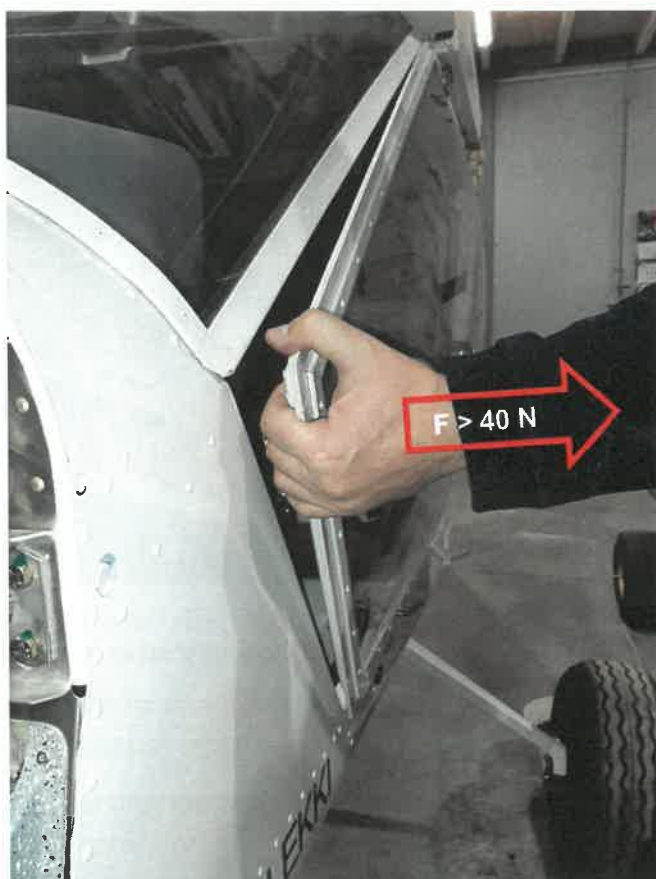
Fig. 8. The force above 40N applied to the door in its front area and a visible gap between the door and fuselage frame

- pulling the door out of the fuselage, perpendicularly to the aircraft longitudinal axis (see Fig. 8), when the force was applied to the forward part of the door, revealed their insufficient stiffness. The formed gap was about 10 mm when the force applied was 30 N and was increasing up to 40+50 mm with the force of 45 N. The applied forces were relatively low and corresponding to aerodynamic forces in flight. This was consistent with observations of some Aeroprakt 22LS users about gaps in the area of the front parts of the doors during flights with high speeds.
