# FINAL REPORT

SERIOUS INCIDENT 2022/2456

OCCURRENCE NO – 2022/2456

AIRCRAFT – Airplane, Tecnam P2006T, SP-MMB

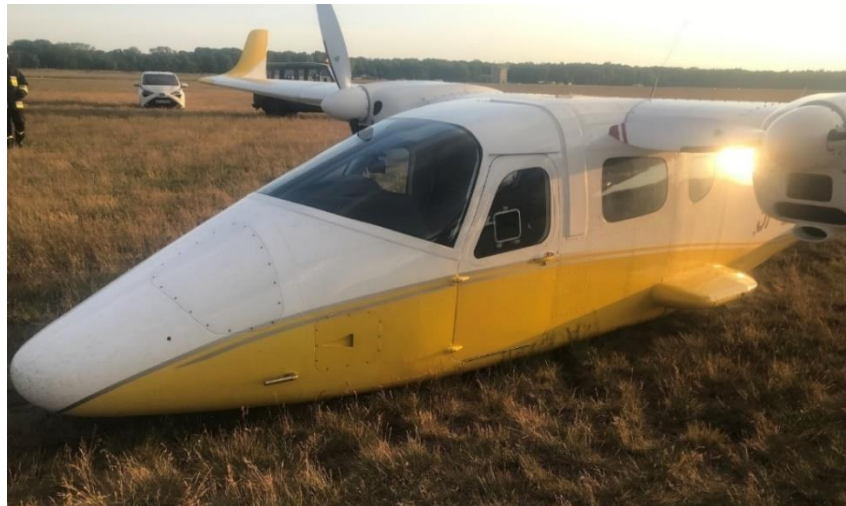
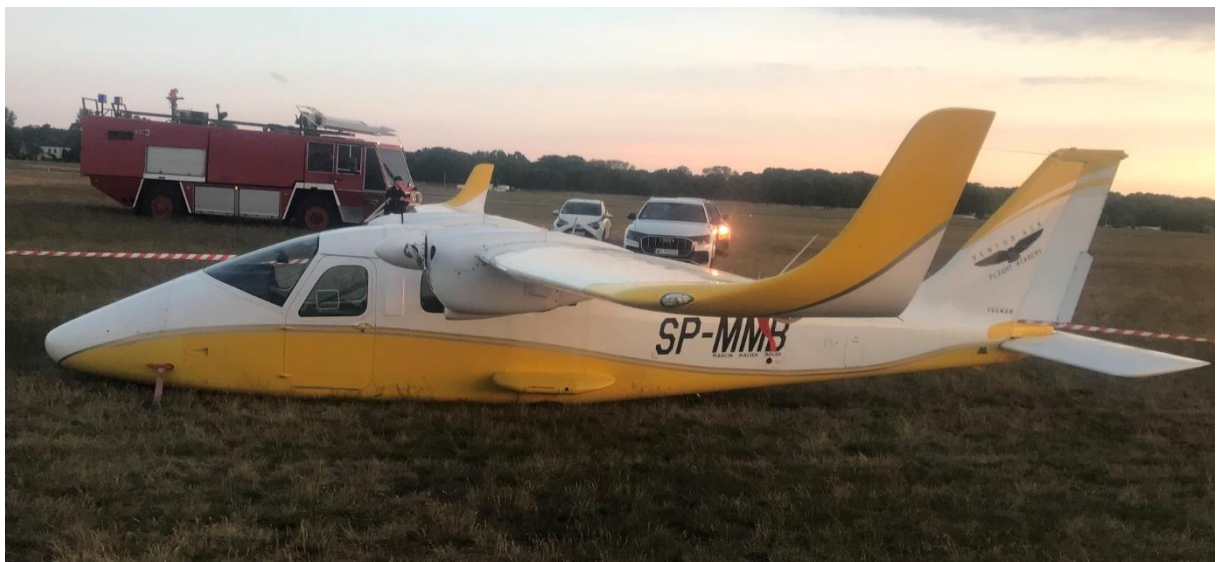
Fig. 1. Tecnam P2006T, SP-MMB, aircraft on the occurrence site [source: PKBWL<sup>2</sup>]

Fig. 2. Tecnam P2006T, SP-MMB, aircraft on the occurrence site

As a result of the serious incident, the lower skin of the airframe, including the main landing gear nacelles, was damaged. After the occurrence, the plane was lifted, the landing gear was extended and the aircraft was towed to an apron.

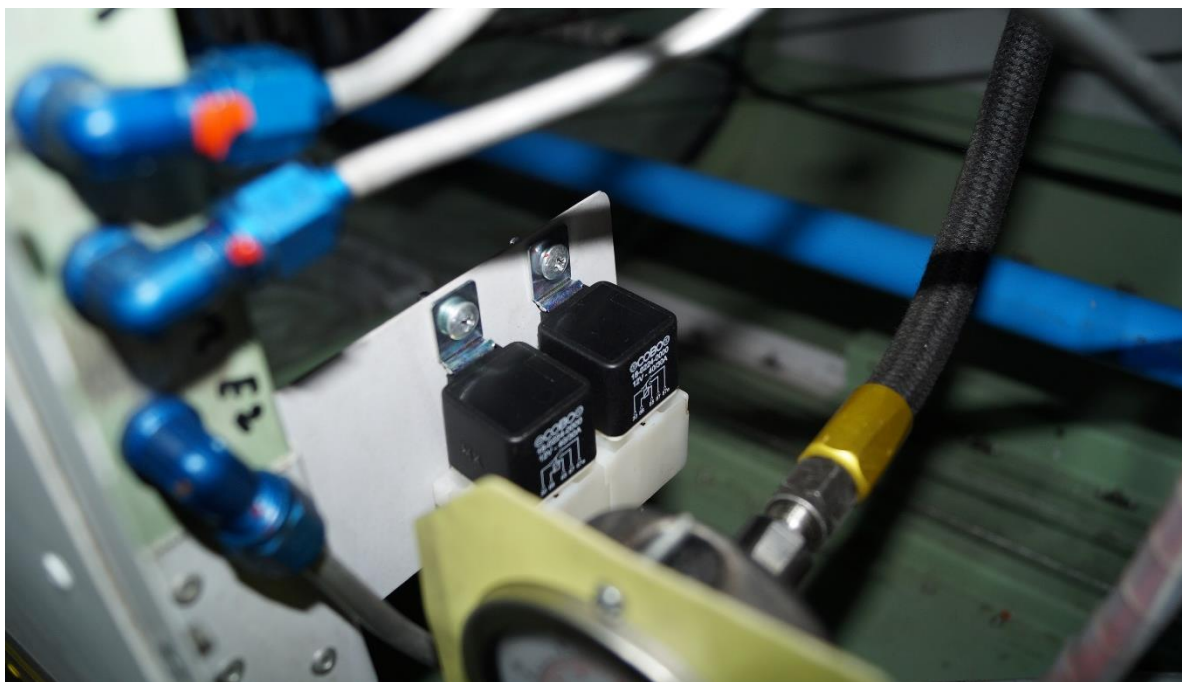
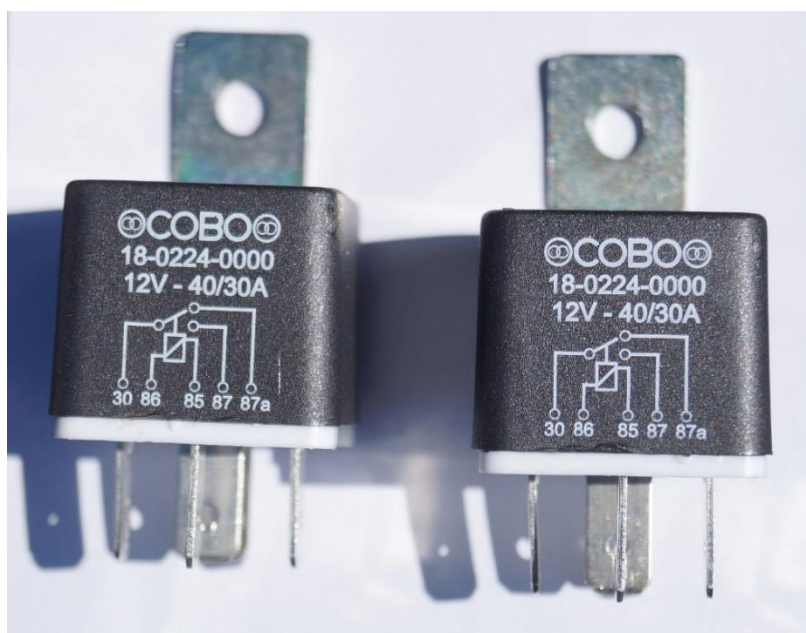
The mass and center of gravity of the aircraft were within permissible limits. Two electric relays are installed in the circuit supplying power to the motor of the hydraulic pump of the landing gear retraction and extension system (Fig. 3 and 4).

Fig. 3. Landing gear extension and retraction system electrical relays installed on Tecnam P2006T aircraft

Fig. 4. Landing gear extension and retraction system electrical relays removed from the Tecnam P2006T aircraft

According to the marking on the housing of each relay, the maximum current load of the relays is 40/30A<sup>3</sup>.

Therefore, PKBWL recommends that the manufacturer of the Tecnam P2006T airplanes analyses the parameters of the components used in the landing gear retraction and extension system, and then replaces all system components whose load is higher than their rated currents values.

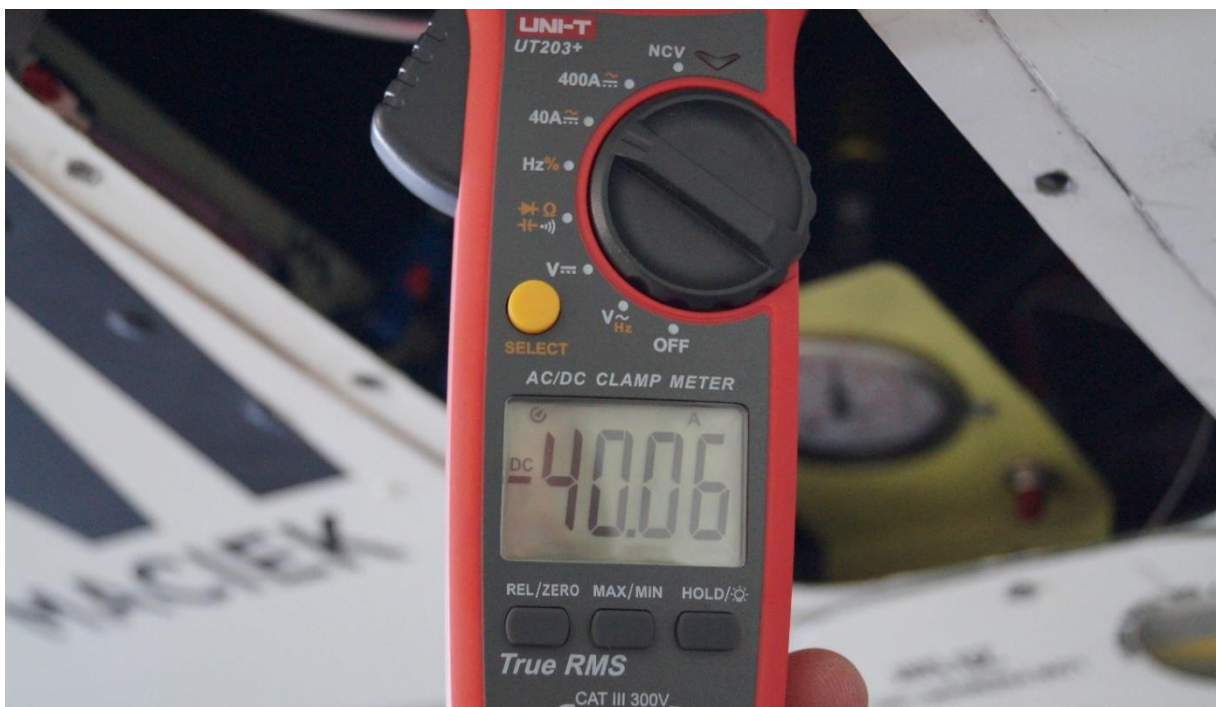
PKBWL, in cooperation with the Tecnam P2006T aircraft maintenance organization, measured the current flowing through the relay in the course of retraction and extension of the landing gear. The results of the measurements show that the value of the current depends on several factors. During multiple landing gear extension and retraction in hangar conditions, the values of the maximum current fluctuated in the range of 20-30 A, however, several times reached the value of 38-39 A, and exceeded the value of 40 A twice. The highest current in the circuit was noticed during the first retraction of the landing gear, after a few days' break in the operation of the aircraft. In subsequent cycles, the "warmed up" system presented lower values of the current of the hydraulic pump motor.

Fig. 5. Measurement of the current flowing through the landing gear extension and retraction system electric relays, photographed during the test

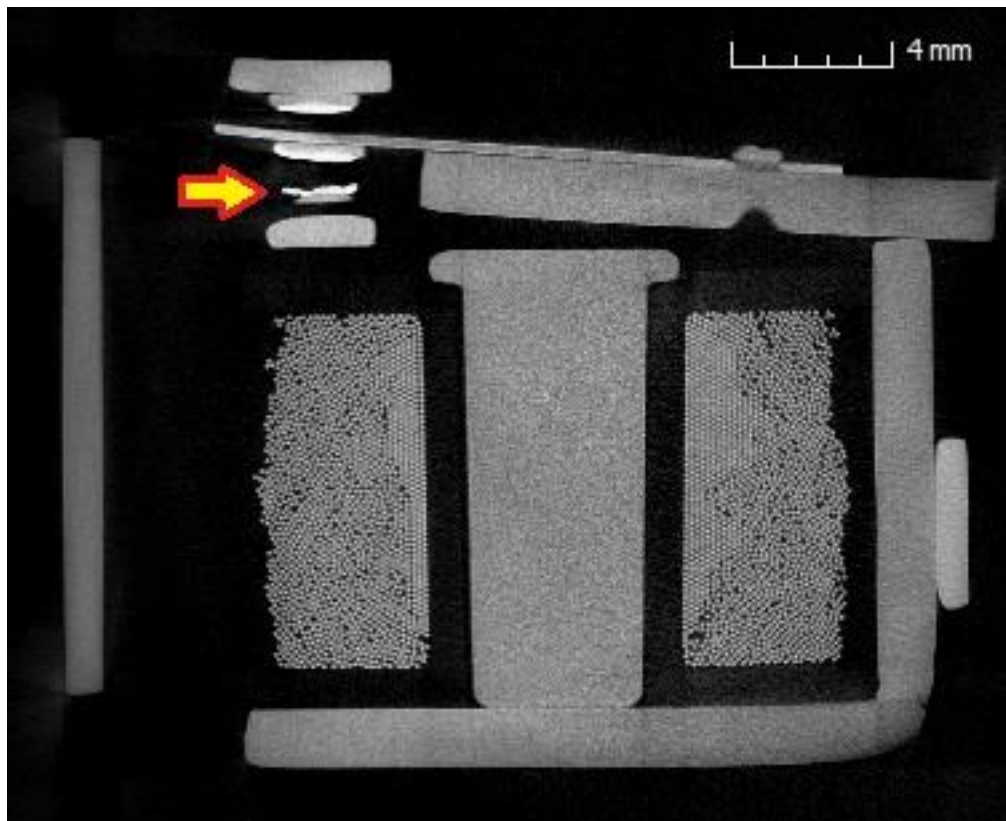
The relays that failed on 23 May 2022 were tested using computer tomography. The tests revealed deep burns and deformation of the relay contacts. The images obtained during the tests are shown in Fig. 6 and Fig. 7.

Fig. 6. Internal structure of one of the relays used in the electric circuit of the landing gear hydraulic pump motor. Visible deep burn is seen on the lower contact (marked with an arrow) [source: Warsaw University of Technology]

When the landing gear was tested in hangar conditions, it was not subjected to aerodynamic and inertial forces acting in real flight conditions. It can be assumed that these forces counteracting the retraction of the landing gear in flight cause an increase in the current consumed by the motor of the hydraulic pump of the landing gear extension and retraction system to a value exceeding the rated current of the relays shown in Fig. 4. In such situations, the contacts of the electrical relays are systematically loaded above their rated operating parameters, which results in their frequent failures.

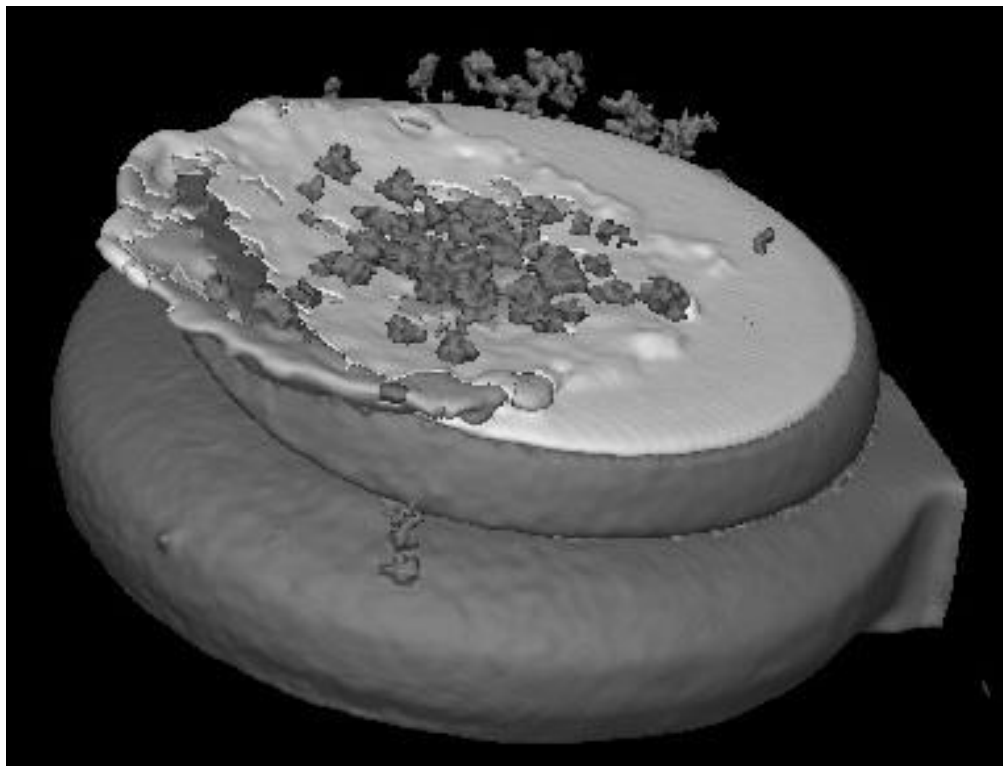
Fig. 7. Degraded contact surface of one of the relays used in the electric circuit of the landing gear hydraulic pump motor [source: Warsaw University of Technology]

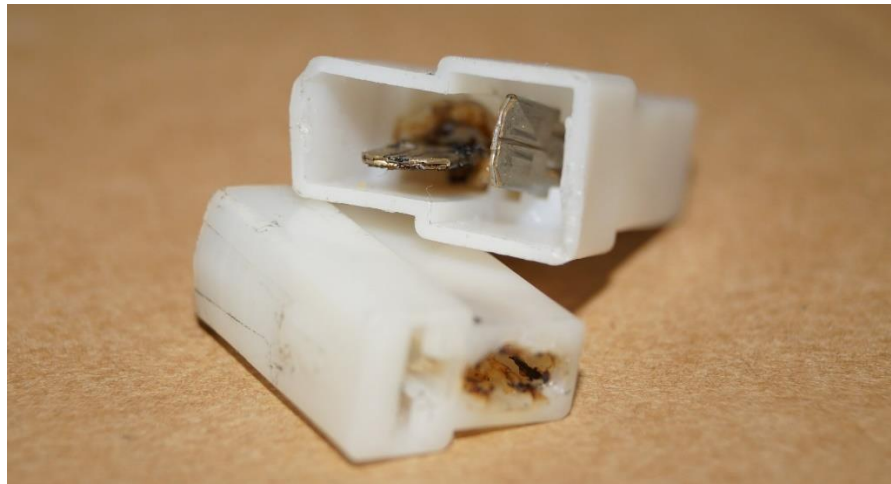
During the inspection some other elements of the electric system of the landing gear control circuit, such as wires and electrical connectors also raised concerns. The used components are not appropriate to the current load in this circuit. An example can be the electrical connector shown in Fig. 7 used on the electric motor of the landing gear hydraulic pump. The information obtained from the Tecnam P2006T aircraft maintenance organization shows that there have been cases of overheating and burning of this connector.

Fig. 8. Damaged electrical connector of the Tecnam P2006T airplane on the electric motor of the landing gear hydraulic pump

The value of the current of the hydraulic pump motor of the landing gear in some situations exceeds the value of the rated current of the components used in this circuit, which causes fusing of the relay contacts and overheating of the connector on the hydraulic pump motor.

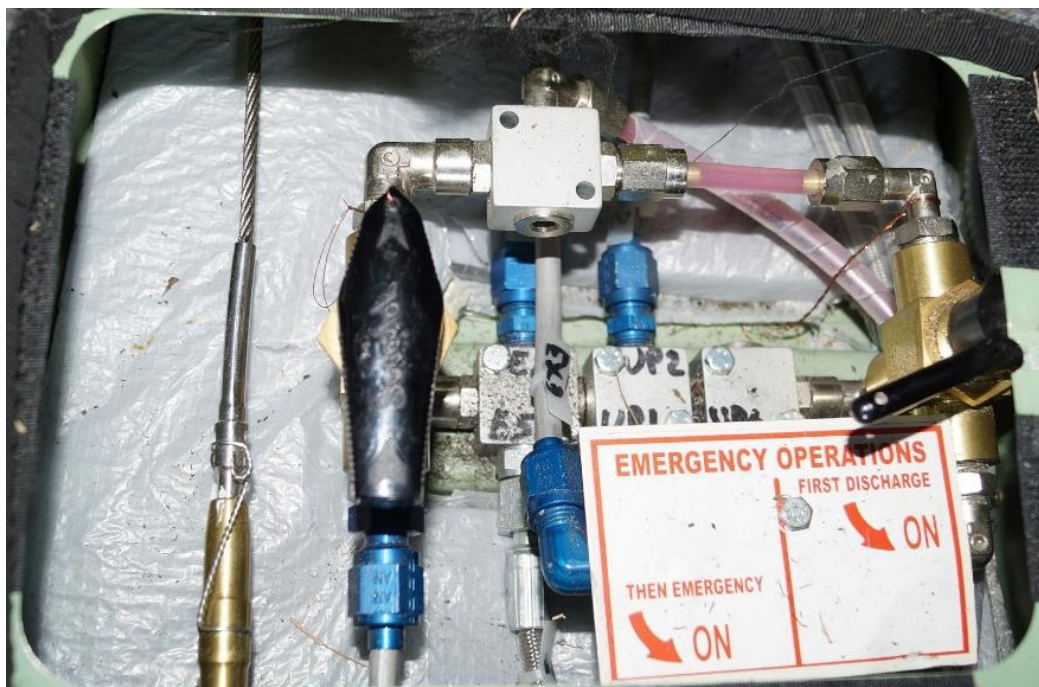
During the inspection of the alternate landing gear extension system of the aircraft, the design of mounting the right valve lever of this system (marked "FIRST DISCHARGE") also raised PKBWL concerns.

Fig. 9. Valves of the emergency landing gear extension system in the Tecnam P2006T airplane

The lever mounted on the valve shaft has been secured by a single grub screw. If this screw is loosened by just a half of turn, the valve remains closed despite the lever rotation to the ON position, which prevents the landing gear from being extended in an emergency

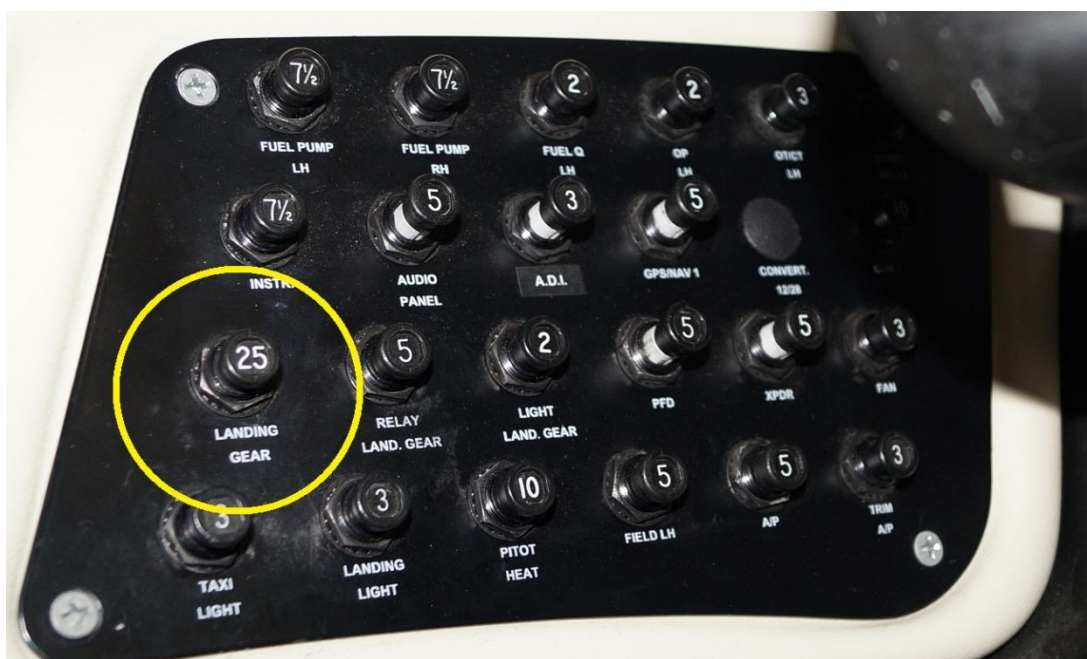
A solution to this problem would be breaking the circuit of the hydraulic pump motor by pulling the circuit breaker labelled "LANDING GEAR". Unfortunately, such an action has not been included in the procedure „EMERGENCY CHECKLIST LDG GEAR”.

Fig. 10. The circuit breakers panel of the Tecnam P2006T aircraft with the marked “LANDING GEAR” circuit breaker

The circuit breaker “LANDING GEAR” should also be marked with a bright colour to avoid an error in a stressful emergency situation when pulling it out.

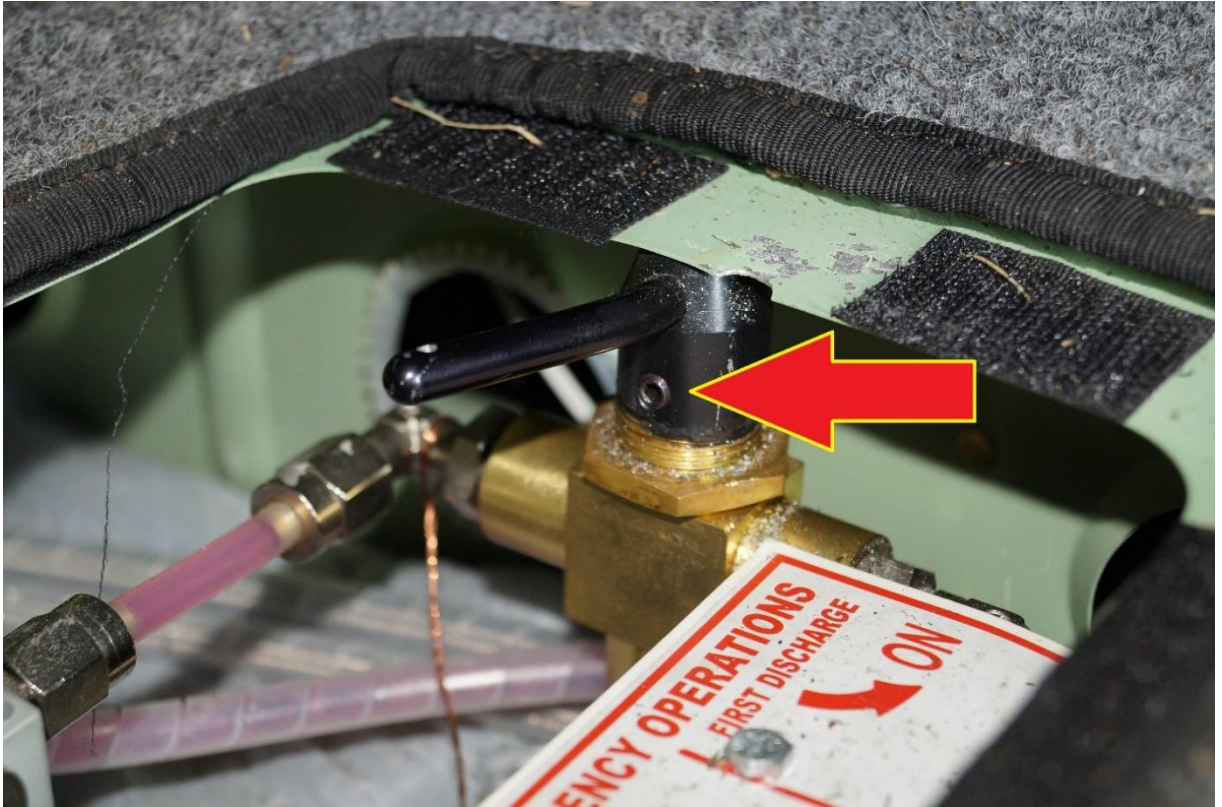
Fig. 11. Connection of the lever with the right-hand valve of the alternate landing gear extension system. The arrow marks the grub screw that prevents the free rotation of the lever on the valve shaft

During the investigation PKBWL determined that the lever mounted on the shaft of the FIRST DISCHARGE valve is insufficiently secured against spontaneous loosening. This fact was revealed on the serious incident aircraft. Loosening of the lever allows for its free rotation around the valve shaft, which prevents the valve opening and reduction of the pressure in the system prior to opening THEN EMERGENCY valve.

In the opinion of the PKBWL, the connection of the lever with the valve shaft (Fig. 11) should be changed so that they cannot be accidentally disconnected during operation of the aircraft.

Therefore, PKBWL recommends that the manufacturer of the Tecnam P2006T aircraft modifies the connection of the FIRST DISCHARGE valve lever with the valve shaft to prevent its spontaneous loosening during operation of the aircraft (e.g. use a splined joint).
