ACCIDENT 2022/3010

State Commission on Aircraft Accidents Investigation

OCCURRENCE NO. – 2022/3010

AIRCRAFT – SAILPLANE, ASG-29E, SP-3818

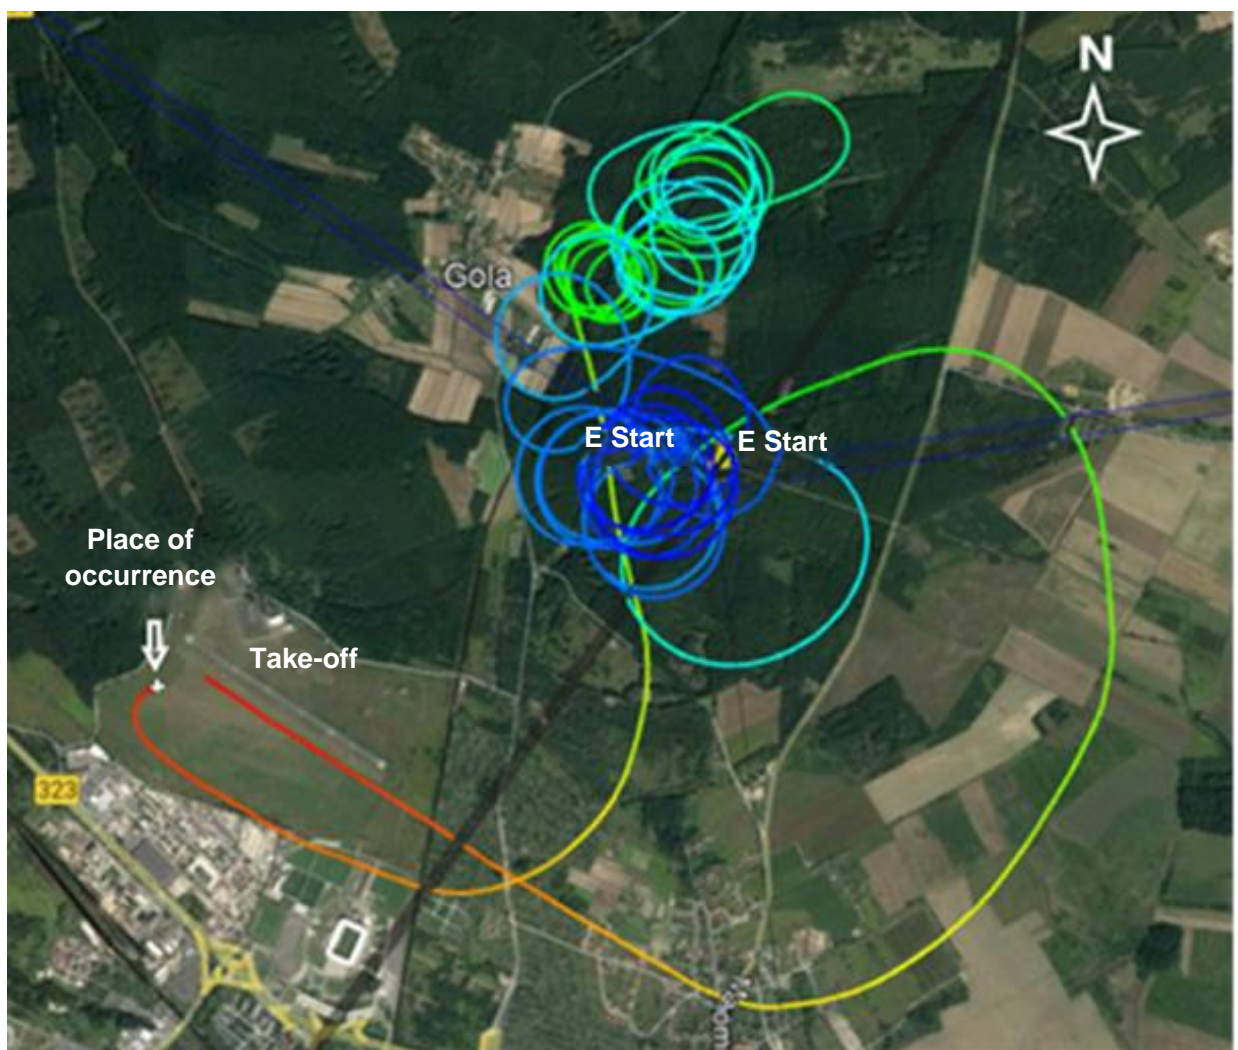
Figure 1. The flight record based on an IGC readout [source: pilot's GPS]

On 15 June 2022, the Lubin Aerodrome (ICAO code: EPLU) hosted sailplane flying competition as part of the 12 SERFTC organised by the Zagłębie Miedziowe Aero Club. Take-offs were carried out from a grass runway in direction 13. At 12:03 hrs, sailplane ASG-29E with registration marks SP-3818, took off. The pilot planned to carry out a freestyle training flight. Following an aerotow, the pilot released his sailplane at a height of about 600 m and started thermalling in circles above the forest to the north-east of the aerodrome (Figure 1). In circling, the pilot climbed additional 80 m and thereafter started to descend.

At about 12:30 hrs, when the sailplane was in the area of the first turn at about 200 m AGL, the pilot commenced an unsuccessful attempt to start the sustainer engine. The pilot was flying downwind leg of the right hand traffic pattern. During the turn to final, the sailplane was stalled at a low height. It hit the ground with the right wing and subsequently with the nose section of the fuselage. Moving on the ground for 50 m,

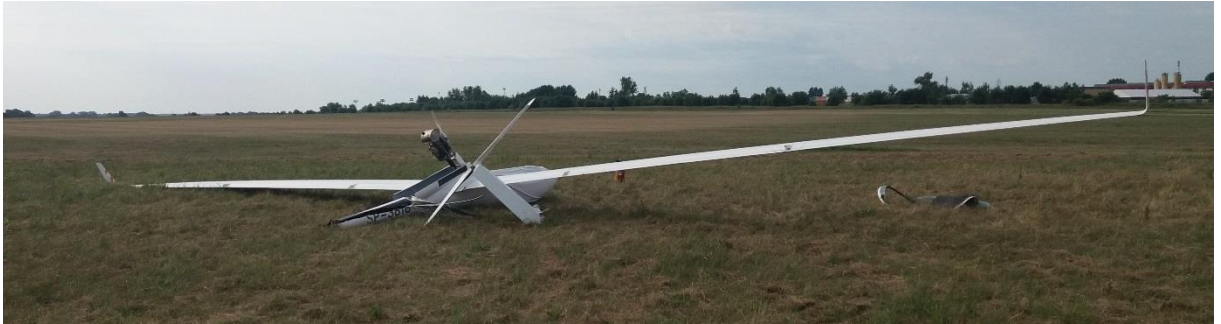
Figure 2. A photograph of the sailplane after the occurrence [source: Dariusz Deptuła]

As a result of the collision, the pilot suffered serious injuries and the sailplane sustained substantial damage (Figure 2).

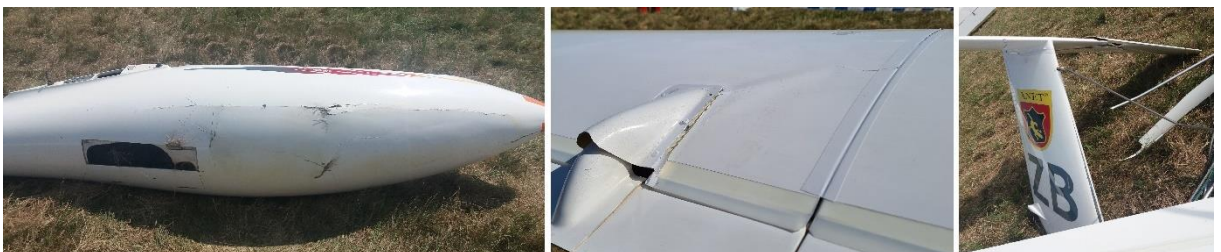
Figure 3. Damage to the sailplane [source: PKBWL]

As a result of the sailplane collision with the ground, the nose section of the fuselage, wings and the vertical and horizontal stabilisers were damaged, the tail boom and the propeller brake cable broke (Figure 3).

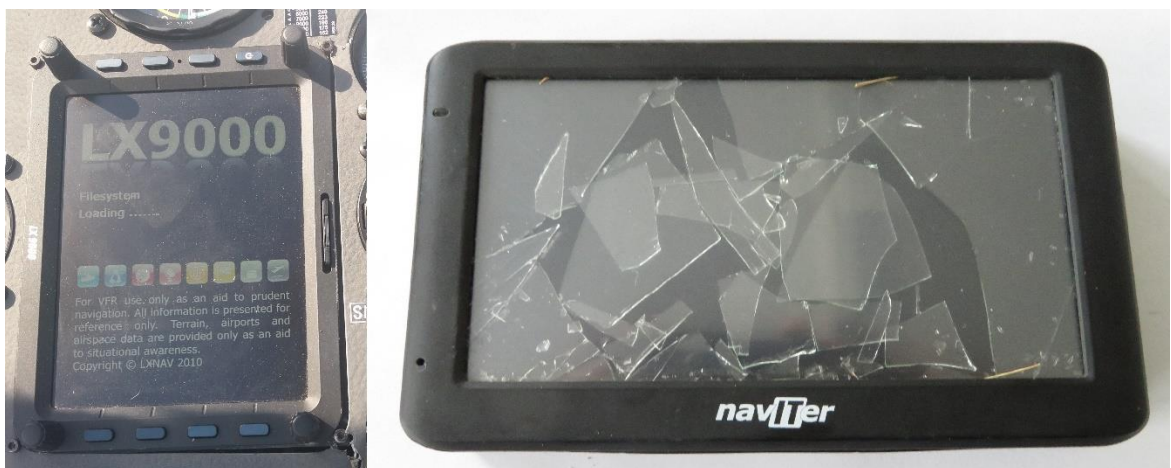
Figure 6. Flight recorders. On the right is the damaged Naviter Oudie IGC [source: PKBWL]

The sailplane instrument panel has a manufacturer-fitted GPS LX 9000, and during the flight the pilot used a Naviter Oudie IGC NAV-96X, which was damaged as a result of the occurrence (Figure 6).

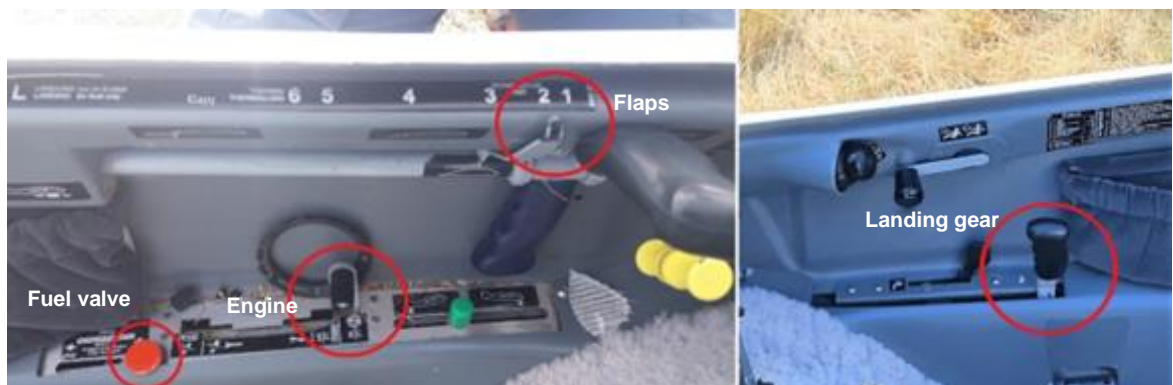
Figure 7. Positions of the levers in the cockpit [source: PKBWL]

- the sailplane moved about 50 m following impact;
- the landing gear lever in the cockpit was in the “retracted” setting (Figure 7);
- the flaps were in the "2" position – a negative deflection angle (Figure 7);
- the fuel valve was open;
- the engine deployment and start lever was in the ON position;
- the ballast tanks contained no water;
- the fuel tank contained 8 l of fuel (Figure 8);
- the fuel in the filter was clean (Figure 8).

A post-occurrence inspection of the cockpit revealed that the flap lever was in the "2" position and the landing gear lever in the "retracted" position.

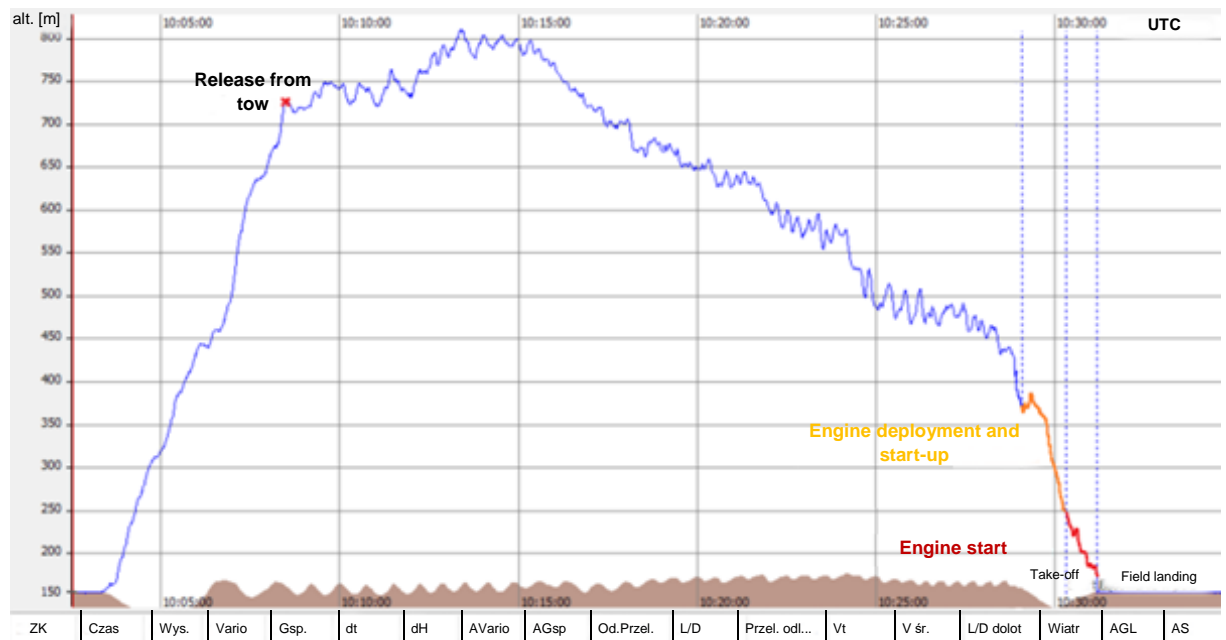
Figure 9. Flight altitude record [source: LX 9000]

aerodrome and accelerated to 152 km/h, and when at 225 m AGL, he initiated engine start up (Figure 1. START E, Figure 9).

The pilot commenced the engine starting process at a too low height, contrary to the FM provisions.

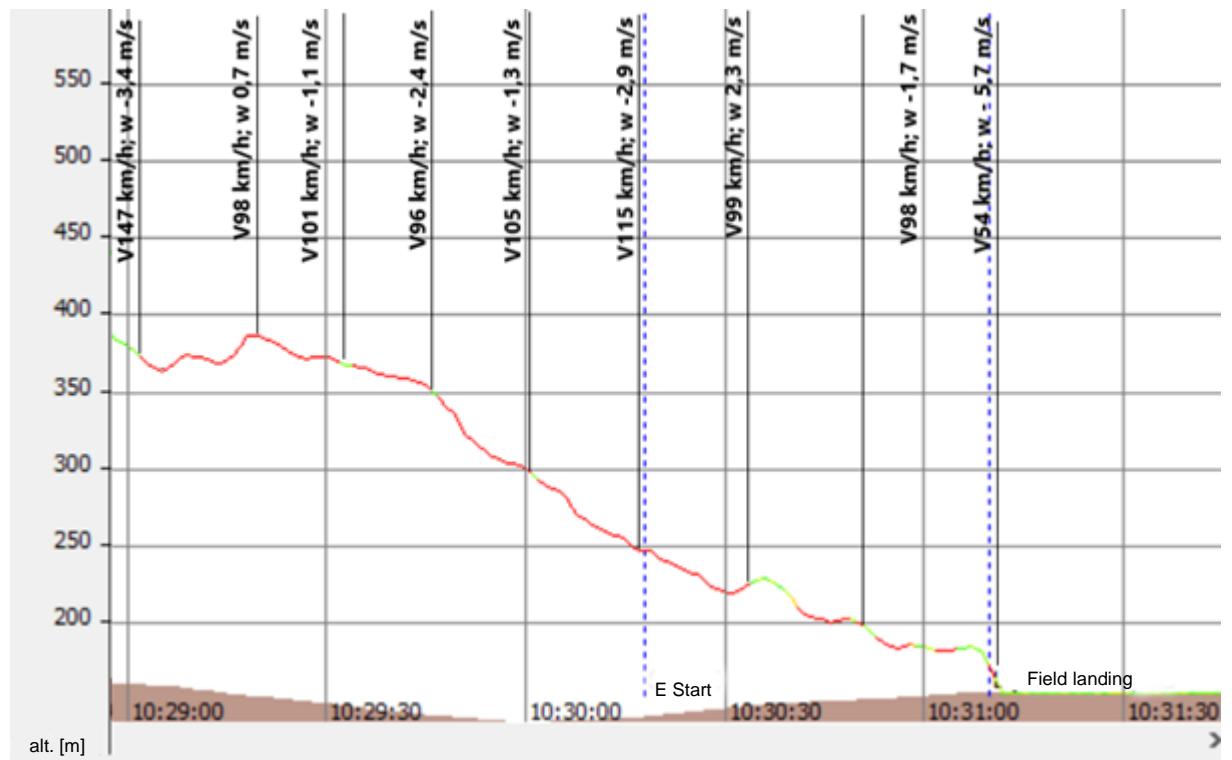
Figure 10. Altitude recording supplemented by airspeeds and rate-of-climb-indicator readouts  
 [source: Naviter Oudie]

Analysis of the final flight phase of the recording (Figure 10) shows that the pilot commenced deploying the powerplant at 225 m AGL with airspeed of 147 km/h and descent rate of 3.4 m/s and then, until the recorded engine start, the airspeed did not exceed 117 km/h. Upon deployment of the powerplant (about 7 s), when the green LED was on, the pilot should move the engine lever to DECO (decompression) and increase airspeed above 120 km/h to increase the propeller RPM, and only then should he move the engine lever to IGNITION. As shown by the recording, the airspeed was too low for starting up the engine, therefore, the engine did not run properly – it did not reach full power.

After starting the engine, the pilot reduced airspeed to ca. 100 km/h and made several attempts to commence climbing, but was unsuccessful as the engine was not working properly.

The unsuccessful attempts to climb during the flight were described by witnesses as "steep climbs made by the sailplane" (Figure 10).

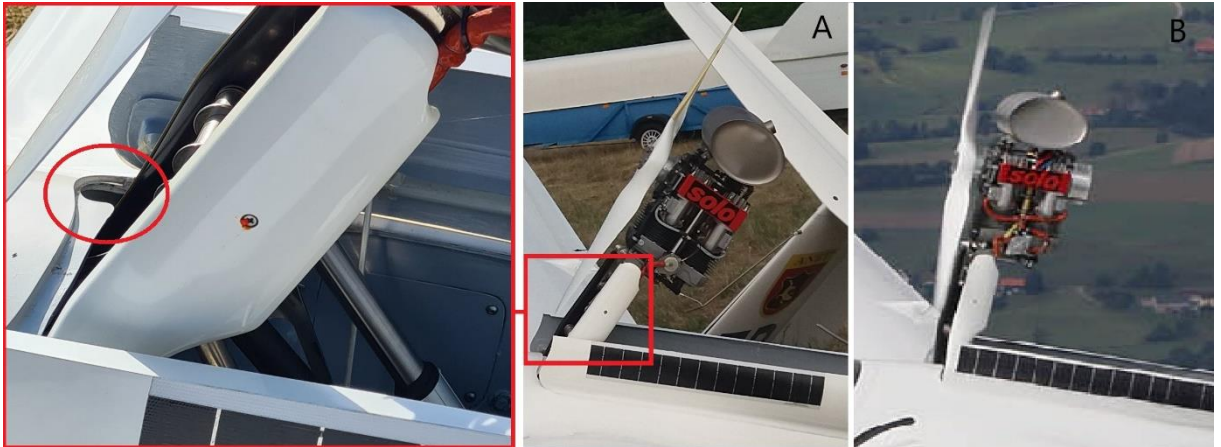
Figure 11. Position of the mast: A: in the accident sailplane after the occurrence, B: correct position [source: PKBWL, Internet]

During a post-occurrence inspection of the sailplane it was established that the mast on which the engine is mounted had not been extended fully (Figure 11).

After an unsuccessful attempt to start the engine and after reading SWITCH E message on the LED panel, the pilot should check the position of the (engine) mast in the mirror. Upon noticing that the mast is not extended properly, the pilot should carry out the procedure provided for such a situation in the FM.

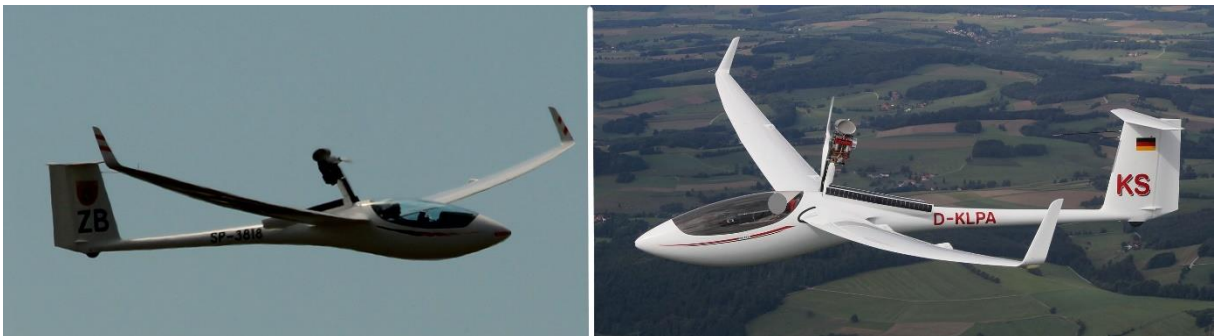
Figure 12. Position of the mast in flight: left – in the sailplane involved in the accident, right – the correct position [source: Dariusz Deptula, Internet]

Inflight photos of the sailplane also show that the mast was not extended fully (Figure 12).

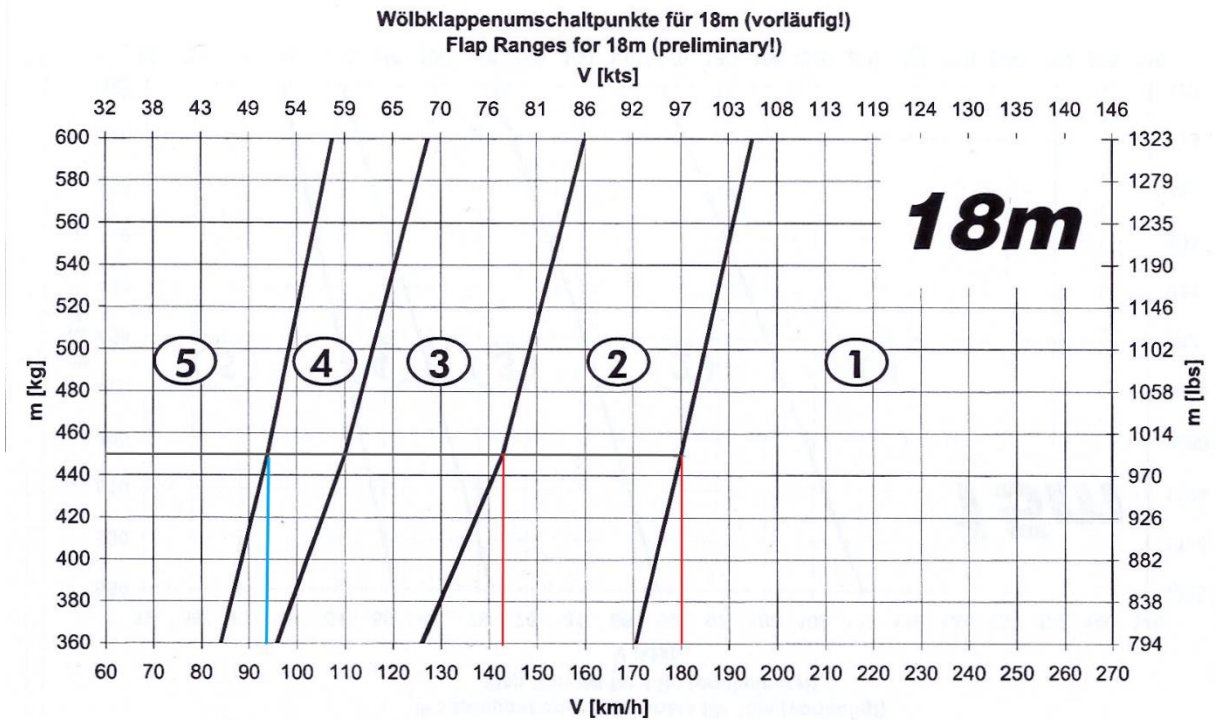
Figure 13. A chart showing recommended flap settings in a straight flight, depending on the sailplane mass [source: FM]

Flap position "2" is designed for performing an optimal flight at higher airspeeds. According to the FM, at the actual weight of 451.8 kg, the airspeed range is 143-180 km/h, whereas flap position "5" is for flying at airspeeds below 93 km/h (Figure 13).

It must be noted that with the flaps set at "2", the minimum (stall) airspeed is greater than in position "5". It is likely that if the flaps had been set at "5", the sailplane would not have been stalled in turn.

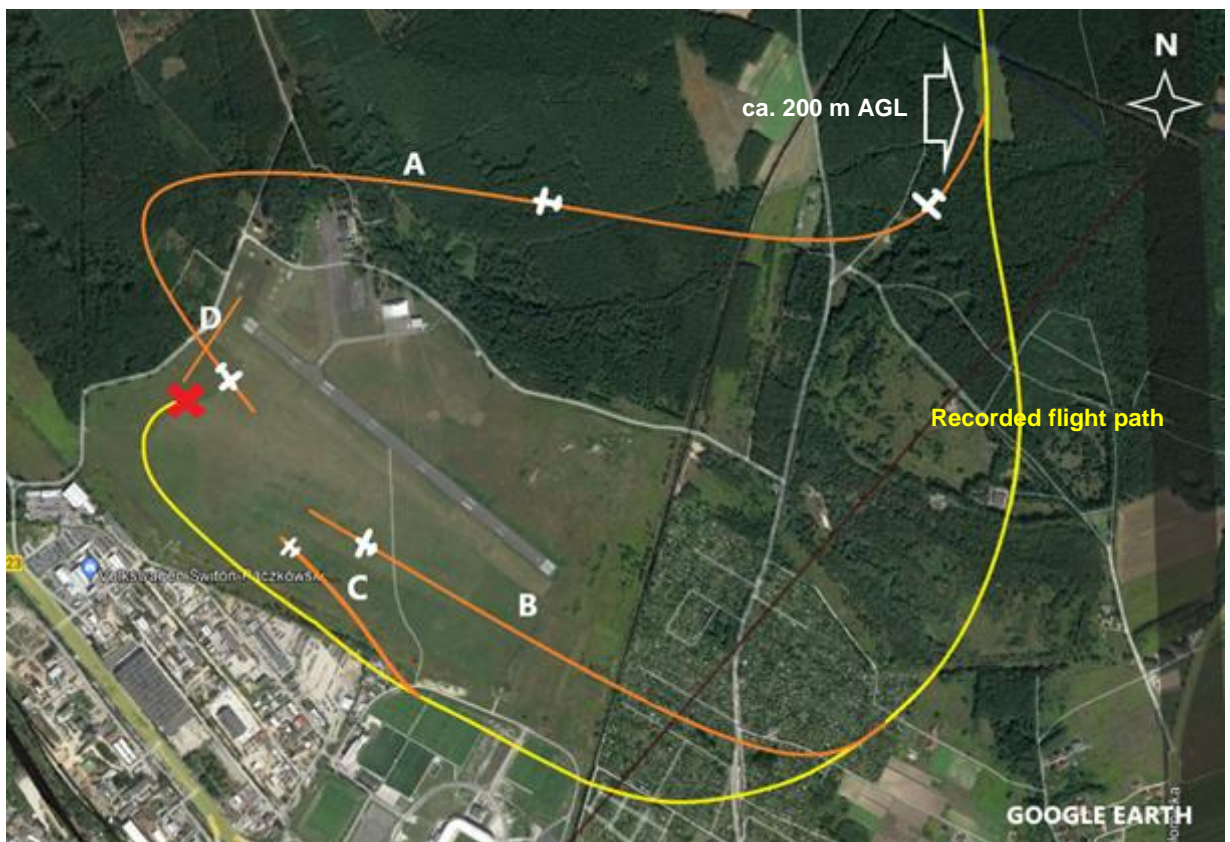
Figure 14. Recorded flight and possible safe approach options [source: PKBWL]

When the sailplane was flying downwind (at about 50 m AGL, and the engine was running incorrectly, the pilot still had time to make a decision to land downwind with the power plant deployed (Fig. 14, section C). To do that, he could have set the engine start lever to DECO to shutdown the engine and land with a windmilling propeller. Had the pilot made that decision, he would have ca. 1 km of ground within the aerodrome limits in direction 31 at his disposal (partially beyond designated runways).

The pilot could have performed the landing approach either by flying along the northern side of the aerodrome and bringing the sailplane on final for landing on RWY 13 (Figure 14, section A) or by landing downwind in the direction of RWY 31 (Figure 14, section B).

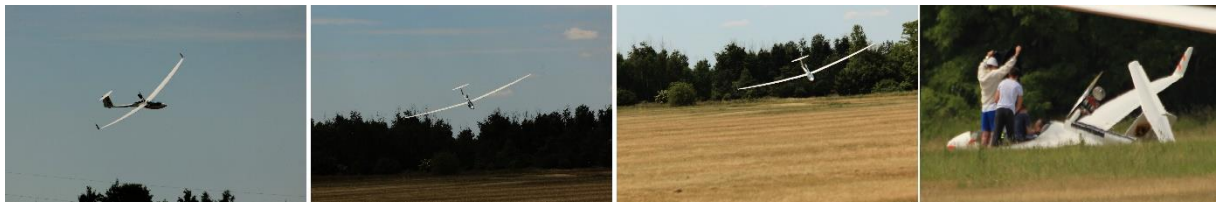
Figure 15. The final phase of the flight and the sailplane after the occurrence [source: Dariusz Deptuła]

The pilot commenced a 180° turn for landing at a height of about 30 m (Figure 15). Until the impact, the airspeed in turn decreased from 108 km/h to ca. 95 km/h. During the turn, the sailplane was stalled, slid down on the right wing, which hit the ground. The wing was bent and, with a spring reaction, threw the sailplane up. Subsequently, the sailplane hit the ground with its fuselage and tail. As a result of the impact, the tail boom broke and the sailplane spun ca. 180° and moved ca. 50 m (Figure 16).

Performing a 180° turn at a height so low, and with the power plant deployed (which had an air brake effect), was bound to be unsuccessful. After a 90° turn, the pilot could have landed across the aerodrome (Figure 14, section D). Then, he would have ca. 350 m of the ground beyond the aerodrome's usable area at his disposal. It is likely that the effects of such landing would have been less serious.
