FINAL REPORT

SERIOUS INCIDENT

OCCURRENCE NO. – 2022/1097

AIRCRAFT – Extra NG, SP-HMM

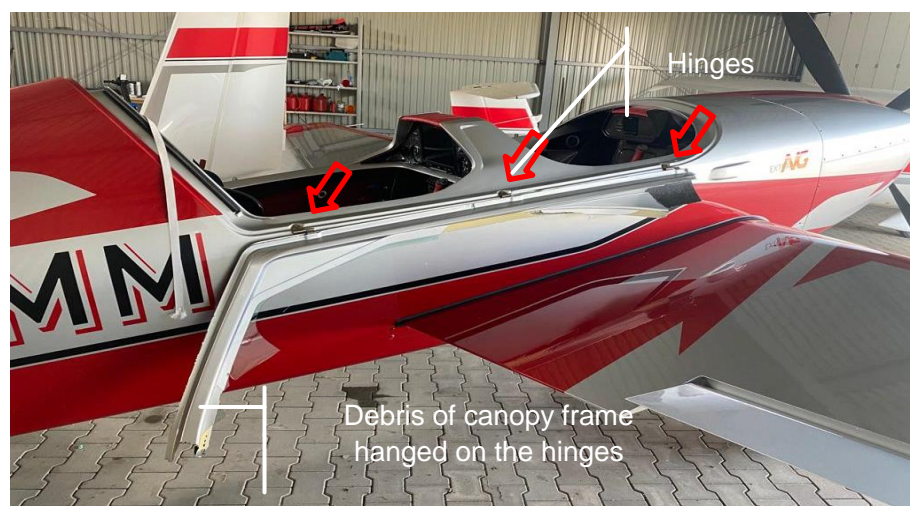
During the flight the canopy released from its locks on the portside of the fuselage, turned on hinges, hit the right upper wing skin and broke. A part of the frame remained on the starboard, some debris detached from the aircraft and fell on the ground. Due to collision with canopy debris, the vertical fin, rudder as well as right side of horizontal stabilizer sustained minor damage (dents, scratches, paint chips).

Fig. 2 Cockpit of the aircraft and a part of the broken canopy frame [source: SCAA]

The aircraft was sent to the manufacturer for repair.

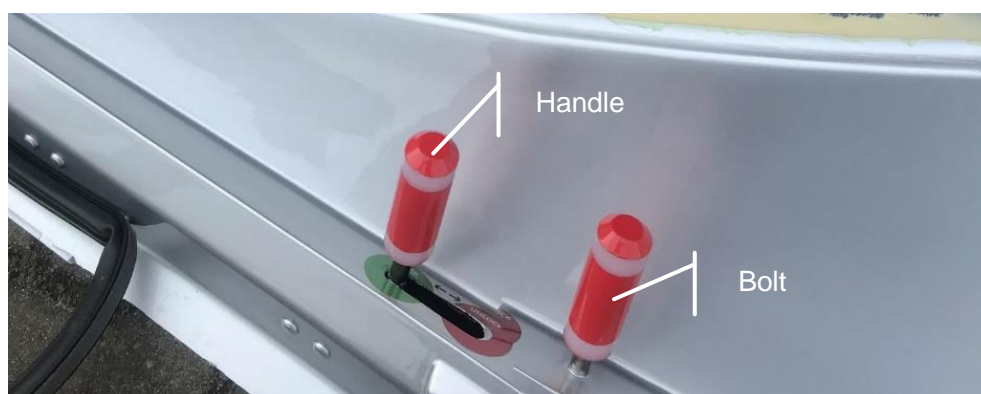
To lock the closed canopy, it is necessary to pull the sliding handle located on the left side of the pilot (Fig. 5). The handle is connected with two pawls getting in contact with appropriate fittings on the cockpit side and creating the locks. The mechanism works in unlocked/locked settings and has been equipped with a notch (dead point) activated after moving the handle to its locked position. Inside the cockpit, on the same pushrod, there are two handles available respectively from the rear and front seat. In flight, in case of unlocking (canopy jettisoning), the canopy moves automatically back on the hinge guides and detaches from an airplane.

Fig. 5 Canopy locking mechanism located at the passenger seat, on the left side (portside). The fixed bolt allows to move the handle in case of high force required [source: SCAA]

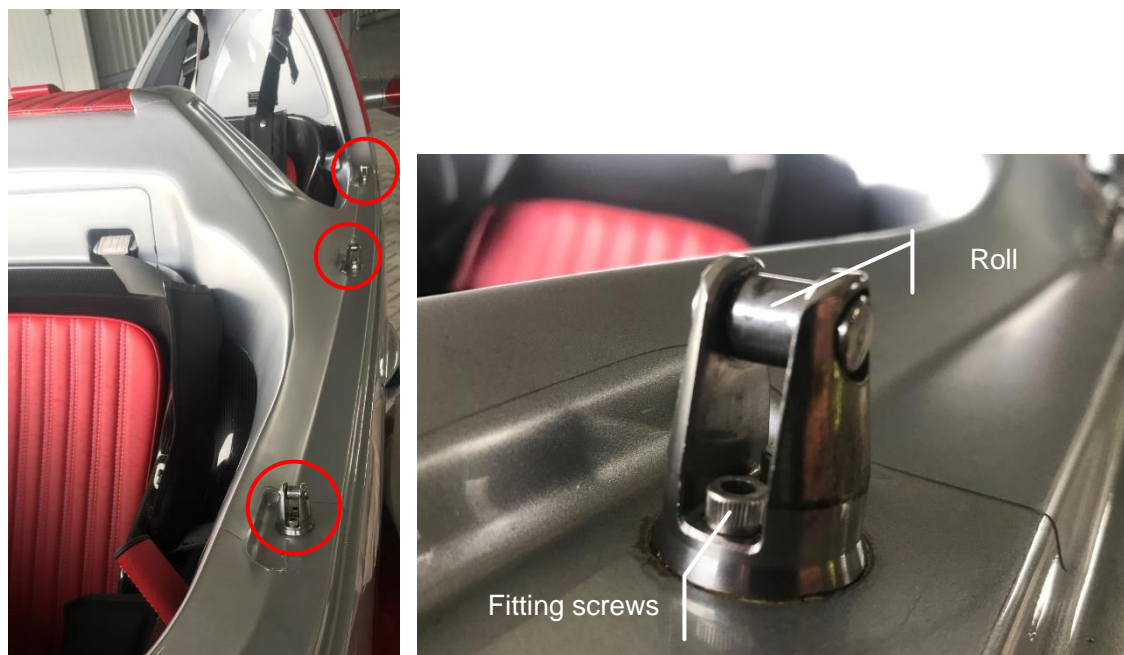
The visual inspection of fittings (Fig. 6) on the portside as well as corresponding pawls located on the same pushrod (Fig. 7) did not reveal their damage. Each fitting was screwed to the fuselage by two screws (Fig. 6). The screws of rear fitting were found loosened, causing that even if the pawl was tightly joined with its fitting, there was a clearance between the fitting and the portside. This clearance could have caused vibrations of the canopy.

Each fitting was equipped with a roll on its upper side, to decrease the resistance during opening and closing the canopy. This solution also allows to increase the force pressing the canopy frame to the fuselage, which combined with a rubber seal allows to eliminate vibration.

Fig. 6 Fittings for pawls on the portside [source: SCAA]

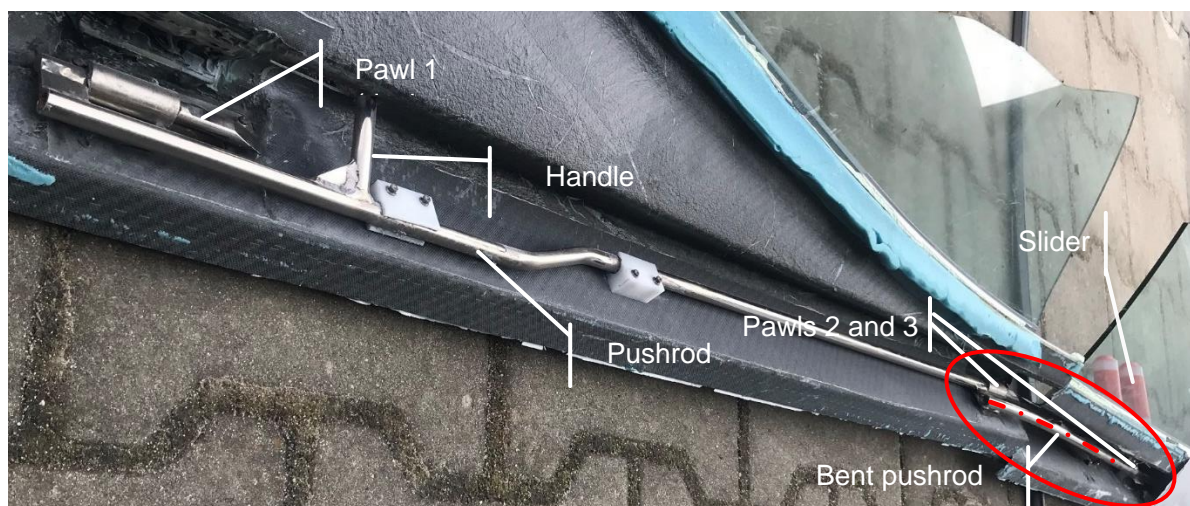
Fig. 7 Pawls on the common pushrod [source: SCAA]

The pushrod with the pawls was found slightly bent, probably due to high stress over the material yield strength, occurred when the canopy was being destroyed – while detaching from the aircraft or/and while hitting the ground. The bent part of the pushrod was marked with the red ellipse (see Fig. 7).

The pawls on the detached part of the canopy were found in their locked settings (Fig. 7). It does not mean that the canopy was detached when the pawls were locked – this would not be possible. The pawls must have been opened prior to the detachment, and after the detachment the pushrod was displaced to the „locked” position of the pawls due to the force exerted by the spring, partially visible in Fig. 8.

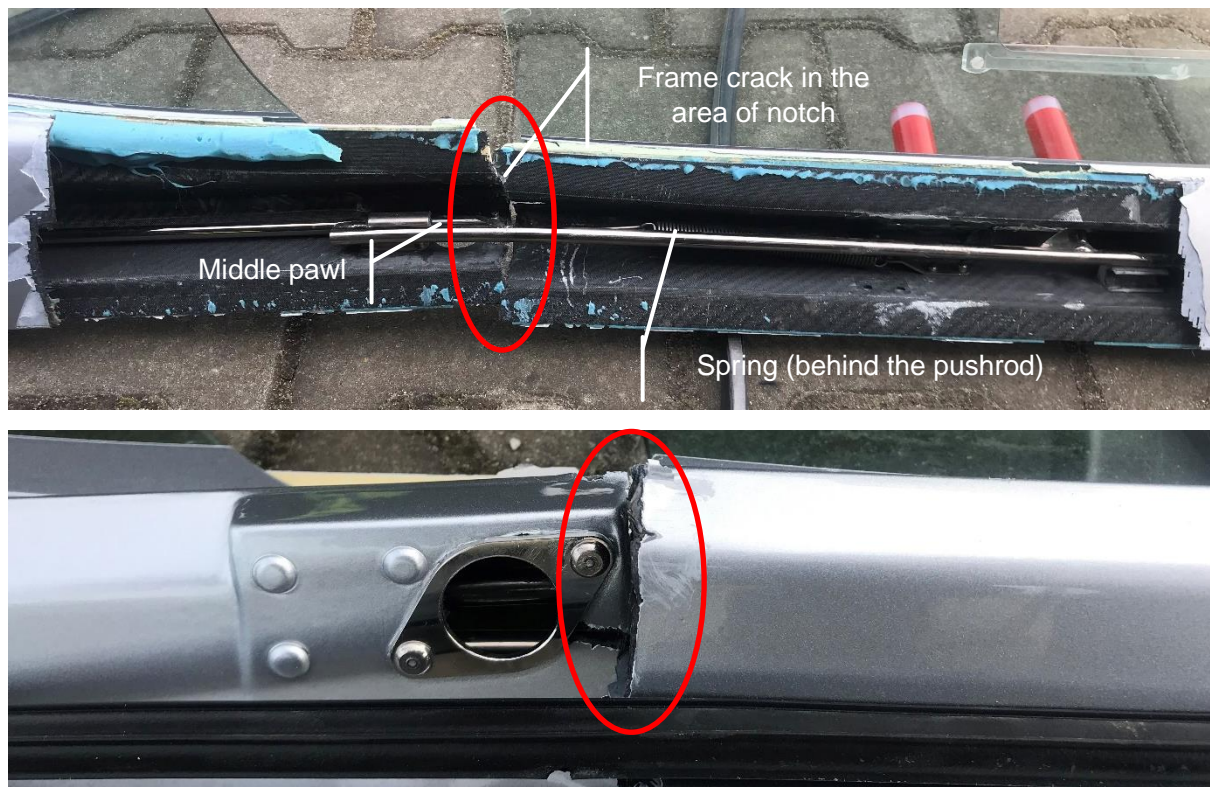
The above leads to the conclusion, the most probable reason of displacement of the pawls from corresponding fittings (if an intended opening is excluded) were vibrations caused by loss of the canopy frame rigidity after its cracking. These vibrations occurred after loosening the rear fitting in the system of pawl locking, when the force pressing the frame to the cabin side decreased. The frame crack started the destruction process. The crack occurred probably in the area of stress concentration (notch), near the middle pawl (Fig. 8).

Fig. 8 Cracked canopy frame in the area of middle pawl location. A notch is present on the edge of fitting slot reinforcement [source: SCAA]

Most probably, the noise heard by the occupants during the flight before the occurrence, came from the canopy – the aircraft element with lost stiffness due to cracked carbon-fibre frame but also the loosened rear fitting.

In case of carbon-fibre composite cracking, the loss of stiffness comes suddenly and usually the whole affected part is destroyed.

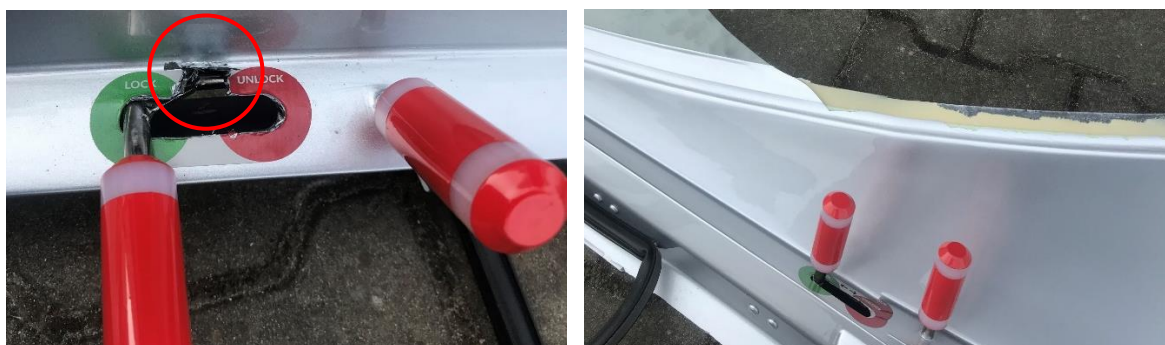
Fig. 9 Handles and sliders locking the canopy: rear (on the left) and front (on the right) [source: SCAA]

The damaged frame in the area of the rear slider (marked by a red circle in Fig. 9) proves high intensity of vibrations. A recess in the composite has been grooved by the handle of the slider.

The vibrations might have been caused by air pulsation around the aircraft flying with a high speed or by high RPM of the powerplant.
