FINAL REPORT

State Commission on Aircraft Accidents Investigation (PKBWL)

OCCURRENCE NO – 2022/1340

AIRCRAFT – ULTRALIGHT AMPHIBIA, N27ZX

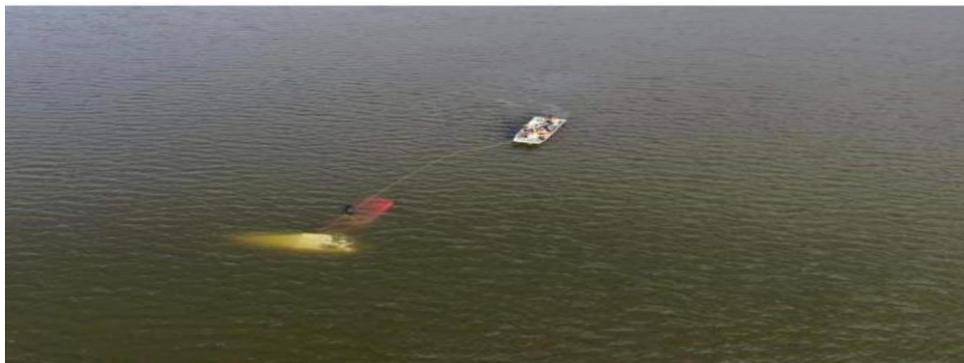
Fig.1. Wreckage of the N27ZX airplane photographed from a drone at the beginning of the rescue operation [source: Internet]

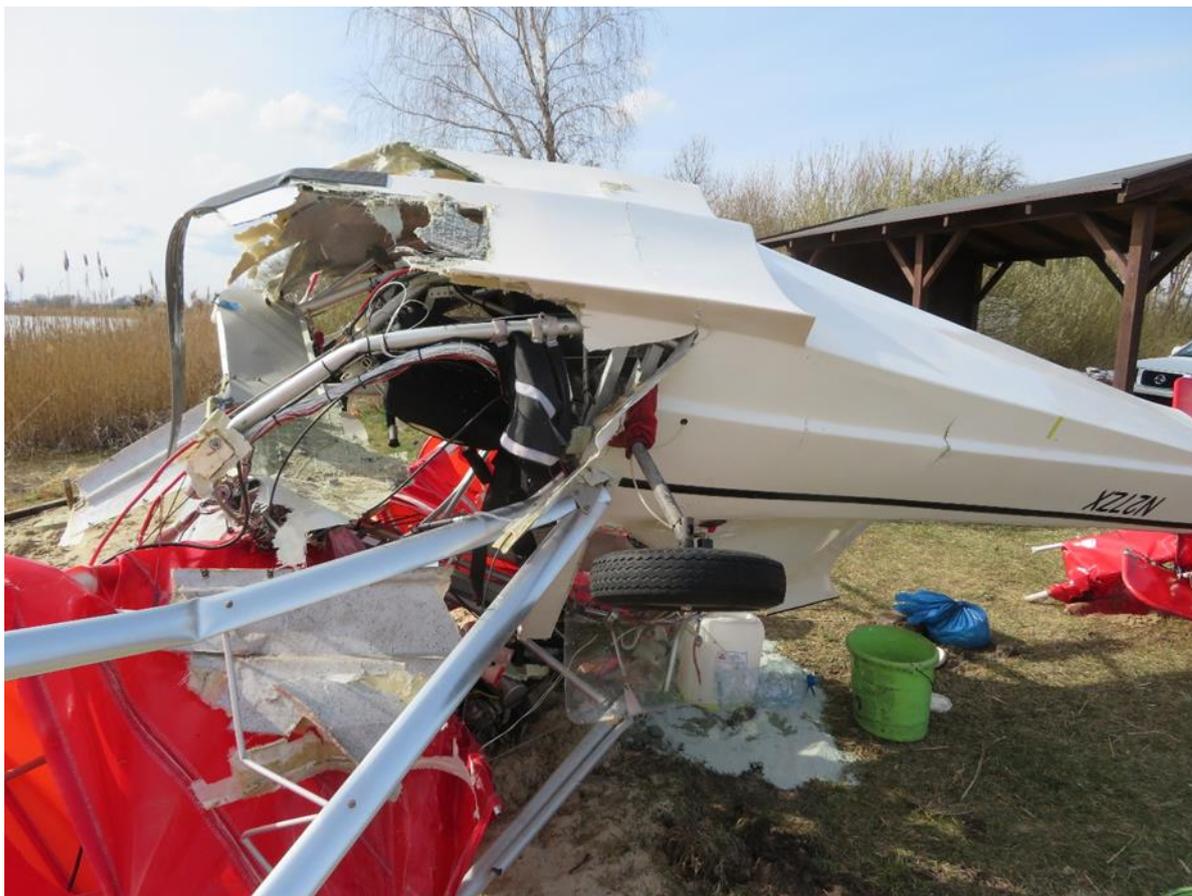
As a result of the collision with water, the plane was destroyed. The nose part of the fuselage, together with the door and left float separated from the rest of the airframe (Fig. 3 and Fig. 4).

Fig. 3. View of the damaged front part of the fuselage in inverted position
[source: PKBWL]

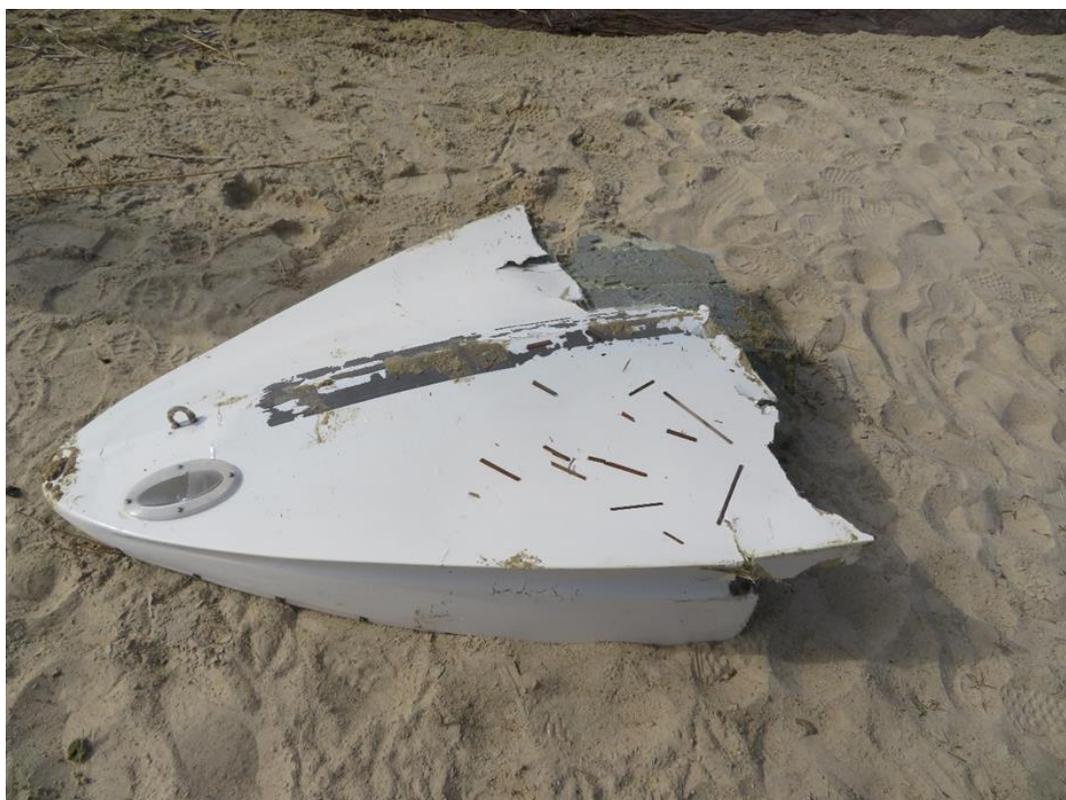
Fig. 4. View of the detached lower part of the fuselage [source: PKBWL]

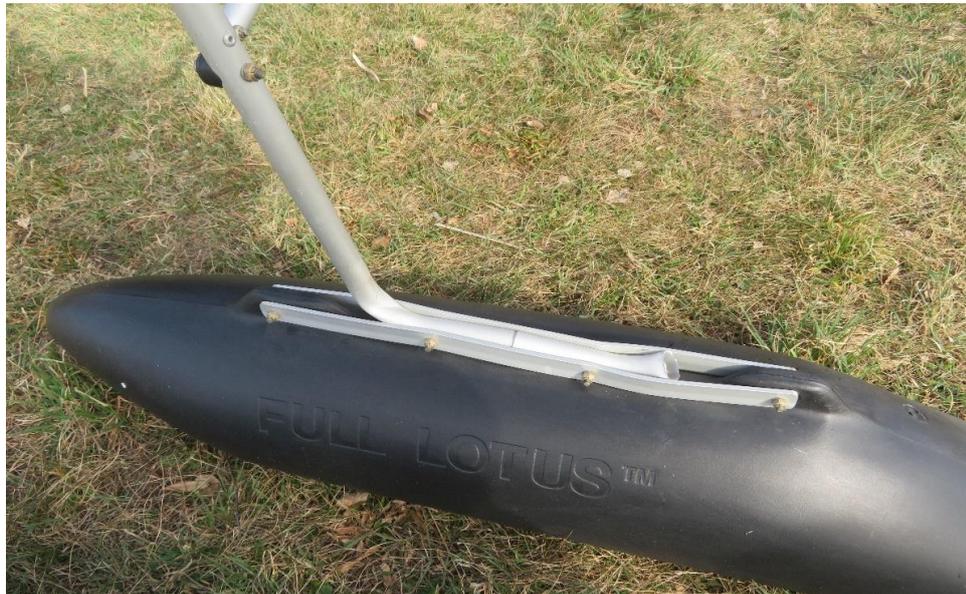
During the inspection, it was found that the airframe was more damaged on its left side, that is evidenced by:

- separated left float from the airframe after collision with water (Fig. 7.);

Fig. 7. Separated left float [source: PKBWL]

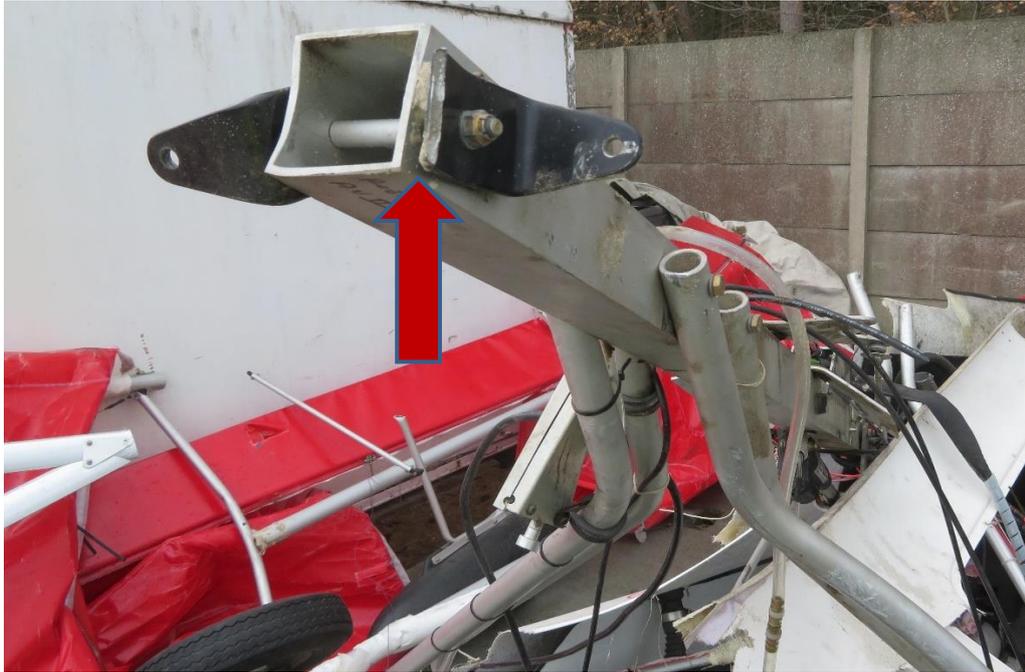
- Broken hinge of the front spar of the left wing (Fig. 8).

Fig. 8. Broken hinge of the front spar of the left wing [source: PKBWL]

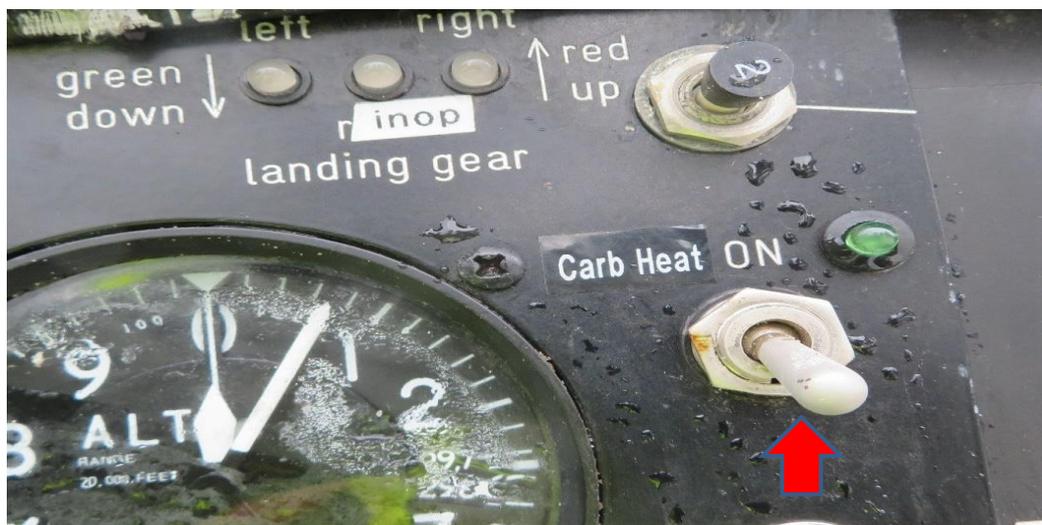
- fuel valve – open;
- electric fuel pump switch – off;
- throttle control lever – retracted;
- carburetor heating switch – off (Fig. 9);
- main electric power switch – off;
- turn indicator – left turn (Fig. 10).

Fig. 9. Carburetor heating switch in off position [source: PKBWL]

- 7) All control surfaces were identified and all damage to the aircraft was the result of high forces resulting from the impact.
- 8) The fuel remaining in the aircraft tanks was not contaminated.
- 9) The engine was running until the collision with water.
- 10) After recovery of the wreckage from the water, it was found that the switch of electric heating of the carburetors was turned off.

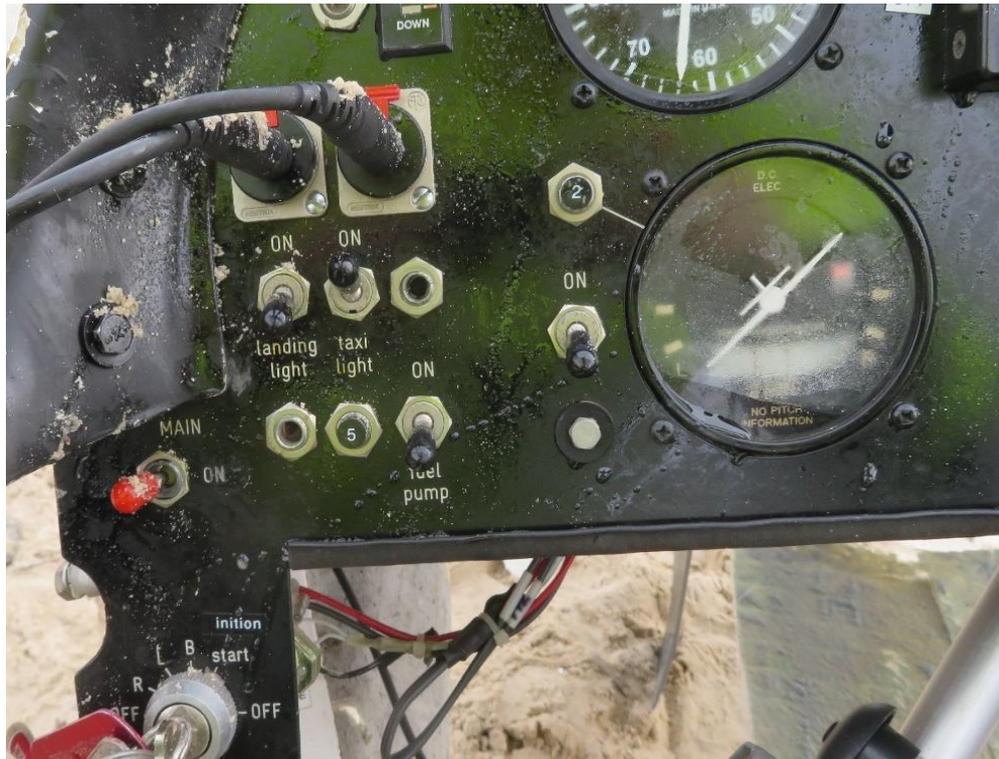
Fig. 10. Turn indicator indicating left turn [source: PKBWL]

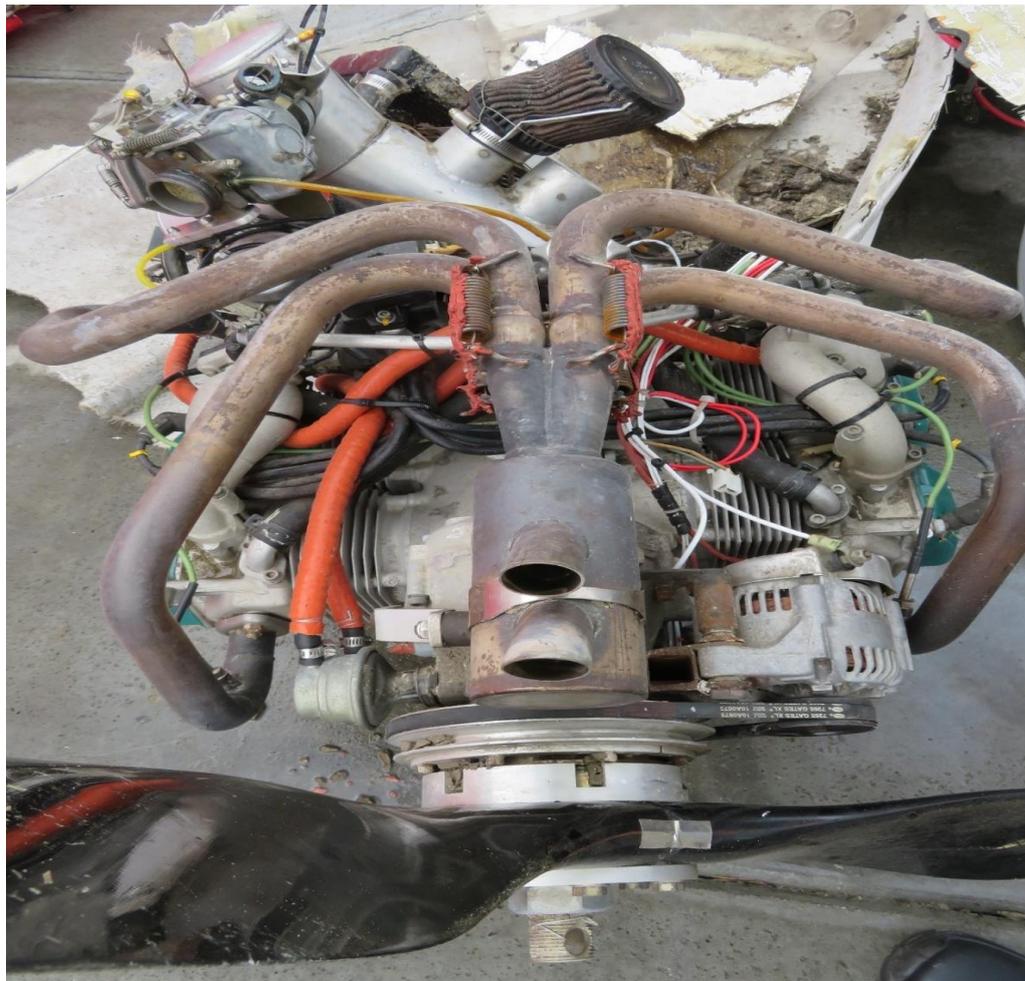
During the inspection of the accident site on 30 March 2022, it was found that only few components installed on the engine (air filters, carburetors) were mechanically damaged due to collision with water. All electric cables, hoses and pipes of the fuel, lubrication and cooling systems were in good mechanical condition. No damage to the engine control system was found (Fig. 11).

The mechanical condition of all spark plugs was checked. Spark plugs were installed on the engine in accordance with the manufacturer's recommendations, and their mechanical condition did not raise any concerns.

Fig. 11. General technical condition of the engine after collision with water [source: PKBWL].

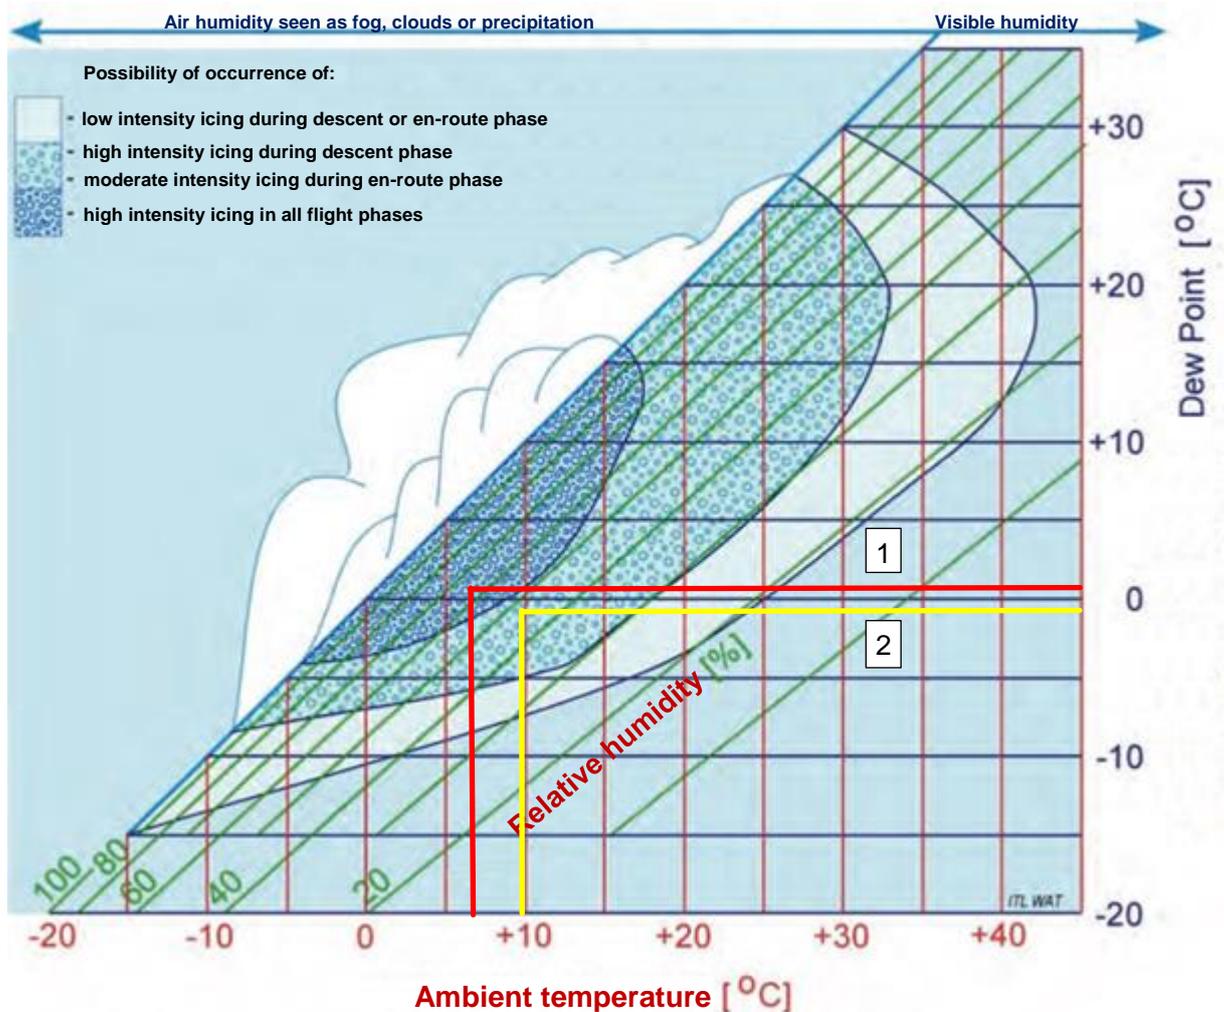
For this purpose, the meteorological data from the accident area were plotted on a graph showing the possibility of icing in aviation piston engines (Fig. 17 - red lines).

Fig. 17. Graph for determination of a possibility of carburetors icing [source: Internet]

The graph clearly shows that during the accident time there was a possibility of high-intensity carburetor icing in each phase of the flight (item 1).

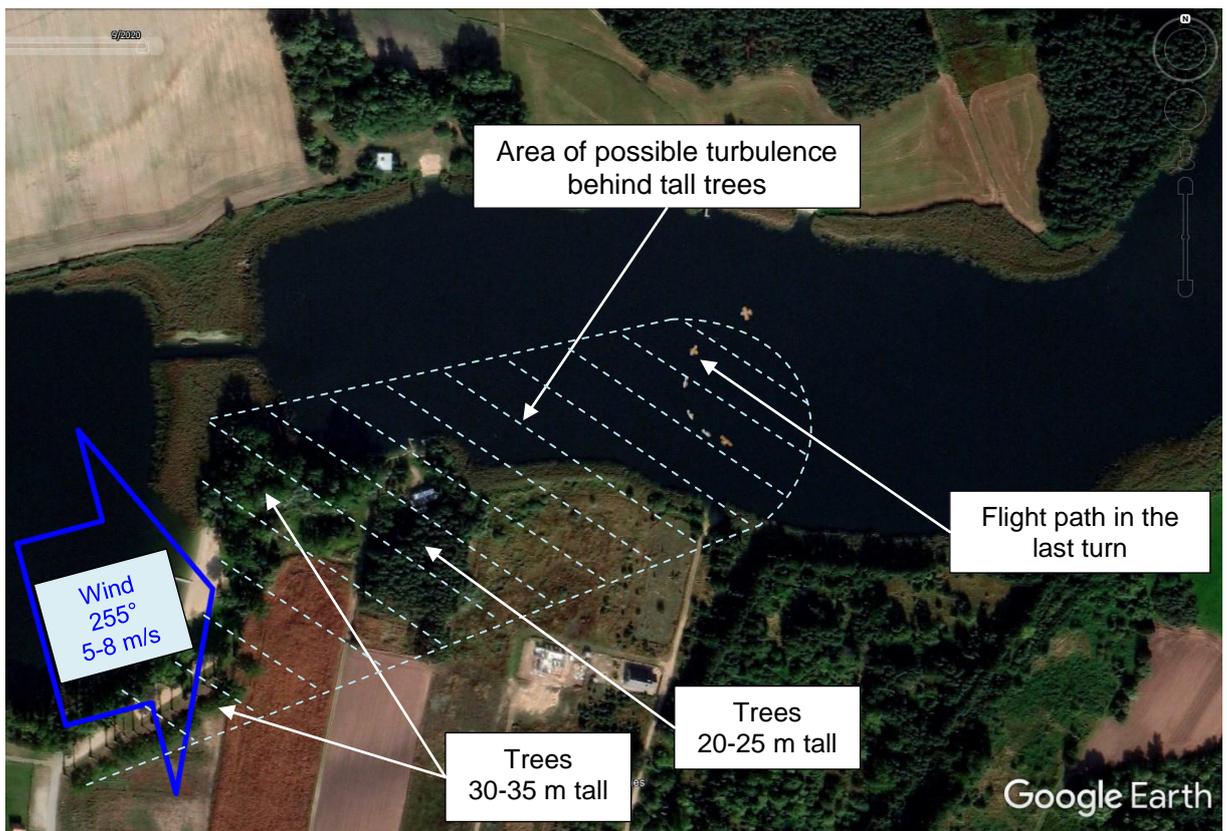
High wind speed at the scene was confirmed by witnesses and participants to the rescue operation. During the left turn, the plane was in a zone of turbulence caused by the wind and the proximity of trees, which disrupted the flow of air streams of the area shown in Fig. 18. Entering the turbulence area could have contributed to an increase in the roll angle and a decrease in the turn radius of the aircraft.

Fig. 18. Area of possible turbulence behind tall trees [source: PKBWL, Google Earth September 2020 r.]

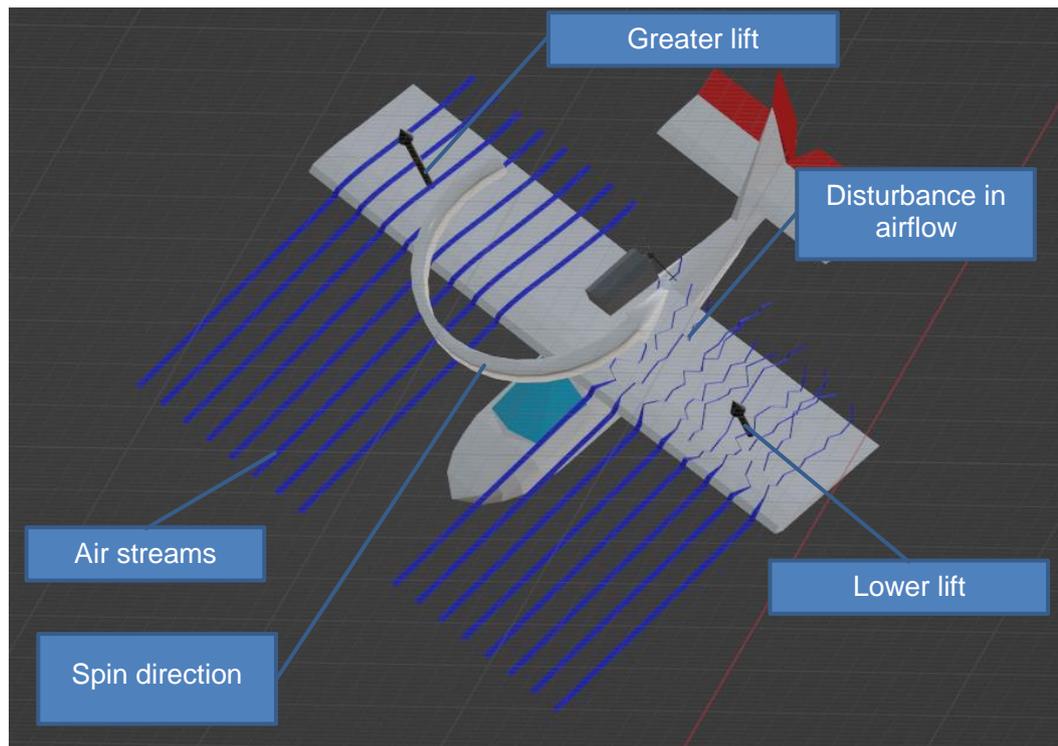
The "howl" heard by the witnesses could have occurred as a result of increase in powerplant RPM. When the airplane stalled and the autorotation started (the first phase of the spin), the airflow on descending wing was separated and turbulent airflow started, which resulted in an increase in roll and a further loss of lift, thus increasing the descent rate. At the same time, the separated airflow began to flow around the propeller (Fig. 19). The factor contributing to such a phenomenon was the fact that the powerplant on the aircraft was mounted on the upper surface of the wing.

The turbulent airflow and the increasingly steep descent caused a reduction in the powerplant load and an increase in its RPM t, which the witnesses heard as the "howl".

Fig. 19. Turbulent airflow on the descending wing during spin [source: PKBWL].
