# FINAL REPORT

2022/2454  
OCCURRENCE NUMBER

## ACCIDENT

**Helipoland Sp. z o.o.**  
**Aerospatiale AS350B3e, F-HCHB**  
**Rogoźnik Lake, 23 May 2022**

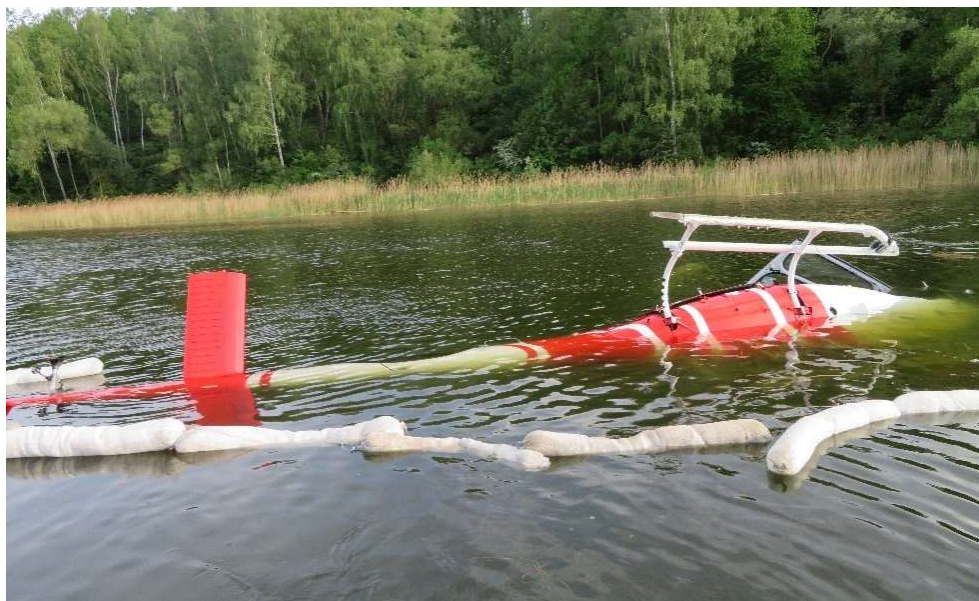
Fig. 1 Accident site – Eurocopter AS350B3e helicopter submerged in the lake and white absorbent sleeves deployed to collect contamination.

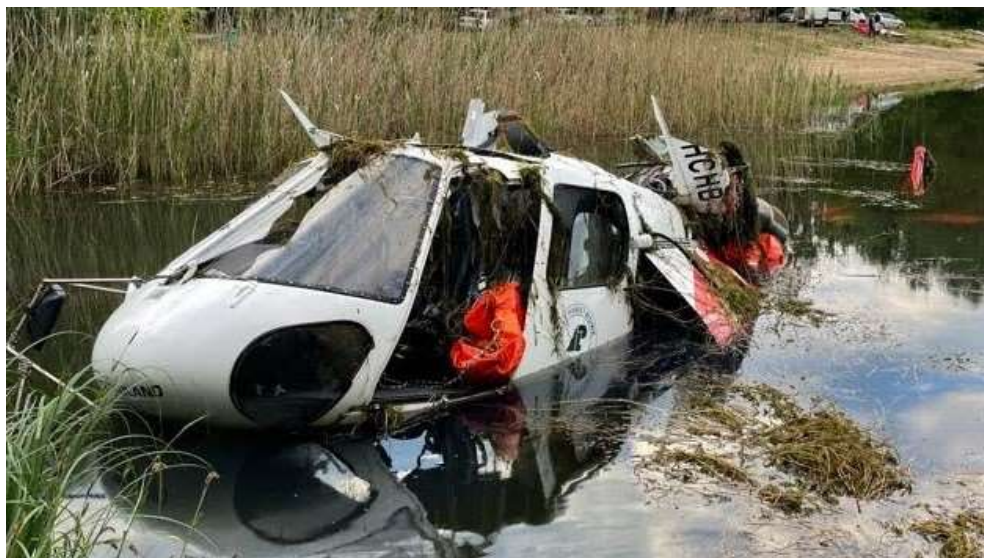
As a result of the collision with water and sinking, and the subsequent recover operation, the helicopter was destroyed (Fig. 2-3).

During the impact against water, the main rotor hub complete with rotor blades and main gearbox detached from the airframe. To lift the wreckage, the divers cut off the oil and fuel pipes and electrical wiring which were connecting the fuselage with the main gearbox, and dismantled (under water) the main rotor blades from the rotor hub.

Due to main gearbox detachment, the kinematic connections between the engine and the main gearbox and between the engine and the tail rotor shaft were severed. The engine was torn out from its rear fittings.

Fig. 2 The helicopter wreckage while being pulled onto the shore of the lake. Note the missing rotor and detached main gearbox.

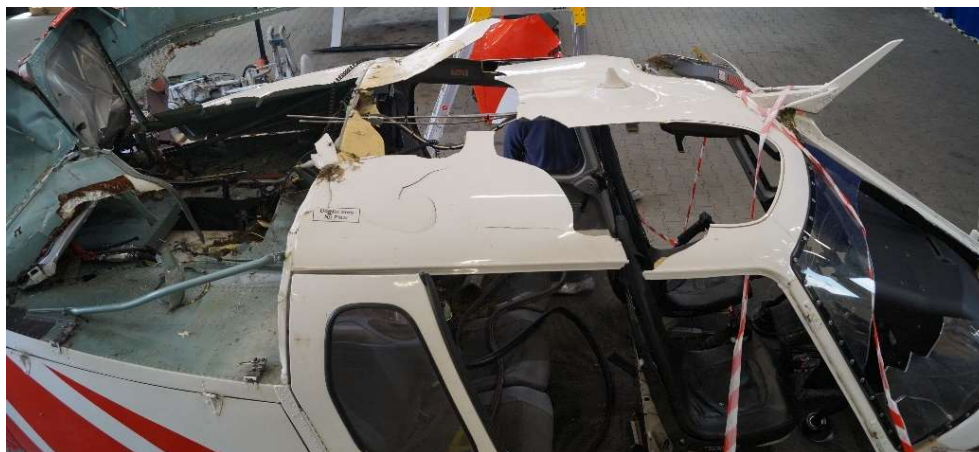
The helicopter's fuselage was substantially damaged - it was deformed and cracked. The windshield was broken and its composite central support was broken away.

Fig. 3 The damaged fuselage of the helicopter and the place of the missing main gearbox.

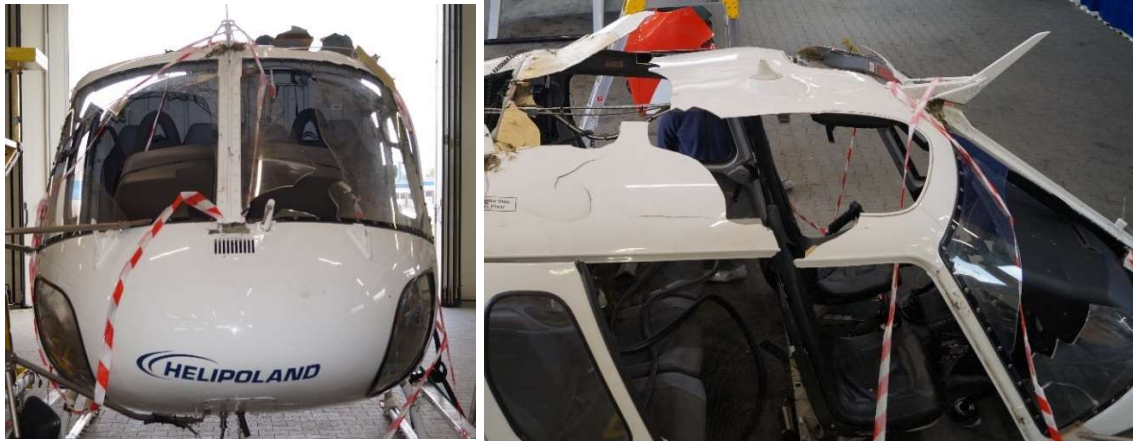
One of the rotor blades hit the left side of the helicopter near the cabin door (Fig. 9). The door was significantly deformed and the composite structure cracked.

The plexiglass cabin glazing was partially broken. The cracked glass shards posed a risk of injuries.

Fig. 9 External damage to the cockpit: breaches in the roof and large glazing fragments missing. The right-hand door is missing because it was released during evacuation.
