PRELIMINARY REPORT

SERIOUS INCIDENT 2022/2456

AIRCRAFT – Airplane, Tecnam P2006T, SP-MMB

DATE AND PLACE OF OCCURENCE – 23 May, 2022, EPBC

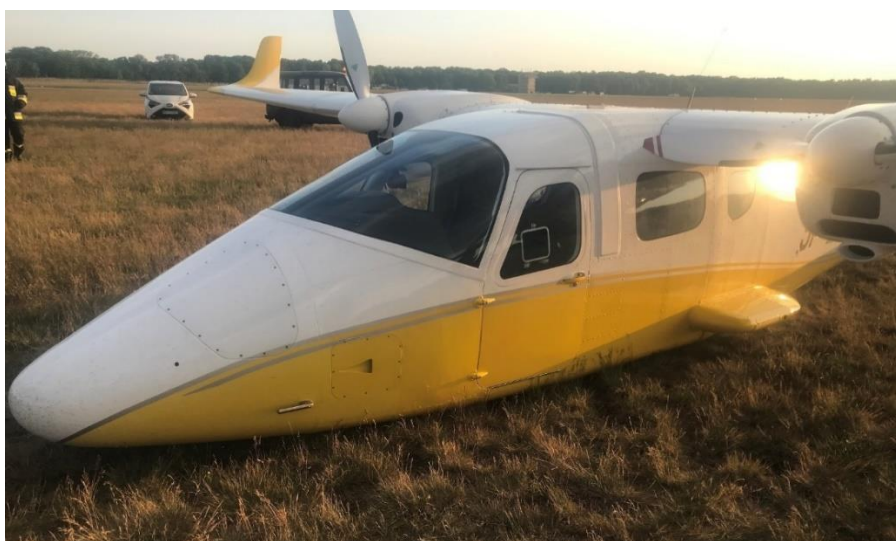
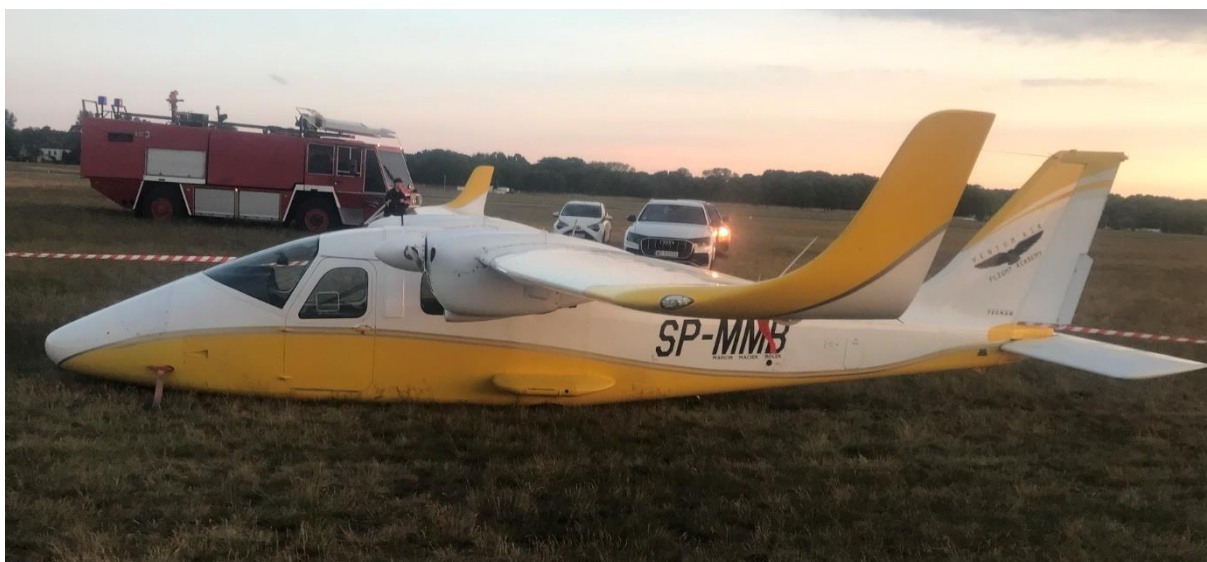
Fig. 1. Tecnam P2006T aircraft at the occurrence site [source: PKBWL¹]

Fig. 2. Tecnam P2006T aircraft at the occurrence site

As a result of the serious incident, the lower skin of the airframe, including the main landing gear nacelles, was damaged. After the occurrence, the plane was lifted the landing gear was extended and the aircraft was towed to an apron.

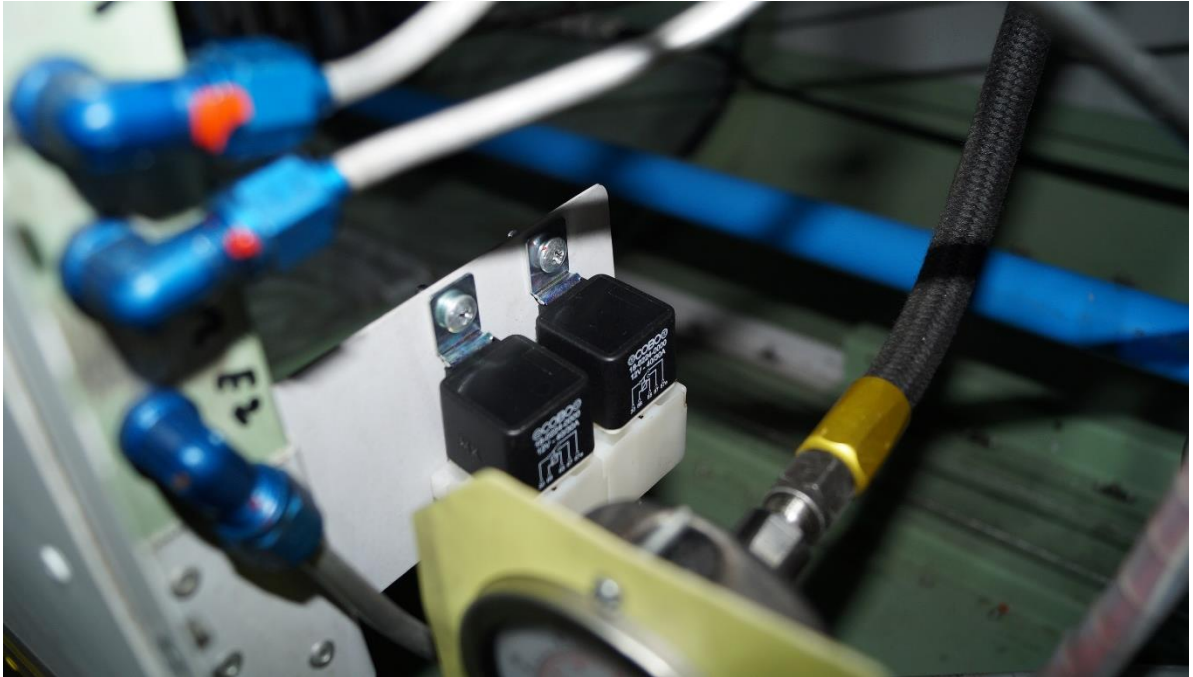
Two electric relays are installed in the circuit supplying power to the motor of the hydraulic pump of the landing gear retraction and extension system (Fig. 3 and Fig. 4).

Fig. 3. Landing gear extension and retraction system electrical relays installed on Tecnam P2006T aircraft

According to the marking on the housing of each relay, the maximum current load of the relays is 40/30A. SCAA, in cooperation with the Tecnam P2006T aircraft maintenance organization, measured the current flowing through the relay in the course of retraction and extension of the landing gear. The results of the

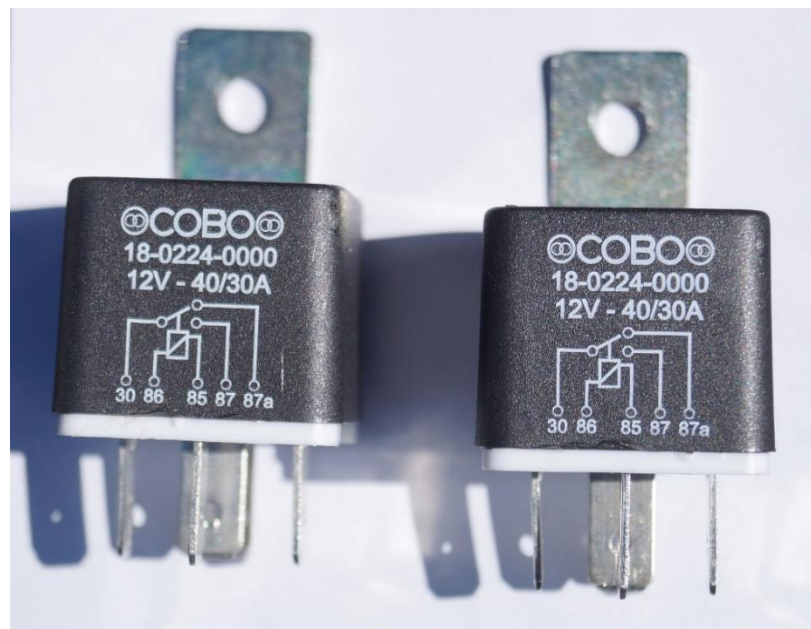
Fig. 4. Landing gear extension and retraction system electrical relays removed from the Tecnam P2006T aircraft

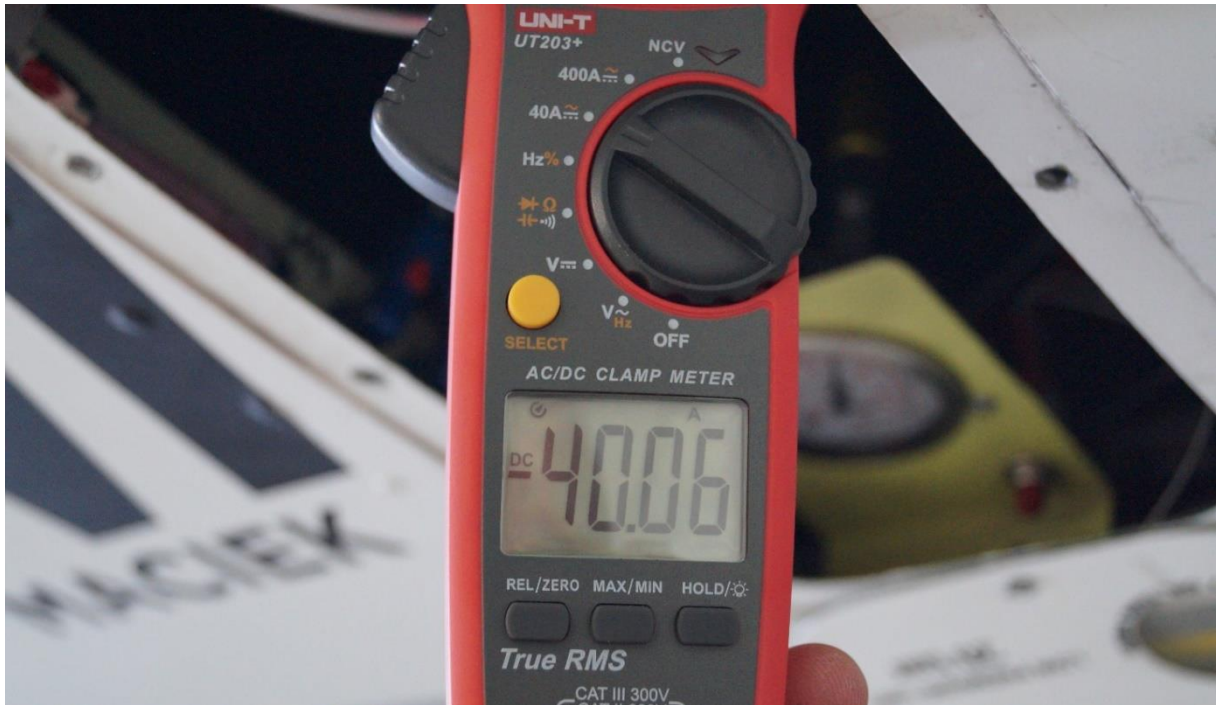
measurements show that the value of the current depends on several factors. During multiple landing gear extension and retraction in hangar conditions, the values of the maximum current fluctuated in the range of 20-30 A, however, several times reached the value of 38-39 A, and exceeded the value of 40 A twice. The highest current in the circuit occurred during the first landing gear retraction, after a few days' break in the operation of the aircraft. In subsequent cycles, the already operating system indicated lower values of the current of the hydraulic pump motor.

Fig. 5. Measurement of the current flowing through the landing gear extension and retraction system electric relays, photographed during the test

It should be noted that the landing gear tested in hangar conditions was not subjected to aerodynamic and inertial forces occurring in real flight conditions. Therefore, it can be assumed that these forces, creating additional resistance against retracting the landing gear in flight, causes an additional increase of the value of the current consumed by the hydraulic pump motor. In the described situation, the electric relays in the landing gear retraction and extension system are systematically overloaded, which results in their frequent failures.

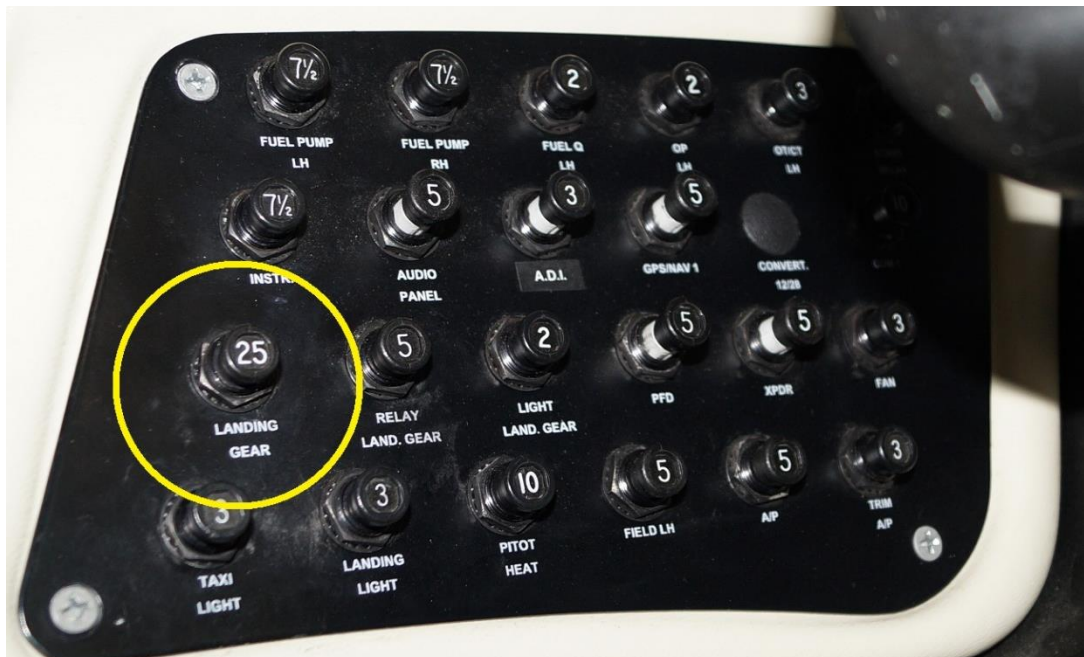
The solution to this problem would be breaking the circuit of the hydraulic pump motor by pulling the circuit breaker labelled "LANDING GEAR". Unfortunately, such an action has not been included in the procedure „EMERGENCY CHECKLIST LDG GEAR”.

Fig. 8. The circuit breakers panel of the Tecnam P2006T aircraft with the marked "LANDING GEAR" circuit breaker

The circuit breaker "LANDING GEAR" should also be marked with a bright colour to avoid an error in a stressful emergency situation when pulling it out.

For the above reasons PKBWL proposes that the manufacturer of Tecnam P2006T airplanes considers a modification of the alternate landing gear extension procedure by adding a provision that in such a need the LANDING GEAR circuit breaker must be pulled out and that the abovementioned circuit breaker must be appropriately marked.

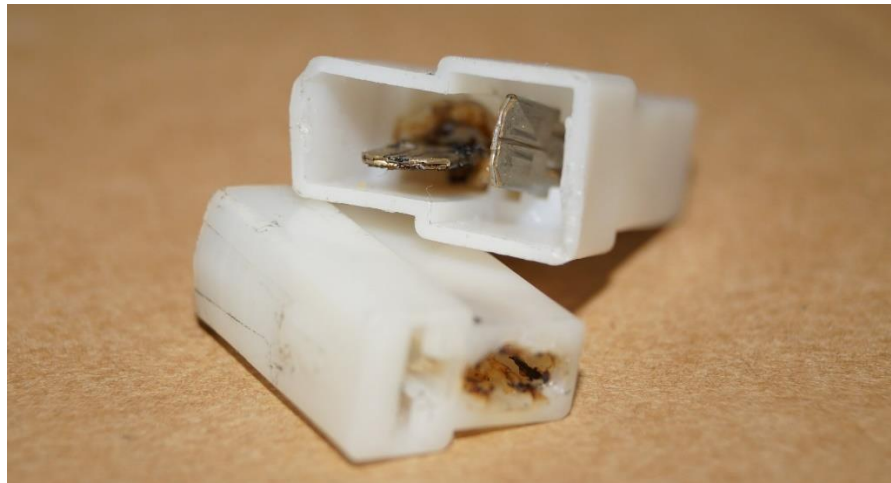
During the inspection some other elements of the electric system of the landing gear control circuit, such as wires and electrical connectors also raised concerns. The used components are not appropriate to the current load in this circuit. An example can be the electrical connector shown in Fig. 7 used on the electric motor of the landing gear hydraulic pump. The information obtained from the Tecnam P2006T aircraft maintenance organization shows that there have been cases of overheating and burning of this connector.

Fig. 9. Damaged electrical connector of the Tecnam P2006T airplane on the electric motor of the landing gear hydraulic pump

Therefore, SCAAI recommends that the manufacturer of the Tecnam P2006T airplanes analyses the parameters of the components used in the landing gear retraction and extension system, and then replaces all system components whose load is higher than their rated currents values.

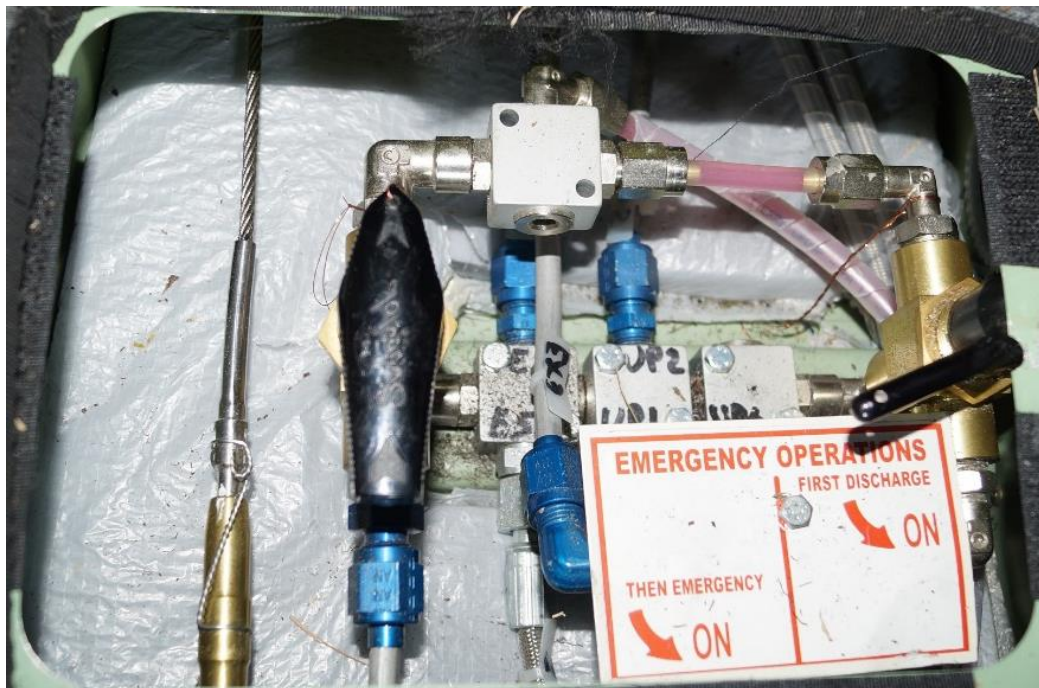
During the inspection of the emergency landing gear extension system of the aircraft, the design of mounting the right valve lever of this system (marked "FIRST DISCHARGE") also raised concerns of the PKBWL.

Fig. 10. Valves of the emergency landing gear extension system in the Tecnam P2006T airplane

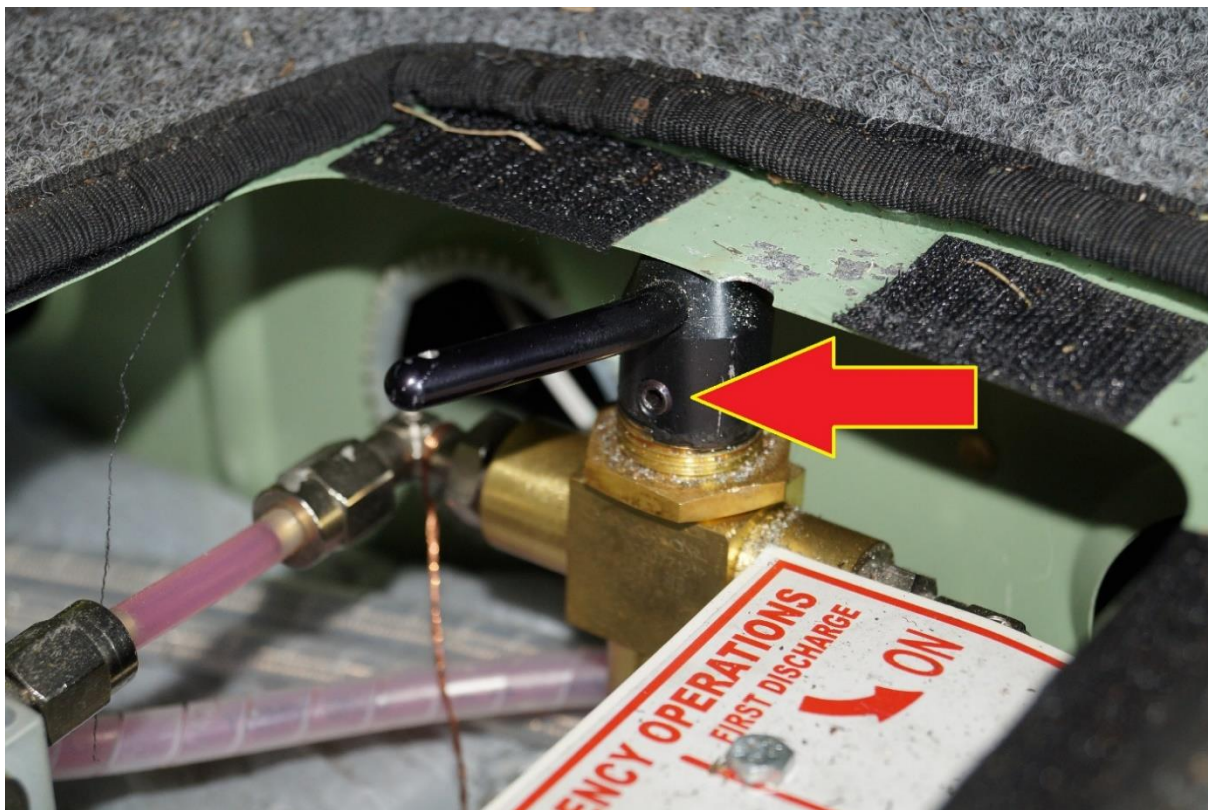
The lever mounted on the valve shaft has been secured by a single grub screw. If this screw is loosened by just half of turn, the valve remains closed despite the lever movement, which prevents the landing gear from being extended in an emergency. In the opinion of the PKBWL, the connection of the lever with the valve shaft should be changed so that they cannot be accidentally disconnected during operation of the aircraft.

Fig. 11. Connection of the lever with the right-hand valve of the emergency landing gear extension system. The arrow marks the grub screw that prevents the free rotation of the lever on the valve shaft

During the investigation PKBWL determined that the lever mounted on the shaft of the FIRST DISCHARGE valve is insufficiently secured against spontaneous loosening. This fact was revealed on the serious incident aircraft. Loosening of the lever allows for its free rotation around the valve shaft, which prevents the valve opening and reduction of the pressure in the system prior to opening THEN EMERGENCY valve.

Therefore PKBWL recommends that the manufacturer of the Tecnam P2006T aircraft modifies the connection of the FIRST DISCHARGE valve lever with the valve shaft so that it is not possible to loosen it spontaneously during operation of the aircraft airplane (e.g. use a splined joint).
