# FINAL REPORT

ACCIDENT 2022/2700

OCCURRENCE NO – 2022/2700

AIRCRAFT – Airplane, Cessna C-152, SP-AKW

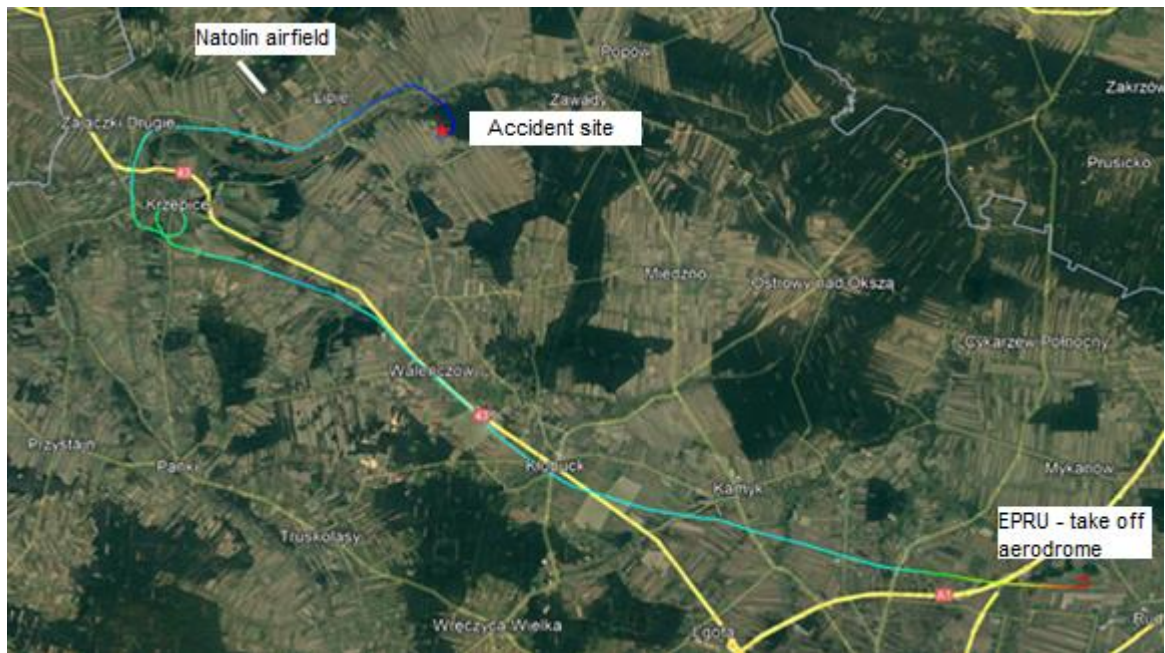
After leaving the EPRU ATZ, at 17:53 hrs, the pilot made contact with FIS Kraków, informing about his position at the WHISKEY point (west of the EPRU) and reported his intention to fly towards Wieluń, and then return to the take-off aerodrome. The FIS provided the value of the QNH and asked the pilot to report return to EPRU. The pilot did not confirm the message. During the onward flight, he did not maintain radio communication. The plane passed the town of Kłobuck and then continued its flight towards Krzepice (flight recording from the FLARM<sup>3</sup>, Fig. 2).

Fig. 2. SP-AKW flight route, created in SeeYou by Naviter [source: FLARM]

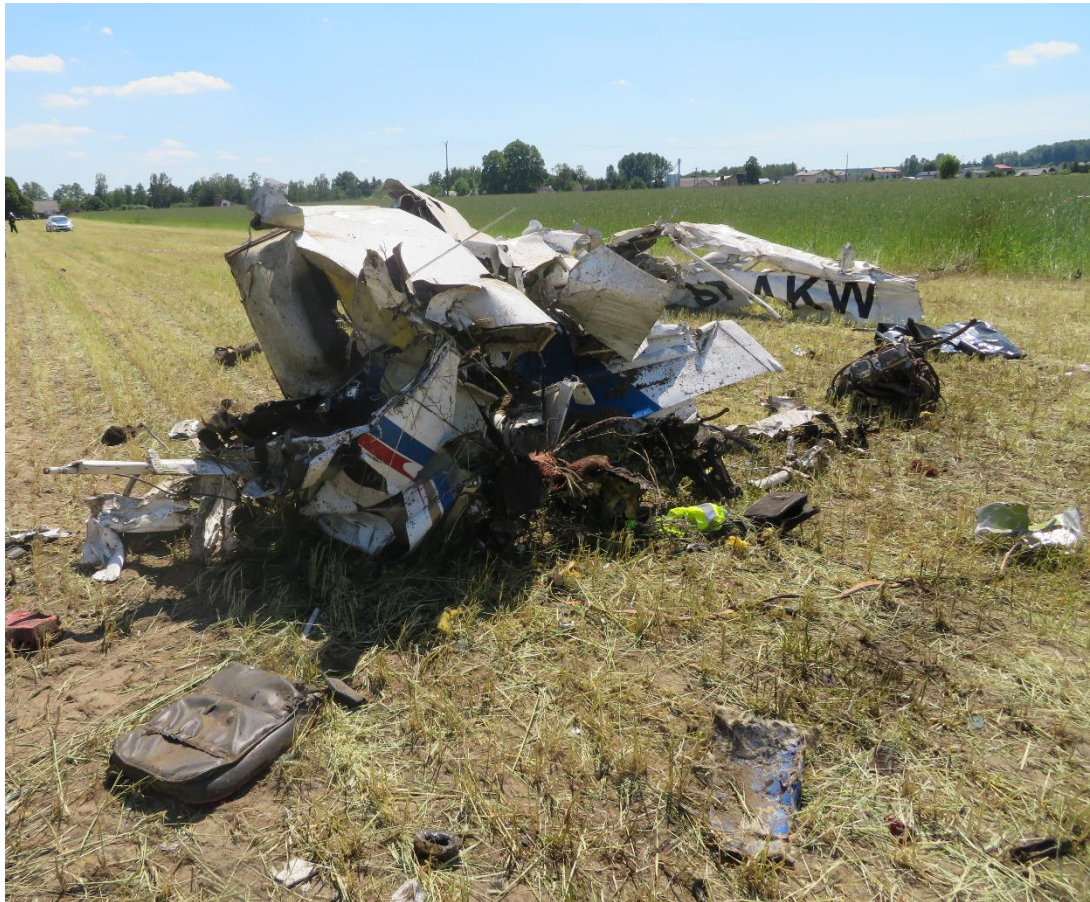
The airplane was destroyed (Fig. 3)

Fig. 3. Airplane wreckage after collision [source: Police]

The accident site is shown in Fig. 7. The airplane crashed into the ground (a farmland) at high speed and was destroyed. The force of the impact ruptured the structure, causing the destruction of each part of the airframe.

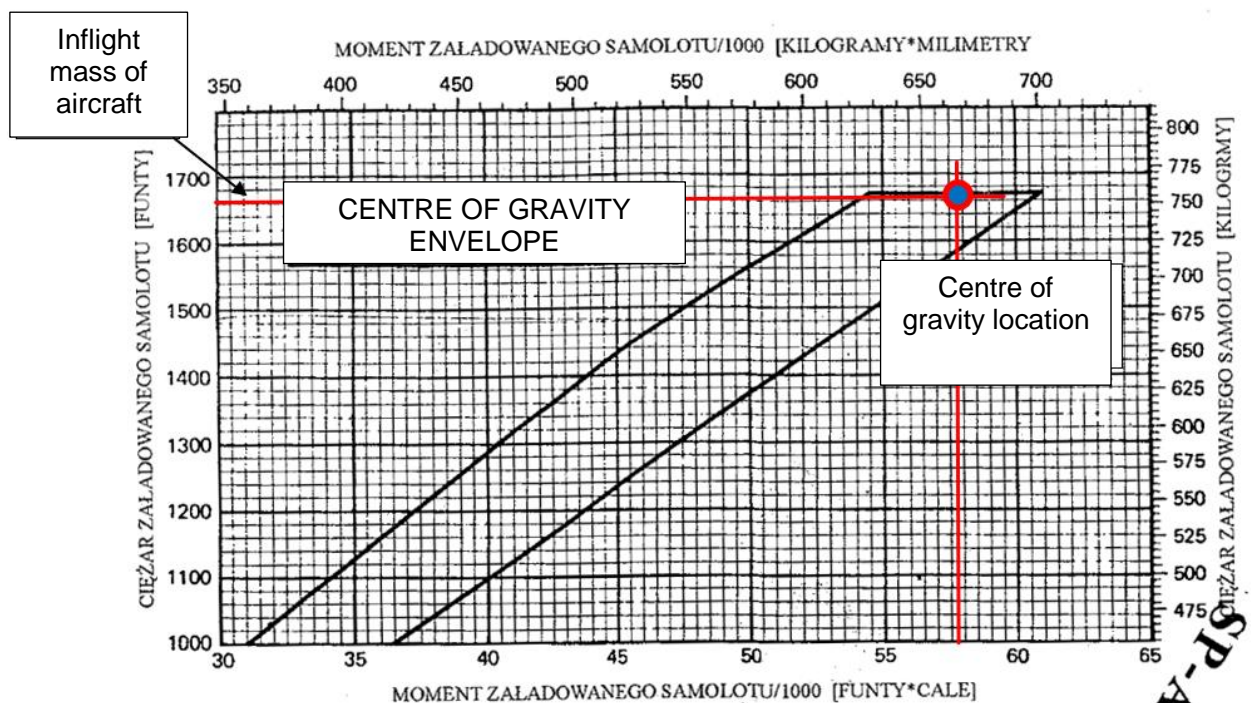
Fig. 6. Graphical determination of the location of the centre of gravity of the airplane for take-off [source: aircraft flight manual]

The airplane centre of gravity for take-off was within the prescribed limits.

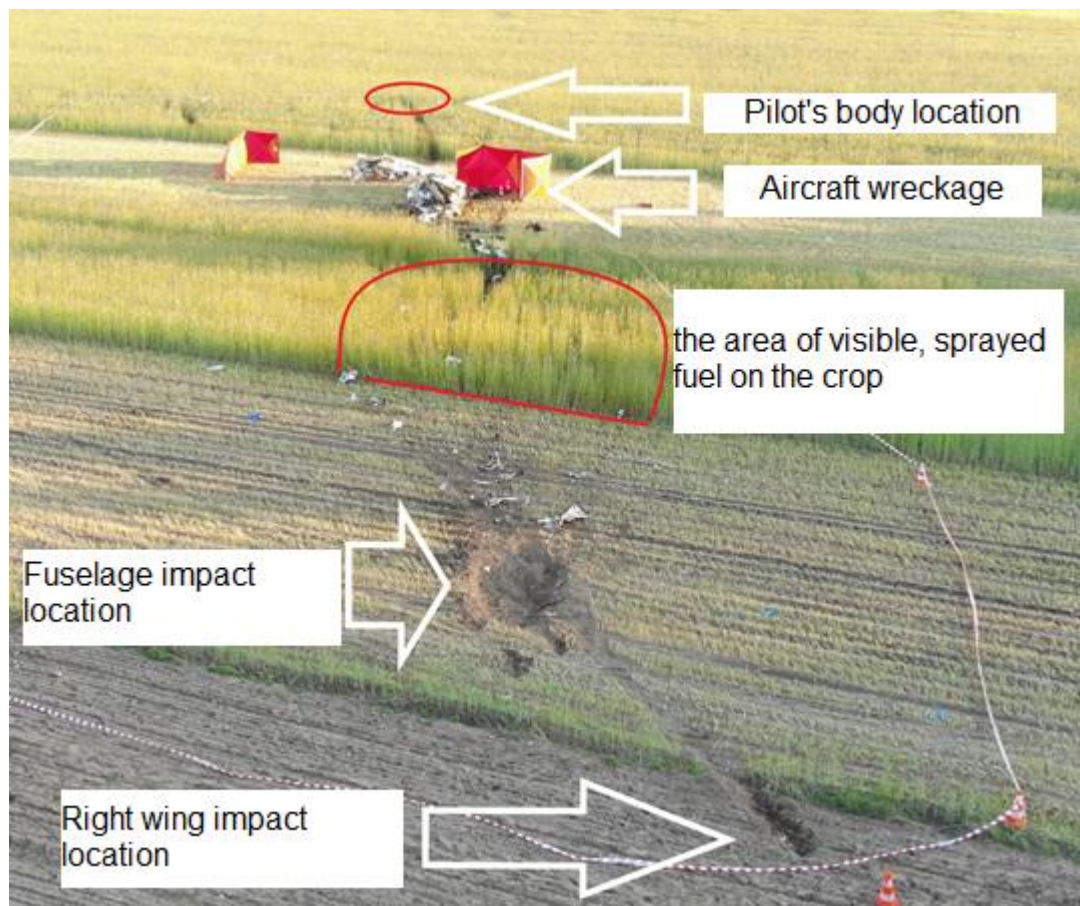
During the impact with the ground, fuel was sprayed into the air, but no fire occurred.

Fig. 7. Accident site [source: Police UAV/drone]

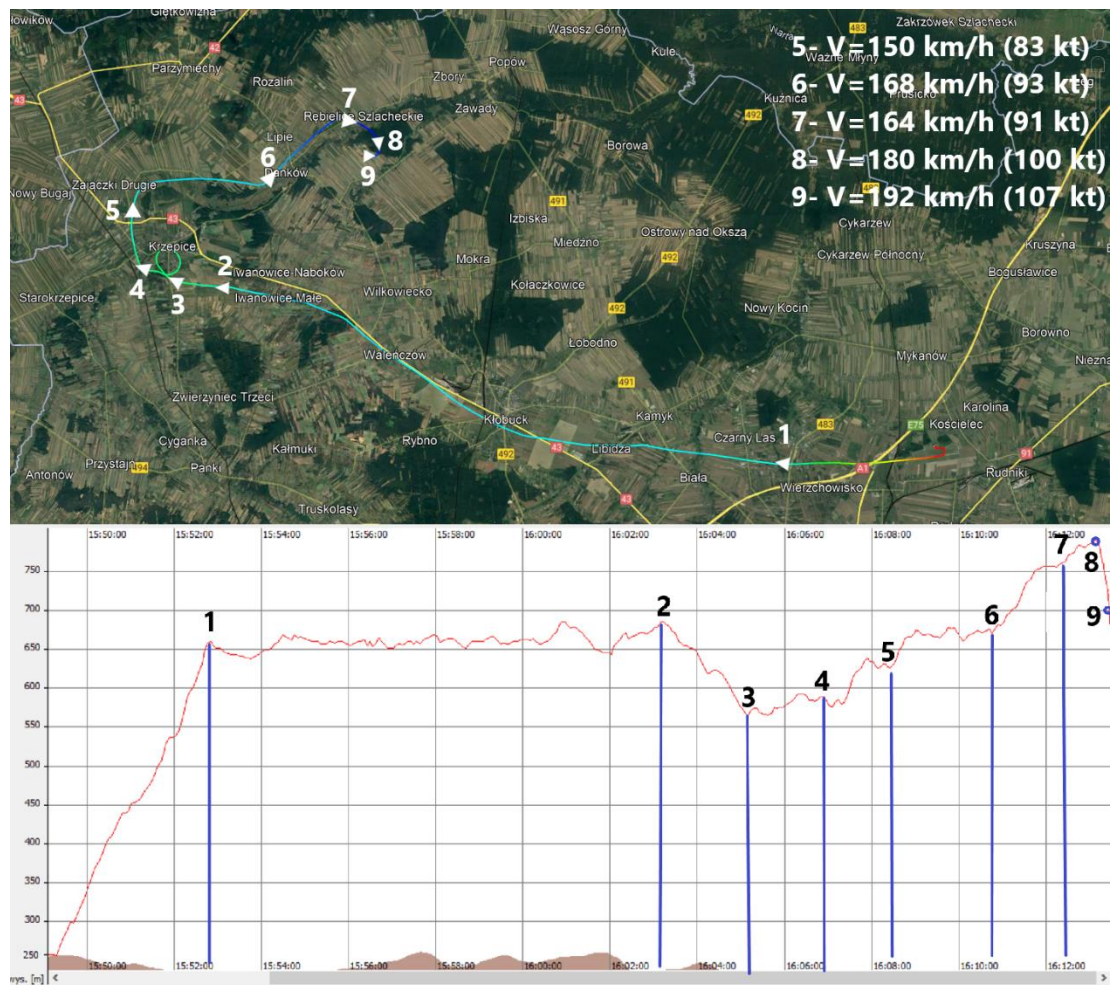
A damaged FLARM device was found in the wreckage of the aircraft. It was sent to the manufacturer (LX Navigation from Slovenia). The data stored in the memory was successfully downloaded, which allowed reconstructing and analysing the course of the flight, but without its final phase. Recording ends at 18:13:30 hrs, when the system only recorded the altitude (see Fig. 8).

Fig. 8. Flight route, altitude and speed in selected places (times given in UTC) [source: FLARM]

After performing a circuit south of the town of Krzepice and departing with a heading of  $15^\circ$  (point 4 Fig. 8), the flight record shows the progressive acceleration of the airplane and altitude gain (Fig. 9).

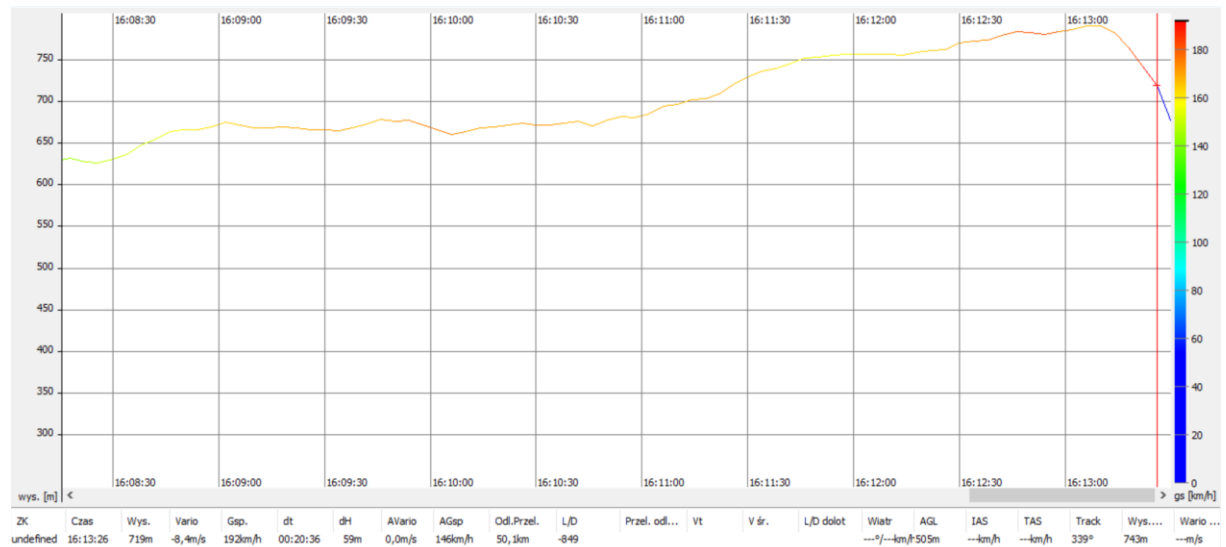
Fig. 9. Flight barogram from 18:08 hrs do the end of the recording [source: SeeYou]

Flying a Cessna 152 with speed above 150 km/h, in climb phase, requires the throttle to be fully or nearly fully open.

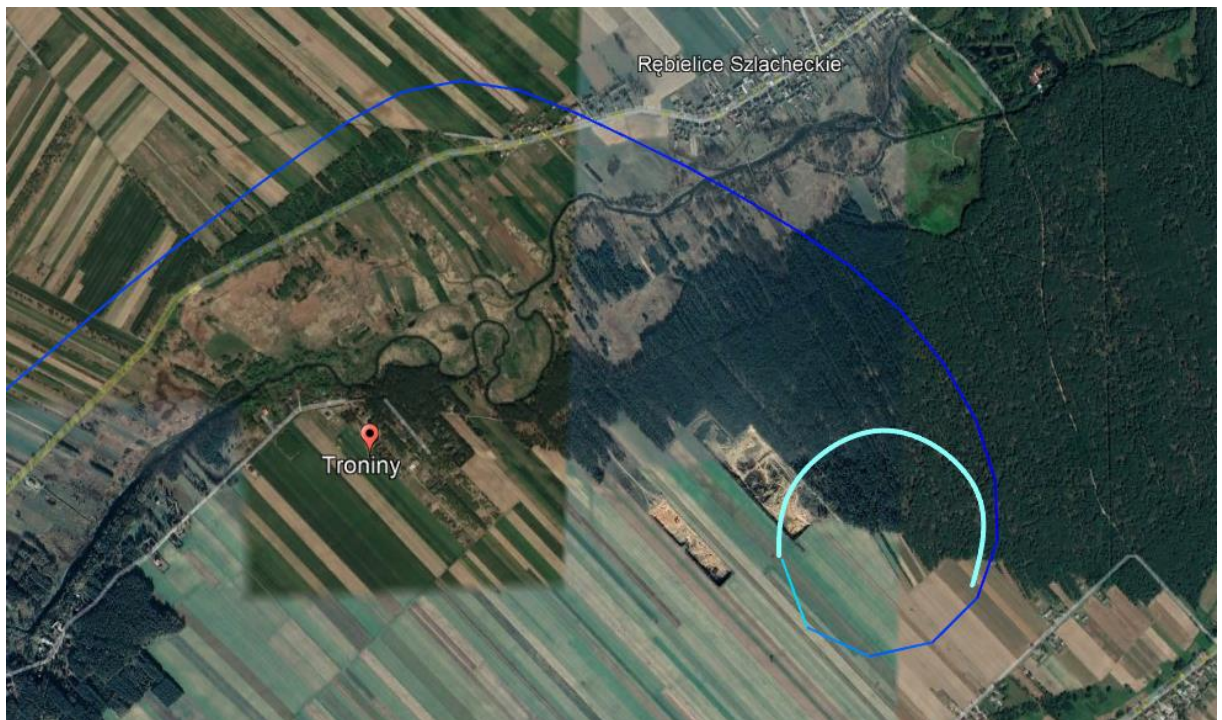
The analysis of the traces and scattering of the aircraft wreckage indicates that the contact of the fuselage with the ground occurred at a speed estimated at over 200 km/h, at an angle of about  $30^\circ$  and with a roll angle of about  $45^\circ$  to the right.

The airplane in the right spiral probably continued its flight until the collision along the trajectory shown in Fig. 10 (light blue section).

Fig. 10. Approximate trajectory of the final phase of flight [source: PKBWL]

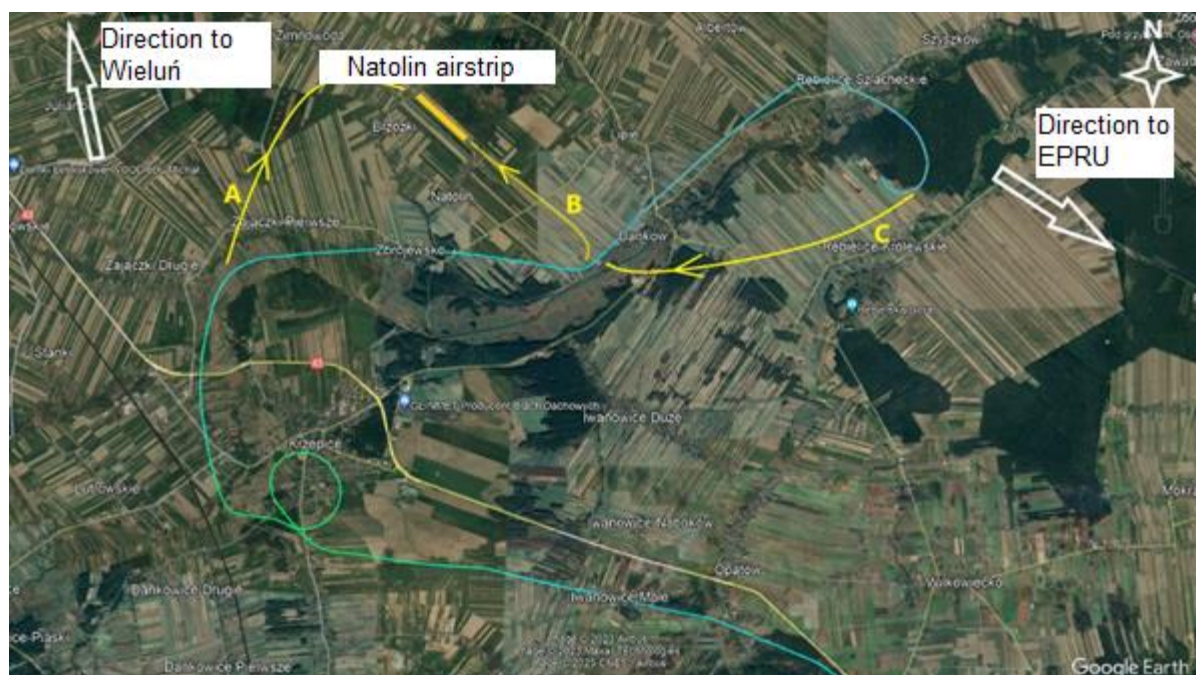
Fig. 11. Final flight route segment

The analysis of the recording of the final part of the flight route, about 6 minutes 20 seconds after passing the village of Krzepice, shows that the pilot made four turns (Fig. 11). This could indicate that the pilot hesitated whether to fly to the Natolin airstrip or to the EPRU airfield. On the final turn to the right, the airplane entered a spiral ending in collision with the ground.
