ACCIDENT 2022/2700

State Commission on Aircraft Accidents Investigation (PKBWL)

OCCURENCE NO – 2022/2700

Aircraft – Cessna 152, SP-AKW

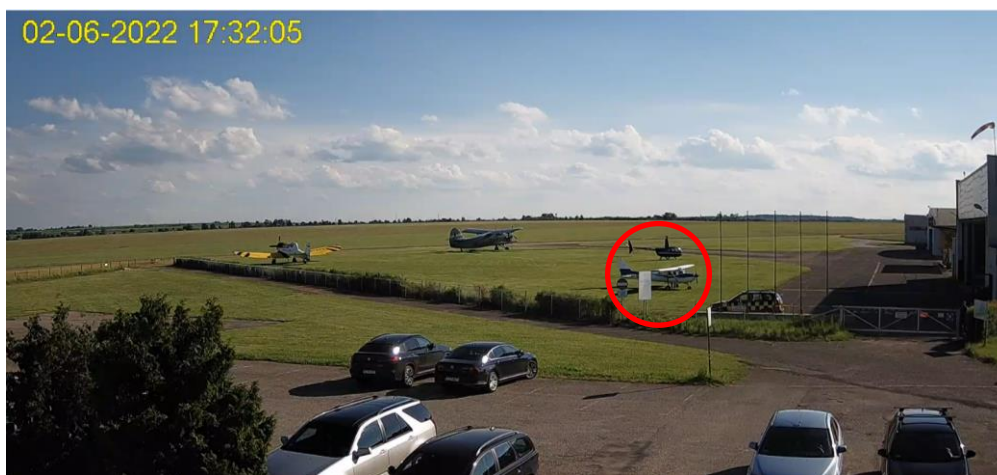
Fig. 1 Cessna 152 SP-AKW before take-off roll [source: PKBWL]

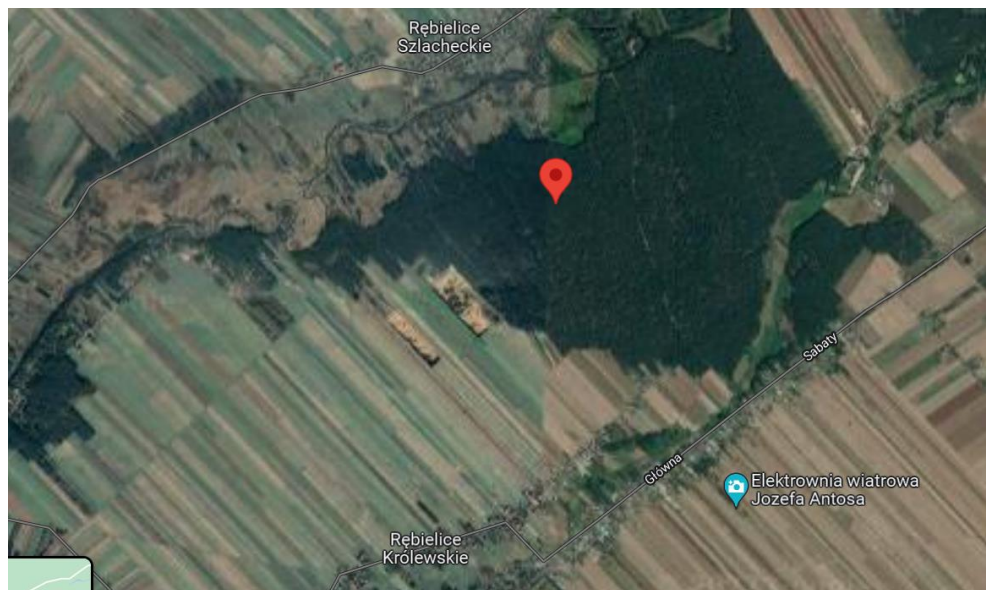
The last record of WGS 84 coordinates: 51°00'44.9N, 18°51'19.6E, indicated the position of the aircraft as it is marked in Fig. 3.

Fig. 3 The last identification of the airplane position, captured by the OGN [source: Google Maps]

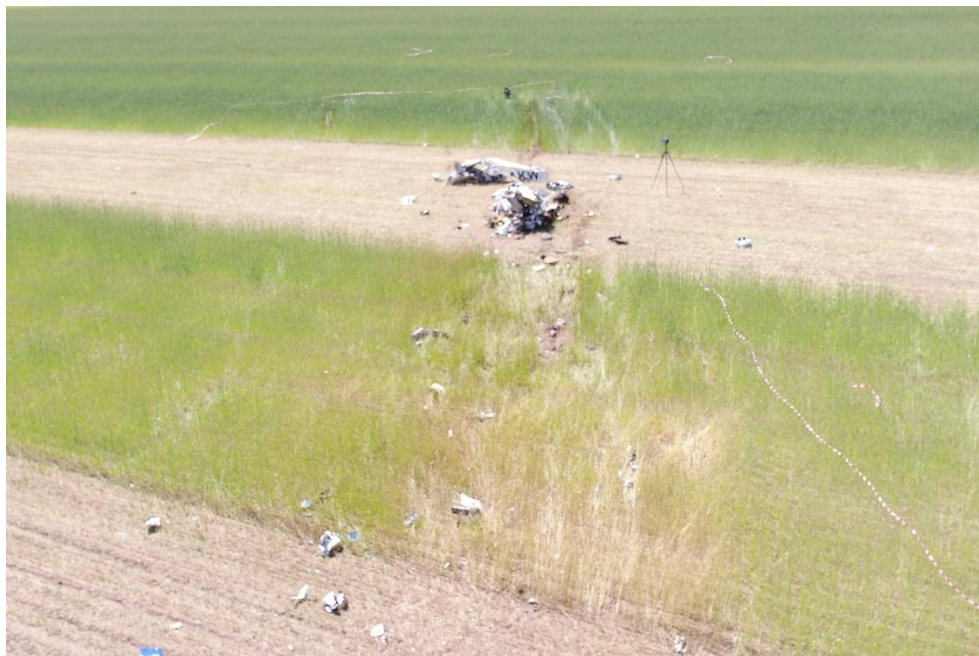
The scale of the damage indicates that the airplane collided with the ground (farmland) at high speed.

The airplane was destroyed. The force of the impact tore the airplane structure apart, and it moved around the farmland in a disorderly manner. None of the main components of the structure preserved its geometry. Although the condition of the wreckage did not allow to determine the kinematic continuity of the airplane control elements, the investigation team made efforts aimed at assessment of the connections in the control surfaces drive systems. However, the obtained results are not reliable in the final assessment of the operation of the aircraft flight control components.

Fig. 4 Traces and the wreckage of the airplane after the collision with the field [source: Police]
