PRELIMINARY REPORT

OCCURRENCE NO – 2022/5134

AIRCRAFT – Aeroplane SKYVAN SC-7 3 Variant 100, SP-HIP

DATE AND PLACE OF OCCURRENCE – 3 SEP 2022, Glina n. EPPT

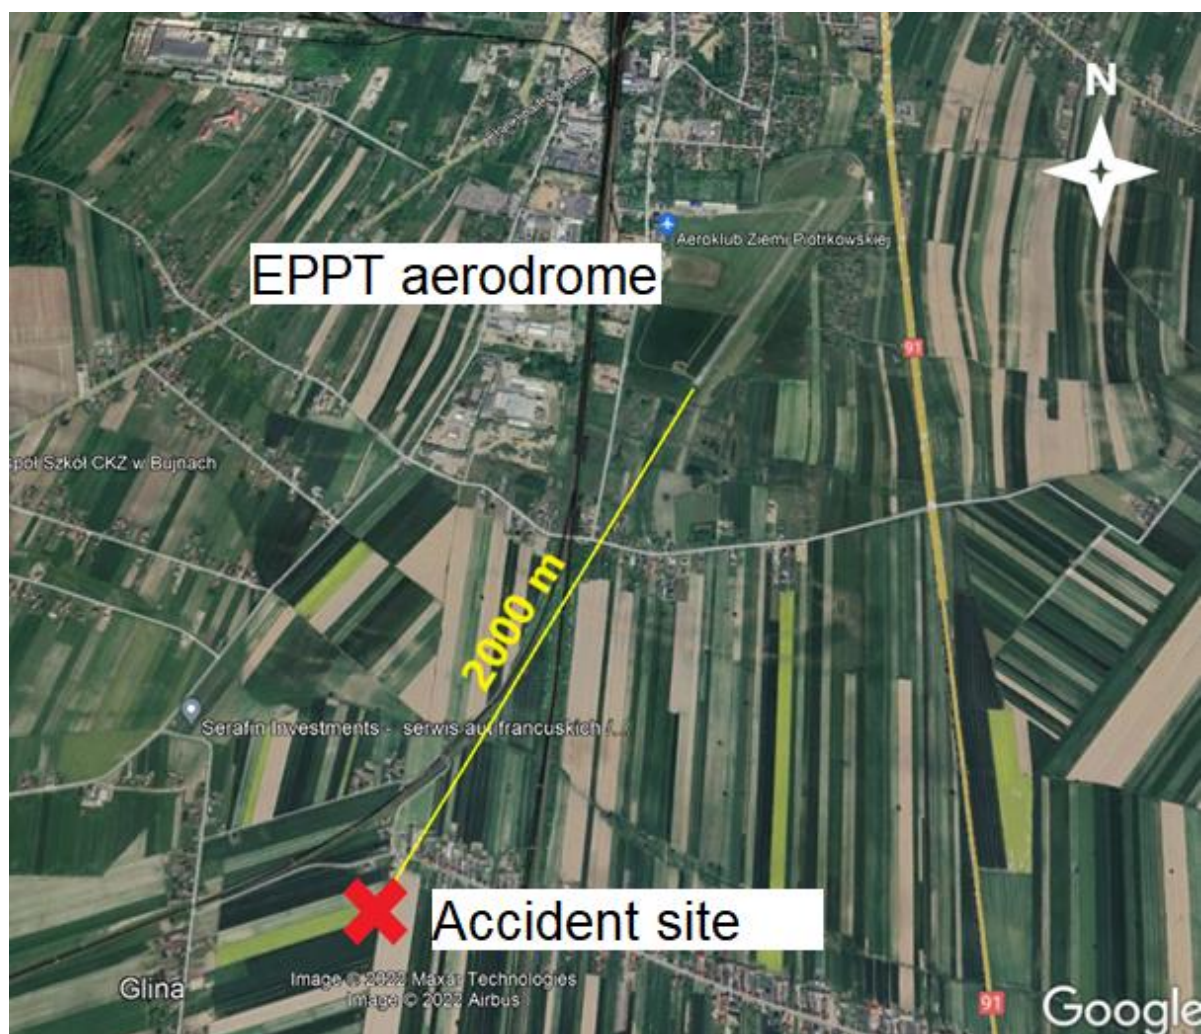
Around 14:16 hrs (LMT), the plane started to climb, then slowed down, and, changing direction, entered a dive and collided with the ground near the aerodrome (Fig. 1). As a result of the collision, the pilot and passenger died on the spot, and the plane was destroyed.

Fig. 1. Accident site location [source: PKBWL]

The accident occurred approximately 2km south of the threshold of EPPT RWY 03 (Fig. 1).

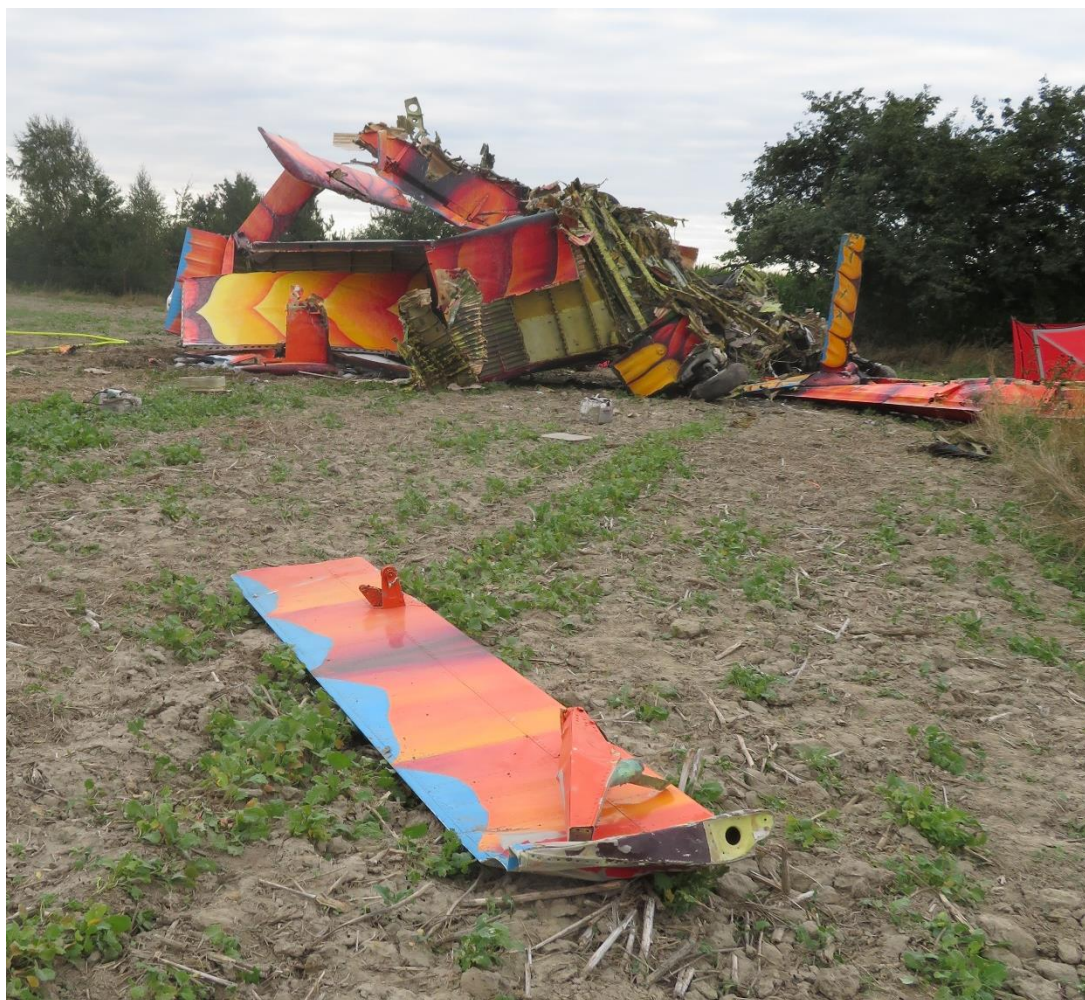
As a result of the collision with the ground, the airplane was destroyed (Fig. 2).

Fig. 2. Aircraft wreckage at the accident site [source: PKBWL]

The wreckage of the aircraft was scattered over a small area. The airplane rested on its left side. All elements of the control system (elevator, rudder, ailerons, flaps) were within the wreckage area and in their immediate vicinity. The right wing was broken about 1 m from the engine and detached with its brace. The right engine detached from the wing during the collision and was located next to the nose part of the fuselage. The root of the left wing together with the engine was located under the fuselage. The rest of the wing with the brace was next to the fuselage. There was a fuel leak after the collision. The fire brigade protected the wreckage against fire with foam.

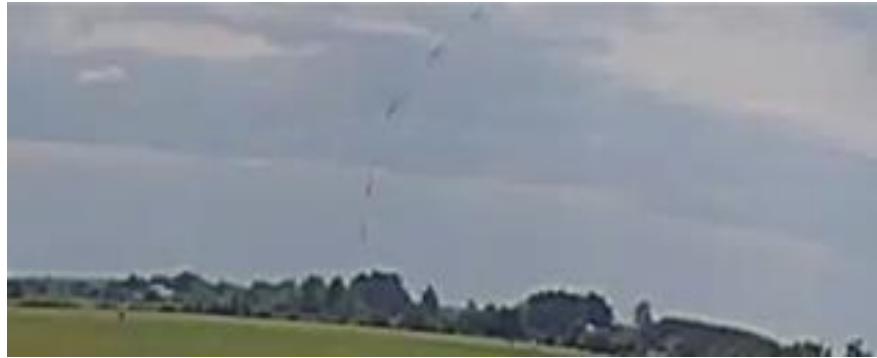
The airplane collided with the ground in a nose down pitch and right wing roll attitude (Fig. 4 and Fig. 5).

Fig. 3. Last phase of the flight path recorded by the aerodrome CCTV camera - time-lapse photos combined into one image [source: Aeroklub Ziemi Piotrkowskiej]

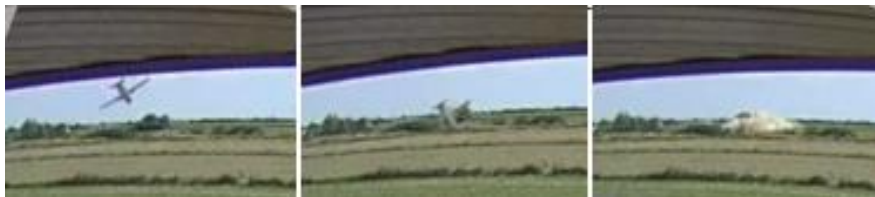
Fig. 4. Last phase of the flight path recorded with a private property CCTV camera near the accident site [source: Internet]
