PRELIMINARY REPORT

OCCURRENCE NO. – 2022/6240

AIRCRAFT – Glider MDM-1 „Fox”, SP-3828

DATE AND PLACE OF OCCURRENCE – 23 October 2022, EPRU

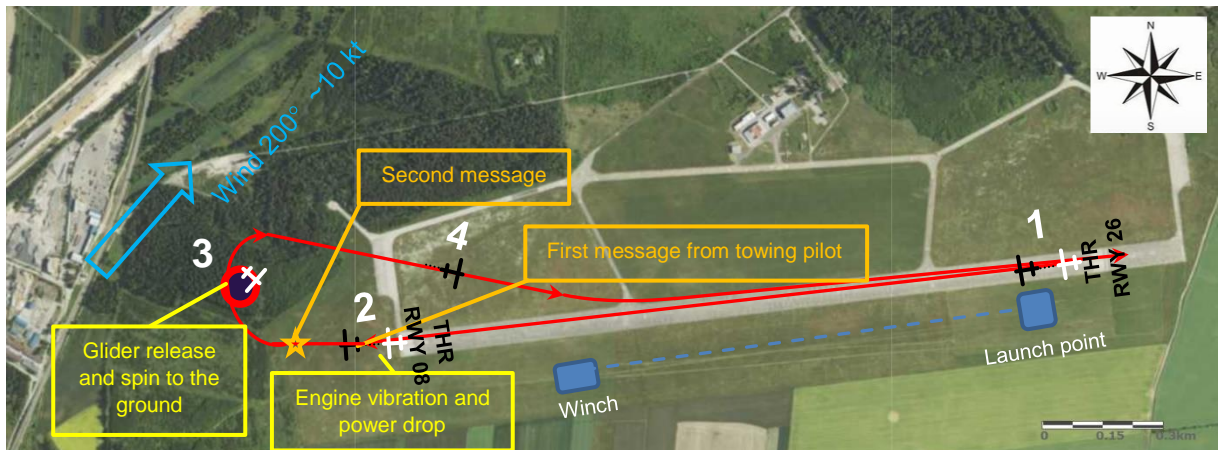
Fig. 1. Trajectory of the flight, place of the glider collision with the ground, approach and landing of the towing plane [source: SCAAI]

After a correct acceleration and lift-off, the climb was normal. About 80÷90 m AGL [2], after passing the threshold of RWY08, the plane "got into vibrations, began to shake" (quote from the statement of towing pilot). The pilot immediately informed via radio the glider crew (the first message): "Fox, I have got the problems with the engine!".

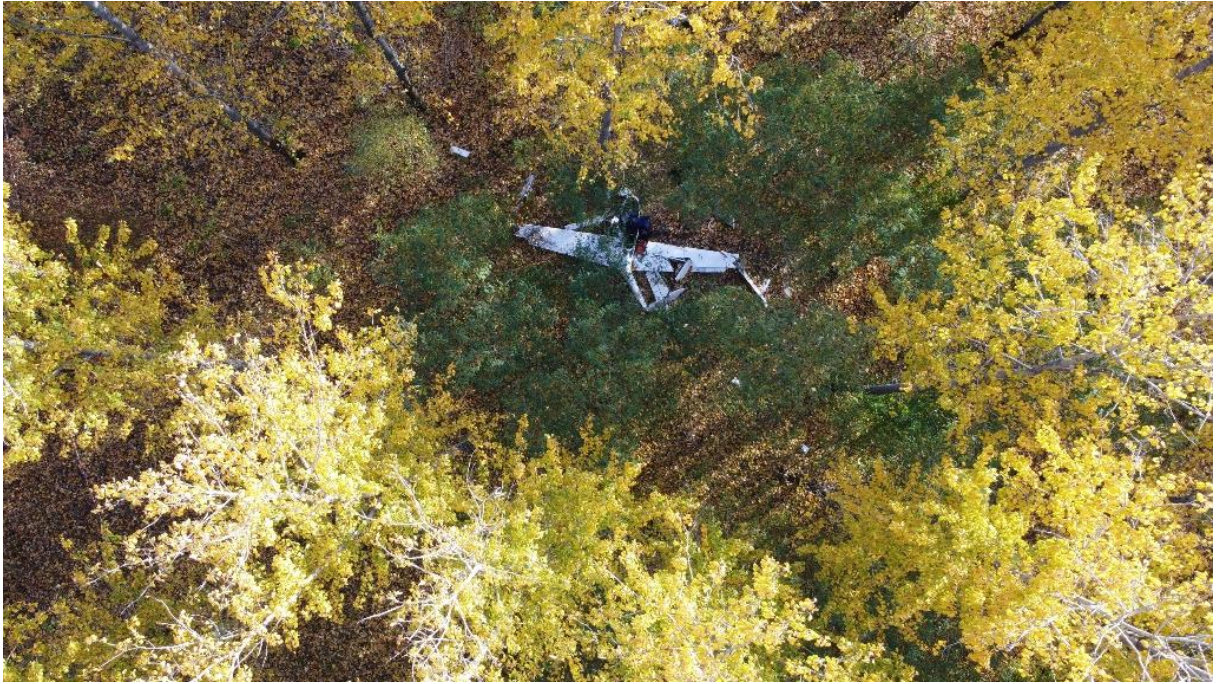
The witnesses notified emergency services and reached the scene in about 3 minutes. The glider wreckage with both pilots in the cockpit was found in the forest (Fig. 2). The pilots showed no signs of life. Their deaths were confirmed by emergency services.

Fig. 2. The wreck of the glider at the crash site.[source: SCAAI]

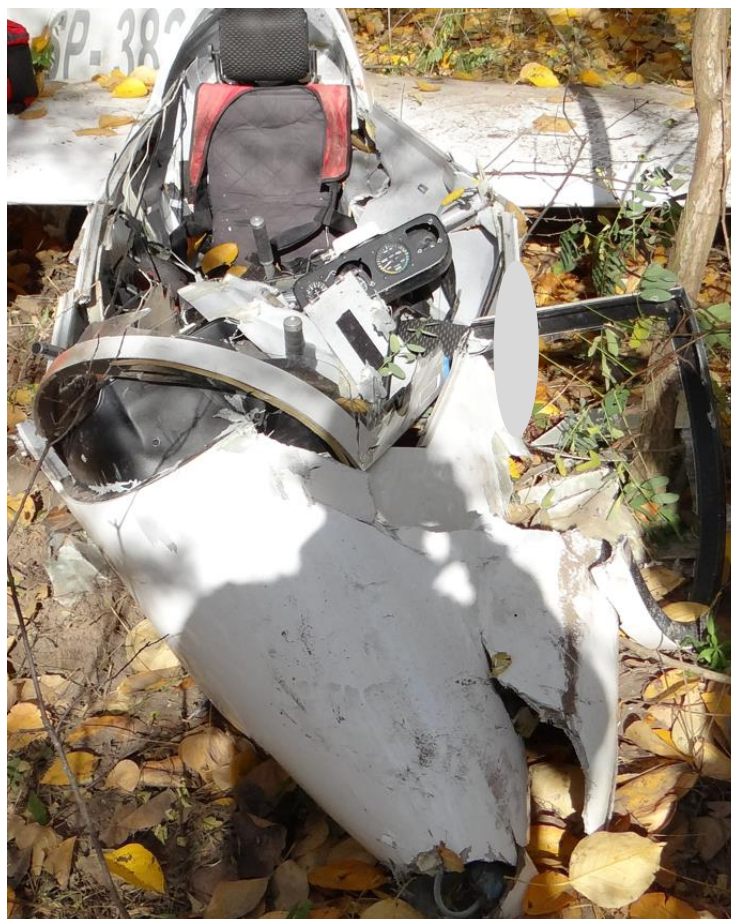
The cockpit broke in the area of the front seat, was crushed and torn. There was a destruction of composite structures, including the nose, floor, sides, instrument panels, all control systems and canopy.

Fig. 3. Damage to the cockpit [source: SCAAI]

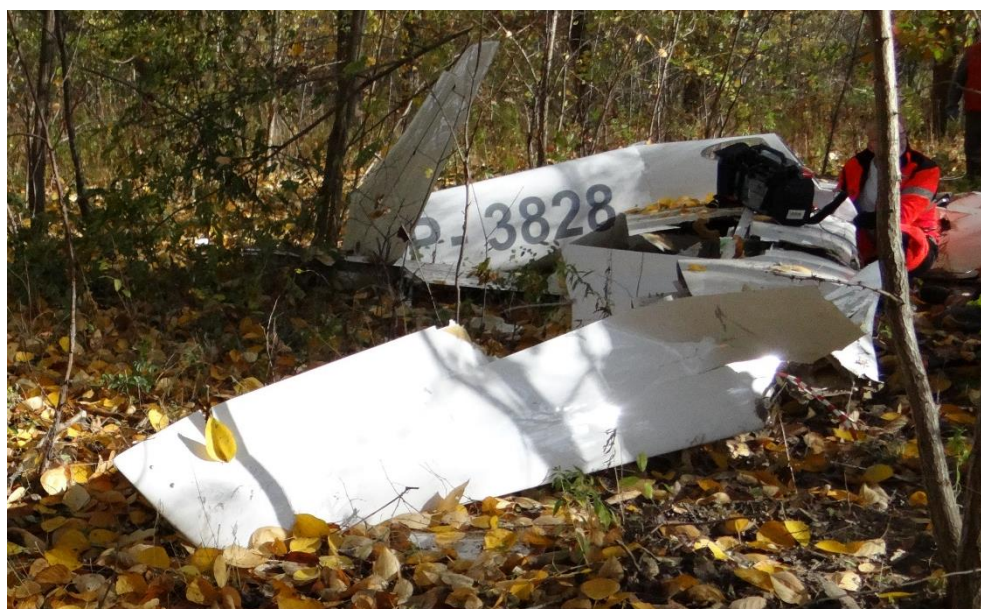
The wings were destroyed but did not separate from the fuselage, like the horizontal stabilizer. The fuselage broke in the rear part and in the area of its transition into the vertical stabilizer.

Fig. 4. Wreckage at the crash site – view from the right wing [source: SCAAI]

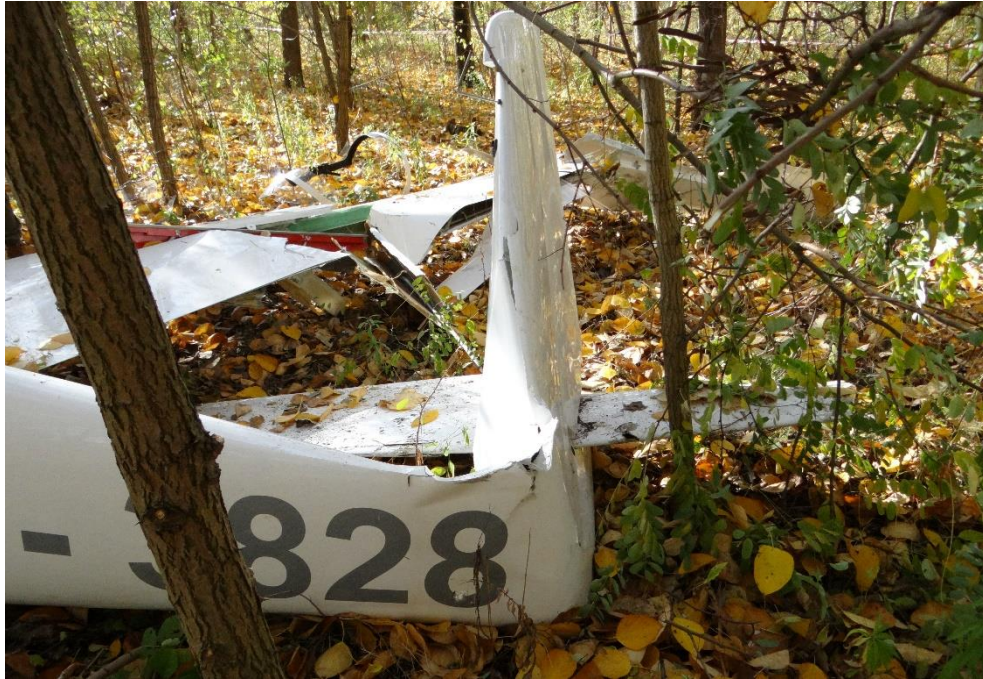
Fig. 5. Crushed and broken tail and torn right wing [source: SCAA]

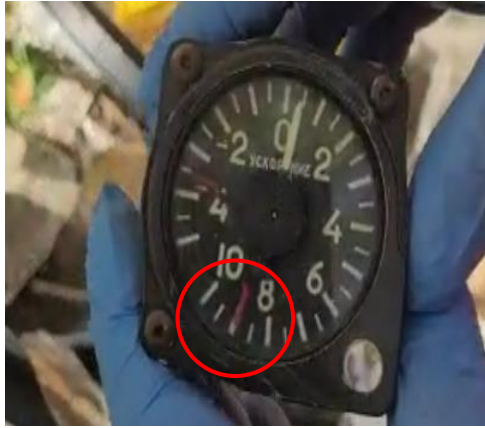
AM-10 g-meter (Fig. 11) with an indication range of +10g/-5g was installed in the nose cockpit. This instrument is a part of the minimum equipment of the glider as required by the TCDS EASA. A.039 and the Flight Manual. During the collision the g-meter detached from the instrument panel.

The instrument pointers are designed to stop at the maximum values of g-load obtained in flight: positive and negative. The pointer stopped at +9g. This is an unreliable value because the g-load when colliding with the ground was several times greater and could not be recorded by the instrument.

Fig. 11. G-meter found in the wreck – frame from the video recording made at the crash site [source: SCAAI]

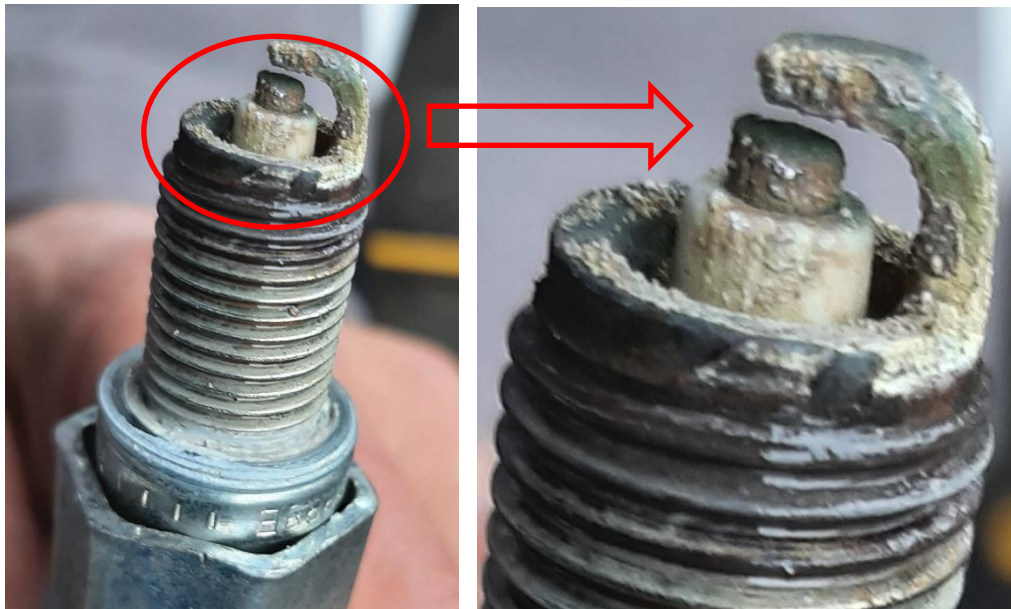
- the entries in the logbook did not include the take-offs made on the day of the occurrence and earlier;
- the aircraft was insured against third party liability and Aero Casco. The policy covered, among other things, glider towing operations and contained family names of the pilots authorized to tow. The name of the pilot involved in the accident was on the list;
- the maximum take-off mass of the aircraft was not exceeded;
- preliminary examination of the engine showed a lack of compression in cylinder no. 1 and the presence of a significant amount of carbon deposits on both spark plugs of that cylinder (Fig. 13);
- the electrodes of spark plugs removed from the cylinders no. 2, 3 and 4 were clean, all in light gray colour.

Fig. 13. Spark plug and its contamination on the electrodes after removal from the head of cylinder no. 1 [source: SCAA]

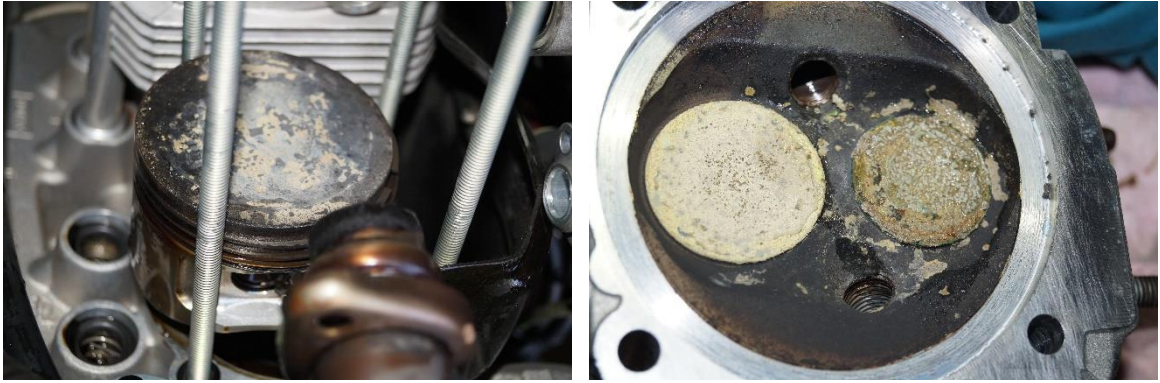
- borescope inspection of each cylinder revealed significant amount of carbon deposit in each cylinder. Cylinder head no. 1 was removed from the engine to check the combustion chamber and the piston;
- the condition of the piston crown (left) and valves (right) is illustrated in Fig. 14.

Fig. 14. The piston and the valves of the cylinder no. 1 [source: SCAAI]

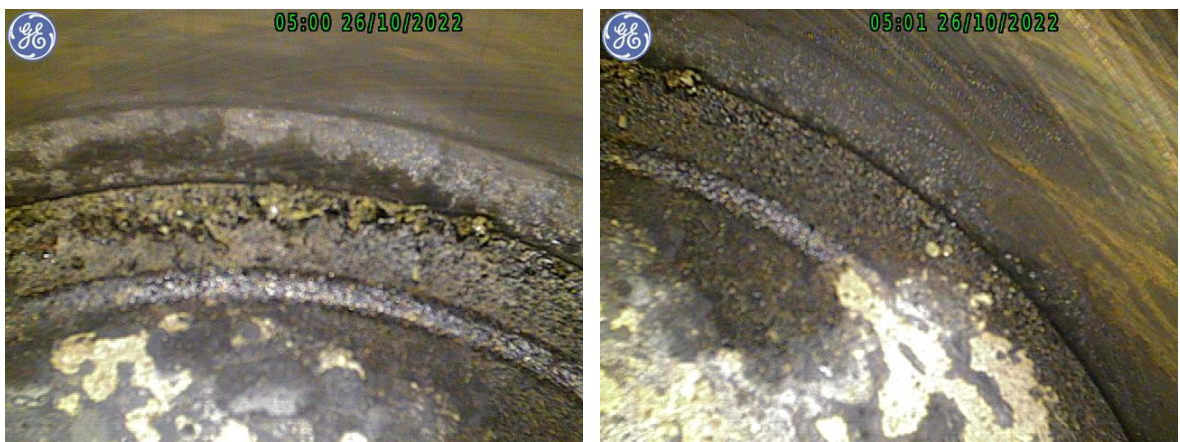
- the condition of the cylinder no.1 interior was inspected with a borescope (Fig. 15);

Fig. 15. Internal corrosion of the cylinder no. 1. Pictures were taken with the borescope camera [source: SCAAI]

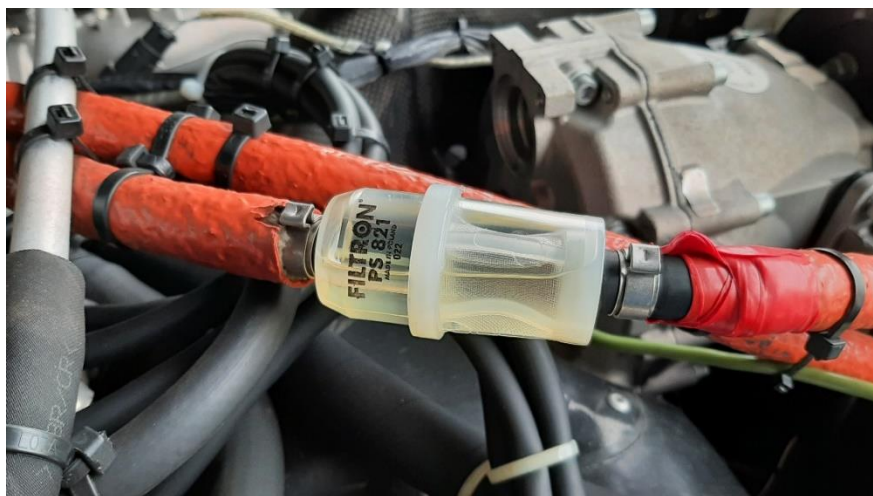
- the fuel samples, taken twice from drainage, were clean, clear and without water inclusions;
- the fuel filter on the engine was filled with fuel (Fig. 16);
- samples of fuel from the aircraft tanks were taken for further examination.

Fig. 16. The outer fuel filter on the engine [source: SCAAI]
