INTERIM STATEMENT

OCCURRENCE NUMBER 67/18

AIRCRAFT – BOMBARDIER DHC-8-402, SP-EQG

DATE AND PLACE OF OCCURRENCE – 10 JANUARY 2018, EPWA

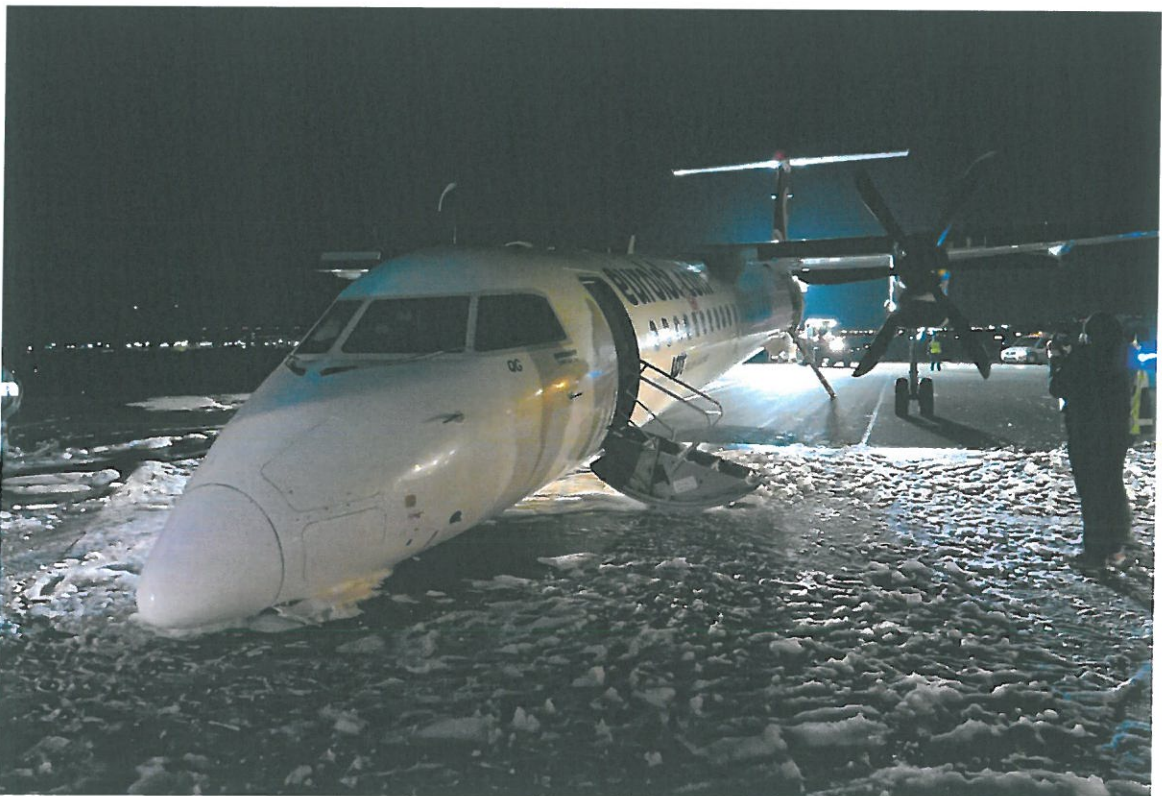
On EPWA the crew performed an emergency landing on RWY11 with NLG in the unlocked position. NLG collapsed during the landing roll. When the airplane came to rest on RWY11 at 19:19 hrs LMT the crew evacuated the passengers. None of the passengers or crew was injured during the evacuation. The airplane was damaged to the extent requiring repair.

Fig. 1. DHC-8-402 SP-EQG after emergency landing on EPWA RWY11.

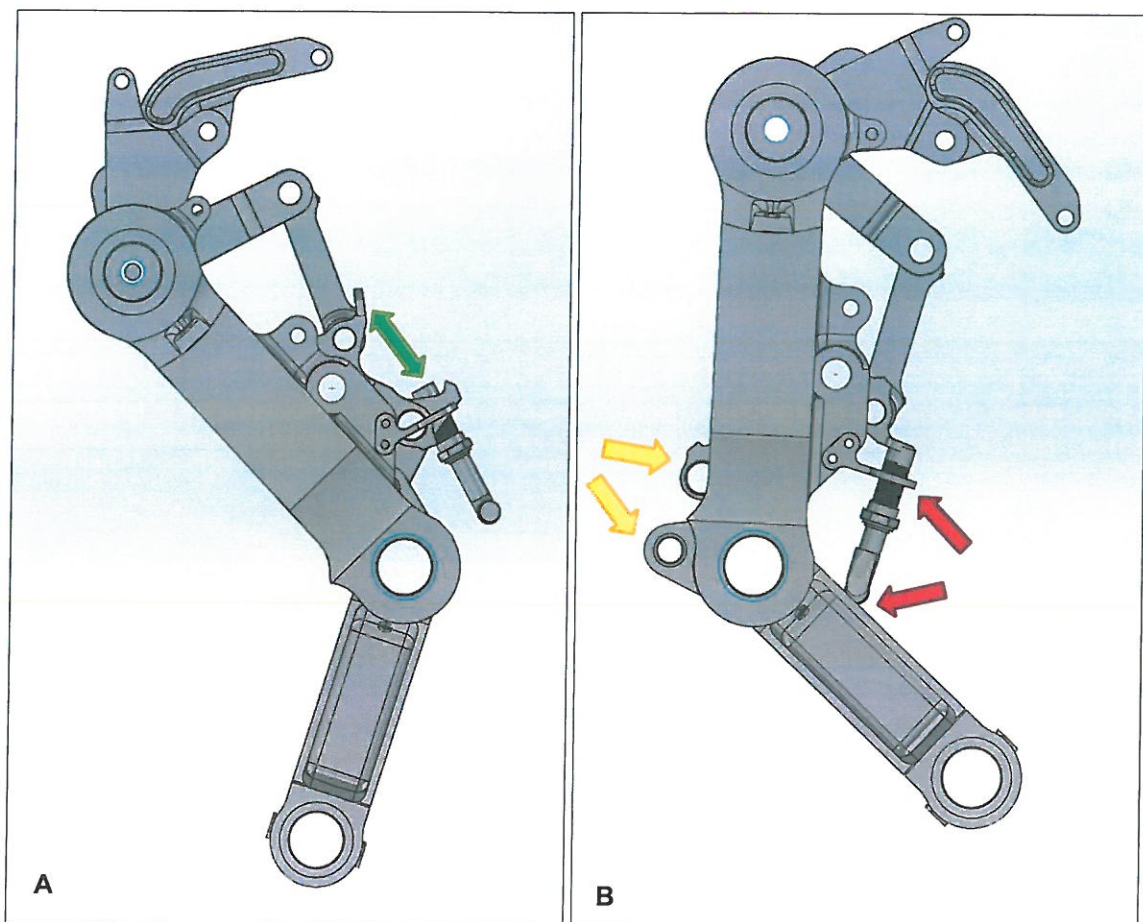
As part of the investigation, the Commission requested the Air Force Institute of Technology in Warsaw (ITWL) to carry out examination of the DSA kinematics and the damage to the DSA. As a result of the above examination, it was found that during retraction of the landing gear after take-off from EPKK, NLG DSA folded in aft direction, opposite to the intended by a designer (Figure 2-B).

Fig. 2. NLG DSA in a transitional position during NLG retraction (side view): A - correct direction of the strut folding, B - reverse direction of the strut folding [source: ITWL expert opinion, figure modified by PKBWL].

In the figure above, the green arrows indicate NGLK2 PS face moving away from the target when DSA is folding in the right direction, the red arrows indicate collision areas

when DSA collapses in the opposite direction and the yellow arrows show disconnection of the link between the LLL and LDS (link which was damaged).
