FINAL REPORT

2023-0003

Tecnam P2008-JC, SP-WBA

8 February, 2023; Aerodrome Rzeszów – Jasionka (EPRZ)

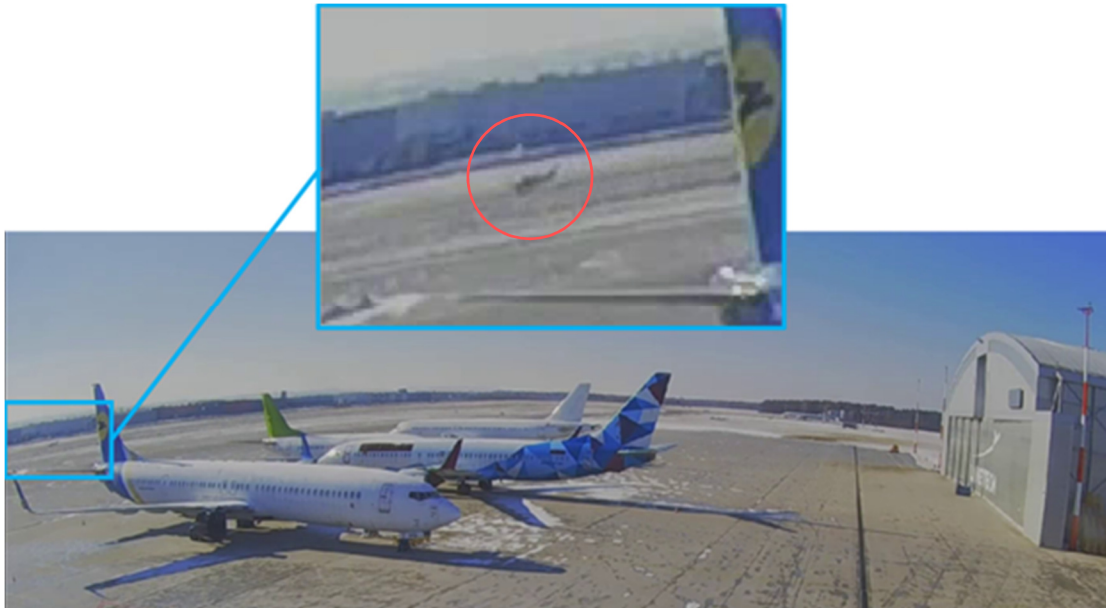
In the opinion of Tecnam pilot, the approach was executed above the descent path to overshoot landing in order to reduce taxiing time. Aware of another airplane close behind, the pilot intended to vacate RWY as quickly as possible. However, the flare was executed too high and at too low a speed and the pilot did not correct these errors. At 12:12, the aircraft stalled, tilting to the left and touched the RWY with wingtip, resulting in a veer off the RWY about 45° to the left. After the touchdown, the pilot increased the engine rpm.

Fig. 1. Tecnam airplane aircraft before touching down on RWY 09 of EPRZ
[source: CCTV camera of Rzeszow-Jasionka aerodrome]

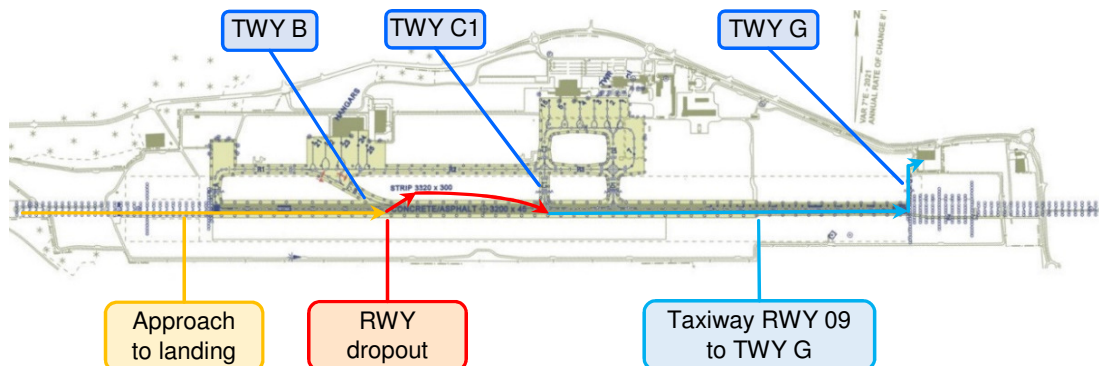
The loss of lateral control during flare, combined with a speed decreasing to the stall (V_{so}^{13}), resulted in directional balance disturbance. This pilot fault was due to improper selection (or lack of selection) of a specific touchdown point, as well as pilot's intention to flare up to RWY and TWY cross. It is likely that the pilot was focused on observing the forward-shifted touchdown zone and did not pay attention to the high flare above the RWY and dropping speed. The pilot explained the flaps were fully released. In such a case, the speed drops even faster and the aircraft performance is significantly reduced. To maintain lateral balance, more intensive aileron control and high pilot attention are required. Flying with full flaps at minimum speed, just above the runway is to be considered as risky. Every time, it should end with a touchdown in around near minimum speed. In such a case, with the engine throttled down to the minimum, the roll-out is short, particularly when affected by a headwind.

A rapid increase of engine power at stall speed on full flaps could most often result in a progressive lateral imbalance (a torque is generated from the propeller tending to roll the airplane). Large angles of attack and full tilted flaps generate significant aerodynamic drag. However, the lift does not increase as quickly - the airplane does not accelerate. This is also what the pilot experienced, moving at high speed on frozen grass, additionally causing a braking effect on the landing gear (due to rolling drag).

Fig. 2. Sketch of the landing of the Tecnam airplane

The results of the analysis of the occurrence indicate that the lateral and directional balance was lost while touching down. At the same time, it was determined that the roll or side-slip could not be the cause of the loss of direction after touchdown.
