ACCIDENT 2021/1048

on investigation of an accident of an aircraft with MTOW below 2250 kg

OCCURRENCE NO – 2021/1048

AIRCRAFT – Gyrocopter TERCEL, SP-XERO

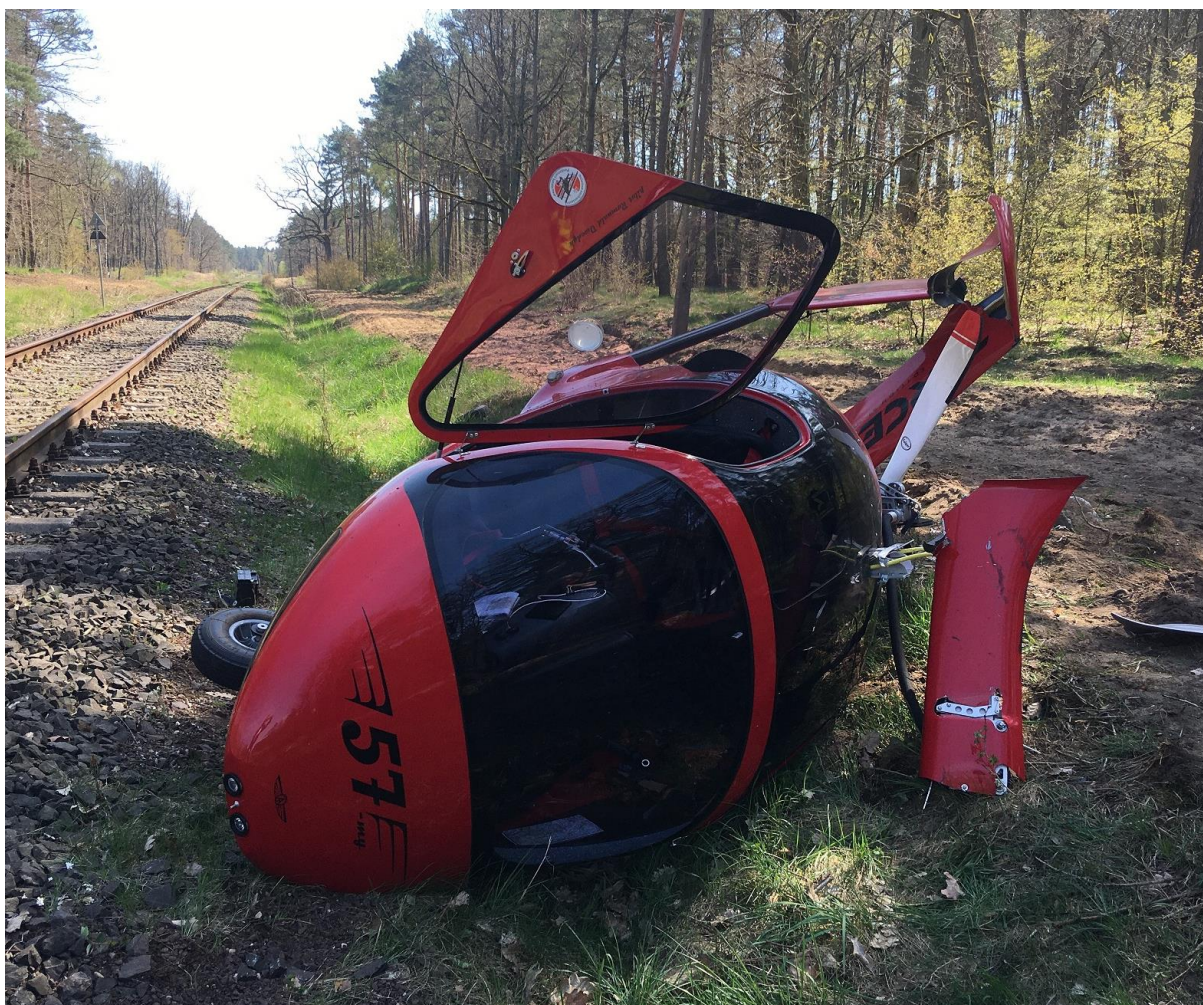
The accident aircraft was significantly damaged. The three-blade rear propeller was damaged, and one of the blades were found detached from it. The main rotor along with the blades and rotor mast were damaged. As a result of an emergency landing, the landing gear, empennage and elements of the cabin skin were damaged.

Fig. 1. Gyrocopter after the emergency landing [source: PKBWL]¹

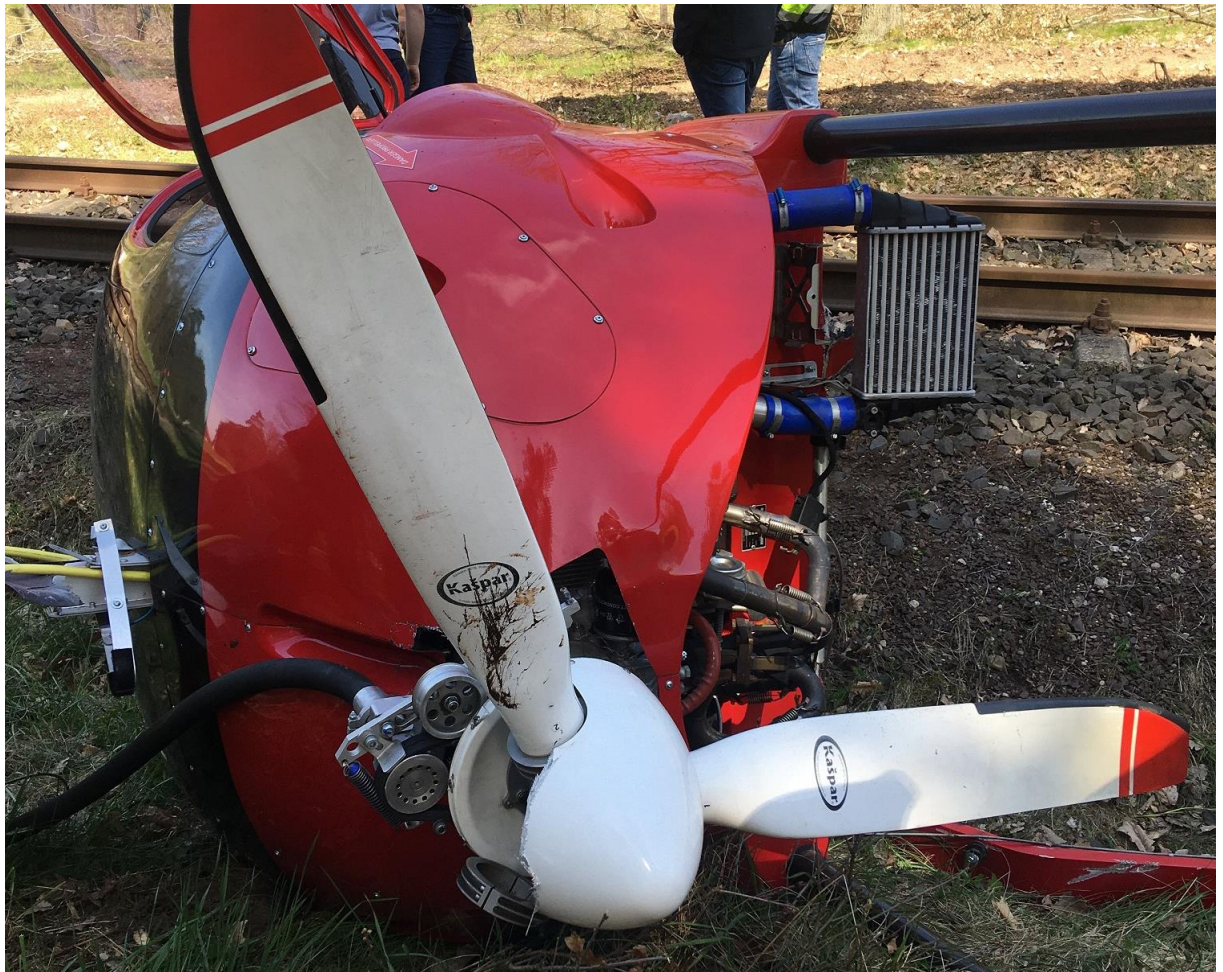
Fig. 2. Gyrocopter after emergency landing

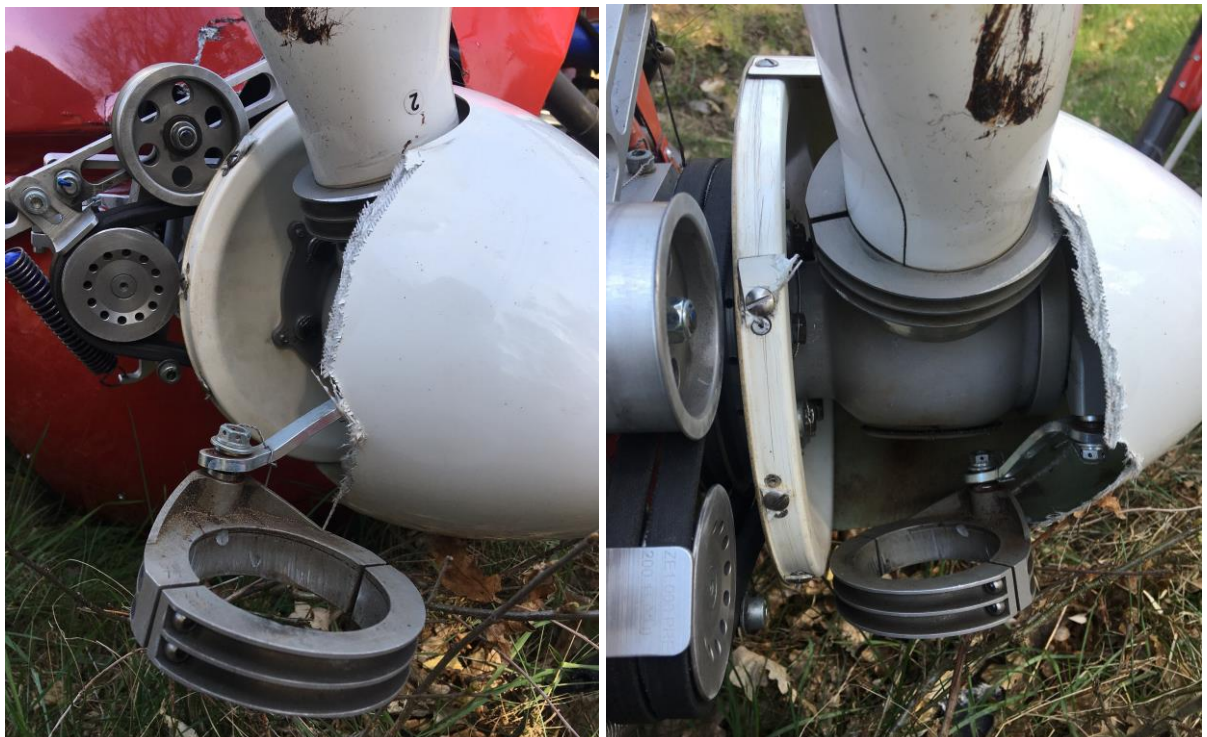
Fig. 3. Damaged propeller hub of the gyrocopter

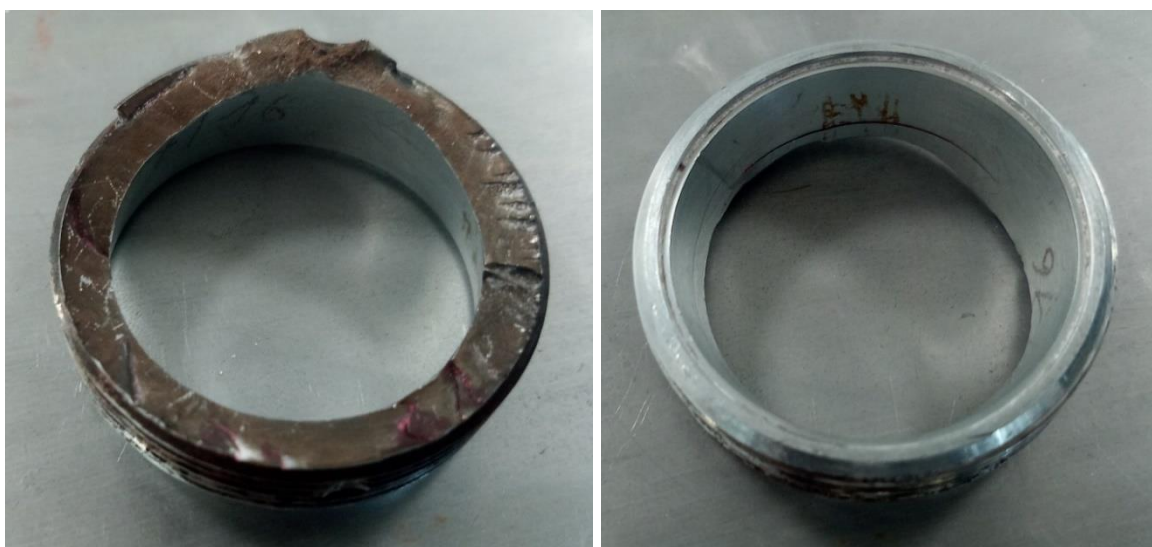
During tests, it was found that the propeller blade broke off in flight as a result of a crack in its mounting part in the area of the thread securing the blade to the propeller hub. Based on visual tests, it was found that the intact mounting element of the damaged blade had fatigue cracks. Analysis of the deformation shape of the damaged blade fragment showed a characteristic fracture area with a clear narrowing indicating large plastic deformations and the surfaces of the fatigue crack. A very characteristic part of the crack is a spherical chipping and bending of the thread. It can be assumed with high probability that the fracture was initiated on the opposite side of the chipping, but the focus is not clearly visible.

Fig. 8. Damaged propeller blade fragment [source: Warsaw University of Technology]

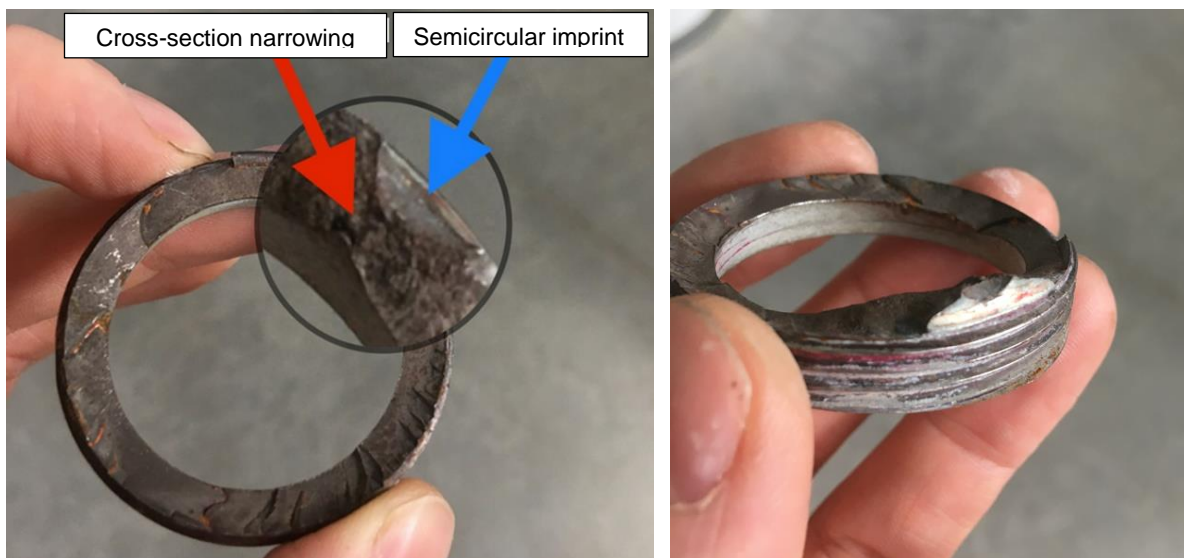
Fig. 9. The place of the breakage with a characteristic semicircular imprint and narrowing area [source: Warsaw University of Technology]

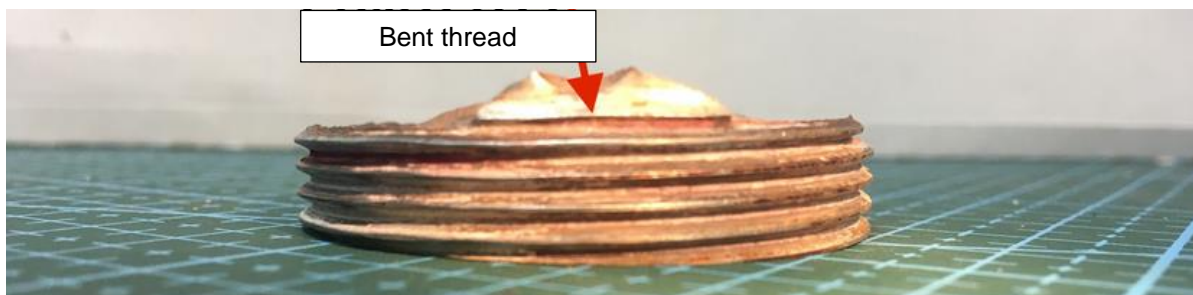
Fig. 10. The place of the breakage with a characteristic bend of the thread [source: Warsaw University of Technology]

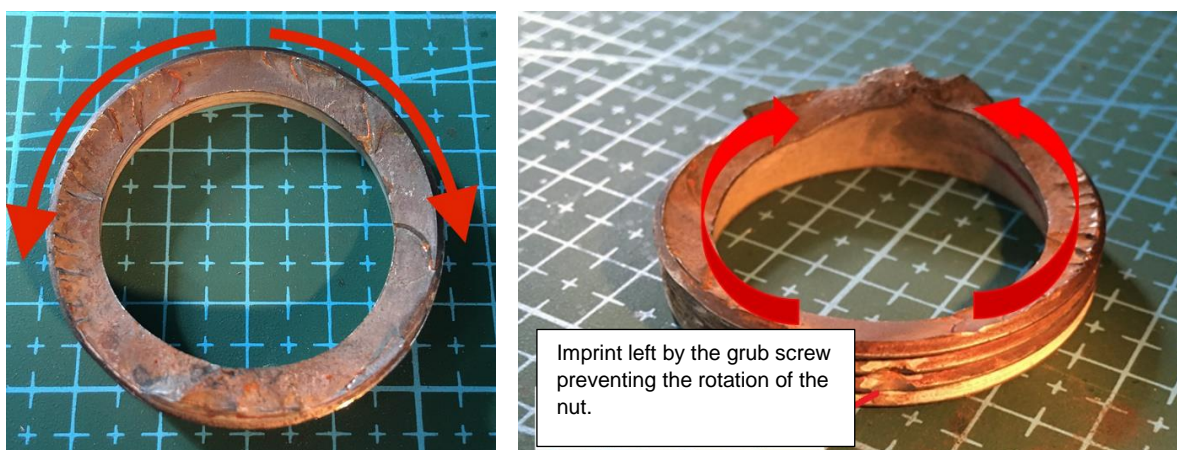
Fig. 11. Direction of crack propagation [source: Warsaw University of Technology]

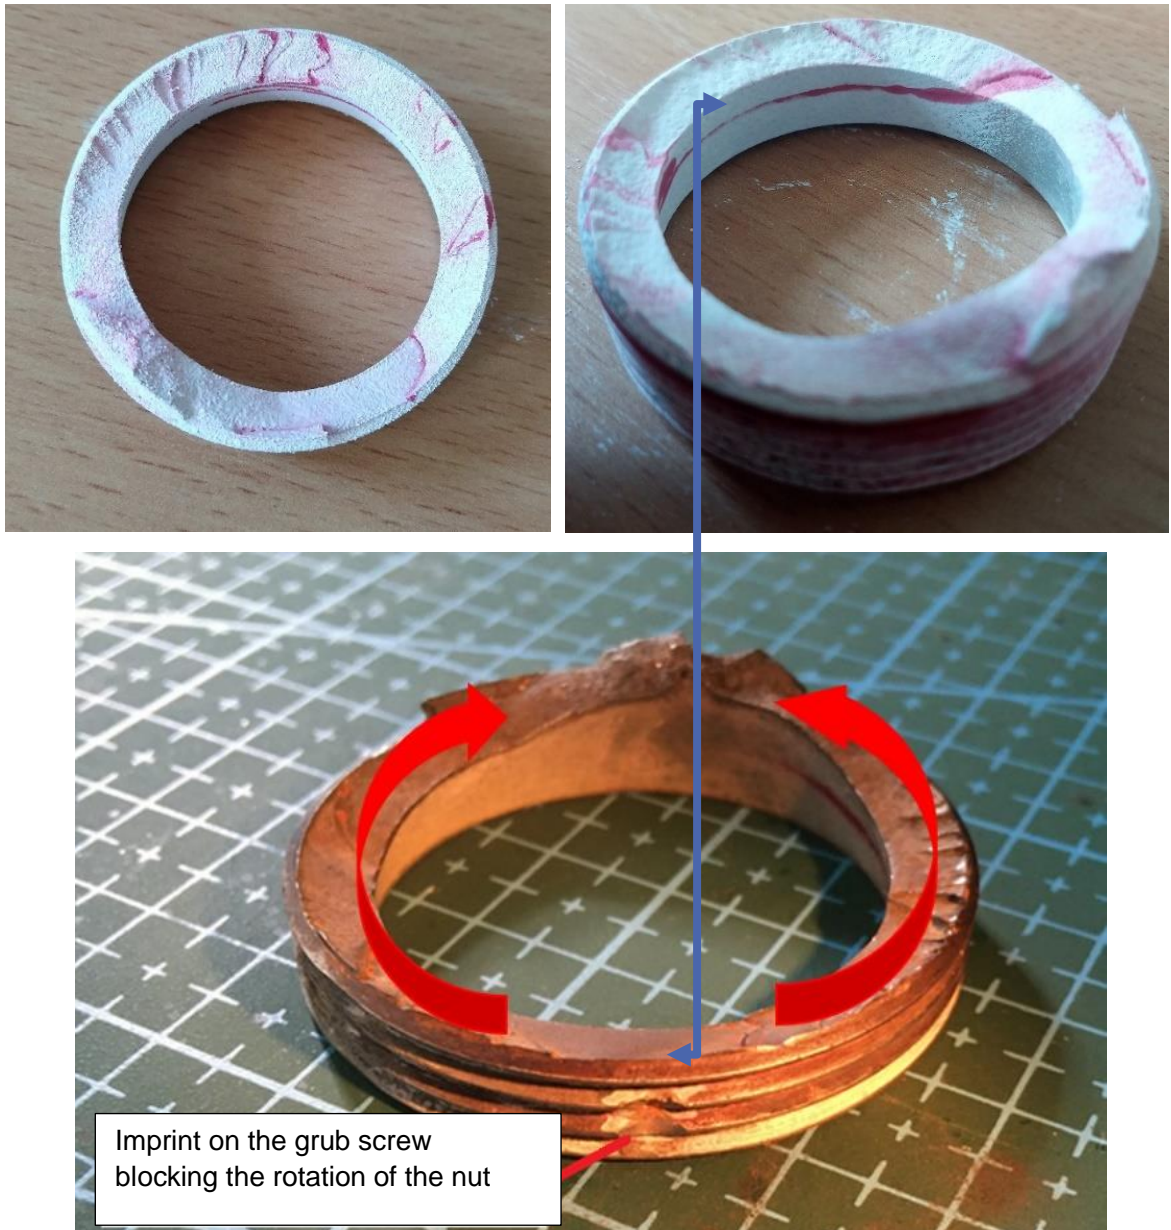
Penetrant tests were carried out on two undamaged propeller blades and on the remaining element of the third, broken blade. Spotcheck SKL-SP1 penetrating agent was used for the test.. No irregularities were found on the undamaged blades, while open circumferential cracks appeared on the damaged element. They were present under the fracture surface. A characteristic place was the area of the grub screw.

Fig. 12. The results of the colour penetration method test – damaged element – clearly visible subsurface crack [source: Warsaw University of Technology]

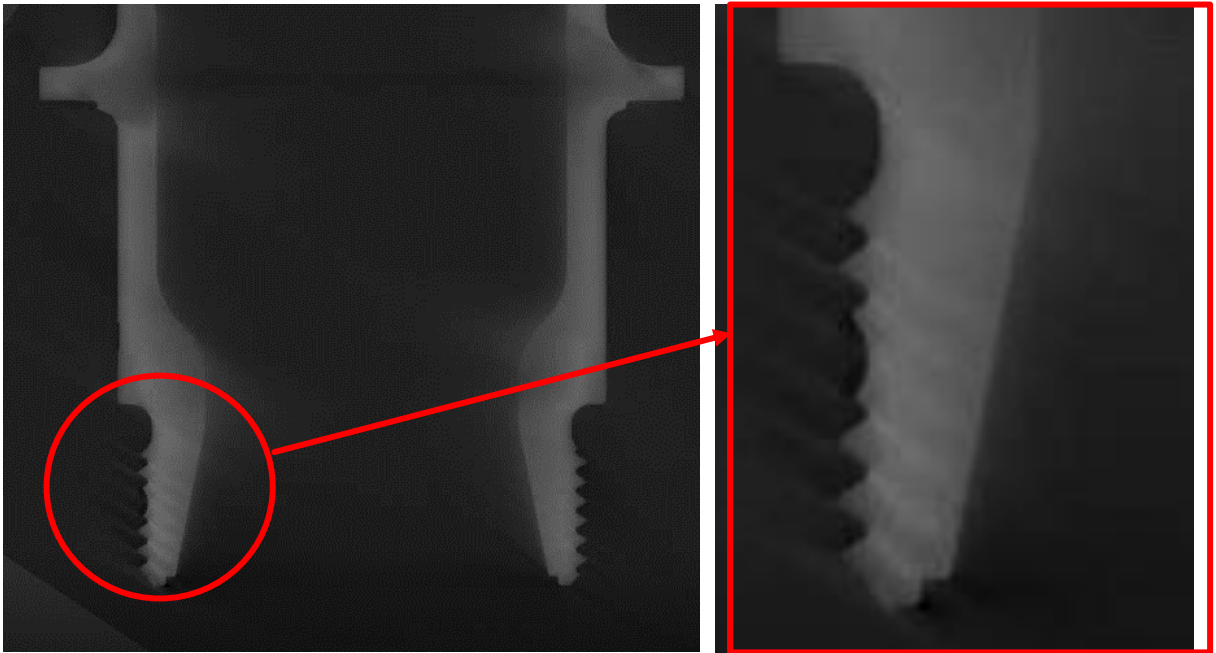
Examination of undamaged blades with an ultrasonic flaw detector showed no cracks. X-rays were made on a blade trimmed to fit it in the chamber of the testing device. Recess places for grub screws were examined. Those places showed no signs of breakage.

Fig. 13. Place of imprint from the grub screw in an undamaged blade - no visible breakage
[source: Warsaw University of Technology]

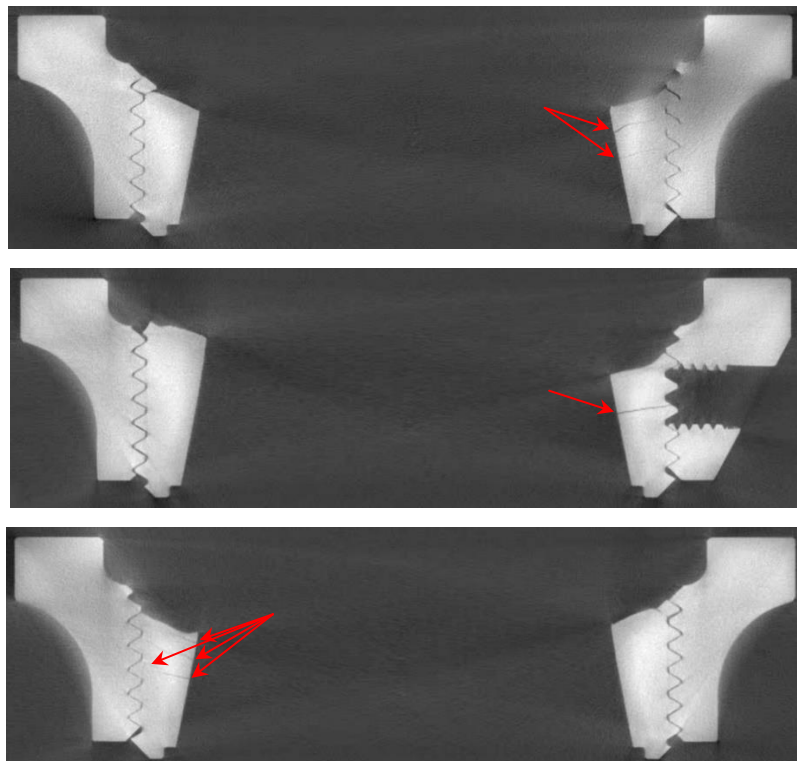
The mounting of the damaged propeller blade was thoroughly examined. The characteristic cross-sections with visible microcracks are shown below.

Fig. 14. Cross-sections of the blade element with visible microcracks marked with red arrows
[source: Warsaw University of Technology]

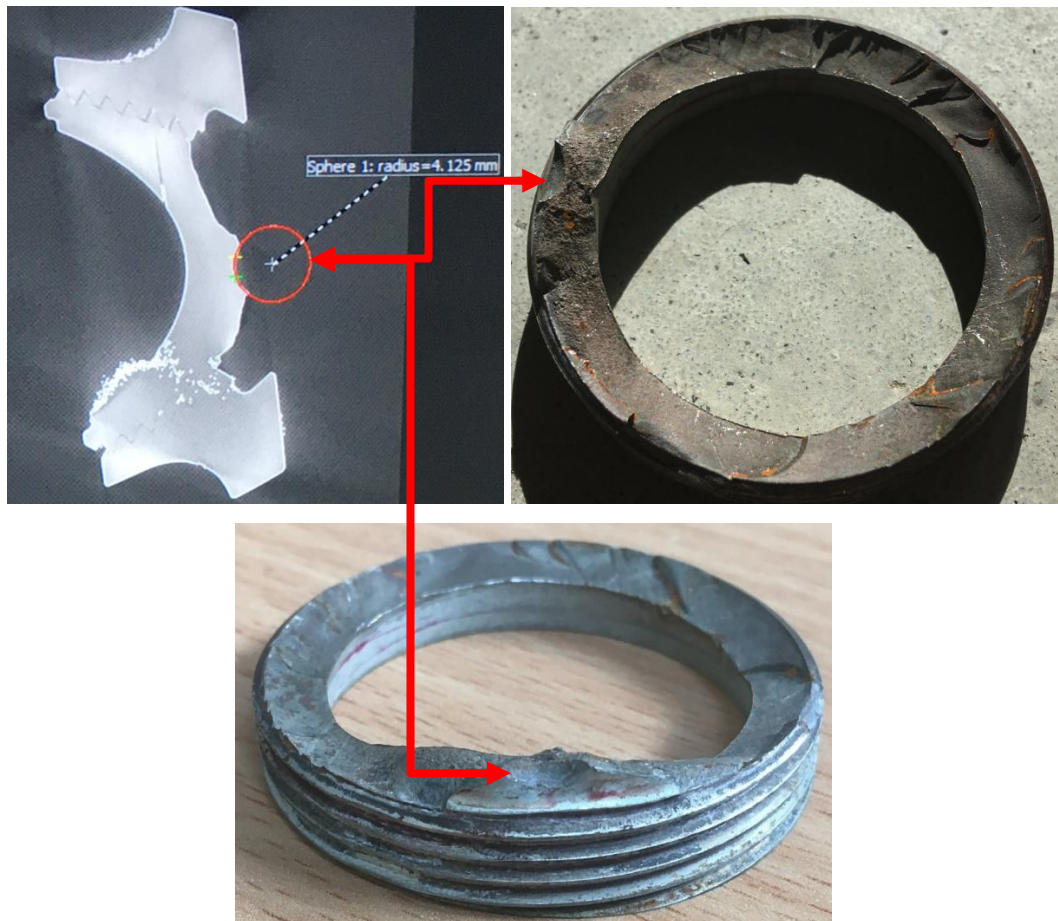
The breakage area with a characteristic spherical chipping is shown on the figure below.

Fig. 15. Spherical breakage area [source: Warsaw University of Technology]

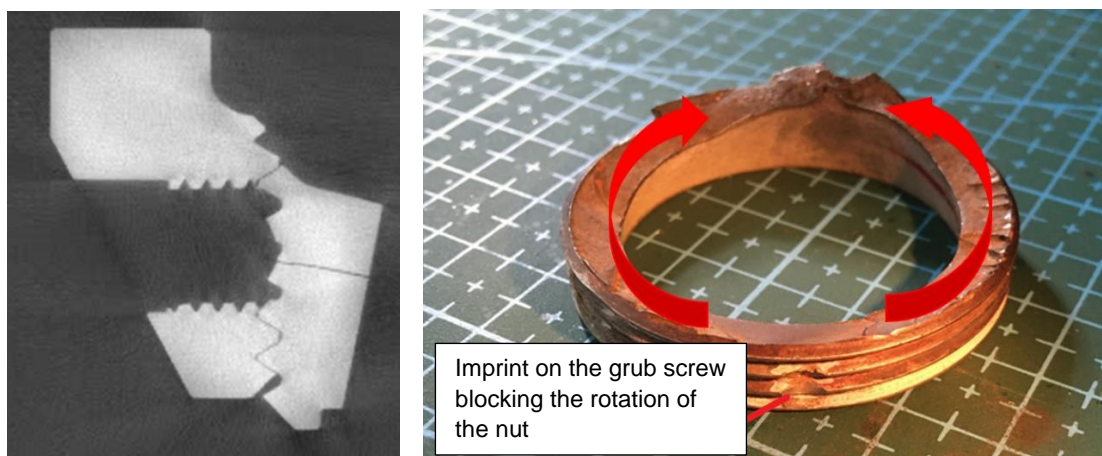
The place of the breakage origination was probably located on the imprint from the grub screw (Fig. 16).

Fig. 16. The probable place of the fatigue breakage origination [source: Warsaw University of Technology]
