FINAL REPORT

OCCURRENCE NO. – 2020/1581

AIRCRAFT – Guimbal Cabri G2, SP-NCA helicopter

DATE AND PLACE – 2 July 2020, Nowe Miasto nad Pilicą, EPNM

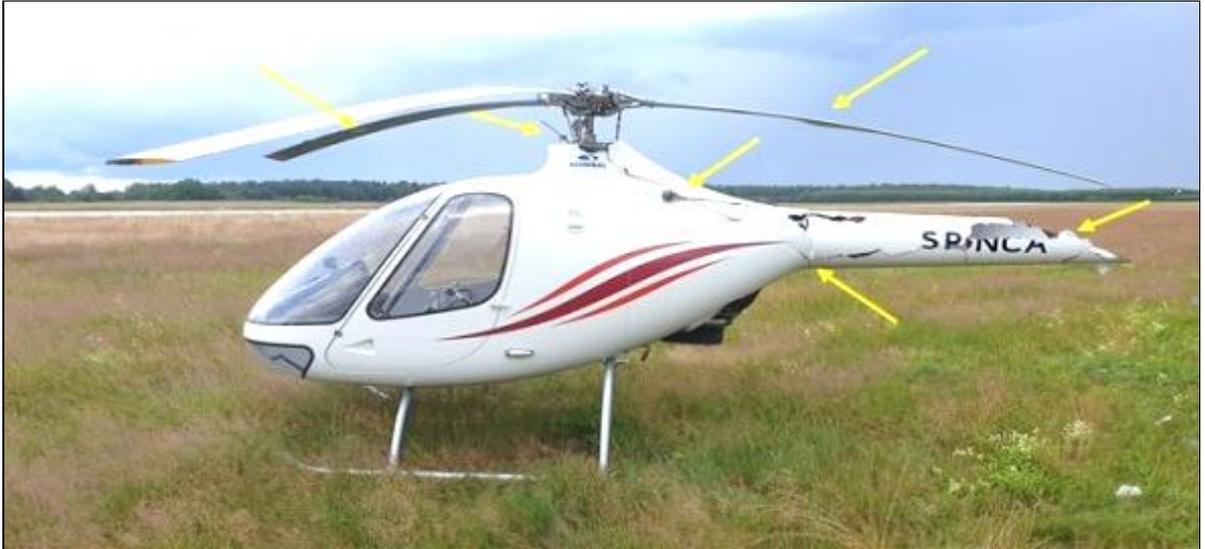
Due to the occurrence the aircraft sustained damage to the tail boom, fuselage skin, tail rotor (fenestron) along with the drive transmission system, two out of three main rotor blades, blade dampers, swashplate scissors, rotor blade pitch control rods, oil pressure sensor. The locations of the helicopter's damage are presented in Figures 3 to 9.

Fig. 3. SP-NCA helicopter damage – general view [source: ACSL LAW]

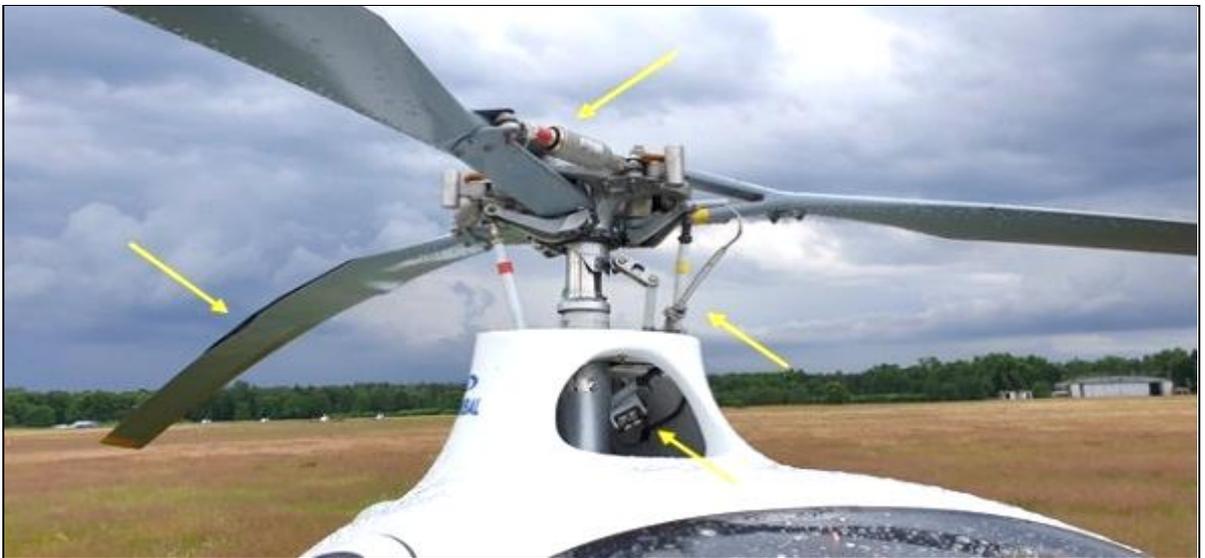
Fig. 4. SP-NCA helicopter damage – main rotor head [source: ACSL LAW]

None of the helicopter parts separated prior to touchdown. The aircraft damage resulted from the cut-off of the tail boom by the main rotor blades and the destructive action of the separated fenestron drive shaft and the fenestron blade pitch control cable. The Bowden cable ruptured the fuselage skin and got entangled in the main rotor hub which was destroyed.

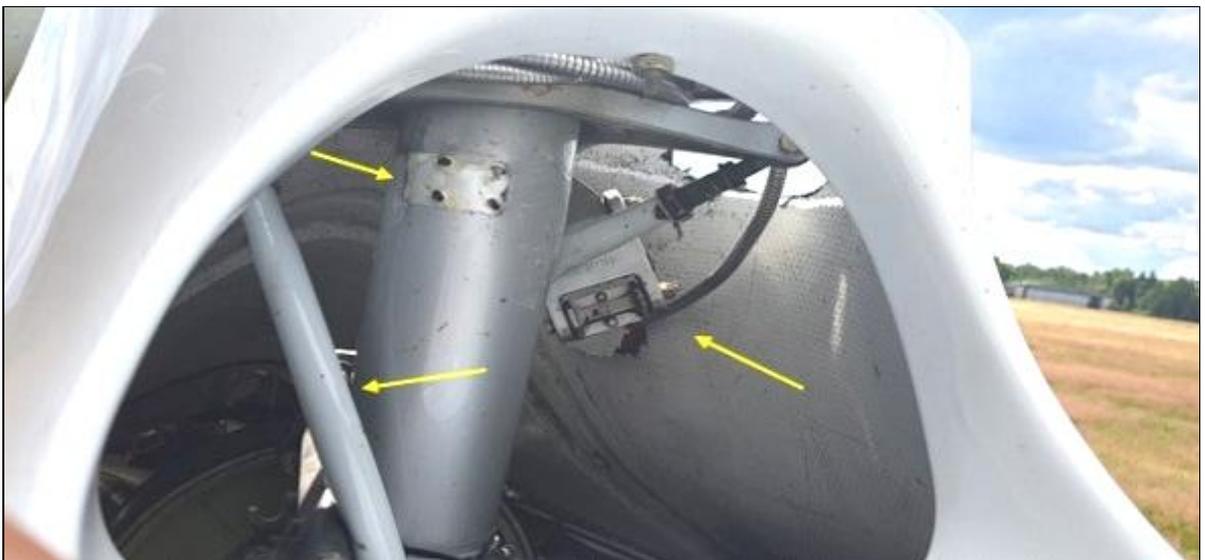
Fig. 5. SP-NCA helicopter damage – main rotor hub [source: ACSL LAW]

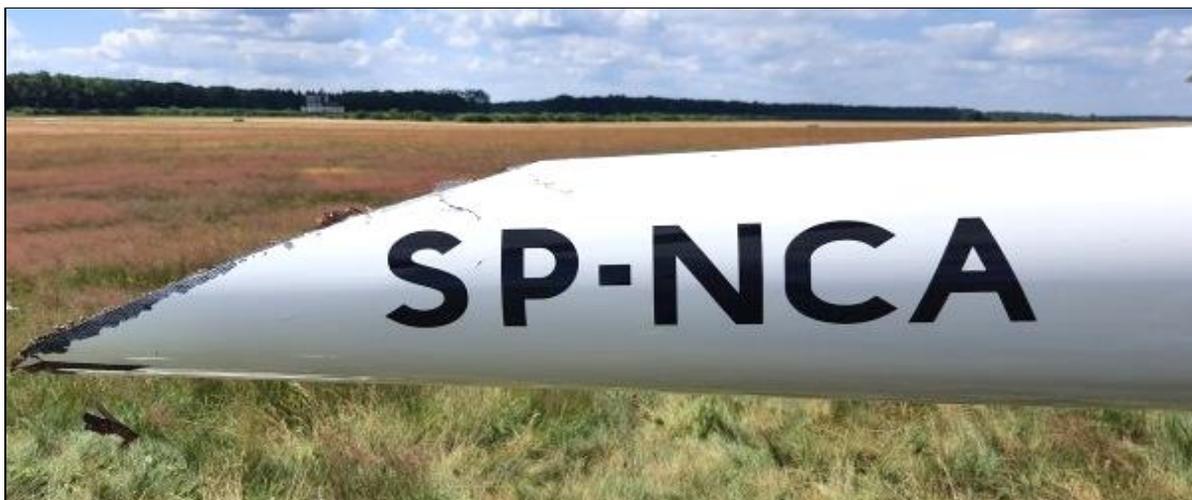
Fig. 6. Sheared tail boom [source: ACSL LAW]

The Commission determined that the helicopter touched down with low forward speed and heading of approx. 275°. During landing roll, as a result of deceleration caused by the dynamic increase in the plane angle of the rotating rotor, the main rotor blades collided with the tail boom and cut off its rear part together with the fenestron. Those elements were located approx. 5 m away from the helicopter fuselage.

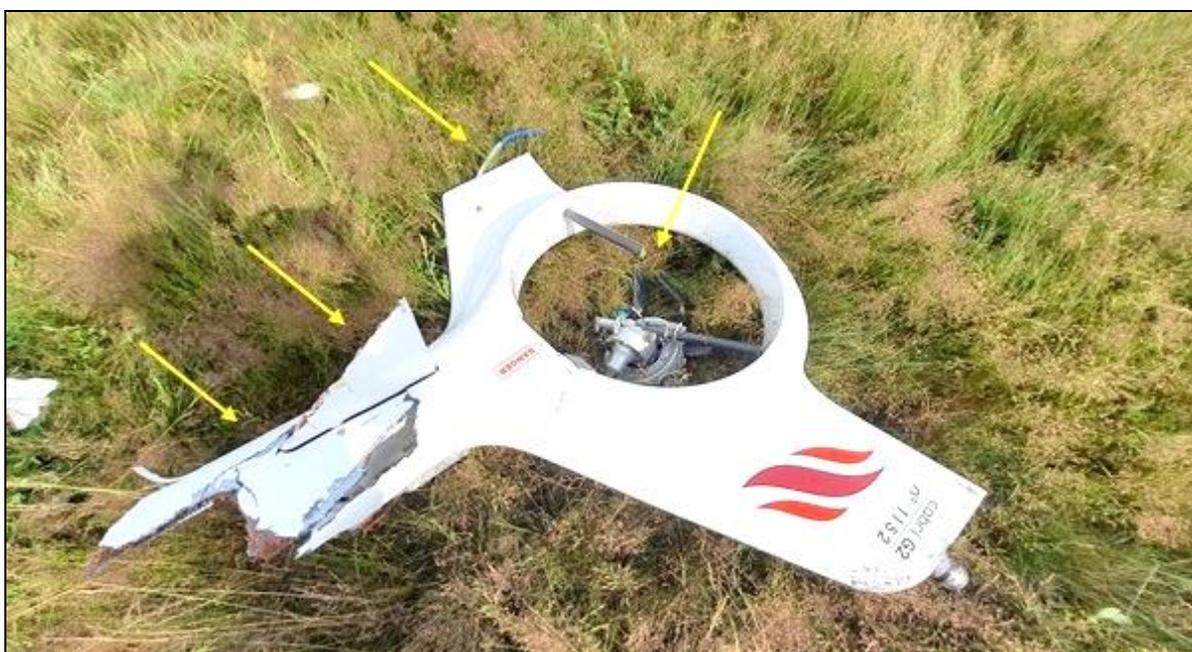
Fig. 7. Sheared rear part of the tail boom with the fenestron [source: ACSL LAW]

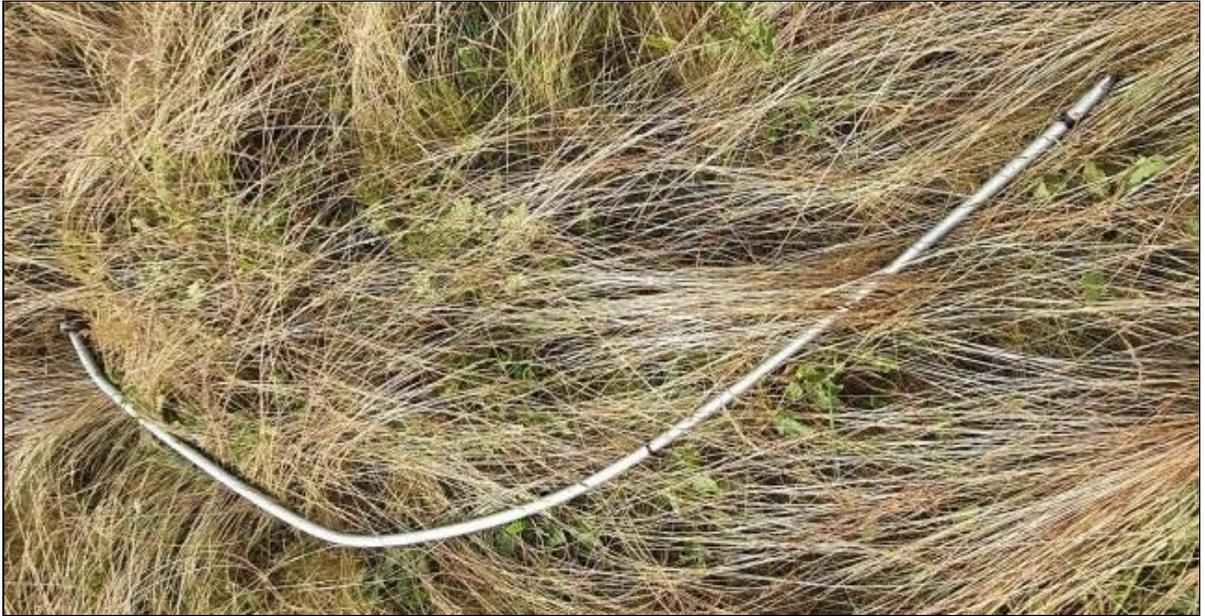
Fig. 8. Middle part of the fenestron drive shaft torn out from SP-NCA helicopter tail boom [source: ACSL LAW]

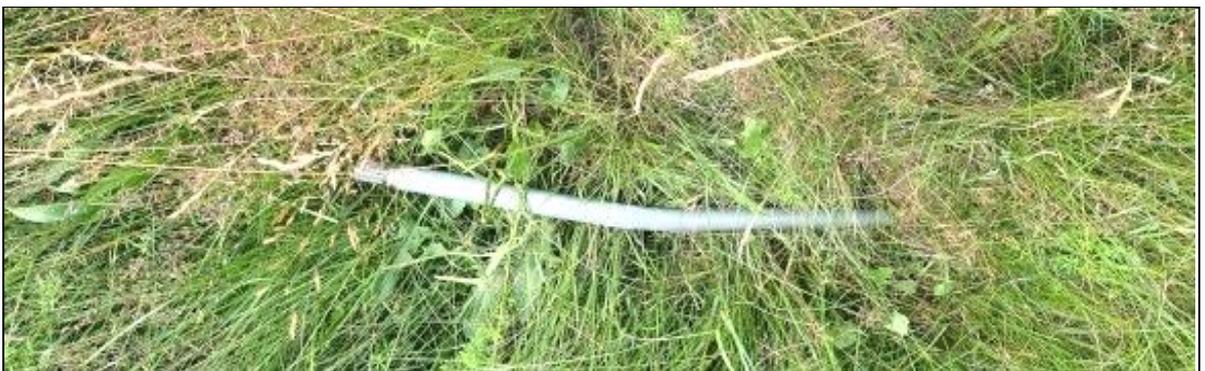
Fig. 9. End part of the fenestron drive shaft [source: ACSL LAW]

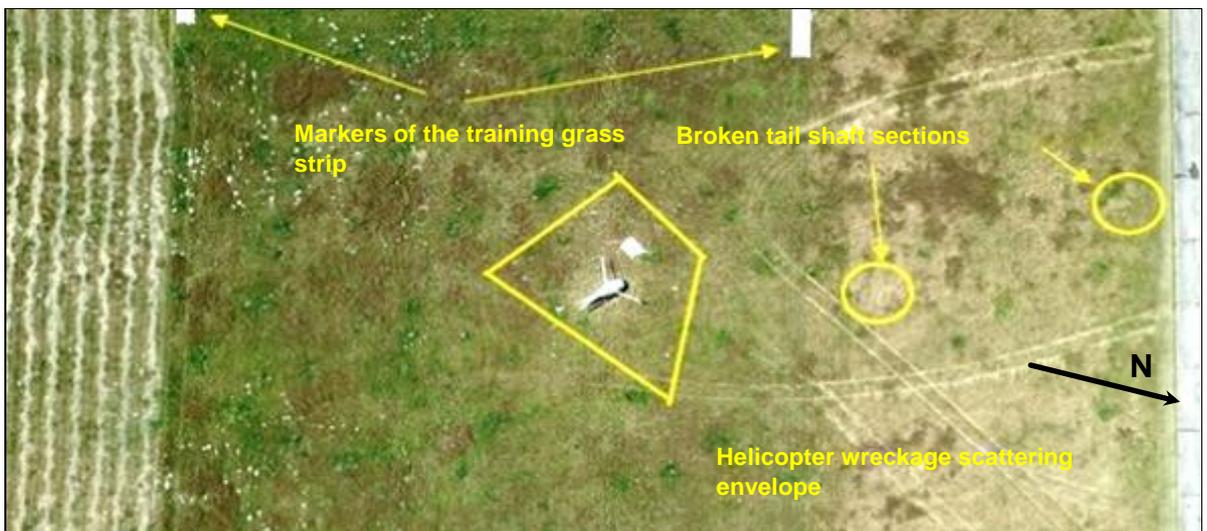
Fig. 12. Helicopter view at the occurrence site – scattering of wreckage [source: ACSL LAW, background: Google Earth]

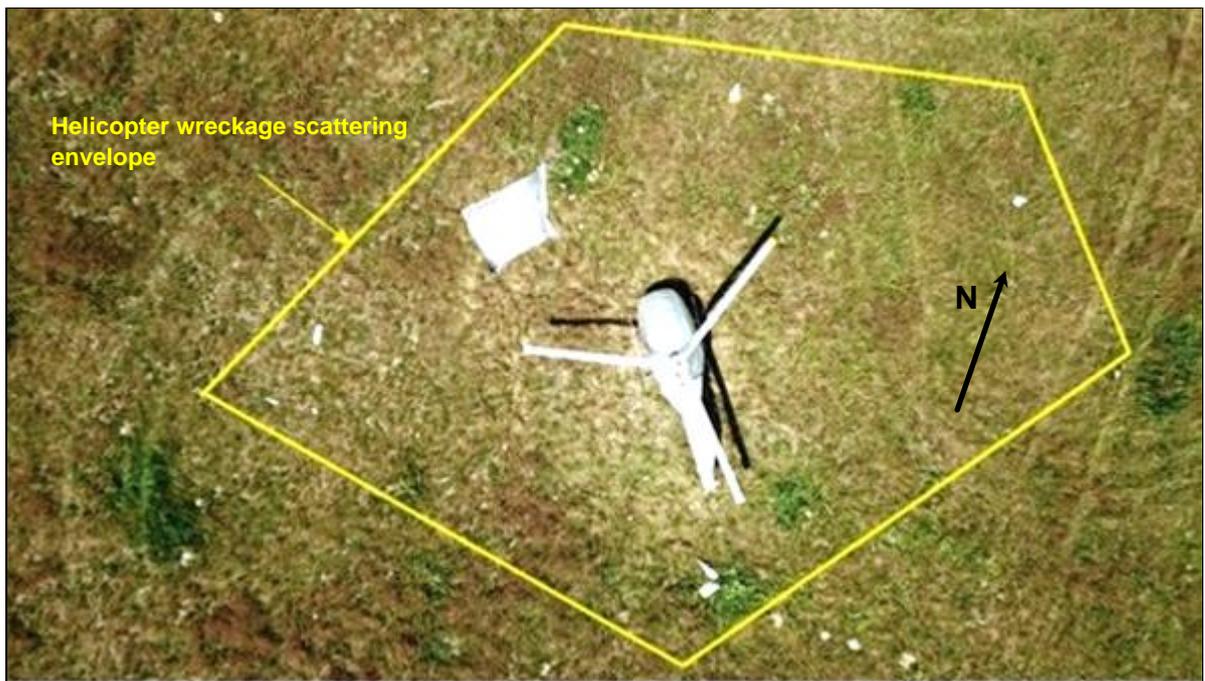
Fig. 13. Close-up – helicopter wreckage [source: ACSL LAW, background: Google Earth]
