# FINAL REPORT

OCCURRENCE NO – 2020/1766

AIRCRAFT – Tecnam P2006T, SP-KEY

DATE AND PLACE OF OCCURENCE – 14 July 2020, EPBY

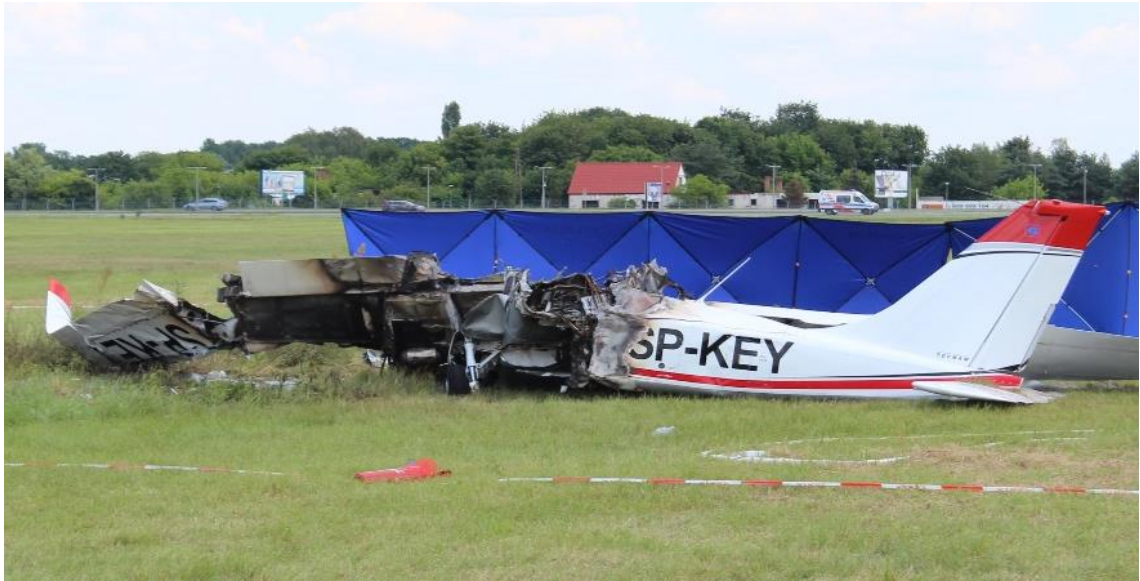
Due to collision with the ground and fire the airplane was destroyed (Fig. 1).

Fig. 1. View of the airplane wreckage at the accident site [source: PKBWL]

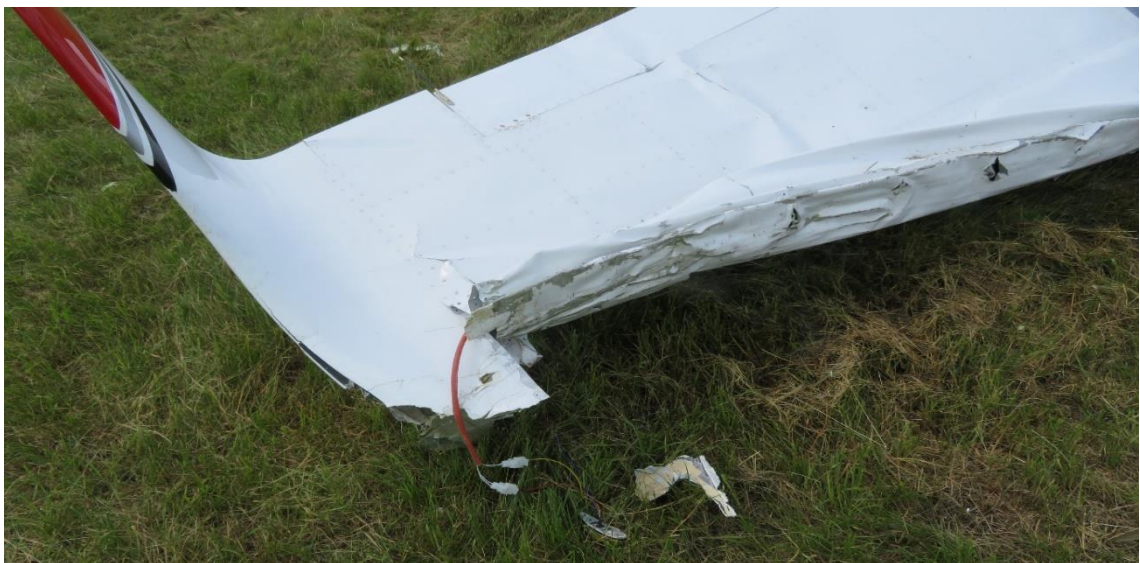
After making a low pass over the end of the RWY 08 runway, the aircraft commenced a slight climb, which led to an increase in the angle of attack and the aircraft entered an autorotation with a roll to the right wing and nose down pitch. The collision with the ground occurred 490 m from the end of the RWY 08 and 125 m from its centre line. The plane crashed into the ground at an angle of about 90°, as evidenced by flat damage to the wing leading edge (Fig. 4).

Fig. 4. Flat damage on the wing leading edge [source: PKBWL]

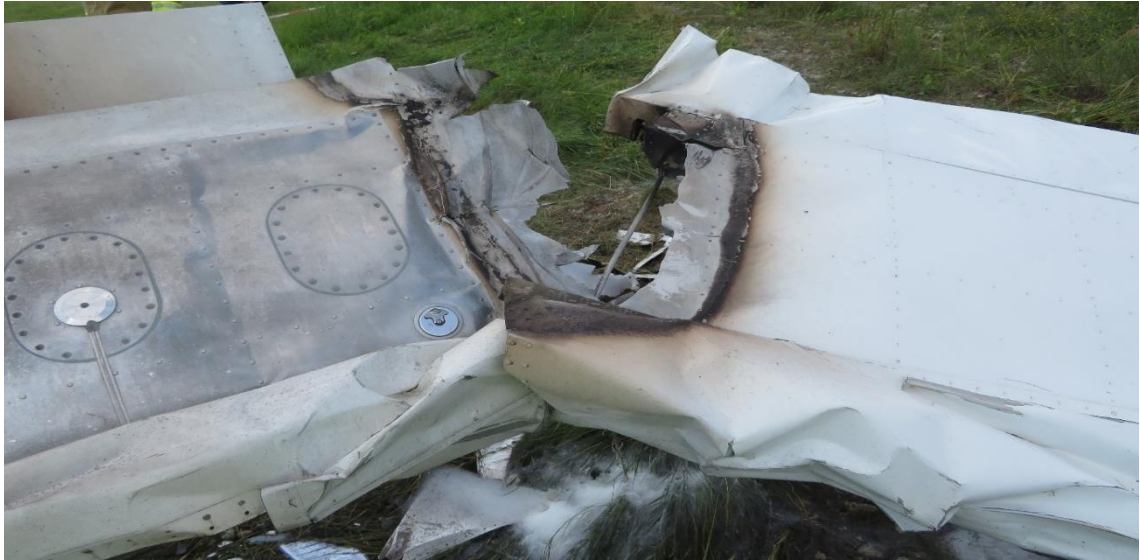
After a slight displacement, the wings remained on the crash place. The rear part of the fuselage was bent and moved towards the right wing. The rear part of the fuselage bending to the right caused a partial tearing of the left wing structure. (Fig. 5).

Fig. 5. Torn and deformed part of the left wing structure [source: PKBWL]

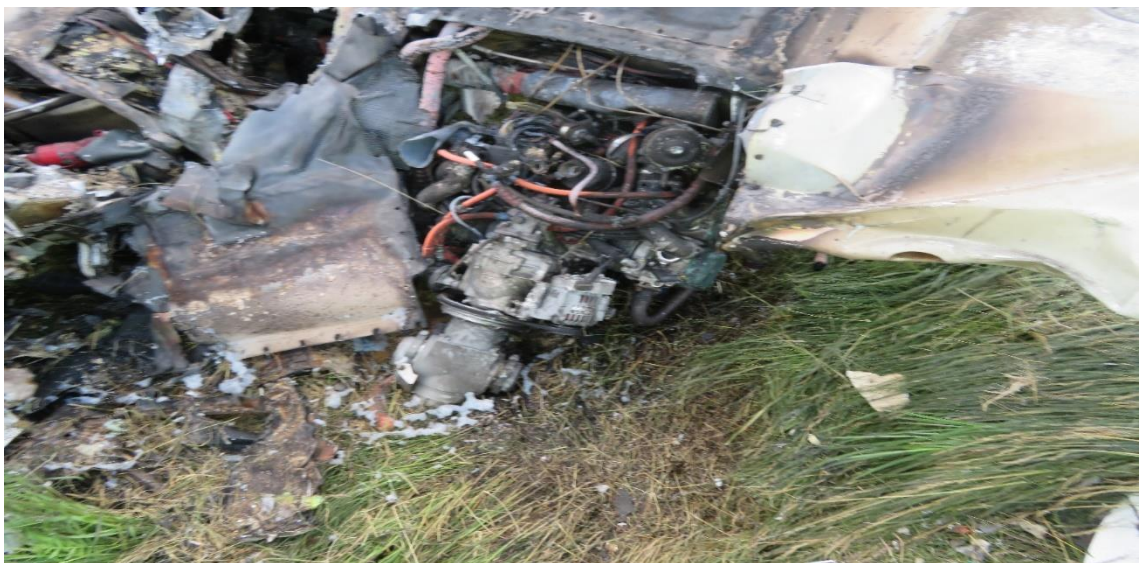
As a result of the collision with the ground, the right wing, and right engine were damaged and the propeller blades were broken (Fig. 6).

The fuel that leaked from the ruptured tank, in contact with hot parts of the engine, initiated a fire.

Fig. 6. Damaged powerplant unit no 1 [source: PKBWL]

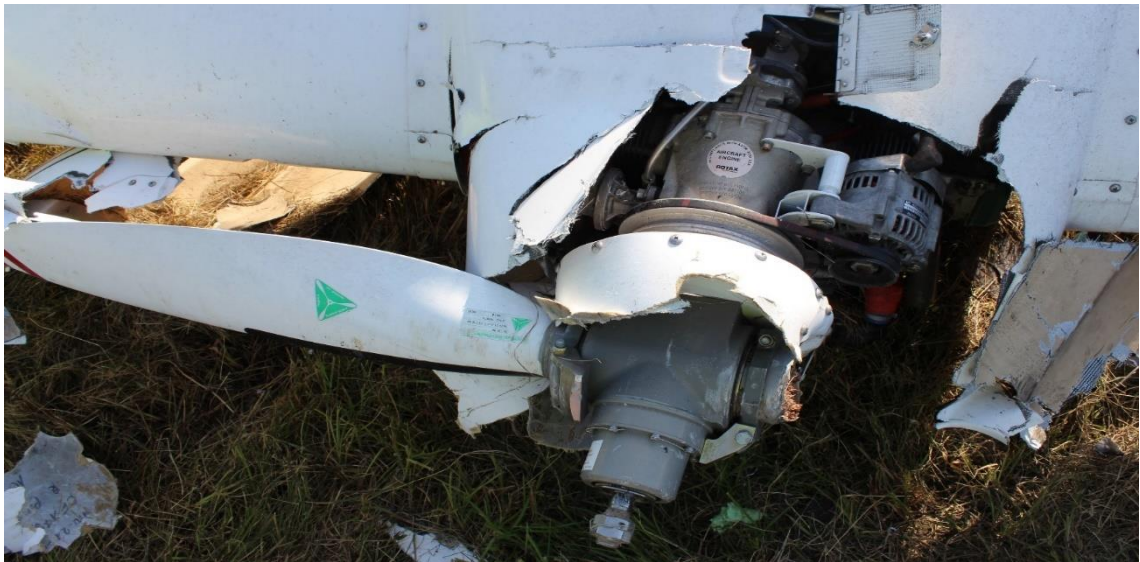
Engine No. 2 was not damaged by fire (Fig. 7).

Fig. 7. Damaged engine no 2 [source: PKBWL].

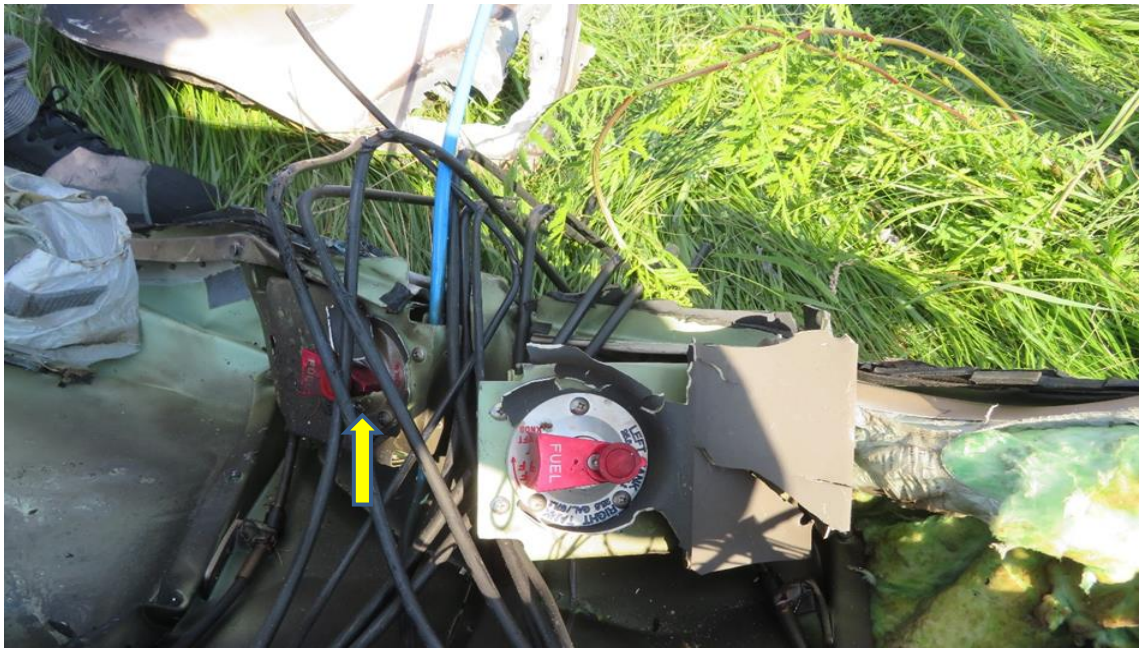
However, during the inspection of the cabin wreckage, it was found that the fuel valve of engine no. 2 (right) was in the closed position and was secured with a lever that prevented its displacement (Fig. 8).

Fig. 8. Engine no 2-fuel valve in closed position [source: PKBWL]

PKBWL determined that the right fuel valve was in the "OFF" position and the left one in the "ON" position, indicating that the right engine was out of fuel and not running.

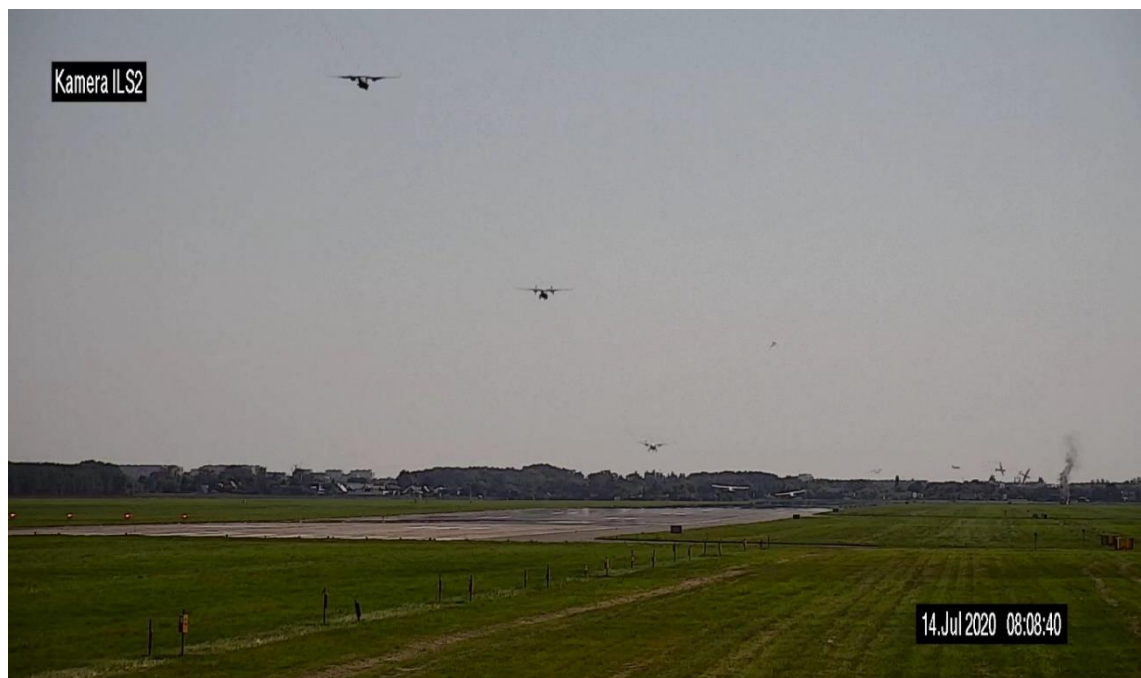
The analysis of the recordings, as well as the statements of witnesses and the TWR controller, indicate that the propellers of both engines were rotating, which could suggest that both engines of the aircraft were working. The aircraft performed the low pass several meters over the runway and according to TWR controller and video recordings, the level flight was performed at high angles of attack at low speed. It could be also seen that the plane rolled slightly to the left and right, but those rolls were corrected by the pilots. After passing the end of RWY 08, the airplane was in a level flight for several seconds and then, in a slight climb, started a turn to the right. During the turn, the aircraft stalled and on descent with a significant roll to the right, it crashed into the ground (Fig. 10).

Fig. 10. Last phase of the SP-KEY flight [source: EPBY CCTV cameras]
