SERIOUS INCIDENT 2022/2076

AIRCRAFT – Tecnam P2008 JC, SP-SCS

DATE AND PLACE OF OCCURENCE – 6 May 2022, Chojna

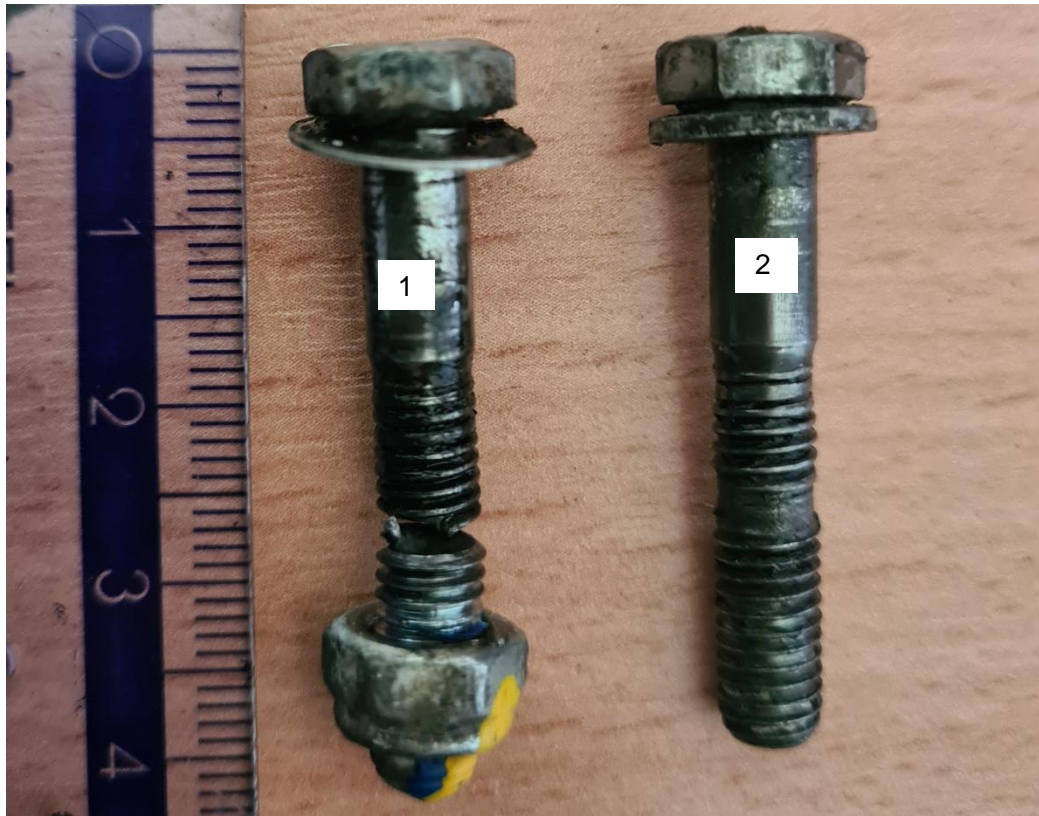
The cause of the serious incident was a design flaw in the stabilator control system, resulting in the breakage of the bolt fastening the stabilator suspension, which led to its jamming.

Two bolts of the stabilator suspension system were damaged (Fig. 1).

Fig. 1. Broken (1) and damaged (2) bolt of the stabilator suspension [source: PKBWL]

For the above reasons, PKBWL recommends, that the Tecnam P2008 JC manufacturer, in consultation with ANSV change the status of Bulletin SB 298 - CS to mandatory.

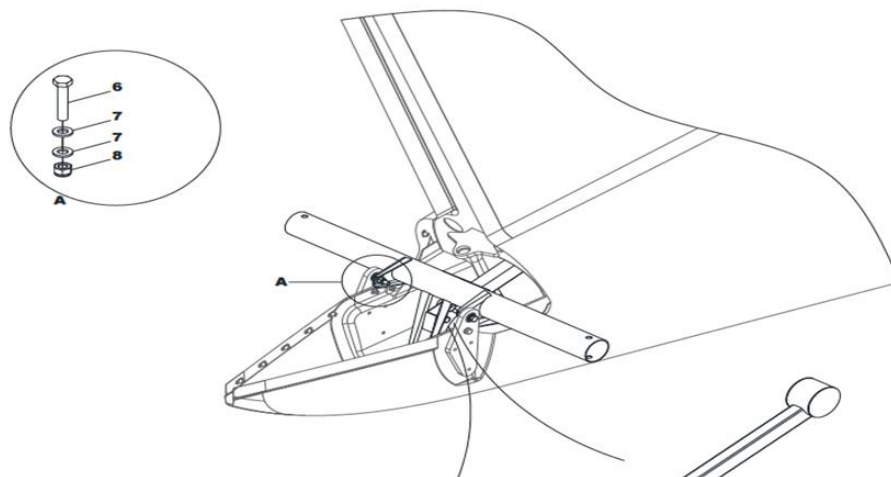
During visual inspection the left bolt of the stabilator hinge (PN UNI 5736-6-35) was found broken (Fig. 2, item 6).

Fig.2. Broken bolt P/N UNI5737-6-35 (item.6) [source: IPC]

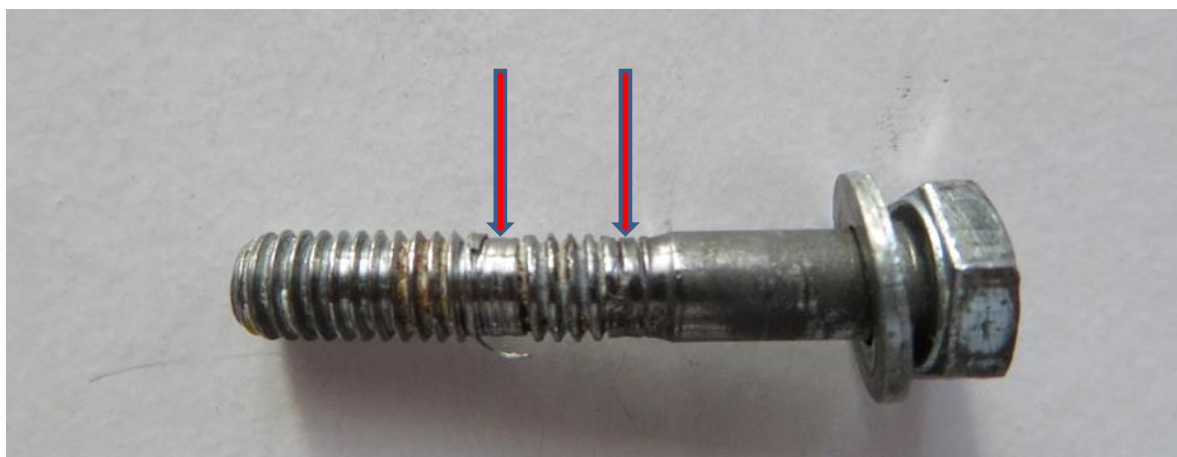
After dismantling the right bolt, damage in the form of dents and material losses was detected on its threaded part (Fig. 3).

Fig.3. The bolt with damaged thread [source: PKBWL]

The thread was also damaged on the broken bolt.

Movement of the connected elements towards the threaded part caused that they rested on the thread and caused its damage, visible on both screws.

On 10 April, 2018 the manufacturer issued the SB 298 - CS Service Bulletin regarding the replacement of bolts with P/N AN4 - 11A. P/N AN4 - 11A bolts with a diameter of 6.35 mm have a much longer unthreaded part (by about 7 mm) and eliminate the main factor of the bolt damage.

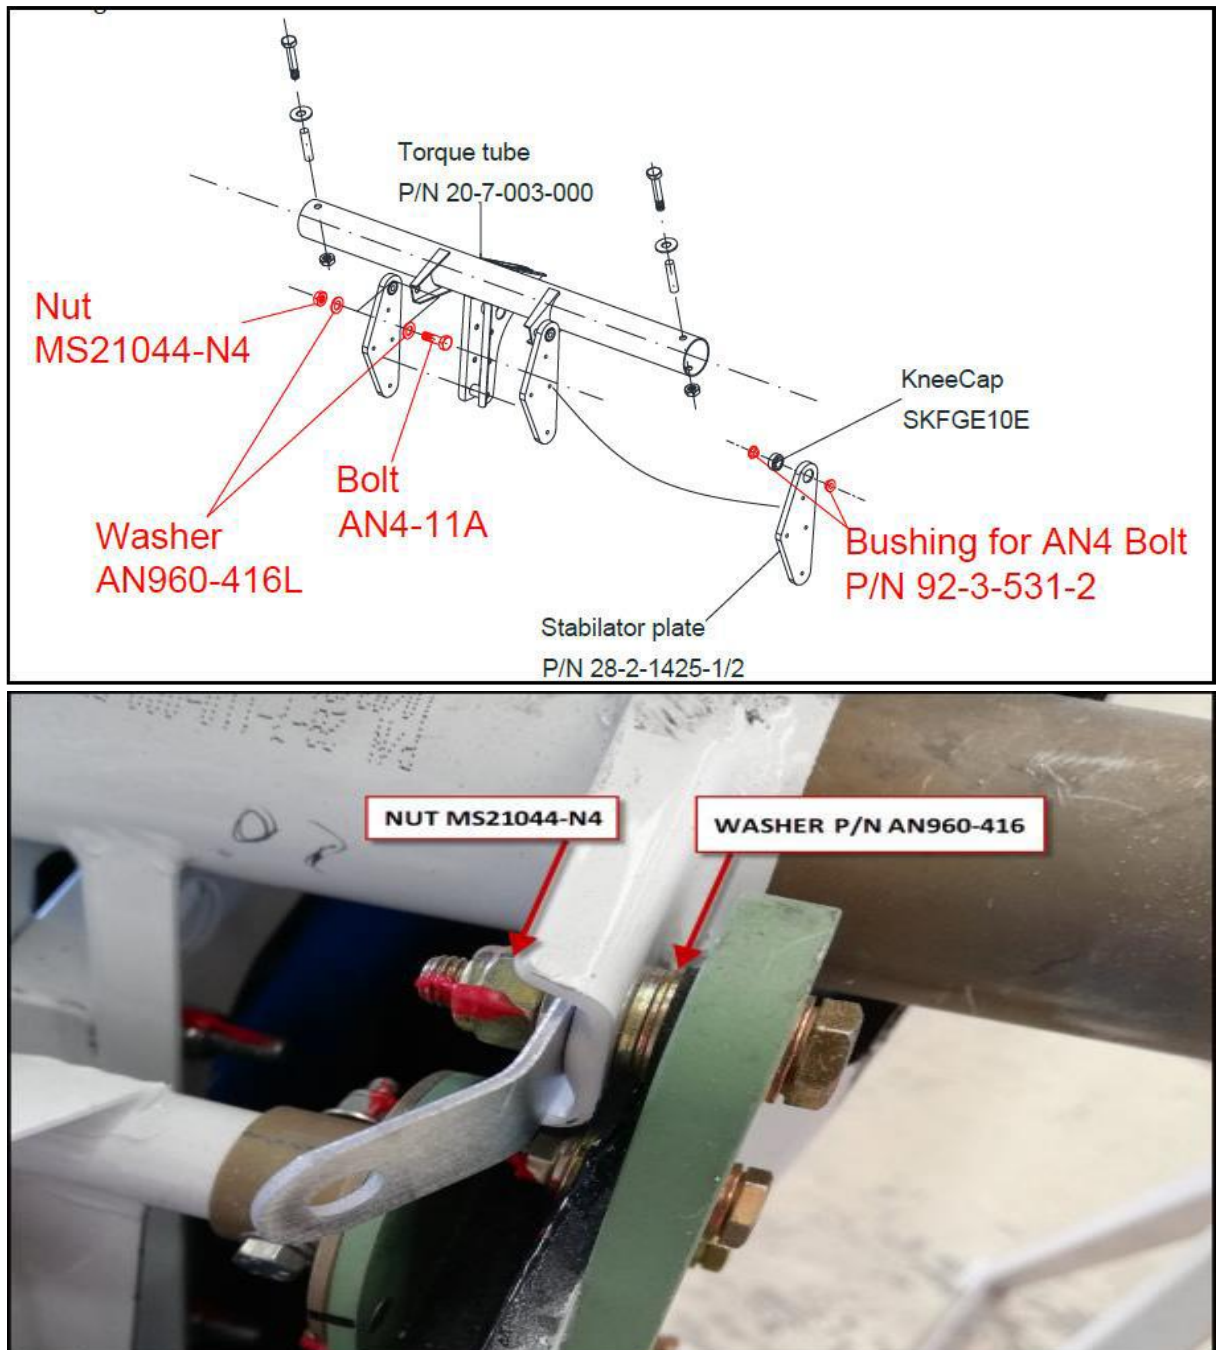
Fig. 4. Arrangement of fastening elements of the stabilator control system [source: SB298 – CS Service Bulletin].

Moreover, the bulletin clearly states that after replacing the P/N AN4 - 11A screw, P/N AN960 - 416L washers (or P/N AN960 – 416 if necessary) should be used to remove clearance in the elevator control system (fig. 4).
