State Commission on Aircraft Accidents Investigation

INCIDENT 2022/7037

RESOLUTION

Type and model of aircraft:	Airplane, Airbus A321
Registration marks:	HA-LVO
Date of occurrence:	11 th December 2022
Place of occurrence:	EPWA, Poland

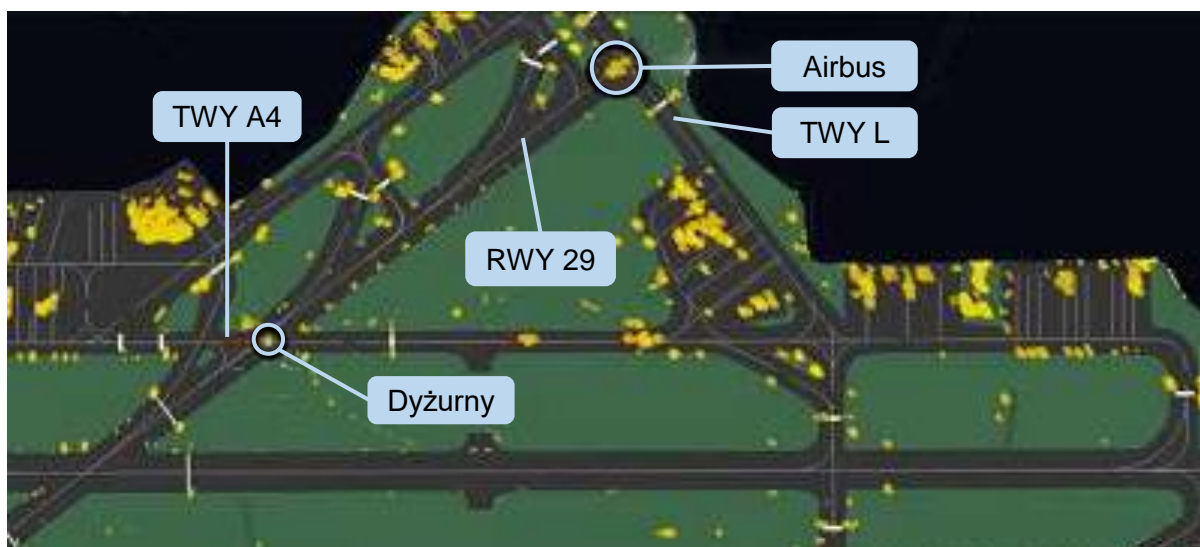
The Assistant heard the Controller giving clearance for the Airbus airplane to take off and informed him that he had already given clearance for the Duty Officer's vehicle to cross RWY 29. At that time, the Duty Vehicle had already entered the intersection of TWY A4 and RWY 29, and the Airbus airplane had taken up takeoff positions on RWY 29 (Figure 1).

Figure 1: SMR radar display at the time when the Controller informed the crew of the Airbus airplane about the Duty Officer's vehicle crossing RWY 29 [source: PANSAs].

The controller did not cancel the Airbus airplane's clearance for takeoff but only informed the crew of a vehicle crossing RWY 29 at the height of TWY A4. The crew of the Airbus airplane began takeoff after the Duty Officer's vehicle left RWY 29.

Issue of runway crossing clearance to a vehicle without coordination with the TWR controller.

- 1) Incorrect assumption by the TWR controller's assistant that there will be no takeoffs from RWY 29 in the short term.
- 2) Issuance of a takeoff clearance for the Airbus airplane in the absence of knowledge of a previously issued clearance for a vehicle to occupy the runway.
- 3) Visibility was limited to 1,500 m in light snowfall.
- 4) Increased traffic on the airfield due to unfavorable weather conditions.
