# Accident involving an aircraft of the model Antonov AN-2

The Swedish Accident Investigation Authority has investigated an accident at Vårgårda, Västra Götaland county, on 08 July 2023

19 June 2024

## Final report SHK 2024:10e

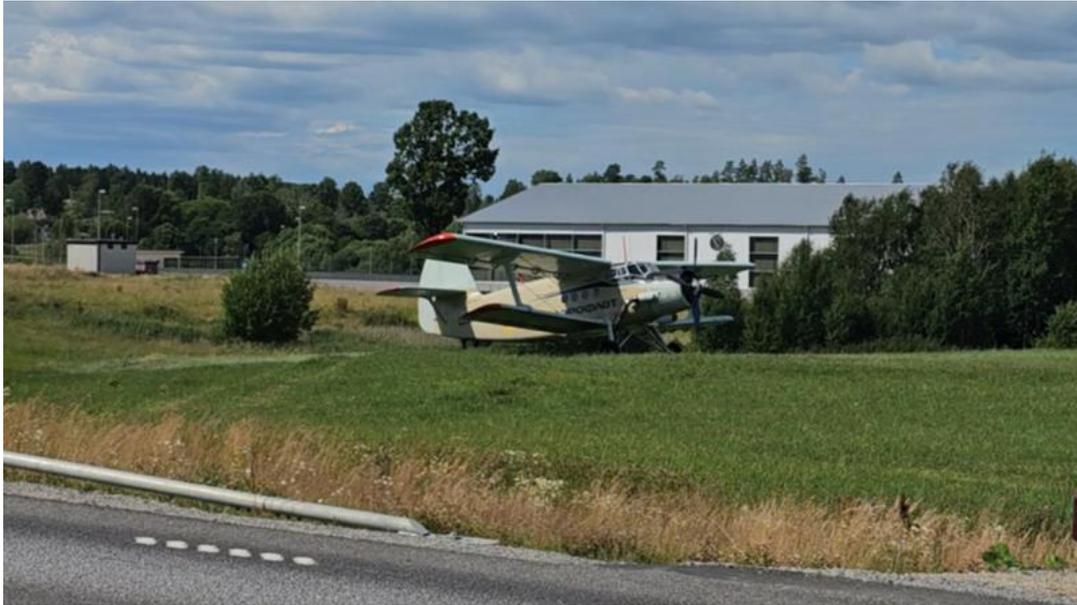
Figure 1. The aircraft at take-off position. Photo: Private.

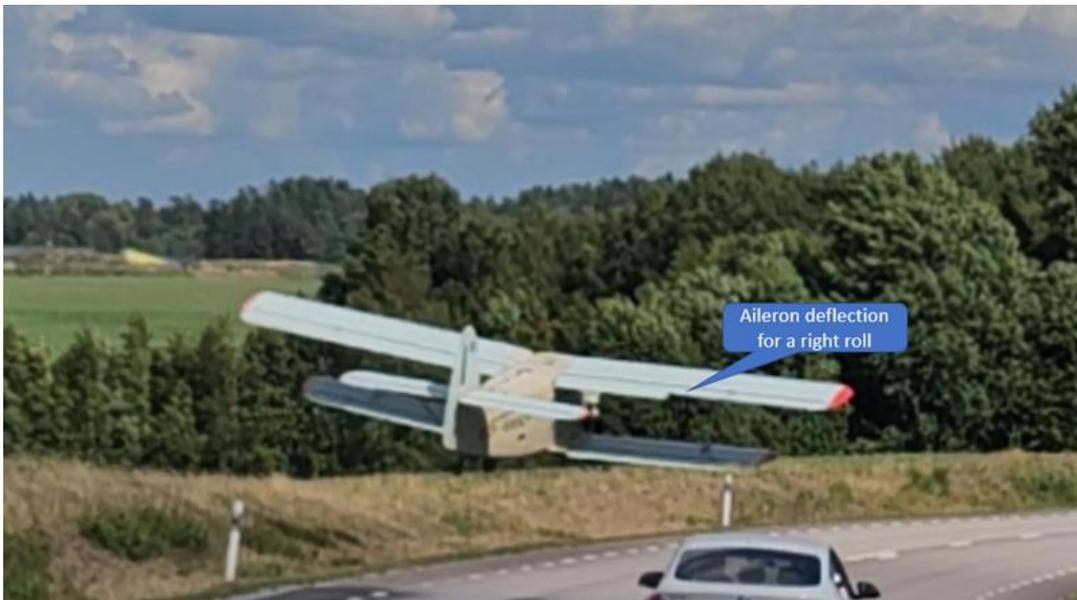
The films show the aircraft taxiing towards the position for take-off and car traffic passing on the road directly adjacent to the field. The aircraft is seen to initiate the take-off in an easterly direction. Evidence observed from the wind on trees, branches, grass and flagpoles, indicates that the wind is westerly, i.e. tailwind in the aircraft's take-off direction. At lift-off, the aircraft is seen to roll to the right and an upward deflection can be seen on the right aileron, (see Figure 2).

Figure 2. Roll to the right in connection with the lift-off. Markings inserted by SHK. Photo: Private.

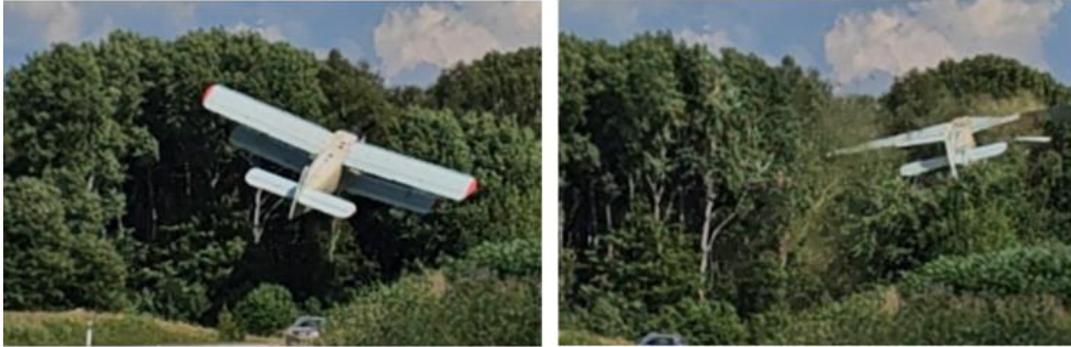
The aircraft's roll angle to the right and pitch angle upwards gradually increase and it can be observed that the rudder has a deflection to the right. The aeroplane collides with the trees, turns to the left and falls between them (see Figure 3).

Figure 3. The left image shows the aircraft the moment before the collision with the trees. The right image shows the collision with the trees. Photo: Private.

The video footage of the event shows that the aircraft had a significant roll and pitch angles at the moment before the collision, (see Figure 3).

From the investigation material it can be concluded that the angle of attack of the aircraft just before the collision with the trees was high. This meant that the induced drag was high and that maximum engine power was probably no longer sufficient to maintain a climb.

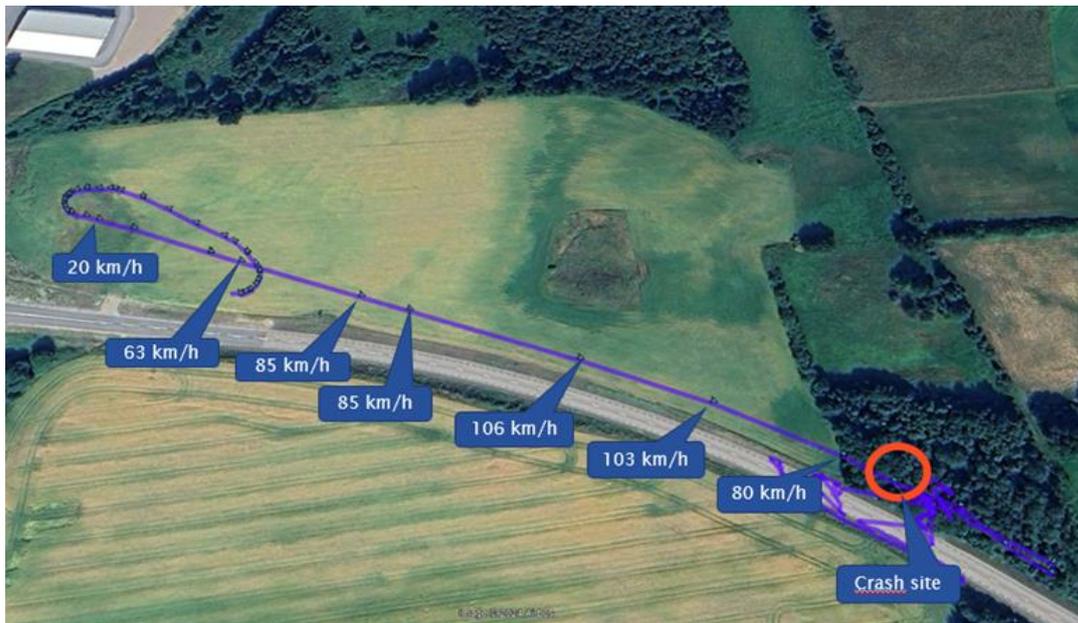
Recorded data shows the flight track and ground speed. The data shows that the take-off direction was 110 degrees. The highest recorded speed was 106 km/hour and was reached around the position at which the aircraft, according to the films, lifted off. Thereafter, the speed decreased until the position where the collision with the trees occurred, (see Figure 5).

Figure 5. Recorded data from one of the navigation applications with the ground speed. Markings inserted by SHK. Image: Google Earth.

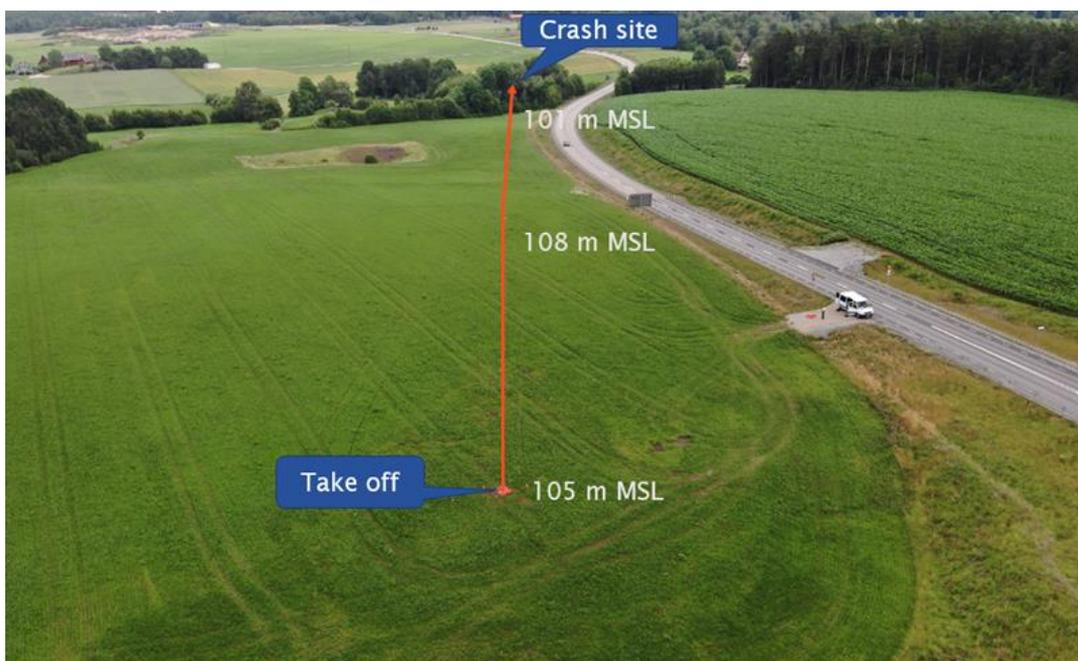
The field had a varying slope. The take-off position height was 105 MSL (mean sea level). The highest point along the take-off run was 108 MSL and the height at the end of the field was 101 MSL. The average slope ratio was  $0.011 = 0.63$  degrees downhill, (see Figure 6).

Figure 6. The image shows the take-off and accident site and the field elevation above MSL. The red arrow shows the take-off direction. Markings inserted by SHK. Photo: The Police Authority.

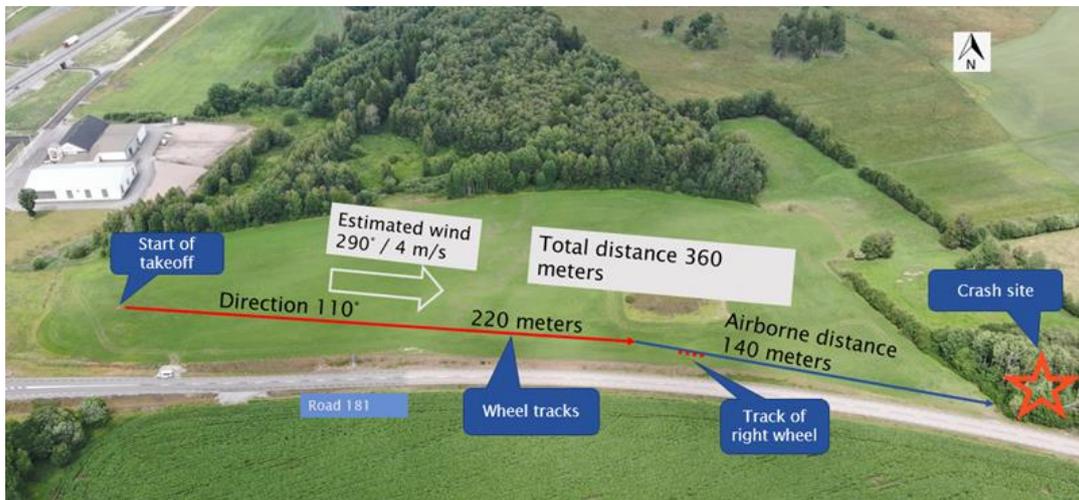
There were clear tracks in the grass from both the main wheels for a distance of 220 metres. After 250 metres there was a short track which was probably from the right main wheel. The total distance from the take-off position to the trees at the end of the field was 360 metres, (see Figure 7).

Figure 7. Tracks in the terrain. Markings inserted by SHK. Photo: The Police Authority.

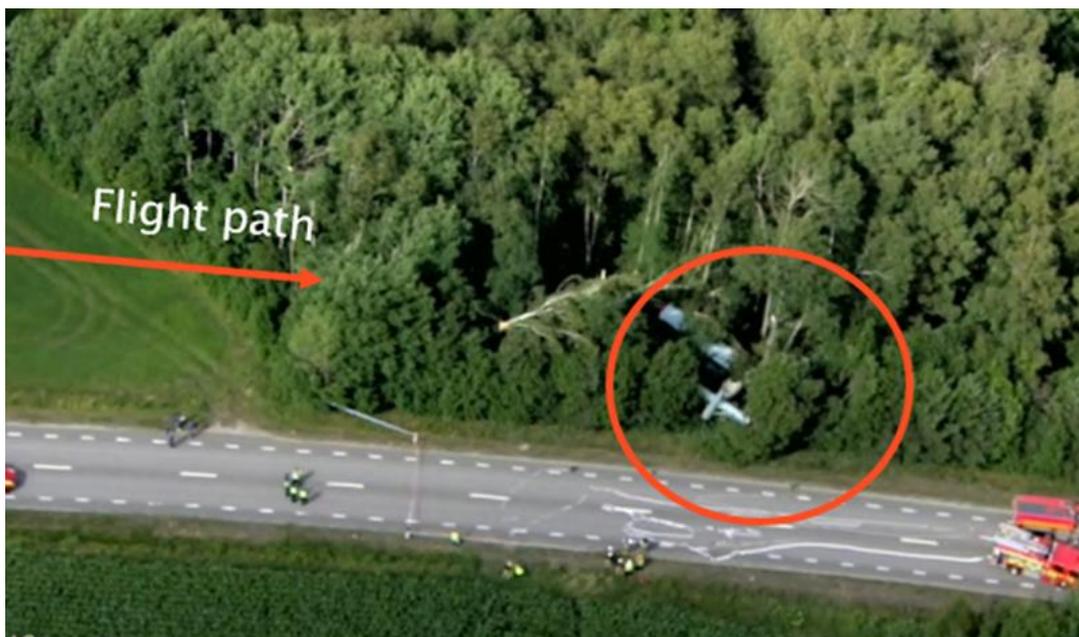
The crash site was in a patch of forest at the eastern end of the field. Large tree trunks were broken off as a result of the collision, (see Figure 8).

Figure 8. The crash site. Markings inserted by SHK. Photo: The Police Authority.

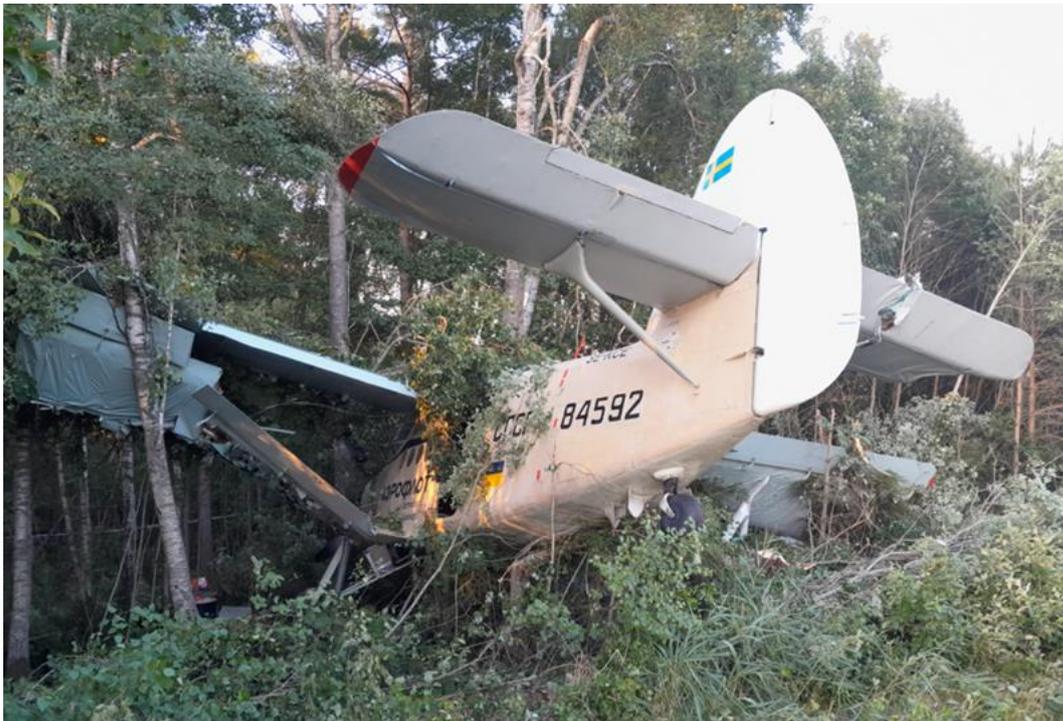
The aircraft sustained substantial damage, mainly to the wings. The cabin received relatively minor damage, (see Figure 9).

Figur 9. The aircraft at the crash site. Photo: Alingsås and Vårgårda rescue services association.

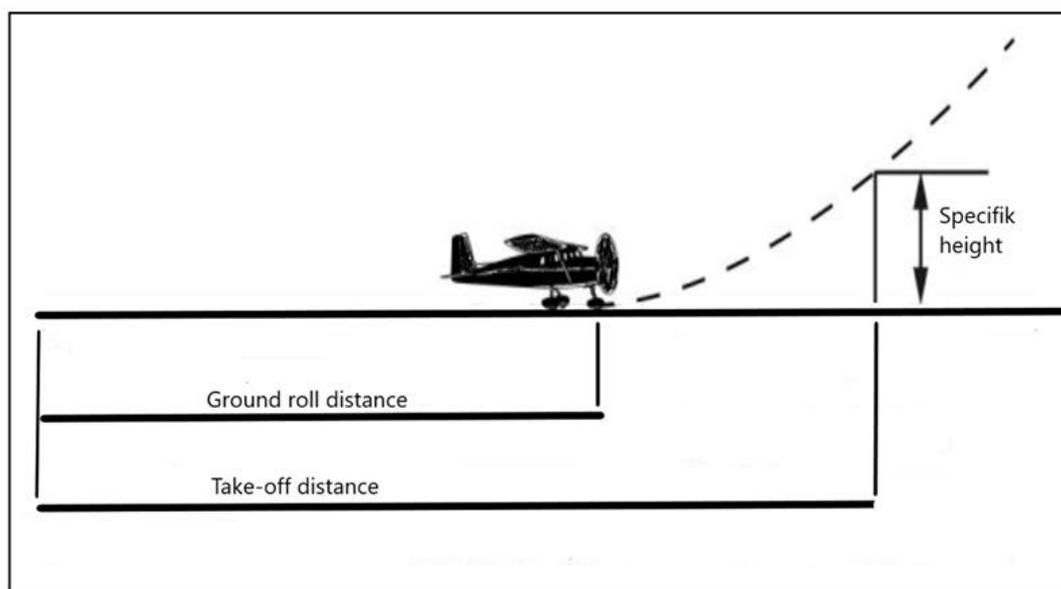
The total take-off distance of an aircraft consists of the horizontal distance it rolls on the ground before lift-off (ground roll) and the climb distance required to reach an obstacle clearance height or a specific height, usually 50 feet (15 metres), (see Figure 10).

Figur 10. Illustration of ground roll and take-off distances.

The total take-off distance (ground roll distance + distance in the air) to reach a height of 20 metres, i.e. the height the aircraft would have had to reach to climb above the trees, is therefore 225 + 186 metres = 411 metres.

The field had, in the chosen take-off direction, an available take-off distance of 360 metres. At the end of the field there were obstacles in the form of 20 metres high trees. SHK's performance calculations show that the required take-off distance to reach a height of 20 metres in the prevailing conditions was over 410 metres. The required distance thus exceeded the available take-off distance. Therefore, a safe take-off was not possible in the chosen take-off direction.

The accident highlights the importance of making performance calculations before each flight. Such calculations should consider the operational conditions and factors affecting the performance.
