**State Commission on Aircraft Accidents Investigation**  
**INCIDENT 2022/6333**  
**RESOLUTION**  
**of 21<sup>st</sup> August 2023**

| <b>Type and model of aircraft:</b> | Airplane, Piper PA28 / Helicopter, Sikorsky S-70 |
| <b>Registration marks:</b> | SP-SWB / SP-YVR |
| <b>Date of occurrence:</b> | 26 <sup>th</sup> November 2022 |

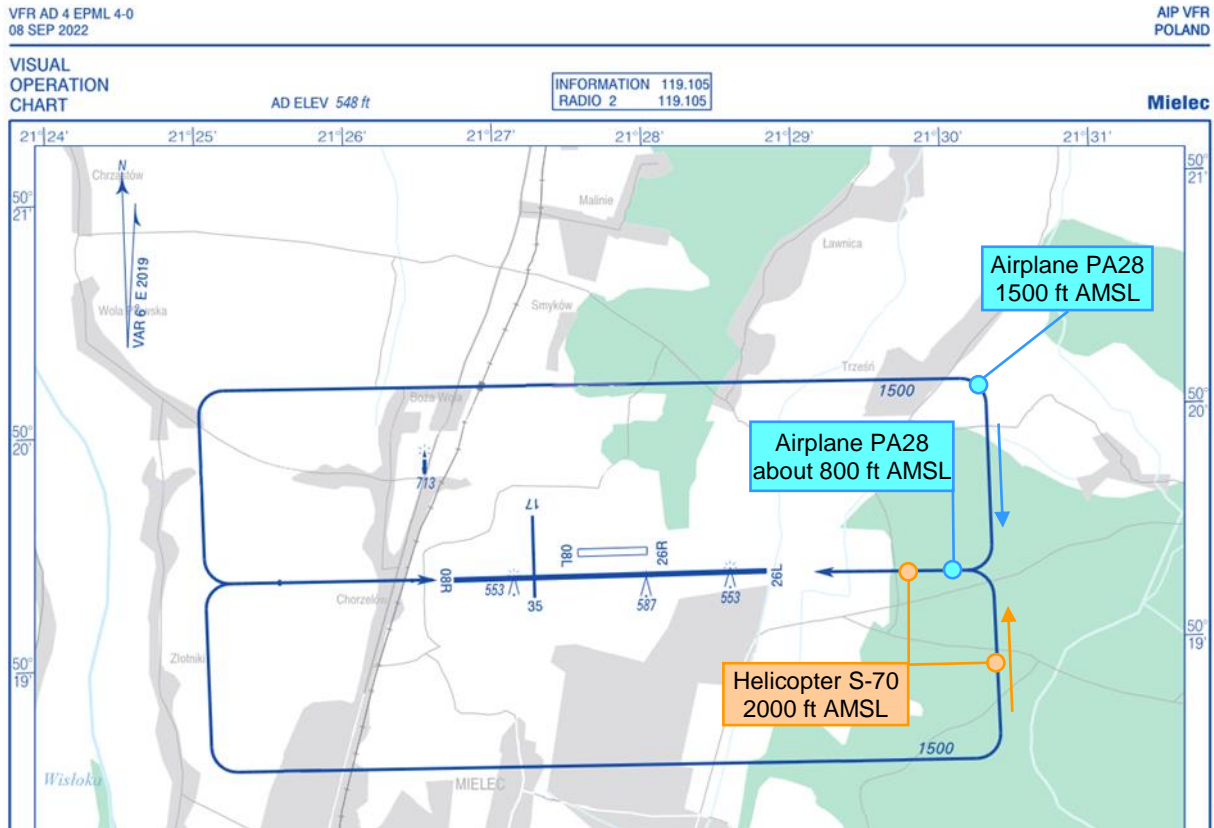
Figure 1. Sketch of the traffic situation at the time of the occurrence [source: SCAAI, PANSA]

Both aircraft were approaching from opposite directions to the fourth turn. The S-70 helicopter was ahead at an altitude of 2,000 ft AMSL, and the PA28 airplane was below and behind it.

<sup>6</sup> Aircraft crews and the AFISO used the expression "26" when specifying a concrete-surfaced runway, and the correct designation for this runway is "26L" (two-six-left), as shown in Figure 1.
