# PRELIMINARY REPORT

2023-0046

**Aeroklub Warszawski, training flight**  
**Cessna Aircraft Company, Cessna Grand**  
**Caravan 208B, SP-WAW**  
**Chrcynno airfield (EPNC), 17 July 2023**

Warszawa, 16th August 2023

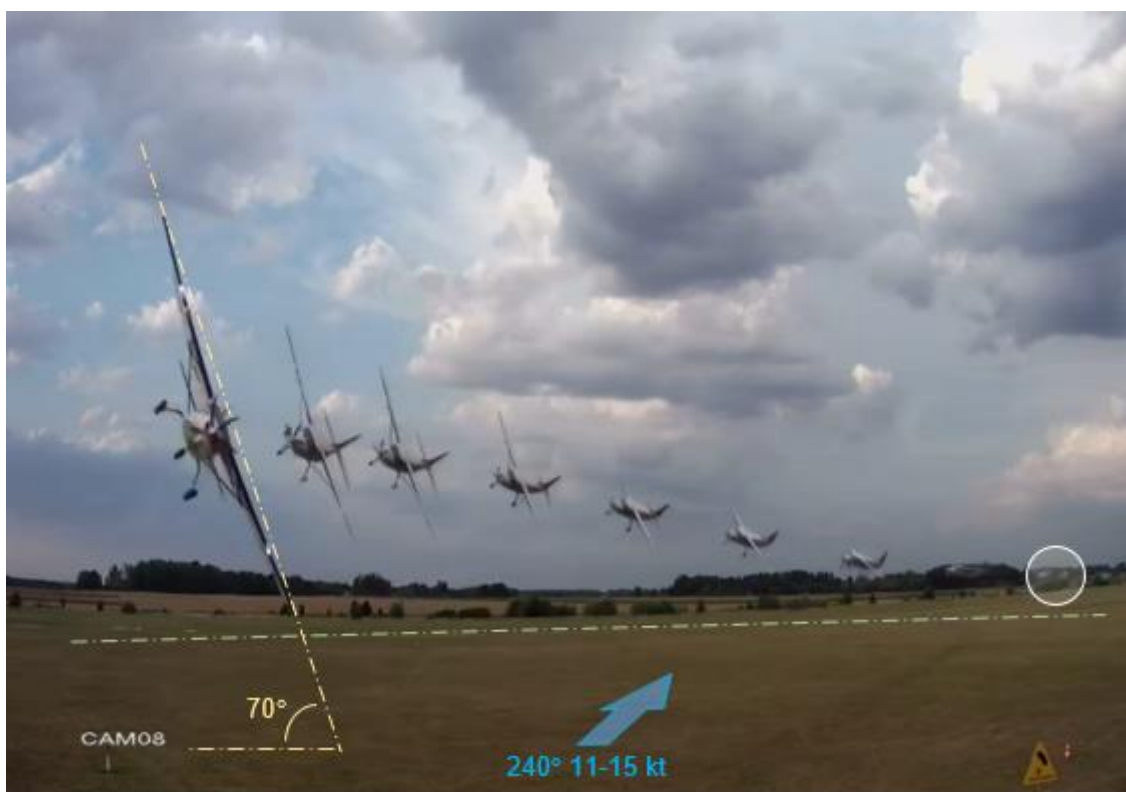
After taking over the control, the instructor increased the engine power to maximum, made a turn to the left, gradually deepening bank angle. With a bank angle of about 60°, the plane began to slide on the left wing, losing height (Fig. 1 and 2 - time-lapse recording from the camera installed on the "tower" of the airfield). At a bank angle of 70°, the left wing came into contact with the grassy surface of the airfield in the immediate vicinity of the "tower" of the airfield and the fence of the playground for children.

Fig. 1. Cessna 208B SP-WAW, in the flight after TAG, where: white circle – flight instructor takes control, yellow dashed line – bank angle, green dashed line – RWY centre line, blue arrow – approximate wind direction.

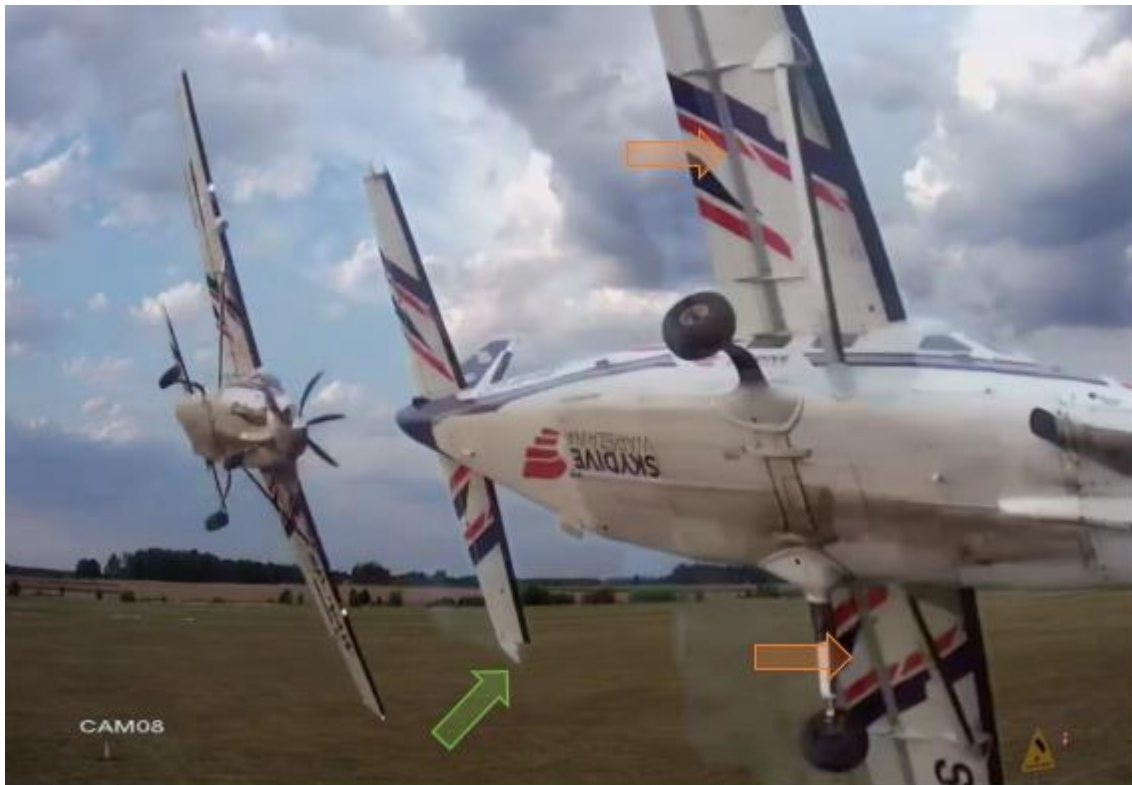
Fig. 2. Cessna 208B SP-WAW (next time-lapse photos - Fig. 1 continued), where: the right photo shows the moment of the left wing contact with the surface of the airfield, orange arrows show symmetrically extended wing flaps and green arrow shows the elevator deflected up.

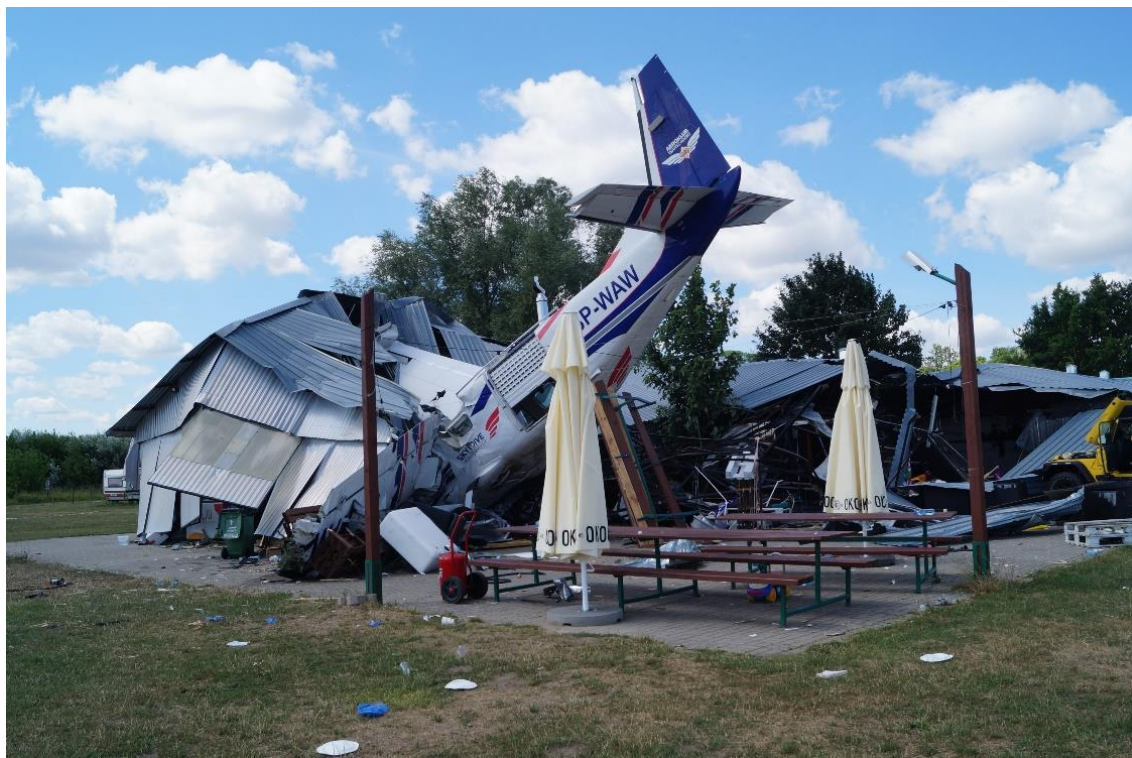
Fig. 1. Cessna Grand Caravan 208 B, SP-WAW, on the accident site.

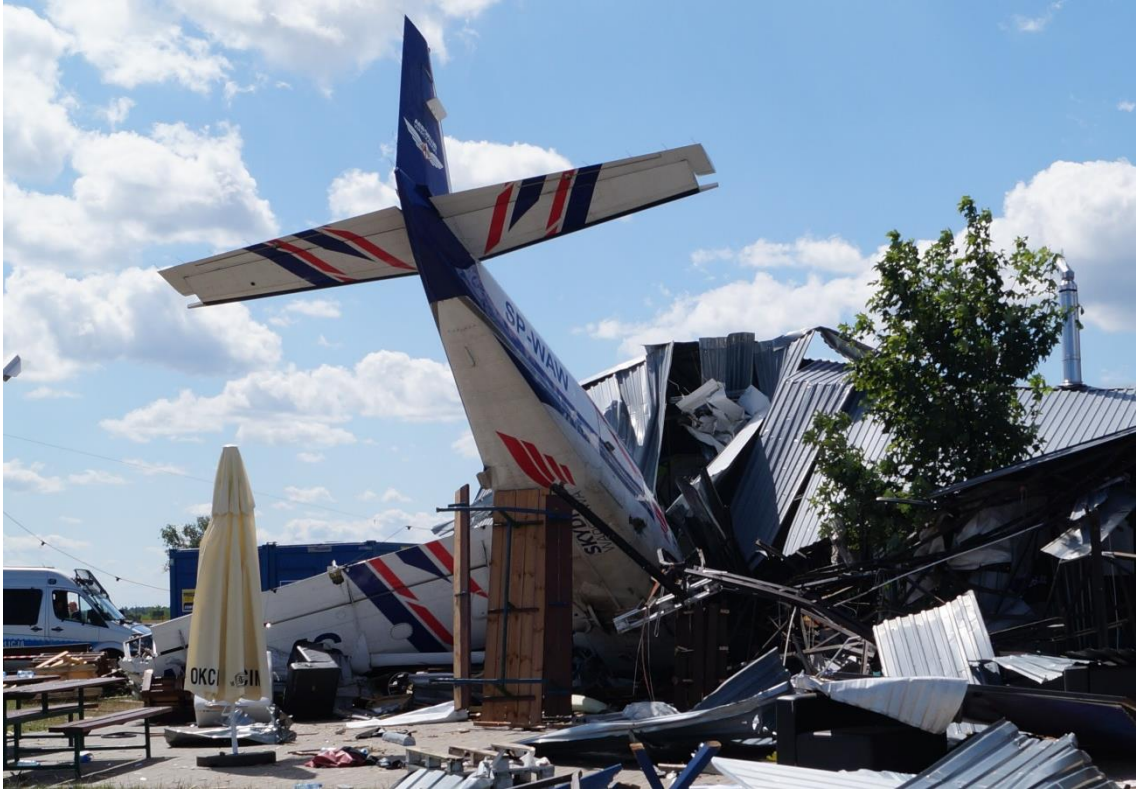
During the removal of the wreckage from the destroyed building, the fuselage skin in the tail part was deformed. When the wreckage was excavated, the fuselage, due to extensive damage, broke in a plane transverse to its axis, just behind the pilots' seats.

Fig. 2. Cessna 208B, SP-WAW – the wreckage before separating from the structure of the building (the photo shows a table supporting provisionally the tail of the aircraft to prevent its accidental movement).

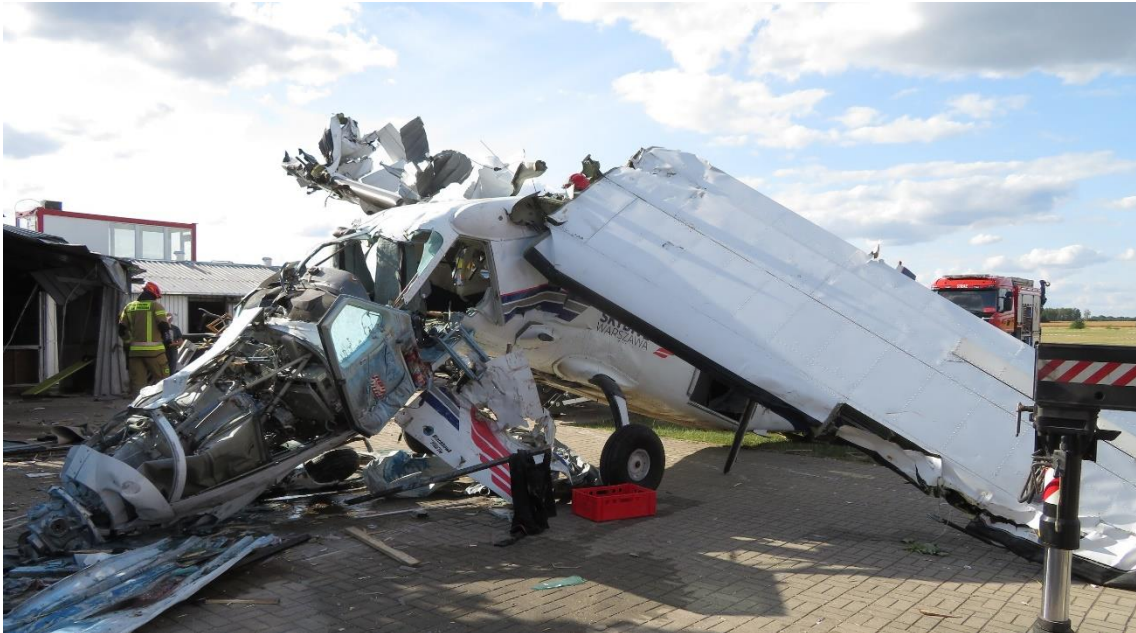
Fig. 3. Cessna 208B, SP-WAW – the wreckage after separation from the structure of the building.

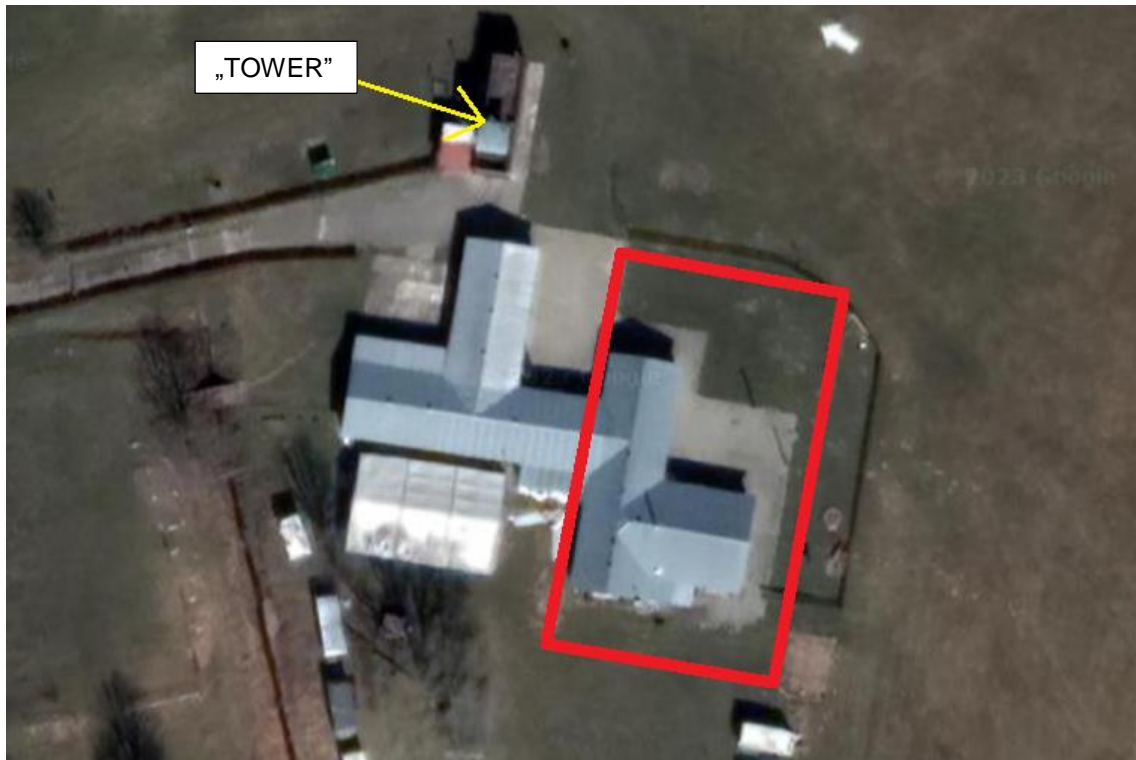
Fig. 4. The building on the airfield partially destroyed during the accident of the SP-WAW aircraft. The destroyed part of the building is marked with a red frame. [source: <https://www.google.pl/maps>].

The destroyed building was constructed of steel profiles constituting its skeleton, which was covered with corrugated sheet. The collision of the plane with the building caused the detachment of the sheet metal covering its front part, as well as the disintegration and deformation of the skeleton elements. The side and rear walls of the building did not collapse, but they were crooked. The roof of the building was torn apart by the plane and fell on its fuselage.

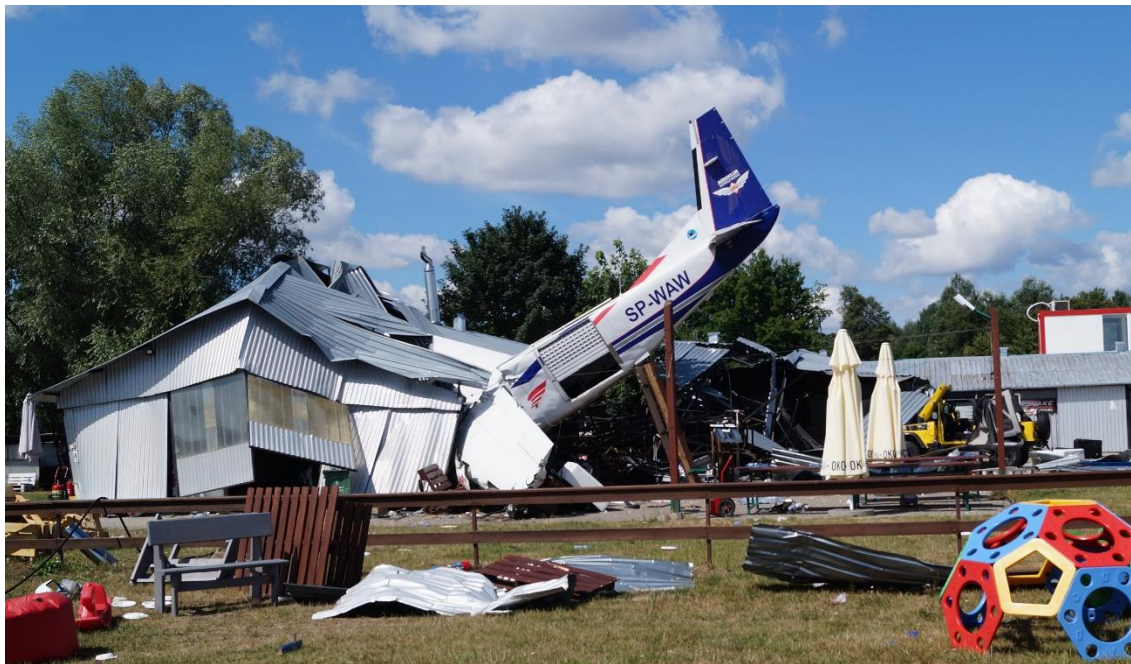
Fig. 5. Destroyed building located on the EPNC landing site. Umbrellas, benches, tables and elements of a playground for children are visible in front of the building.

Around the building, as a result of the rescue operation and then the operation of removing the wreck, the building's fence and the decorative lighting of the area in front of the building were destroyed.

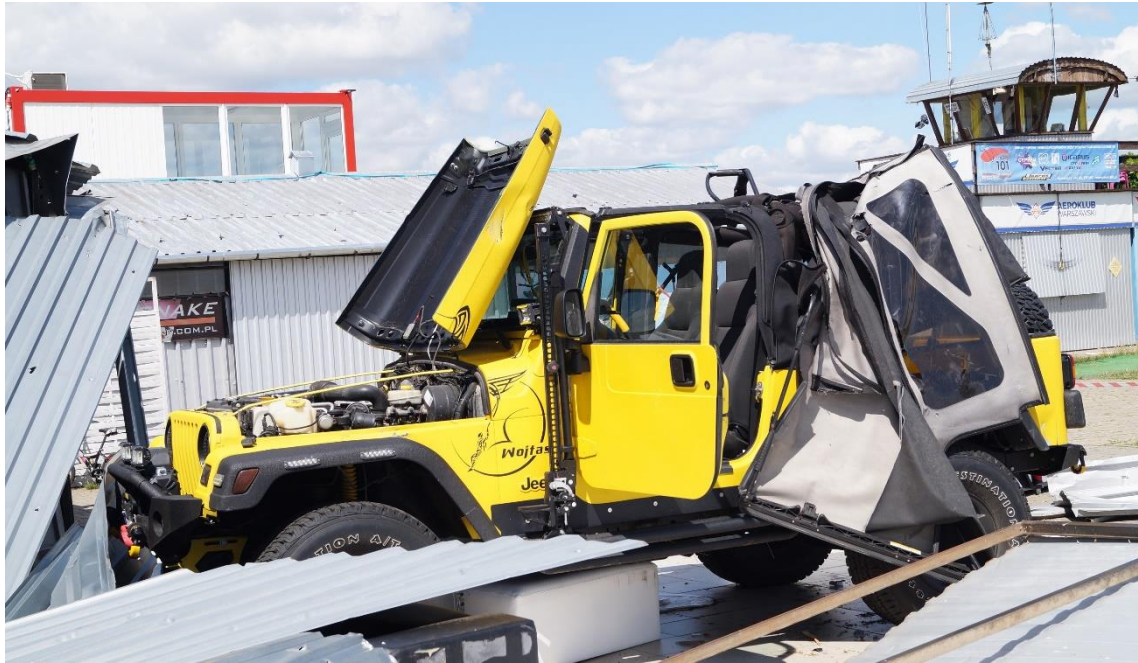
A Jeep was parked to the right of the building's front. The right wheel of the main landing gear hit the roof of the car during the accident, as a result of which the flexible roof covering of the vehicle was destroyed and the frame on which it was stretched was deformed. A number of personal belongings of the injured persons located in front of and inside the building were also damaged, such as mobile phones, children's bicycles, etc.

Fig. 6. The Jeep car damaged during the accident.

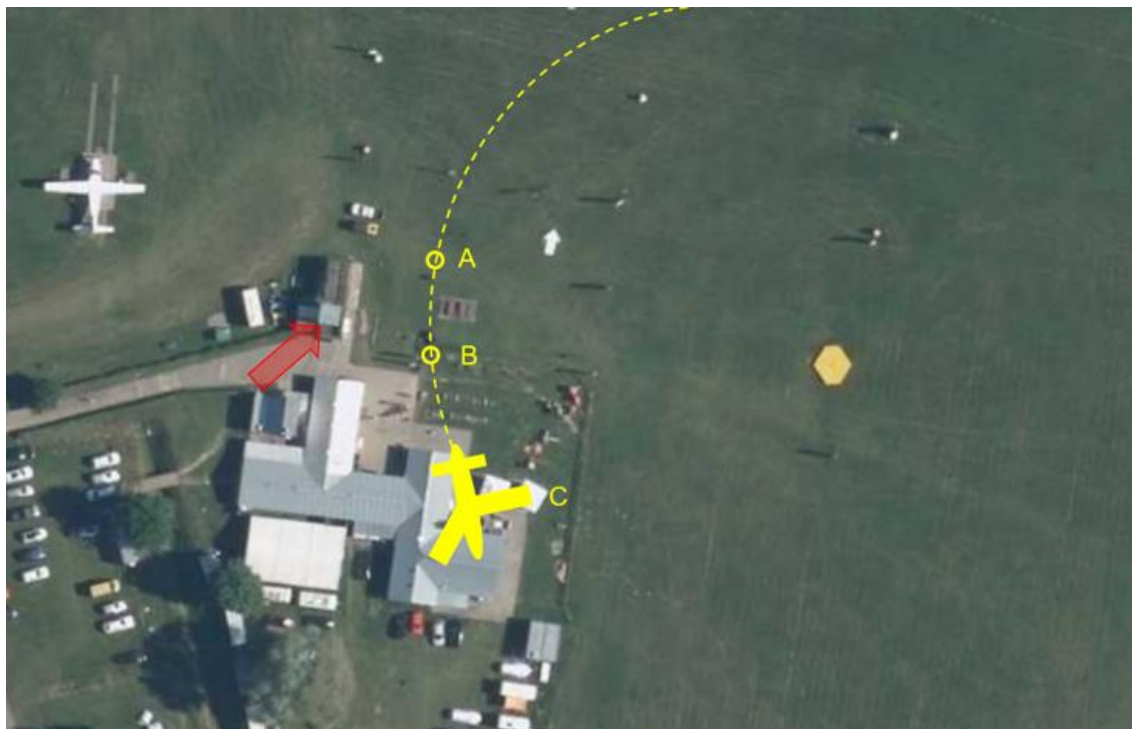
Fig. 7. Accident site. The following elements are marked in yellow: A – the place of the aircraft first contact with the ground (left wing tip); B – the place of the plane collision with the fence of the building; C – position of the wreckage. "Tower" of the airfield indicated by red arrow [source: <https://mapy.geoportal.gov.pl>].

The aircraft collided with the ground and then with the building having a high bank angle ( $70^\circ$ ) to the left wing. The first contact with the ground occurred in front of the building, next to the "Tower" of the landing site. After the accident, a trail of the left wing on the grass was visible in front of the building.

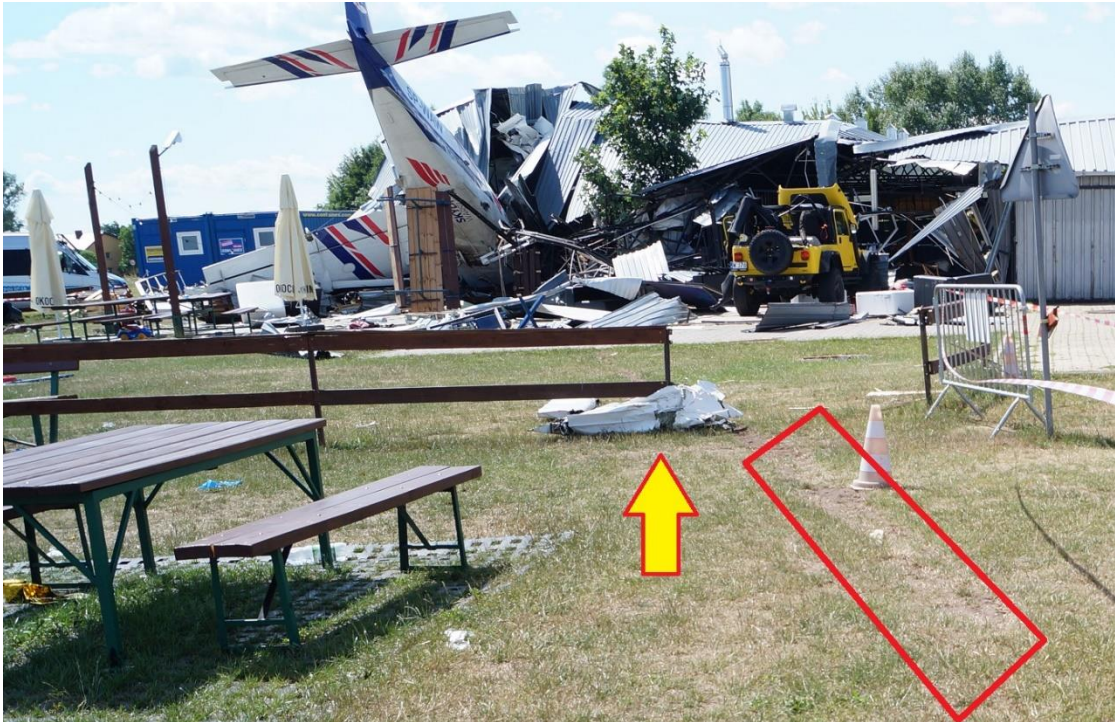
After about 10 meters, the left wing hit a low wooden fence in front of the building, as a result of which its tip and the left aileron separated from the wing. The wing tip remained on the fence post, while the aileron was found several meters further towards the building.

Fig. 8. Accident site. The red frame marks the trail of the left wing tip left on the grass in front of the building. The yellow arrow marks the tip of the left wing, which was torn off as a result of the collision of the wing with the building fence.

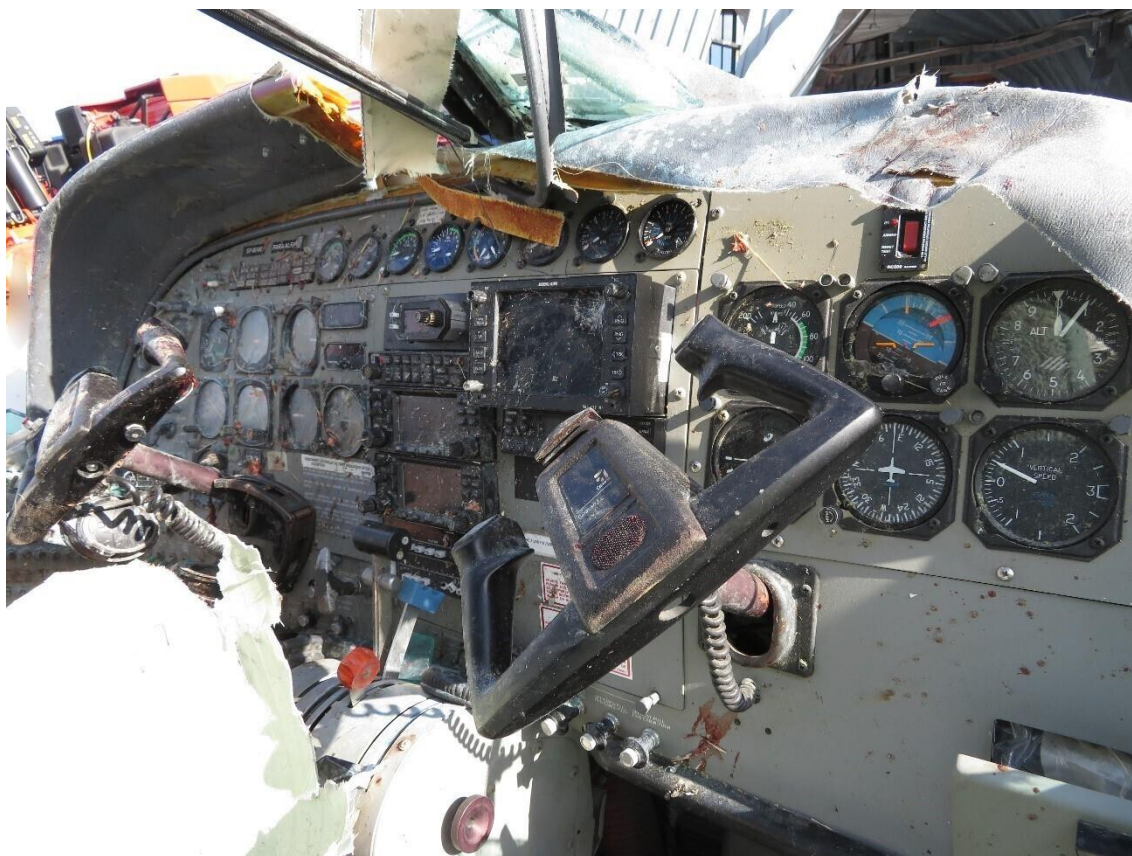
The figure below shows the cockpit after the accident. After the impact, the right control wheel was clean unlike the left one, which contained human remains. This proves that at the time of the collision the flight instructor had his hands on the control wheel, i.e. he was a Pilot Flying.

Fig. 9. Cockpit of Cessna 208B, SP-WAW after the accident. It is visible, that the right control wheel is clean in the places of hands location.

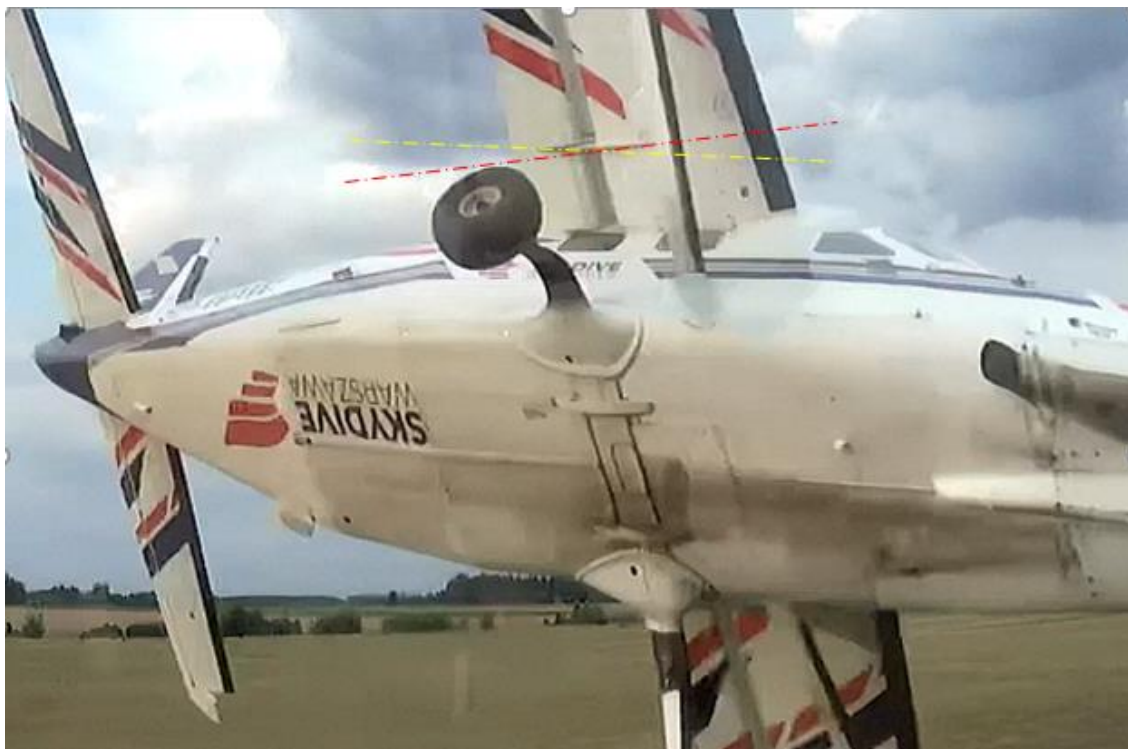
The above comparison shows that during the accident, the wing flaps of the aircraft were extended to an angle of 20°.

Fig. 15. Cessna 208B SP-WAW – enlargement of one of the frames from aerodrome camera, where: red line - extension of the edge of the flap track, yellow line - extension of the edge of the flap support assembly.
