PRELIMINARY REPORT

2023-0046

Aeroklub Warszawski, training flight
Cessna Aircraft Company, Cessna Grand
Caravan 208B, SP-WAW
Chrcynno airfield (EPNC), 17 July 2023

Warszawa, 16 August 2023

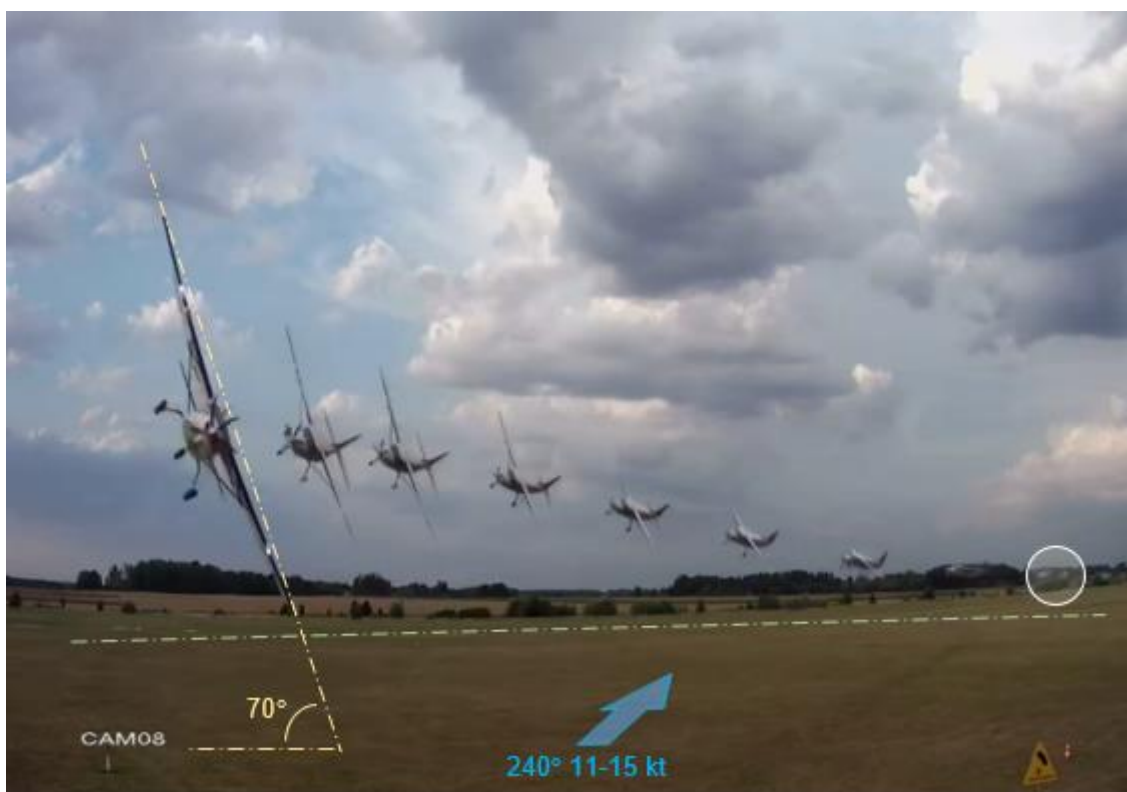
After taking over the control, the instructor increased the engine power to maximum, made a turn to the left, gradually deepening bank angle. With a bank angle of about 60°, the plane began to slide on the left wing, losing height (Fig. 1 and 2 - time-lapse recording from the camera installed on the "tower" of the airfield). At a bank angle of 70°, the left wing came into contact with the grassy surface of the airfield in the immediate vicinity of the "tower" of the airfield and the fence of the playground for children.

Fig. 1. Cessna 208B SP-WAW, in the flight after TAG, where: white circle – flight instructor takes control, yellow dashed line – bank angle, green dashed line – RWY centre line, blue arrow – approximate wind direction.

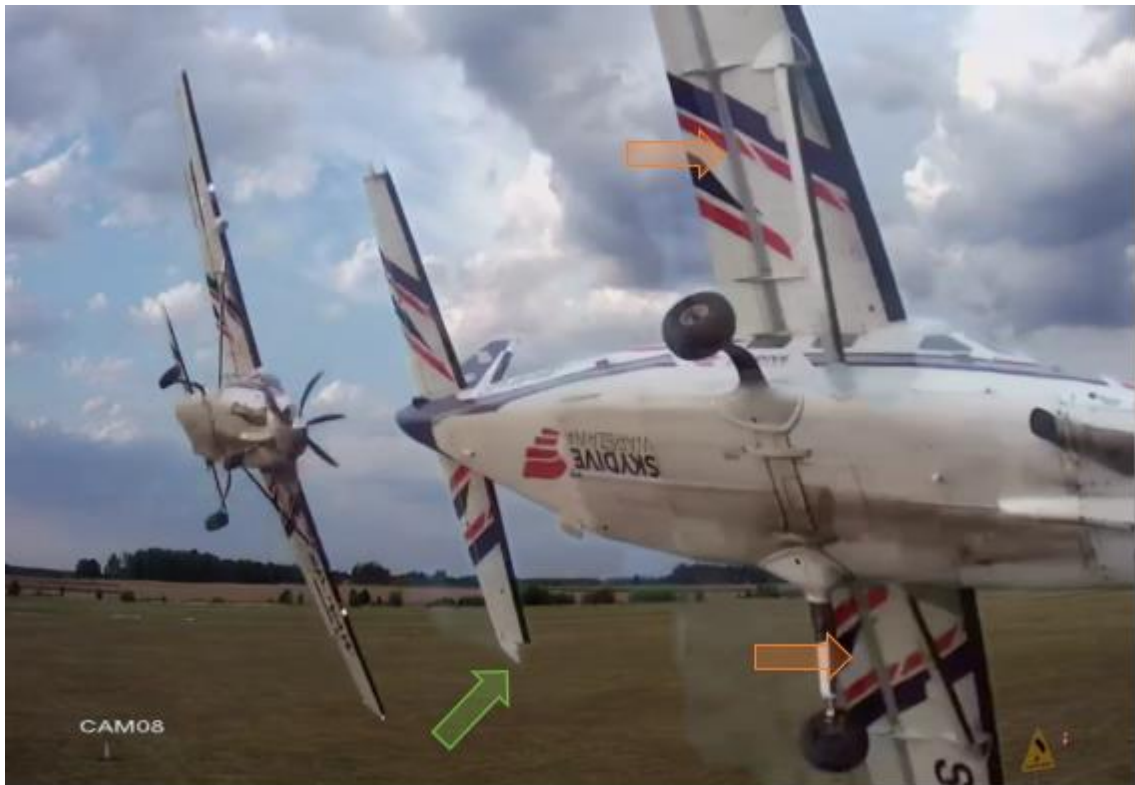
Fig. 2. Cessna 208B SP-WAW (next time-lapse photos - Fig. 1 continued), where: the right photo shows the moment of the left wing contact with the surface of the airfield, orange arrows show symmetrically extended wing flaps and green arrow shows the elevator deflected up.

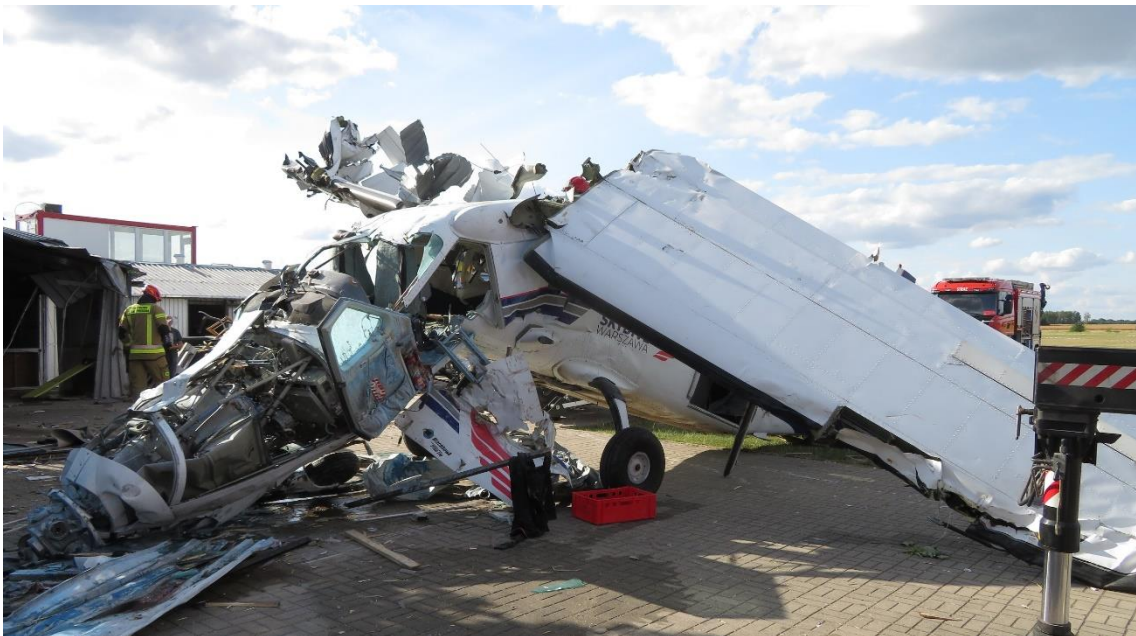
Fig. 3. Cessna 208B, SP-WAW – the wreckage after separation from the structure of the building.

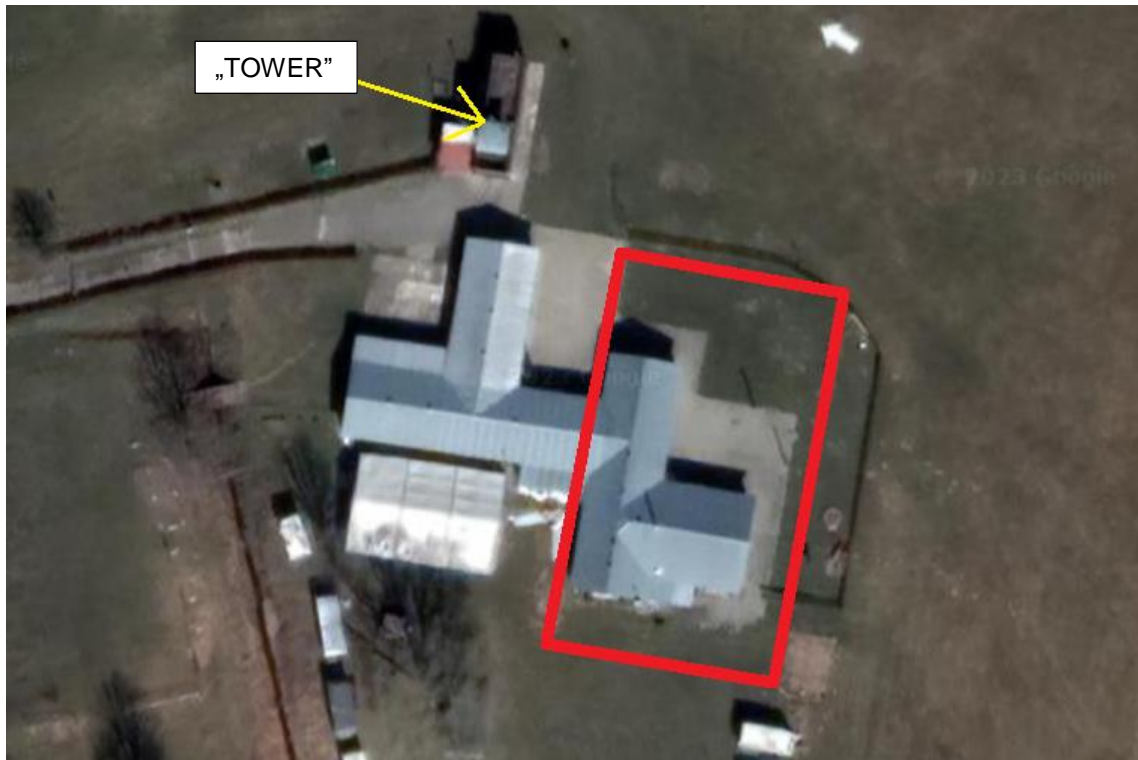
Fig. 4. The building on the airfield partially destroyed during the accident of the SP-WAW aircraft. The destroyed part of the building is marked with a red frame. [source: <https://www.google.pl/maps>].

The destroyed building was constructed of steel profiles constituting its skeleton, which was covered with corrugated sheet. The collision of the plane with the building caused the detachment of the sheet metal covering its front part, as well as the disintegration and deformation of the skeleton elements. The side and rear walls of the building did not collapse, but they were crooked. The roof of the building was torn apart by the plane and fell on its fuselage.

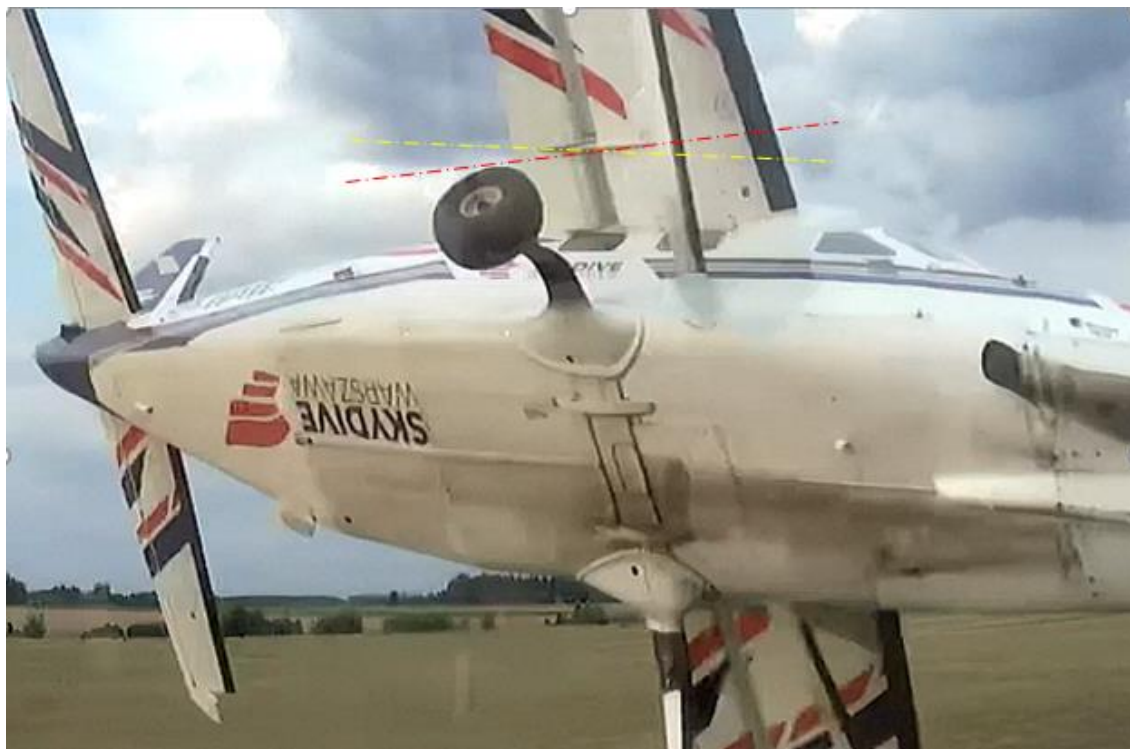
The above comparison shows that during the accident, the wing flaps of the aircraft were extended to an angle of 20°.

Fig. 15. Cessna 208B SP-WAW – enlargement of one of the frames from aerodrome camera, where: red line - extension of the edge of the flap track, yellow line - extension of the edge of the flap support assembly.
